Phase I
Inspection
Report for
June 1979 **MATILIJA
DAM**

NATIONAL PROGRAM FOR INSPECTION OF DAMS
PHASE I INSPECTION REPORT
FOR
MATILIJA DAM
VENTURA COUNTY, CALIFORNIA

NATIONAL DAM INSPECTION PROGRAM
PHASE I REPORT
MATILIJA DAM

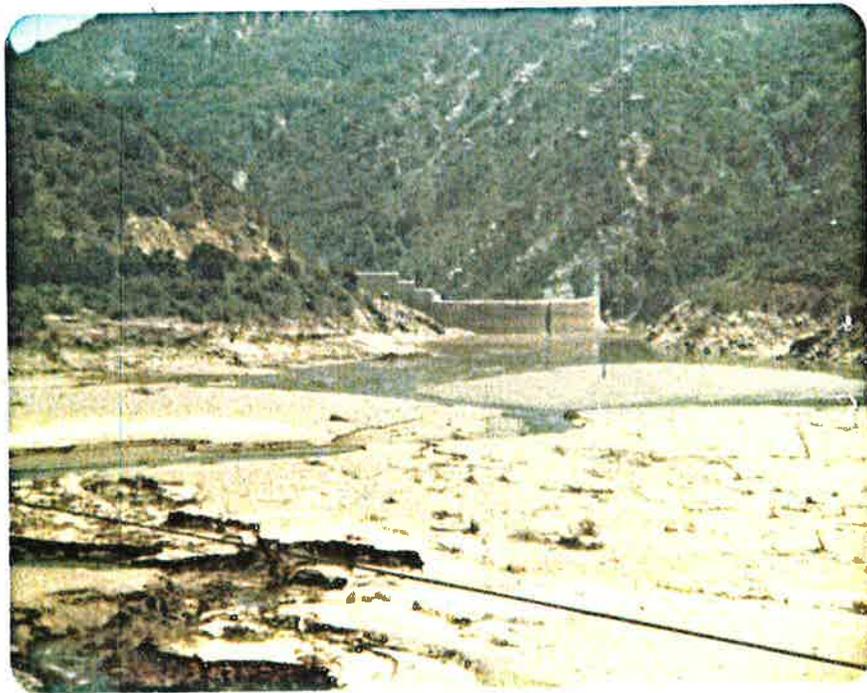
Photo No. 5.1
Dam and reservoir depositions.

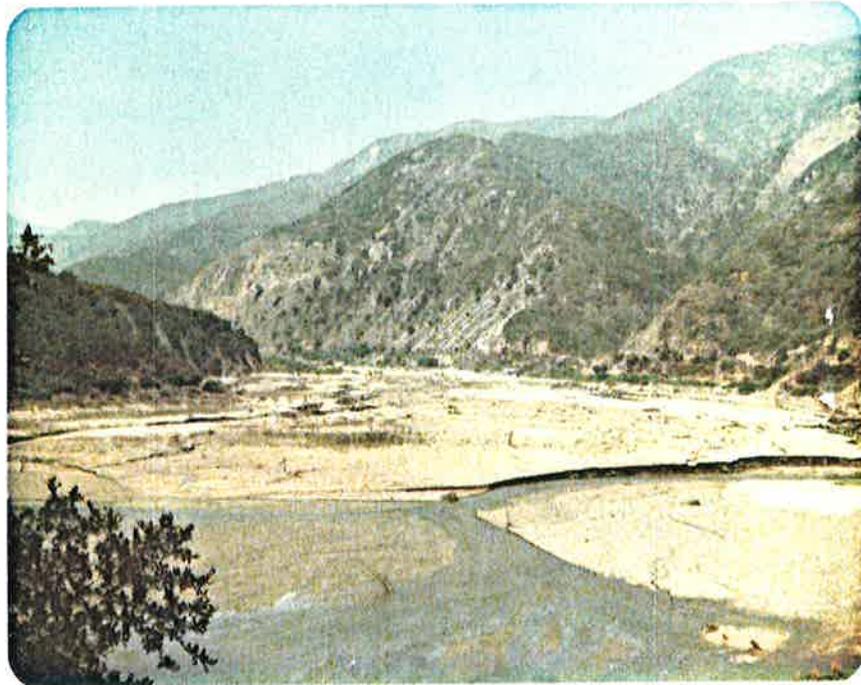
Photo No. 5.2
Drainage area showing steepness
and erosional areas.

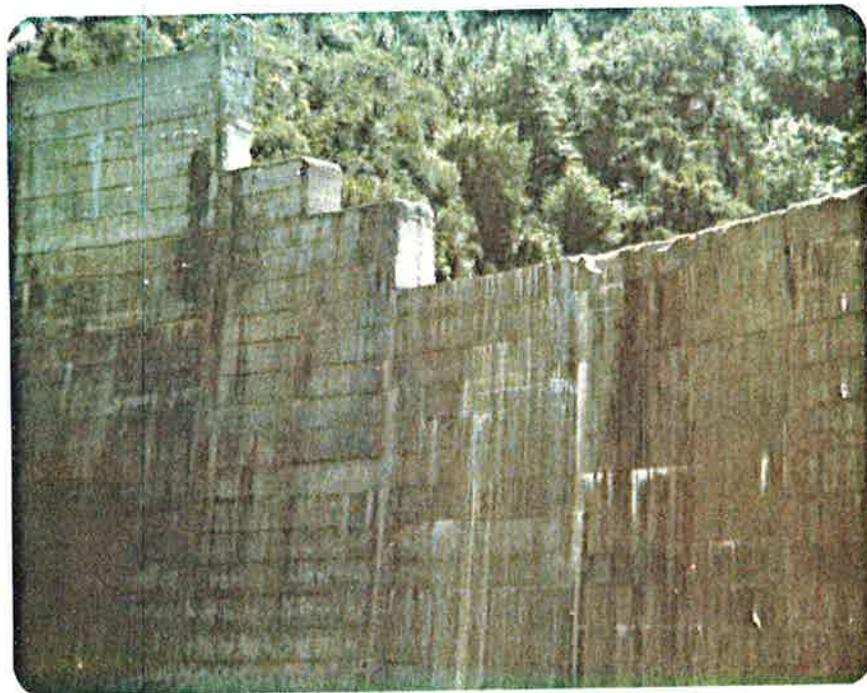
The dam continues to crack both along lift lines and subparallel to the boundaries of the spillway notch which was cut in 1965 and enlarged in 1978.

Photo No. 5.3
Left side of arch. Note cracking at
lift lines.

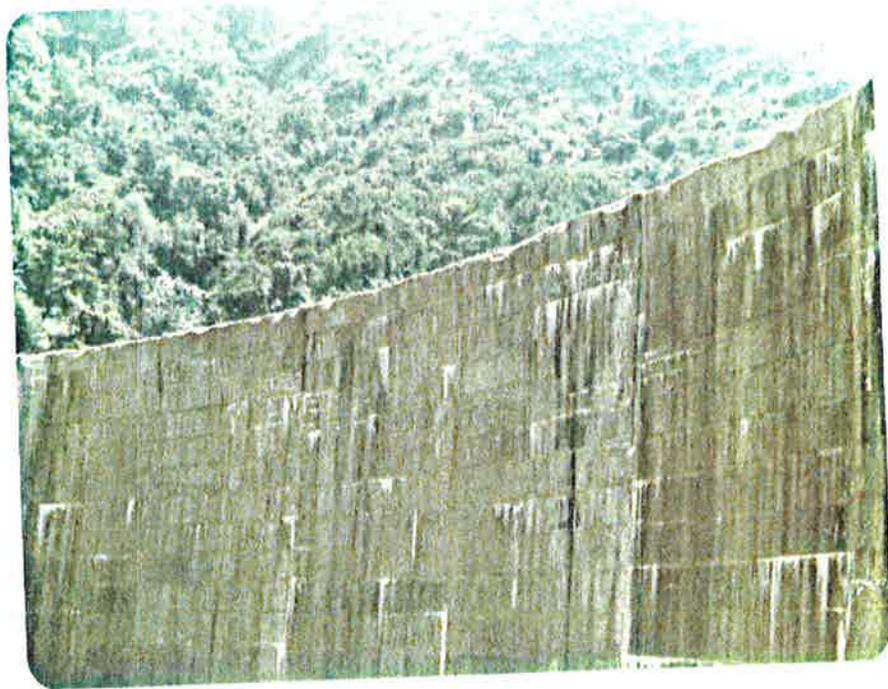
Photo No. 5.4
Center arch. Note crack pattern on
lifts and between lifts.

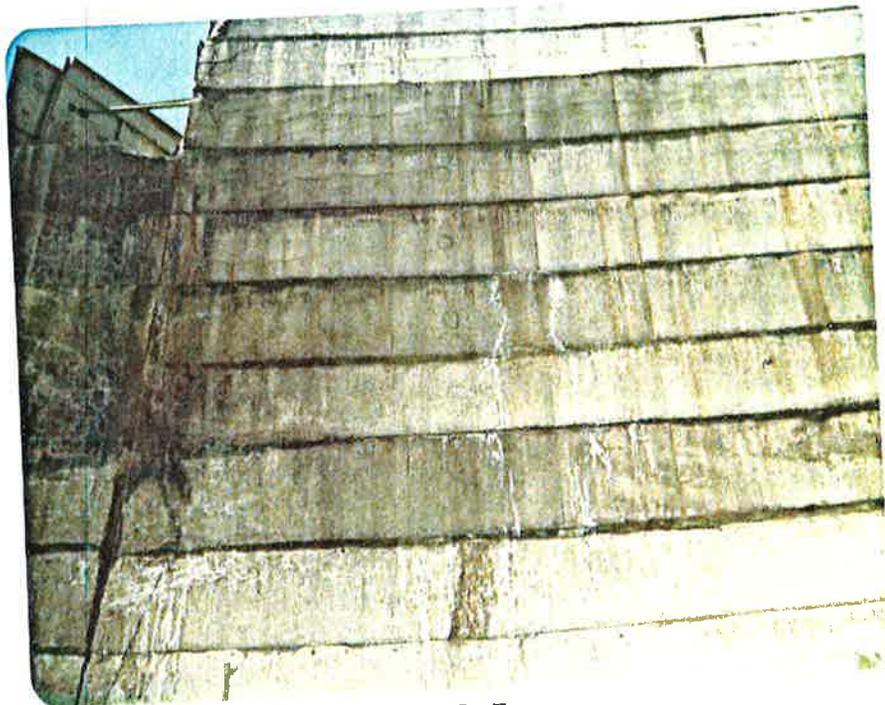
Photo No. 5.5
Downstream face above outlet. Note
cracking adjacent to notch and large
crack openings on lift joints.

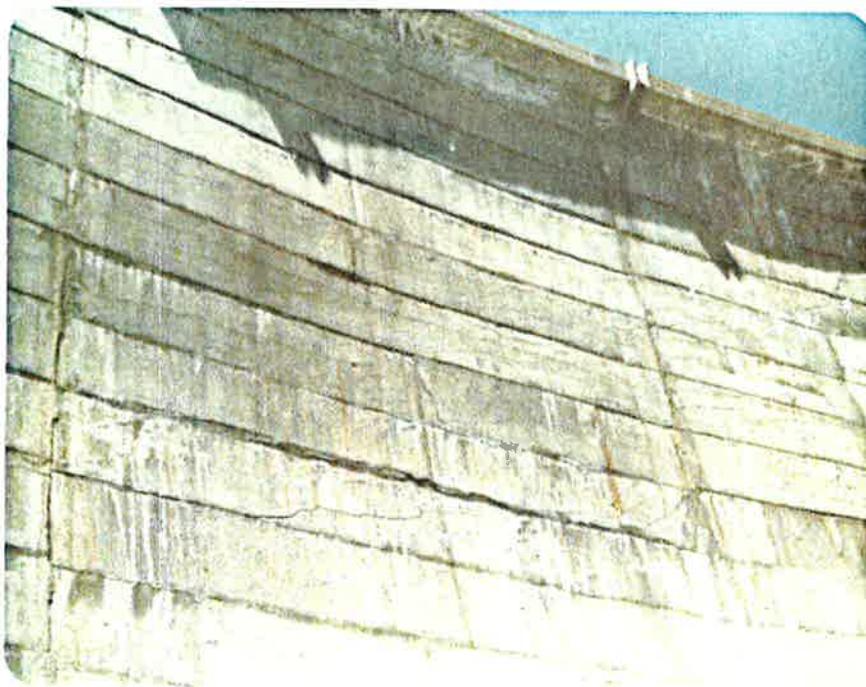
Photo No. 5.6
Downstream face above and left of
outlet. Note cracking.

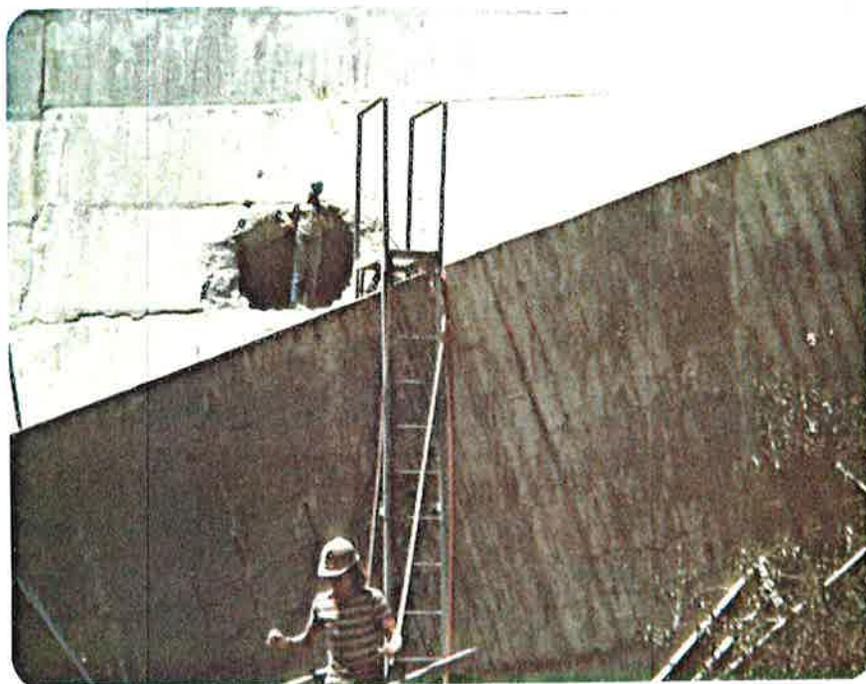
Photo No. 5.7
New 42-inch outlet under construction.

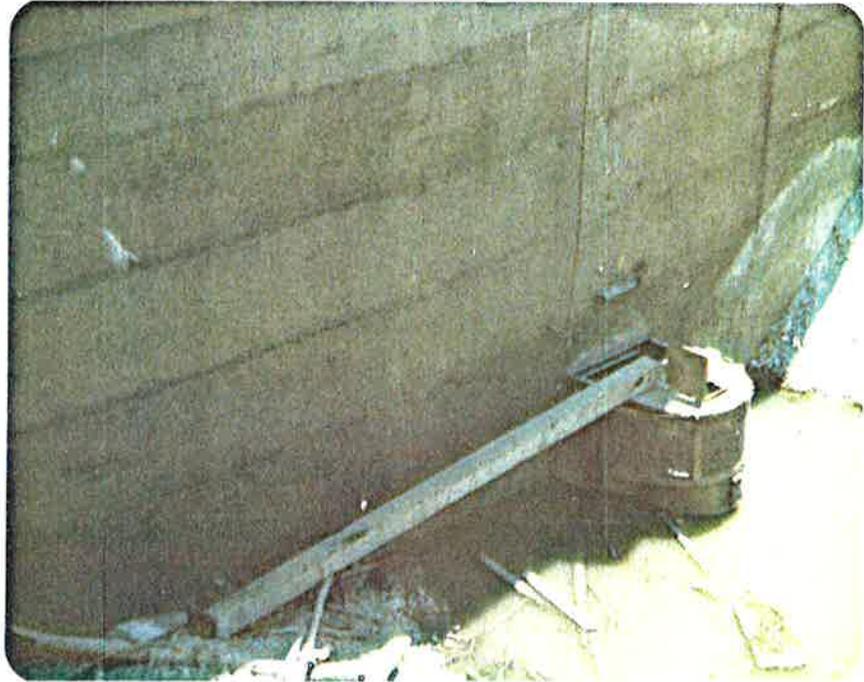
The temporary meter riser installed in 1970 was found to be damaged, apparently buckled inward during releases this past winter. Mr. Stephenson informed Mr. Sheydayi that the riser should be replaced this year. (Subsequently confirmed by letter July 12, 1978.)

Photo No. 5.8
Outlet intake riser. Note damaged area.

3. To maintain outlet capacity the intake riser should be repaired. This has been requested of the owner. The owner has filed and received approval from the California Division of Safety of Dams for replacement of the intake riser; construction is scheduled for the fall of 1979.
