GEOLOGICAL REPORT

MATILIJA DAM

GEOLOGICAL CONDITIONS AT MATILIJA DAM

A Report as of May 25, 1947

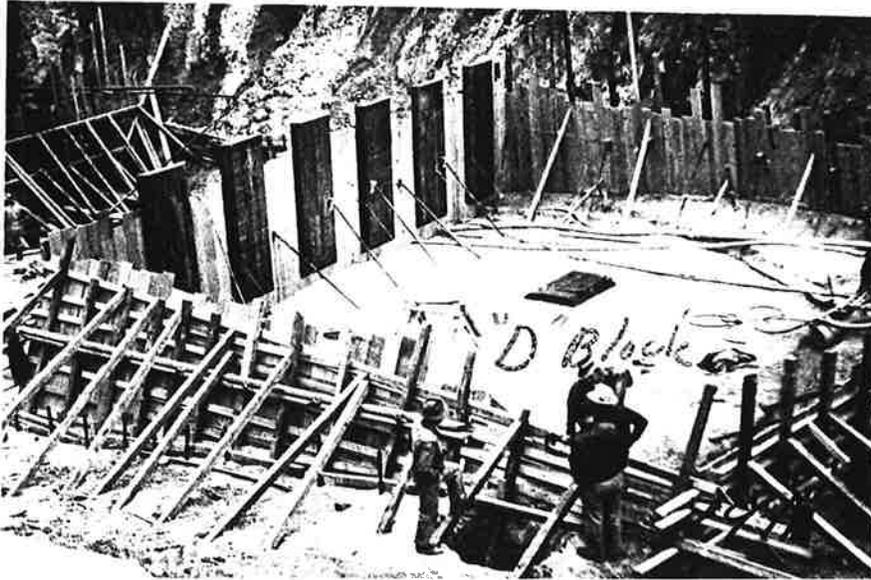
PHOTOGRAPH NO. 1

Photograph of the Base and Block D showing only white sand with entire lack of sound rock ledges of any kind. In places such ground as this was said to be have been so soft that marks would be made if one simply walked across the floor. It is such condition that suggests the probability that hot waters and gases have in former time issued from this ground.

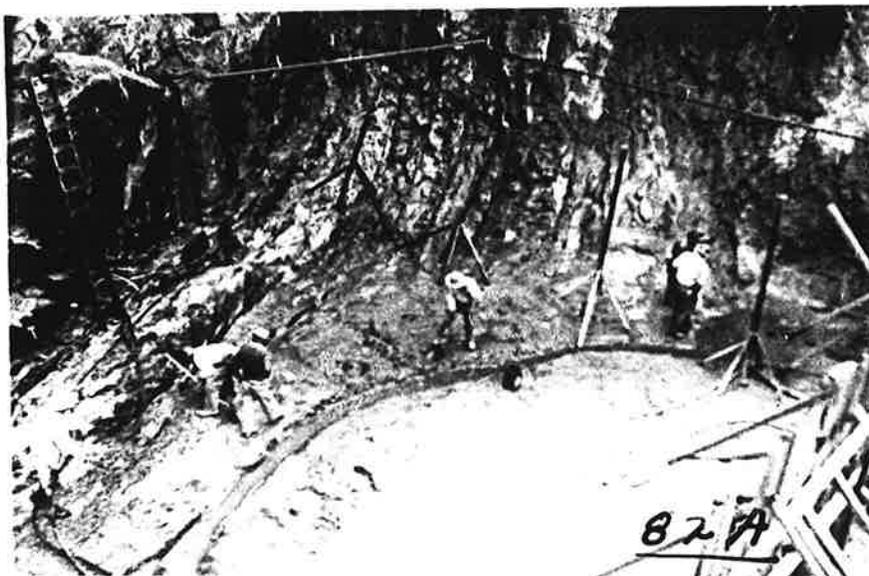
PHOTOGRAPH NO.3

This is a photograph of an excavation at a point where up-standing ledges of more or less stability begin to come in and take the place of superficial talus and river debris and over-soft rock. Exact location not given.
