MATILIJA DAM

F.E. BONNER 5/25/49

MEMORANDUM RE
MATILIJA DAM - VENTURA COUNTY

F. E. Bonner
Consulting Engineer
San Francisco, California

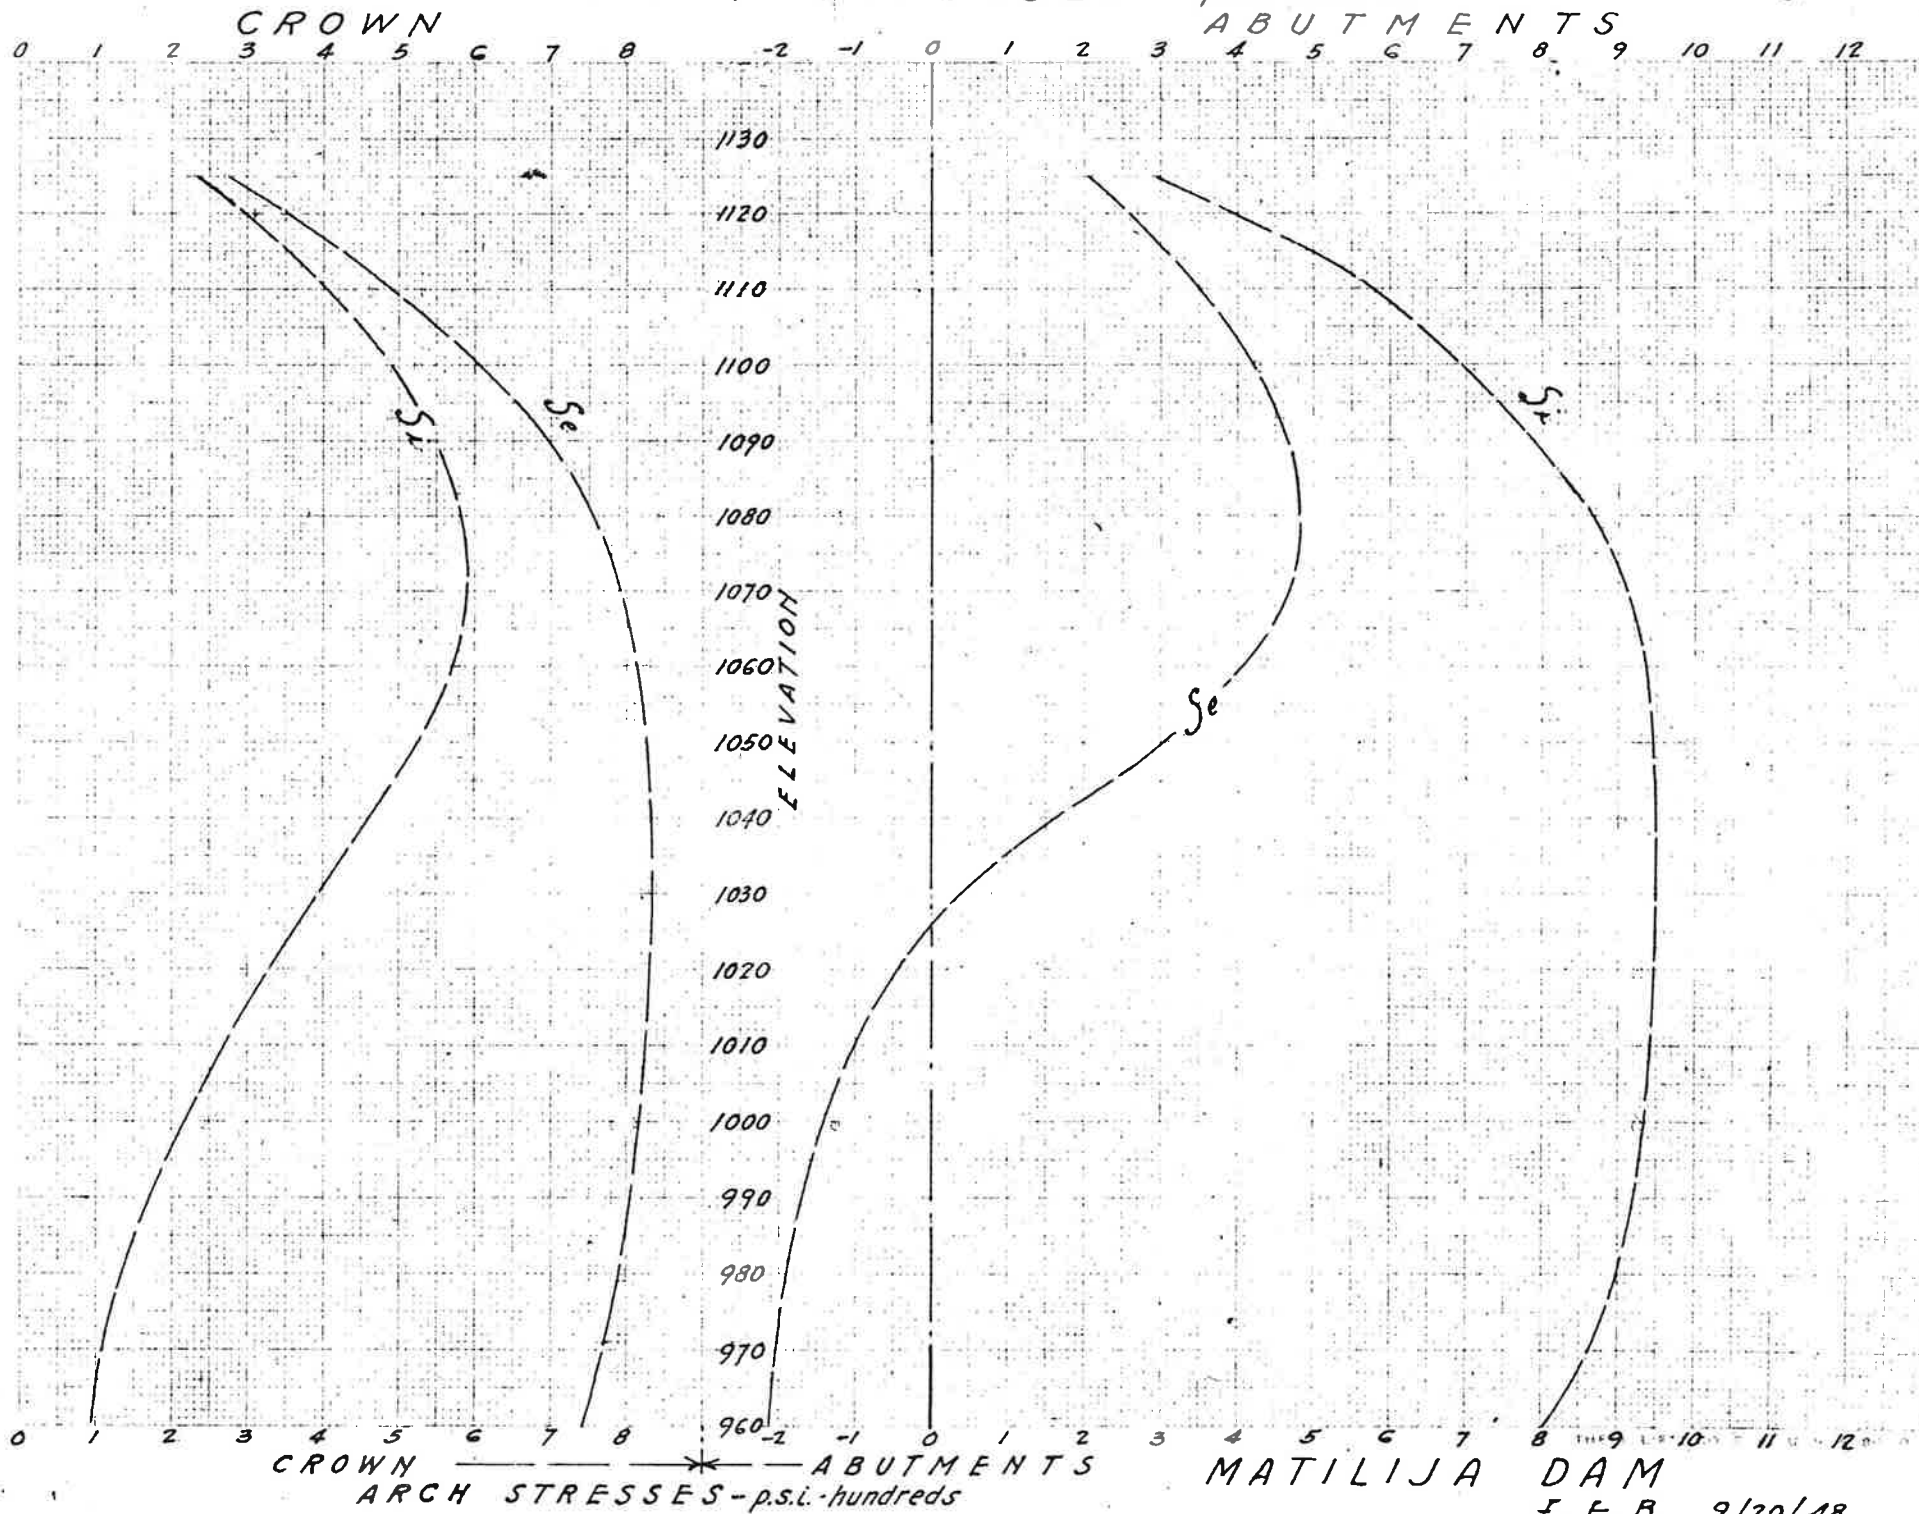
PLATE 1

With the improvement of the technique of making high strength concrete in recent years, the tendency has been toward the allowance of greater stress limits in the design of arch dams. In the design of the Matilija arch full advantage was taken of this tendency and the resulting structure has more slender proportions than usual. A general check of the arch stresses shows rather high values over large sectors but they can hardly be rated as dangerously high for good quality concrete. Plate 1 herewith shows the stresses to be expected under full water load. It will be observed that the crown stresses at the extrados range slightly above 800 p.s.i. up to elevation 1070 and more than 900 p.s.i. may develop at the intrados of the abutments. In current conservative practice a maximum working stress of 800 p.s.i. is customary. On the other hand, the record of the Smith Emery Laboratory tests of the concrete placed in the arch indicates average 28 day compressive strength of approximately 4500 p.s.i. This is better quality than usual and serves to compensate for the high unit working stress of the design. The factor of safety of 4 to 5 which is provided is about the margin considered necessary to allow for indeterminate internal stresses arising from other forces than the water load. One feature not to be overlooked is the added load which may be placed on the arch by the accumulation of silt in the reservoir. It is known that the tributary watershed rates high in silt production. No investigations have been made in this specific basin, but conditions are similar

To summarize my opinion regarding the adequacy of the arch it may be stated that while conservative practice would require a structure of more ample proportions, particularly in view of the precarious foundation and the proposal to pass large flood flows by free overfall, the excellent character of the concrete construction compensates for the slimness of the cross section in such degree that the arch is safe against com-

pression failure. This is on the assumption, of course, that the abutment and foundation rock as now fortified through grouting operations proves to be tight and unyielding. That question is in the hands of the geologists.

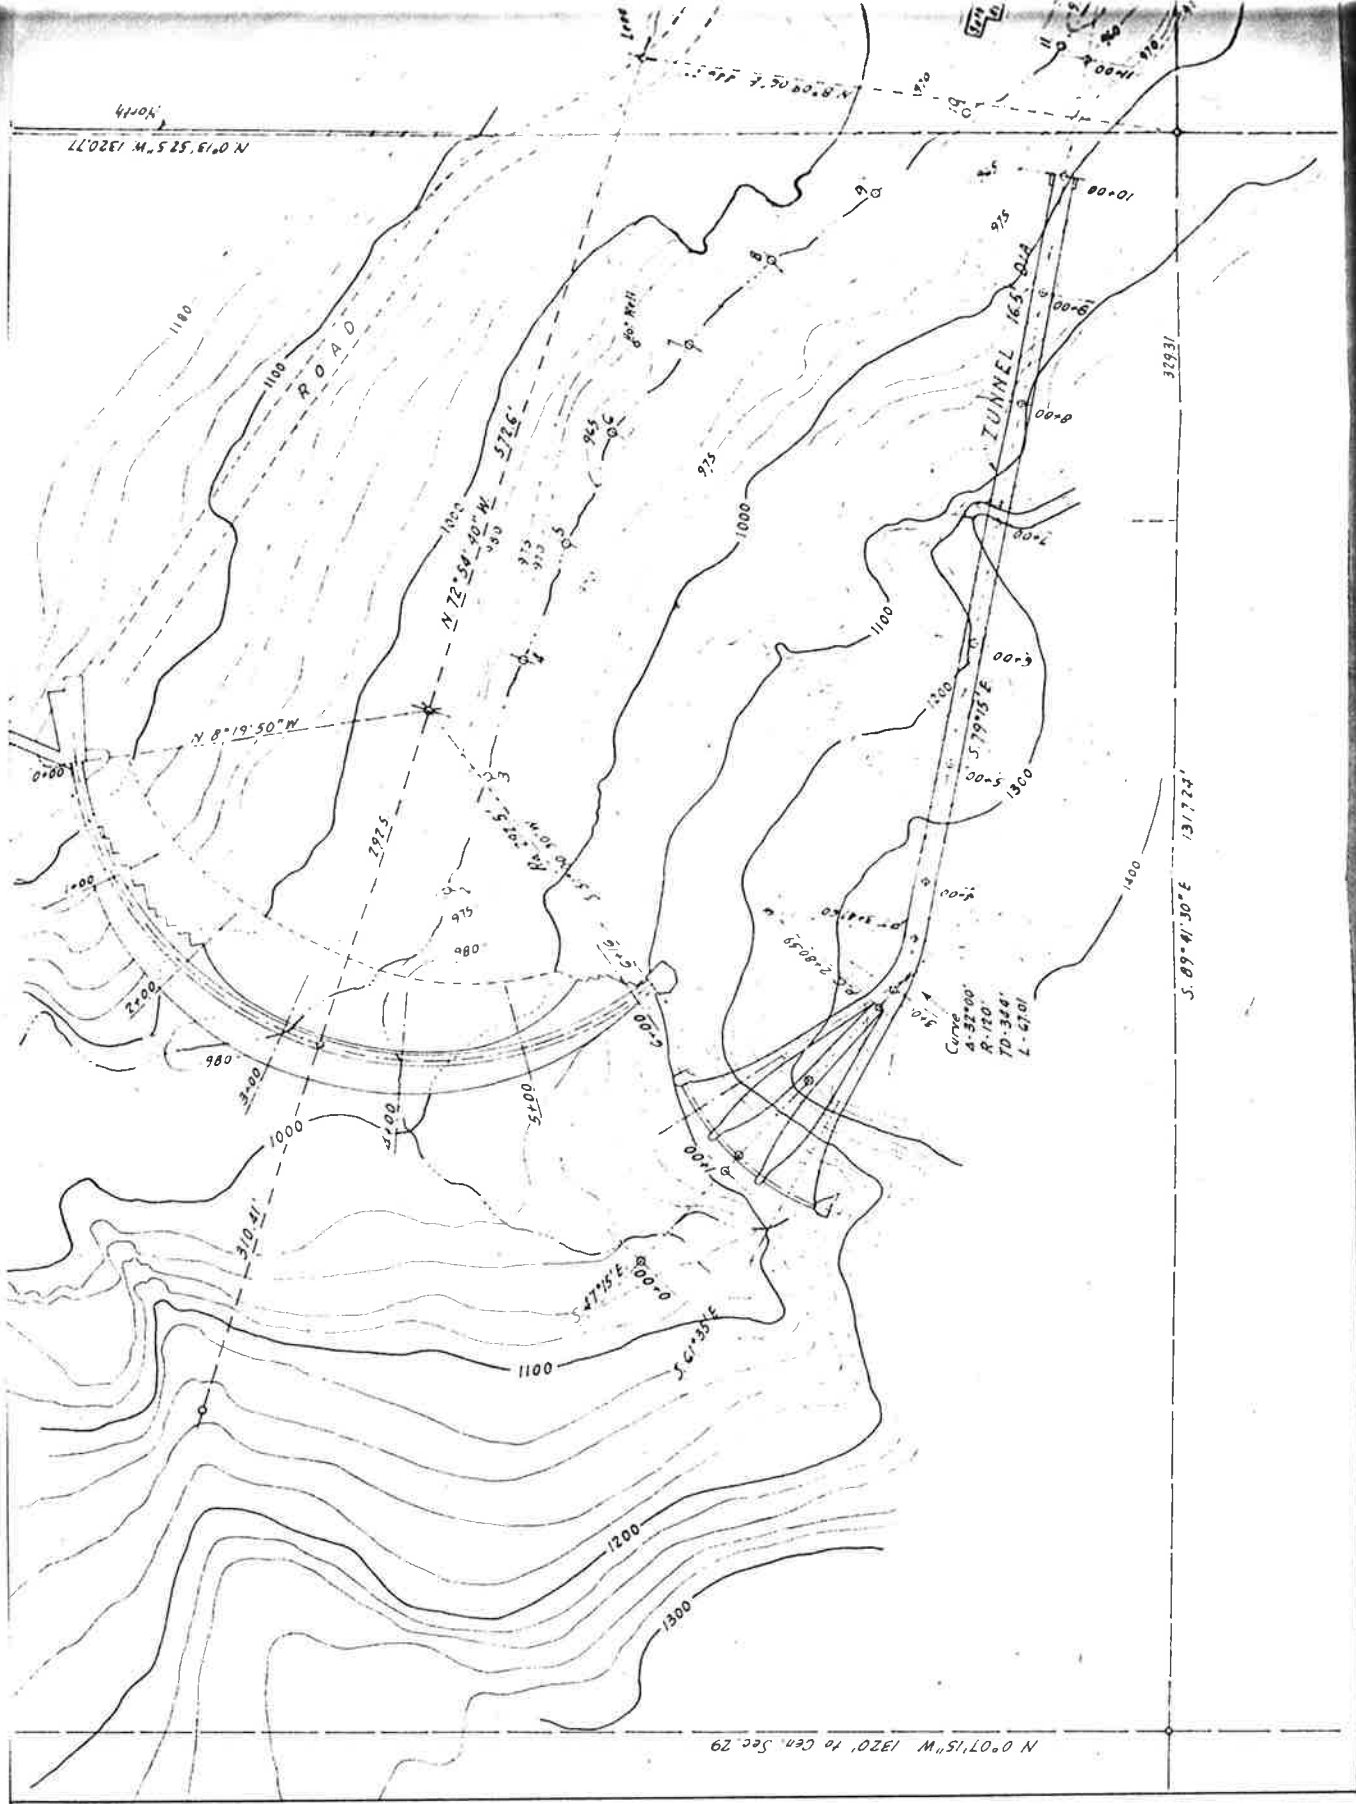
PRELIMINARY LAYOUT
 TUNNEL SPILLWAY
 MATILIJIA DAM
 SCALE 1"=100'
 F.E. BORNHAR 1/20/49

Further study demonstrated that the most favorable prospect for a separate spillway comprises a tunnel around the right abutment of the dam. A preliminary plan is presented by Plate 11 herewith. Plate 12 shows the design in profile. The concrete entrance weir, with crest at elevation 1115 would consist of three bays, each 45 ft. wide and discharging to steep inclined tunnels of 10 ft. diameter. At the bottom of the 45° slope the three tunnels would be merged by transition section into a single concrete lined tunnel of 16.5 ft. diameter extending 650 ft. on 7.5% grade to a junction with Matilija Creek just above the Springs. With reservoir water level at elevation 1125 this spillway would discharge about 16,000 sec. ft. In the opinion of the District's geologists the sandstone ledge formations, through which the tunnel would penetrate at right angles, is entirely suitable for this type of construction. The cost of construction is

estimated at \$670,000 without crest gate control. The effective capacity of the reservoir would be reduced 1200 acre feet. In the event crest gates were added to avoid this loss of storage capacity, the cost would be increased about \$60,000. Map data upon which the plan was based is subject to question and reliable surveys are needed before detailed layout, quantity calculations and cost estimates may be undertaken. This is particularly true at the site of the weir.

(b) Topographic survey and geological investigation be made of the area involved in the suggested tunnel spillway around the right abutment of the dam to serve as a basis for detailed plans and estimates.
