***Inspection Report
Of
Foothill Road over Adams Barranca
Bridge No. 402
Santa Paula, California***

Inspected for:
County of Ventura
Transportation Department
800 S. Victoria Ave
Ventura, CA 93009

Inspection Date: November 11, 2010
Report Prepared by: Gary Buelow
Load Rating Calculations by: N/A
Report Reviewed by: Sam Xie, PE

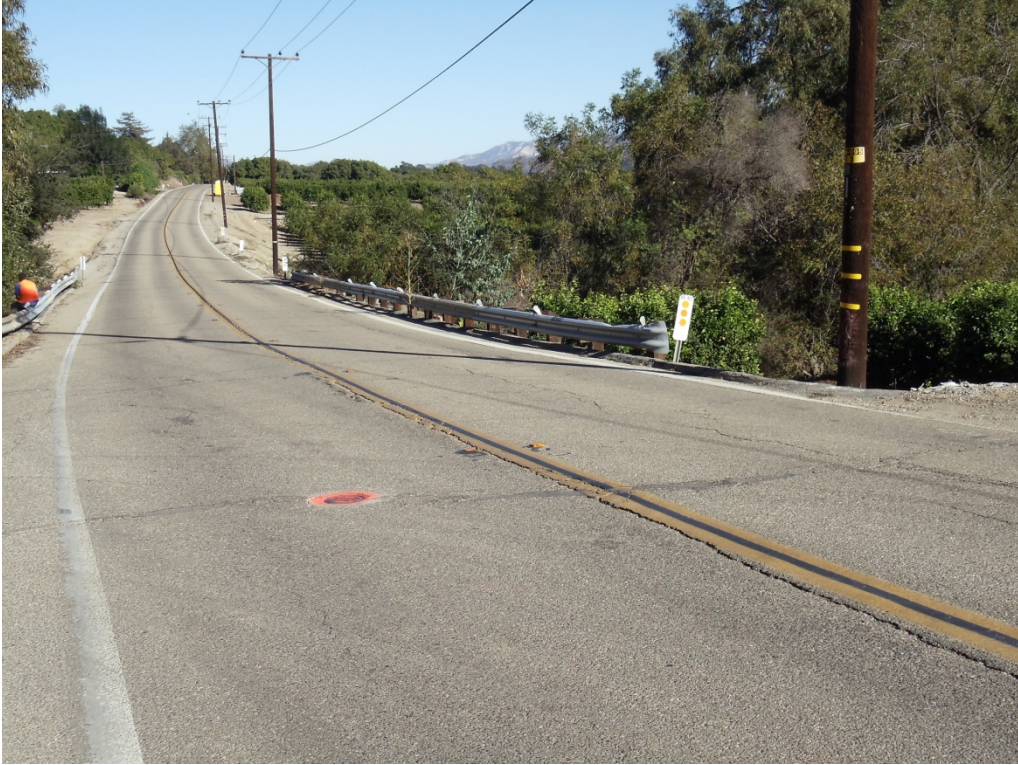
1	Roadway Looking East
---	----------------------

Approach alignment curved to the right advancing east Foothill Road (Appendix A Photo 1). There are no concrete approach slabs. The AC pavement shows transverse and longitudinal cracks over the entire section of Foothill Road.

The bridge railing is MBGR mounted on 6"x6" wood post at the approaches and over the bridge, which meets current standards both on and off the structure. The ends of the rails have rounded ends (Appendix A Photo 1).

There are Type OM2-1V roadway markers at the approach and departure MBGR railings. There is no load rating sign (Appendix A Photo 1).

There is an overhead power line running along the eastbound shoulder of Foothill road (Appendix A Photo 1). There is an 8” steel water line mounted on top of the downstream parapet wall (Appendix A Photo 5). Previous reports indicate a buried 8” steel waterline near the upstream rail.

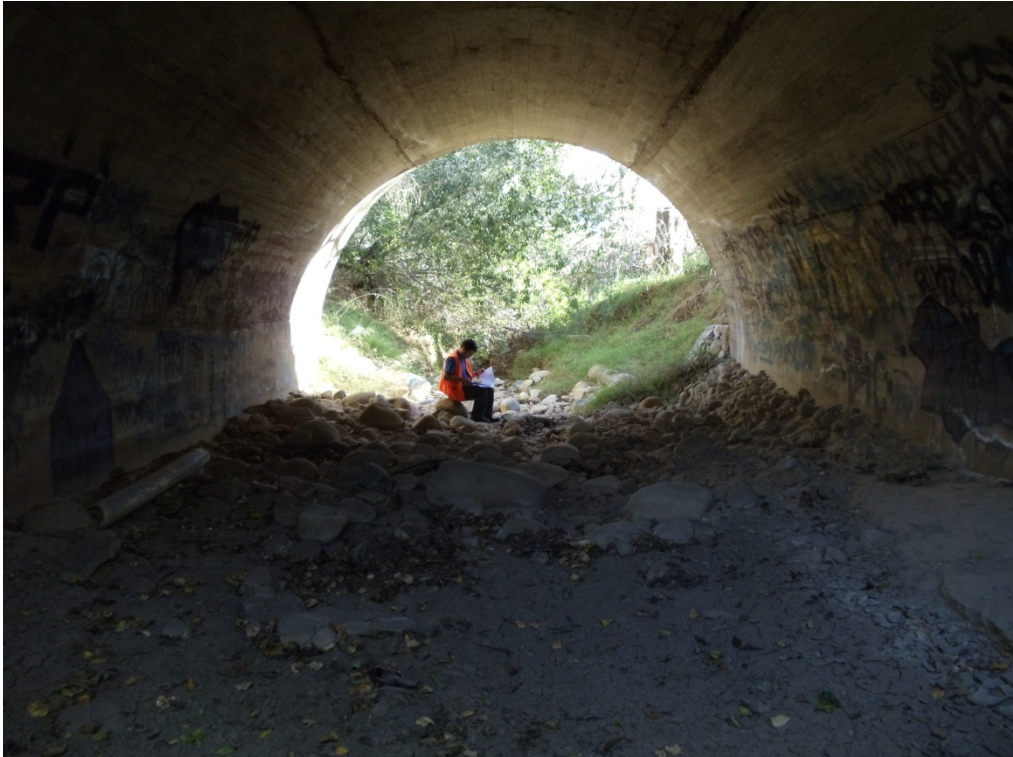
2	Unreinforced Concrete Arch Culvert (Looking Downstream)
---	---

Unreinforced mass concrete arch culvert 19'-11" span x 13' tall at center of arch to soft bottom of the channel (Appendix A Photo 2). The arch culvert has longitudinal construction joints near the third point of the arch (Appendix A Photos 3 & 4). There is a horizontal joint at the parapet wall and the intrados crown (Appendix A Photos 5 & 6). The deck is covered by AC pavement over approximately 10' of fill. The upstream and downstream side has reinforced concrete wing walls flared at approximately 45 degrees (Appendix A Photo 6). The roadway was raised in the 1970's. To retain the fill, the downstream parapet wall was raised with sacked concrete, the upstream parapet wall with pipe and rail crib wall. This type of earth retention should be replaced with new wing walls and reinforced parapet walls to protect the roadway embankment.

Adams Barranca is a high flow natural terrain creek with some cobble and vegetation in the invert and side slopes (Appendix A Photo 2). There is evidence of erosion on the upstream and downstream side behind the wing walls and downstream slopes. The retaining wall footings are exposed (Appendix A Photo 6). There is no estimated flow of the channel, but by observation the arched culvert is adequate for the flows.

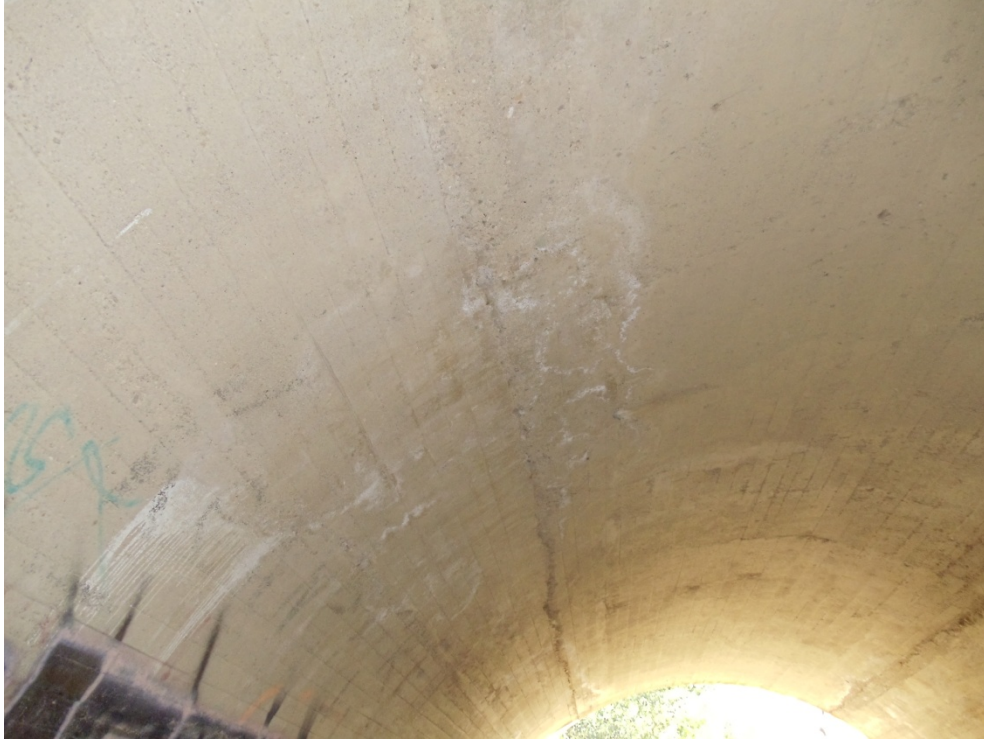
3	Longitudinal Construction Joint in Arch
---	---

Underside _____ Longitudinal Cracks in Upper 1/3 Pts Each Side (Full Length) Appear to be Construction Joints with Surface Spalls.

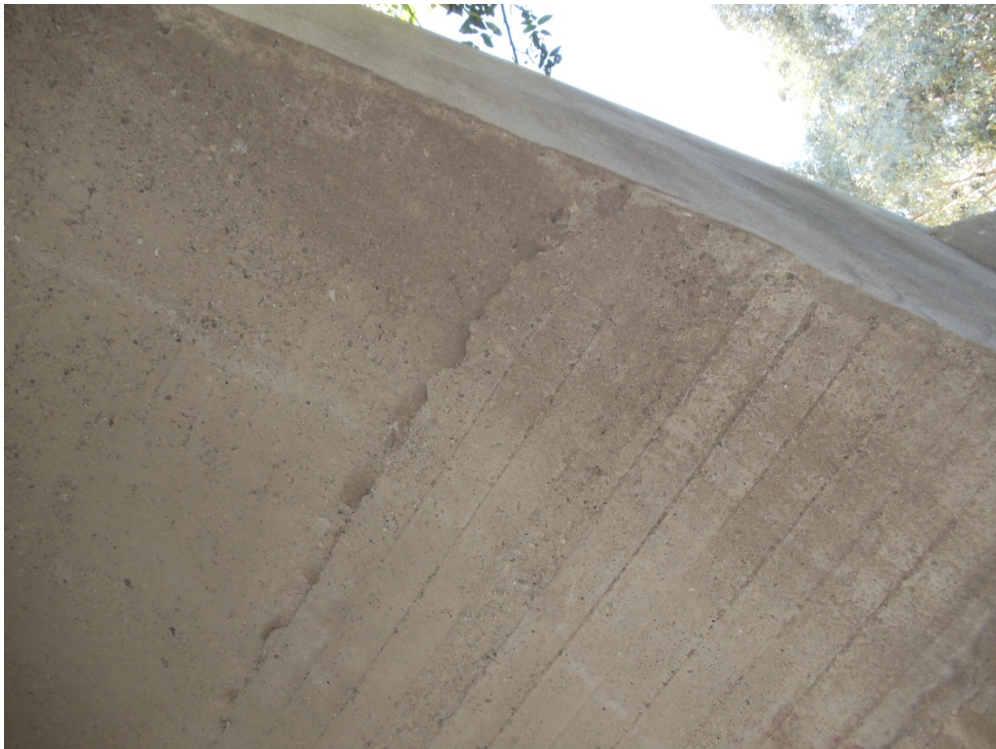
4	Longitudinal Construction Joint at Upstream Headwall
---	--

Headwall The Parapet Wall has a Horizontal Crack 18" Above the Outlet Across the Entire Opening (Indicated in the 1970 Report). This is the Joint Between The Crown and Headwall.

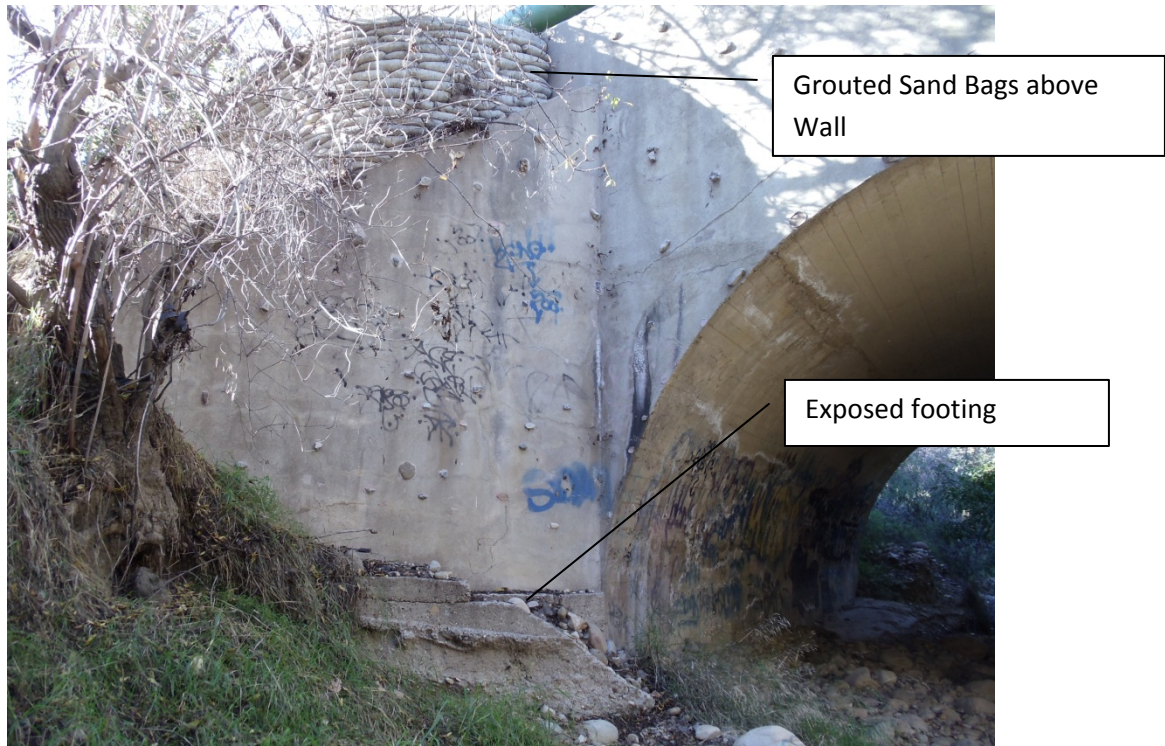
6	Down Stream Wing Wall
---	-----------------------

Wings 20' Tapered Wingwalls have Map Cracking. There is Grouted Sand Bags Above the Wingwalls on the downstream side, and there pipe and crib wall on the upstream side. The retaining wall footings on the downstream side are exposed.

Replace upstream and downstream wing walls to accommodate fill.

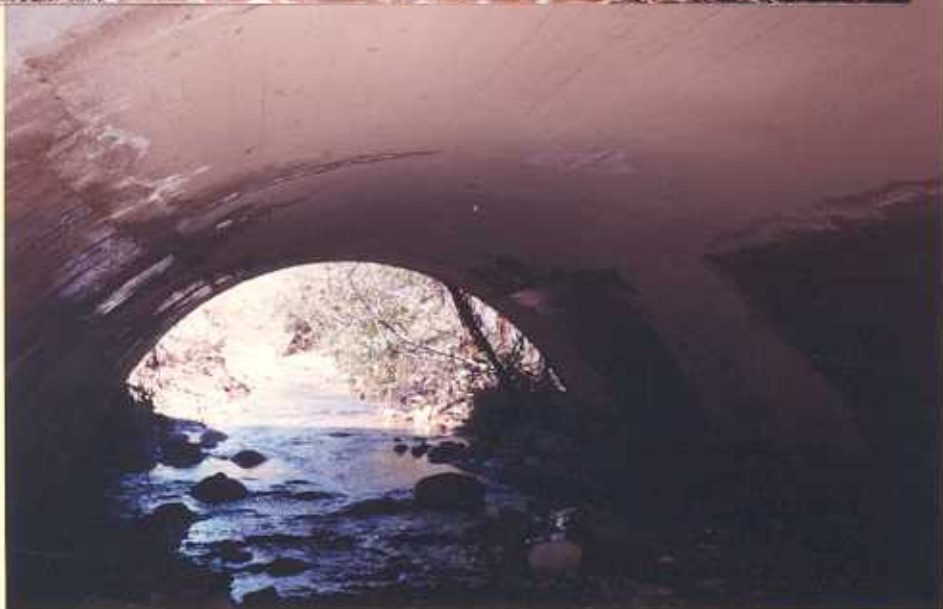
Interior:

Note: Water Seepage at the cold joints. Water is from recent rains.
