GEOLOGIC CONDITIONS AT MATILIJIA DAM
AS DISCLOSED BY EXCAVATIONS FOR
SPILLWAY APRON

Thomas L. Bailey
Consulting Geologist
Ventura, Calif.

September 15, 1947

September 9, 1947

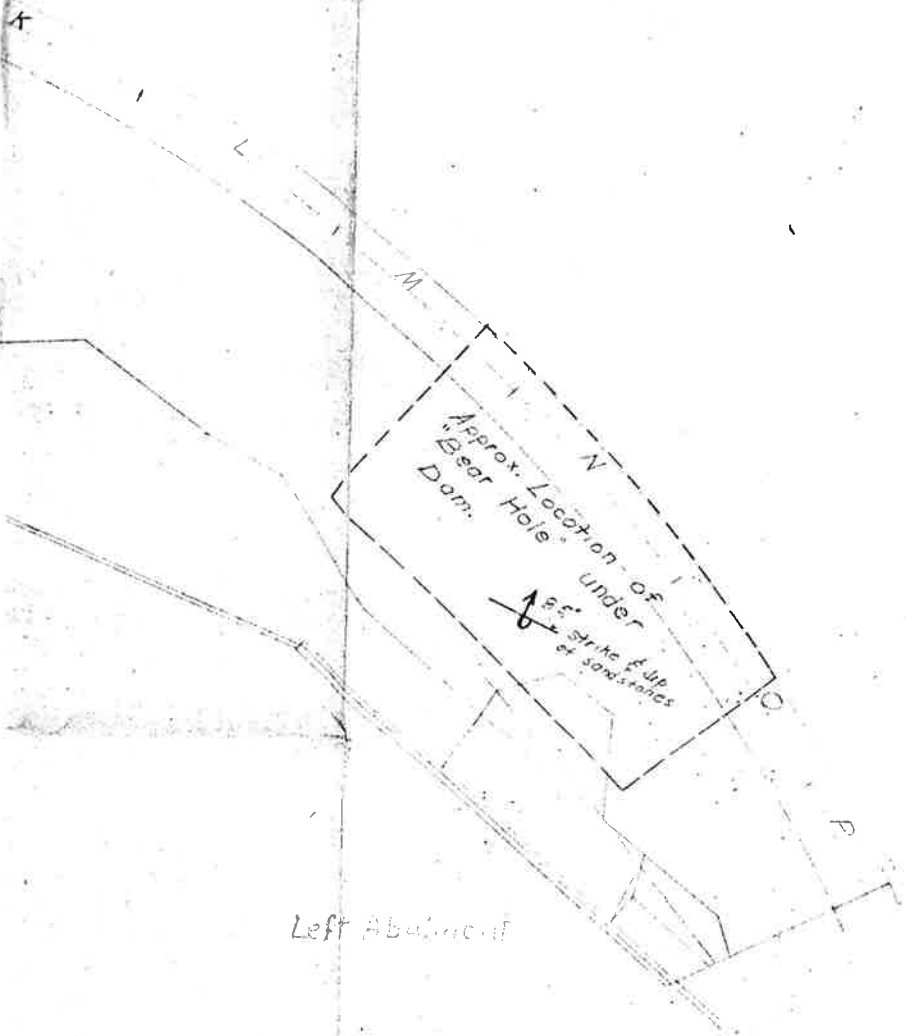
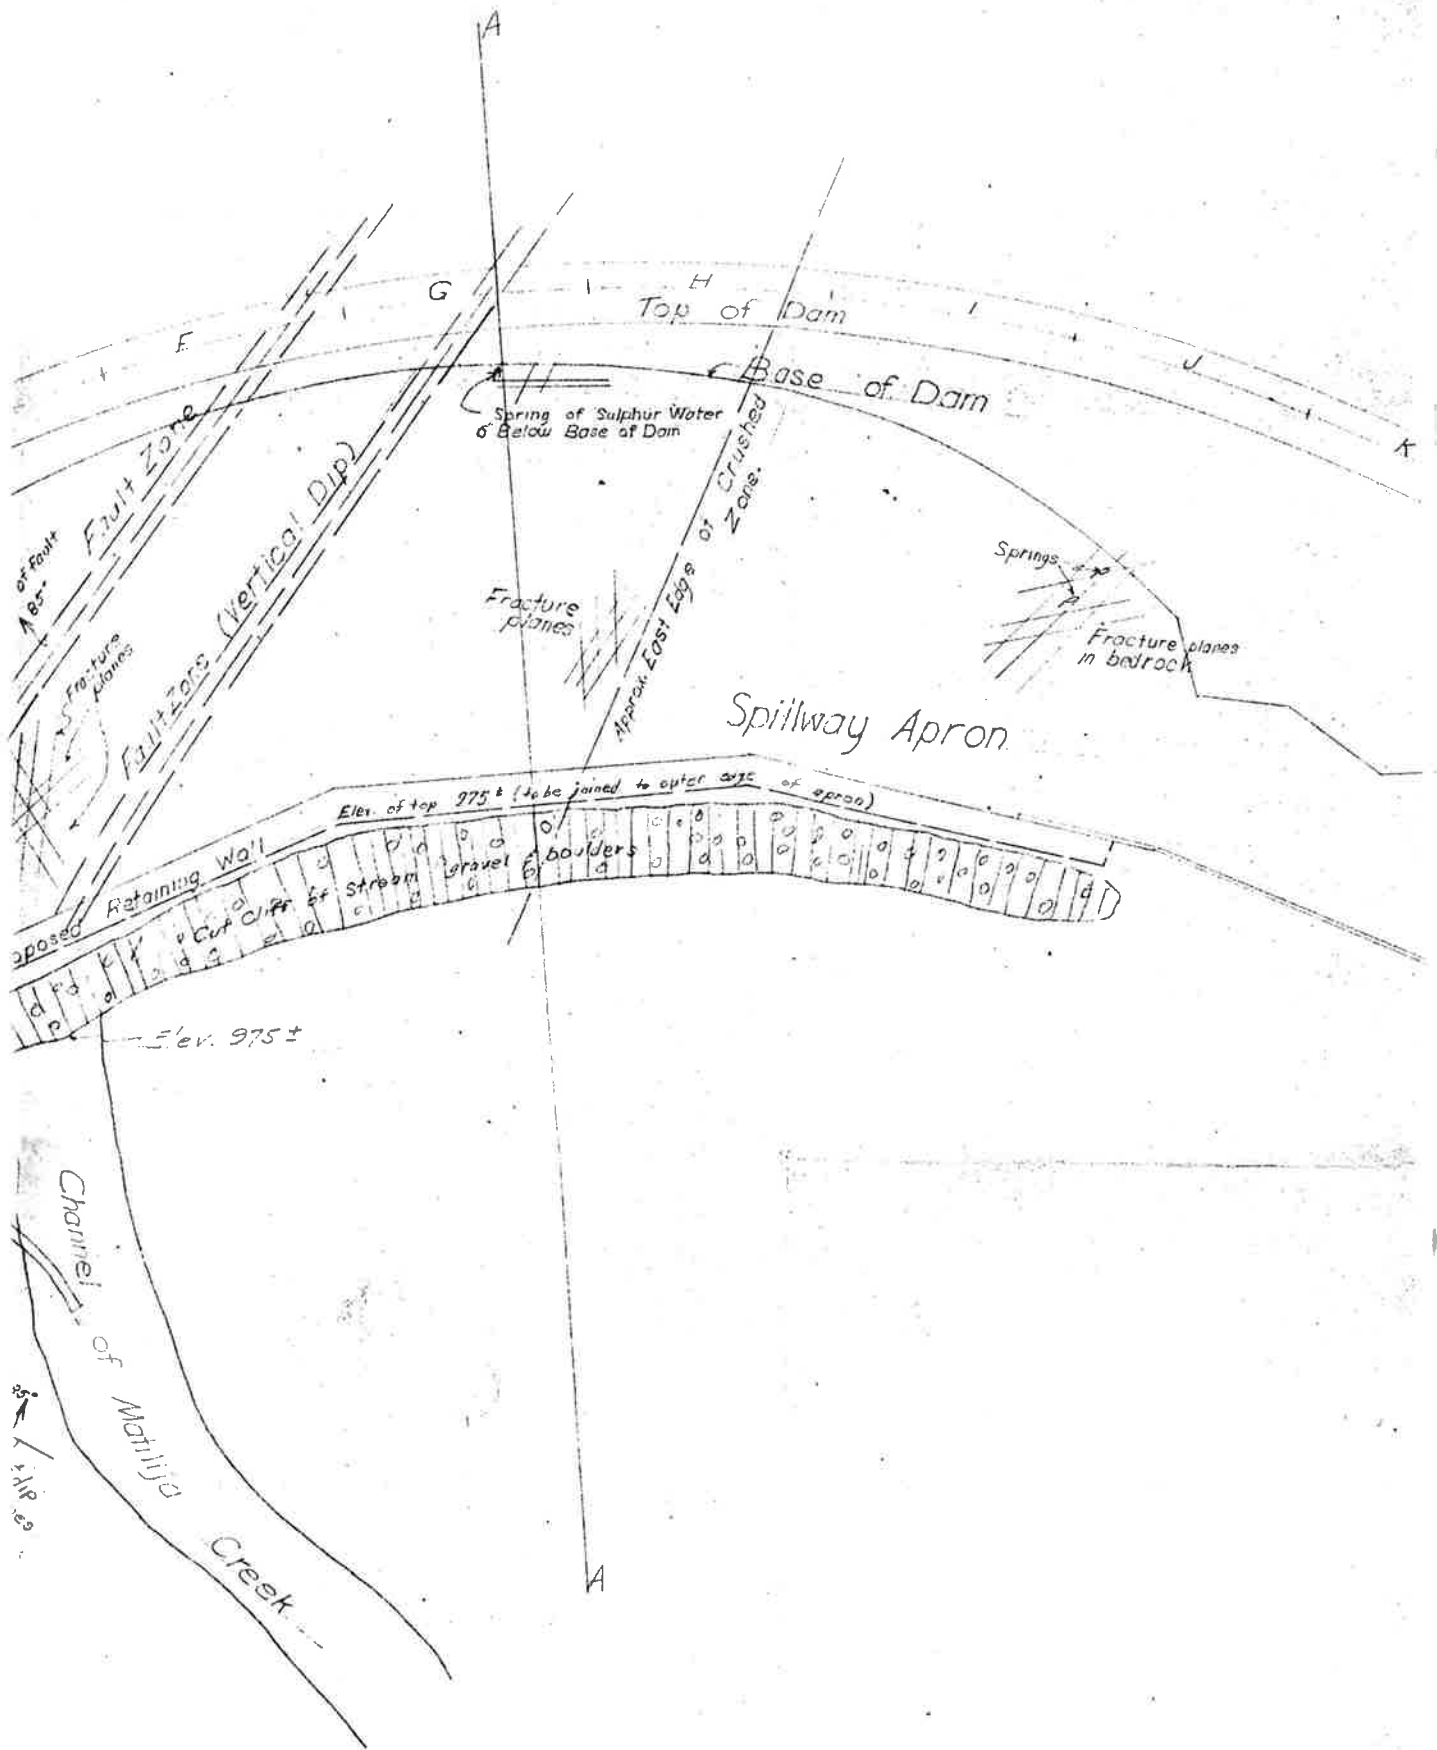
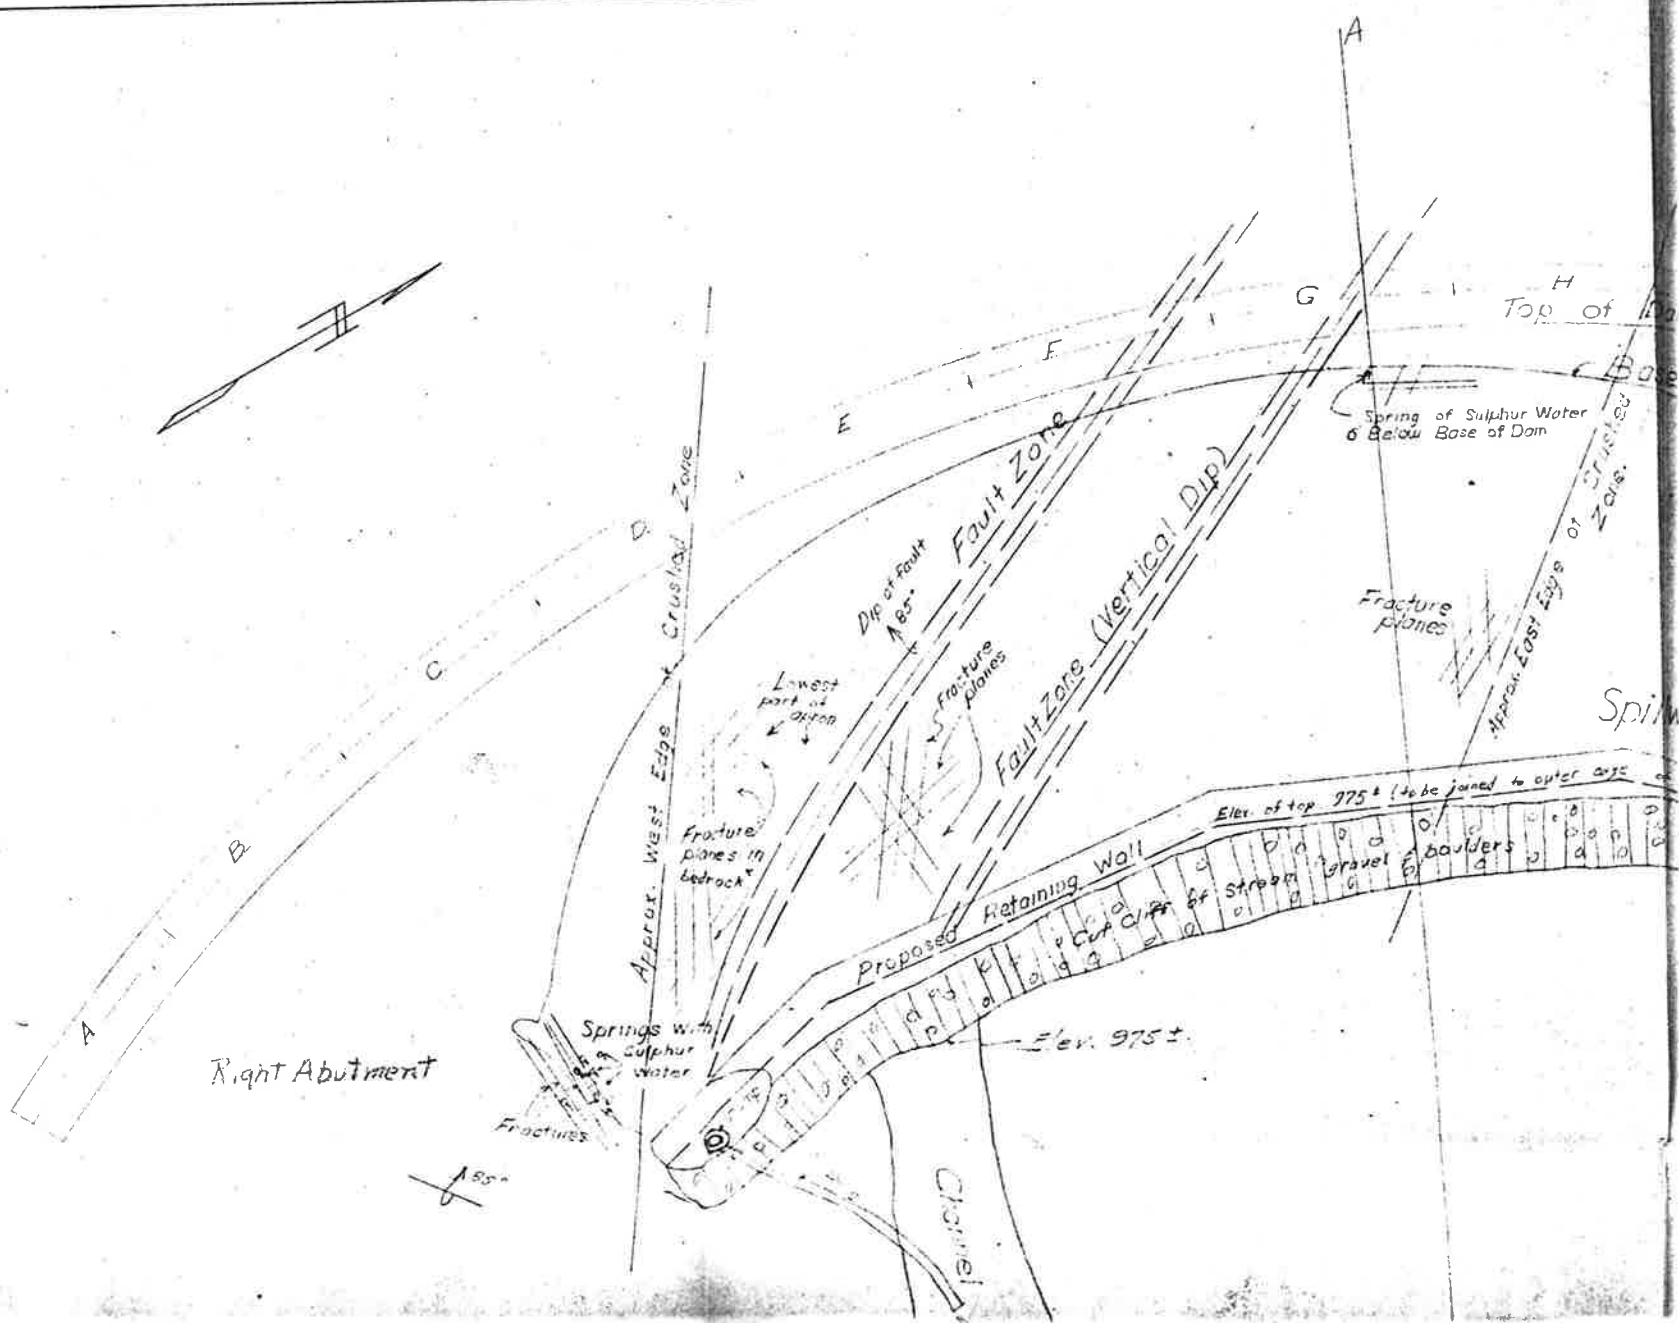
VIATILJA DAM
 CONCRETE APRON
 GEOLOGICAL STUDY BY
 THOMAS L. BAILEY

1. Practically all the rock floor beneath the central quarter of the dam (under Blocks E, F and G and parts of D and H) consists of white or very light gray soft sandstone which has been so severely crushed and shattered that most of it can be easily powdered between the

2. A fault zone consisting of 5 or 6 fault planes in a band 4 feet wide passes diagonally under the dam below Block F. Each of these nearly vertical (dip 75 to 88° West) fault planes is lined with black to dark gray, slickensided gouge 1/2 to 2 inches thick. This gouge is a clay-like substance composed of completely crushed and dragged out rock including considerable crushed black shale that gives it the dark color. It is compact and tough in its present unweathered condition but, when exposed to the weather long, it will change into a soft plastic light gray or buff clay, like the so-called clay seams

3. Another parallel fault zone about 4 feet wide and also with 5 or 6 vertical fault planes lined with similar dark gray gouge passes diagonally under Block G. As was the case with the fault zone under Block F, about 40 feet to the southwest, this fault zone heads (strikes) about 15 degrees West of due North (N 15° W). Fortunately, these faults make an angle of 45 to 55 degrees with the face of the dam. This is much safer than if the faults passed directly under the dam at right angles to its face but, if possible, dam sites cut by faults are to be avoided because such faults or crush zones are zones of weakness and require close and extensive grouting and other precautions to hold the fractured rock fragments together and prevent excessive seepage beneath from undermining the dam.

One good sized spring of clear, cool, fresh sulphur water issues from a fracture plane only 6 inches below the concrete near the center of Block G. It comes out of two or three fracture planes a fraction of an inch apart; these fractures are roughly parallel to the face of the dam and dip 20 to 30 degrees upstream (under the dam). This spring had doubled in size in 10 days from about 1 gallon a minute or less when first observed on August 13 to about 2 gallons a minute when studied again on August 23. It is now underneath the apron and presumably was piped into the drainage system of the apron. Another small seepage of water was noted just below the base of Block F.

As shown by the attached drawing, "Enclosure 1, the spillway apron, 6 feet thick, is about 67 feet wide opposite the center of the dam. It narrows to about 20 feet toward the left abutment and to about 30 feet at the foot of the right abutment. The surface of the apron is nearly flat, sloping about 3 degrees (6 per cent grade) toward the dam. The southwestern third or so of the apron slopes toward the right (southwest) abutment 4 to 10 degrees (7 to 17 per cent grade) except for a steeply northward sloping wall about 15 ft. wide at the foot of the right abutment. This construction of the apron produces an irregular shallow basin the deepest part of which is close to the right abutment. Below (southeast of) the downstream edge of the apron there stands now a nearly vertical cut or cliff from 20 to 30 feet high of unconsolidated boulders and gravel (stream bed deposits of Matilija Creek). The front of this easily eroded cliff at present is separated from the downstream end of the apron by a trench to bed rock 4 to 6 feet wide, part of which is used to collect seepage water and waste water from the construction operations. The water collecting at the southwest end of this trench is pumped up over the cliff into the stream bed a short distance downstream.

1. Build a strong concrete retaining wall to the elevation of the stream bed (975 feet) just back of (downstream from) the outer edge of the spillway apron. (A safer alternative to this is to extend the length of the apron to 126 feet but I believe that a concrete sill or retaining wall at the end of the apron is needed anyway).

2. Line the stream channel downstream from the retaining wall with concrete for a distance of 20 feet or more.

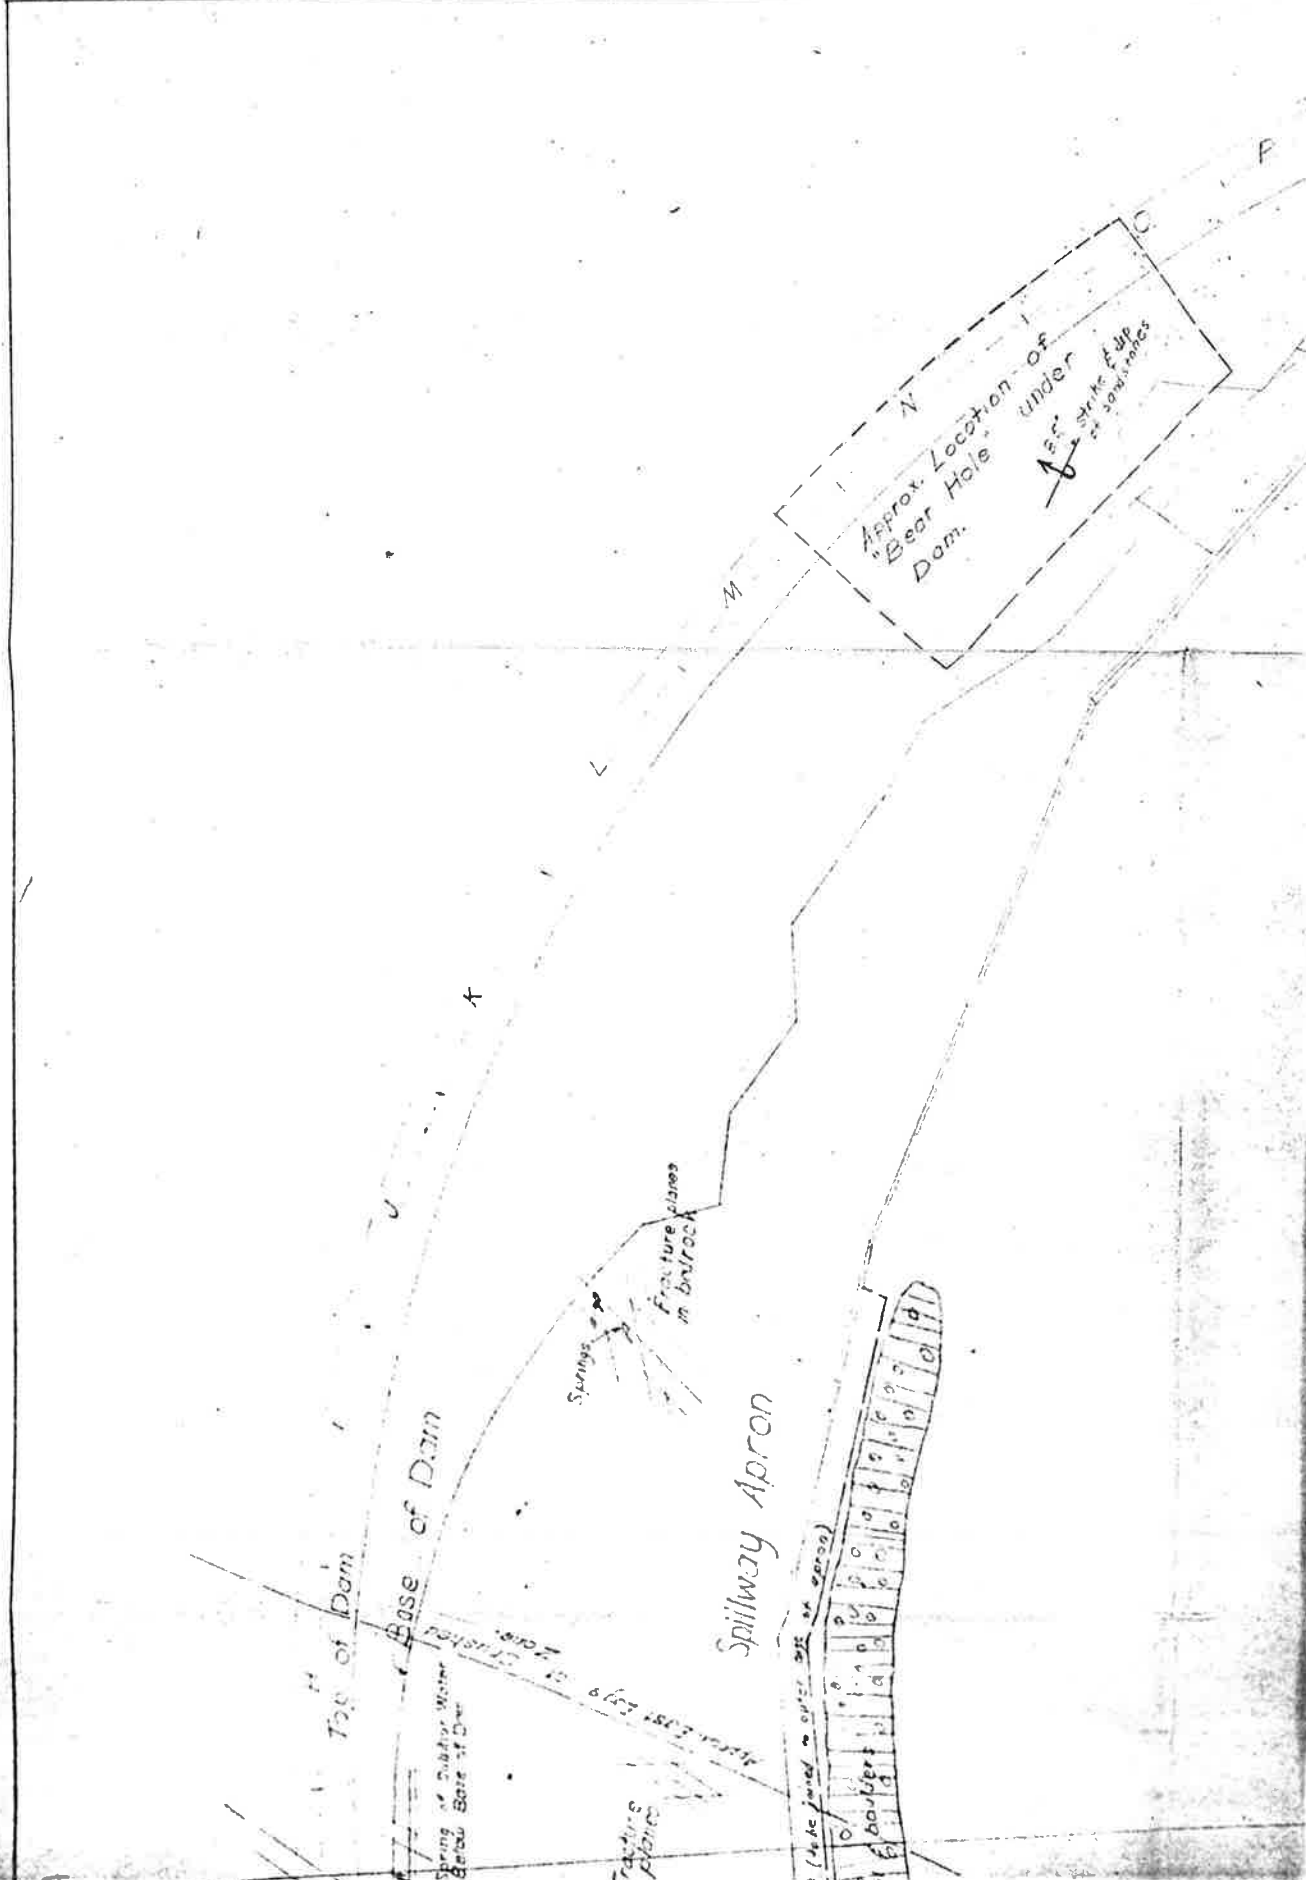
SECTION ALONG LINE A-A

It is my understanding that the cliff of loose gravel and boulders just downstream from the apron is to be left in its present form without support. This is a dangerous condition because the top of the easily eroded gravel cliff will be the outlet of the stilling pool at the base of the waterfall and the face of the cliff will be saturated with water as soon as the stilling pool fills up with water pouring over the dam. The southwest slope of the surface of the apron from near the center of the dam to the foot of the right abutment will start a strong eddy or whirlpool at the foot of the falls as the pool below the dam fills with water. When this gravel cliff becomes soaked with water, especially when subjected to lateral scour by the whirlpool, the boulders and pebbles from this cliff will fall down on the apron and fill up much of the pool. As it now stands (before the cliff caves on to the apron) the pool near the right abutment and a few feet below the base of the dam will have a maximum depth of 40 or 50 feet which is a fairly effective cushion. From the center of the apron northeastward (toward the foot of the left abutment) the water will be shallow and have little stilling effect on the powerful turbulent water falling over the dam during or after a heavy rain. In fact the northern part of the apron with its southward slope will probably be covered with a thick sheet of very turbulent rapidly southward flowing water directed at the gravel cliff just back of the apron and at the right abutment. There will be insufficient cushioning effect of

tail water on the northeastern half of the apron during a severe storm when 6 feet of water or more will be rushing over the top of the dam. The now nearly vertical gravel cliff will soon be reduced to an inclined surface sloping toward the dam. Waves of agitated water (Everett's hydraulic jump) can rush up this slope causing erosion and probable severe damage to property below during floods. The filling of the deeper part of the stilling basin with debris will reduce the depth of the water and the effectiveness of the tail water cushion. The stilling pool should be at least 40 feet deep (fide E. E. Everett) or $1/4$ the height of the fall to be effective. Not only that, but the boulders and pebbles scouring around in the whirlpool on the southern part of the apron, during floods will act as abrasive tools and will wear down the surface of the concrete apron by the formation of pot-holes. After the gravel cliff is worn away by the overflow from the first big storm or two, the downstream edge of the apron will very probably be attacked and undermined by the swirling waters. Blocks of the apron will begin to cave off and if the process is permitted to continue upstream, the dam itself will be undermined. The crushed sandstone beneath the central part of the apron and dam is so soft that it will be easily washed out once the apron starts to break up. If this undermining process began during a storm like that of 1914 or even 1938 the water below the dam would be so deep and turbulent that the undermining probably could not be detected. The dam itself might fail because it could not be drained during such a flood. With its small outlet some time will be required to drain a full reservoir above the dam even if it weathered the storm and the damage was detected. Most dams fail during floods

2. Fill in the space between the downstream end of the apron and the gravel cliff with a strong, nearly vertical, concrete retaining wall at least 3 feet thick at the top. The top of this wall should be level with the bed of Matilija Creek which has an elevation of 975 feet a short distance downstream from the apron. It will have a maximum height of about 40 feet above the top of the apron. This retaining wall will serve two purposes:
