2005 ANNUAL PROGRESS REPORT
FOR THE
ROBLES DIVERSION FISH PASSAGE FACILITY
AND
VENTURA RIVER IMPEDIMENT MONITORING

CASITAS MUNICIPAL WATER DISTRICT
1055 N. VENTURA AVENUE
OAK VIEW, CALIFORNIA 93022
DRAFT

October 27, 2005

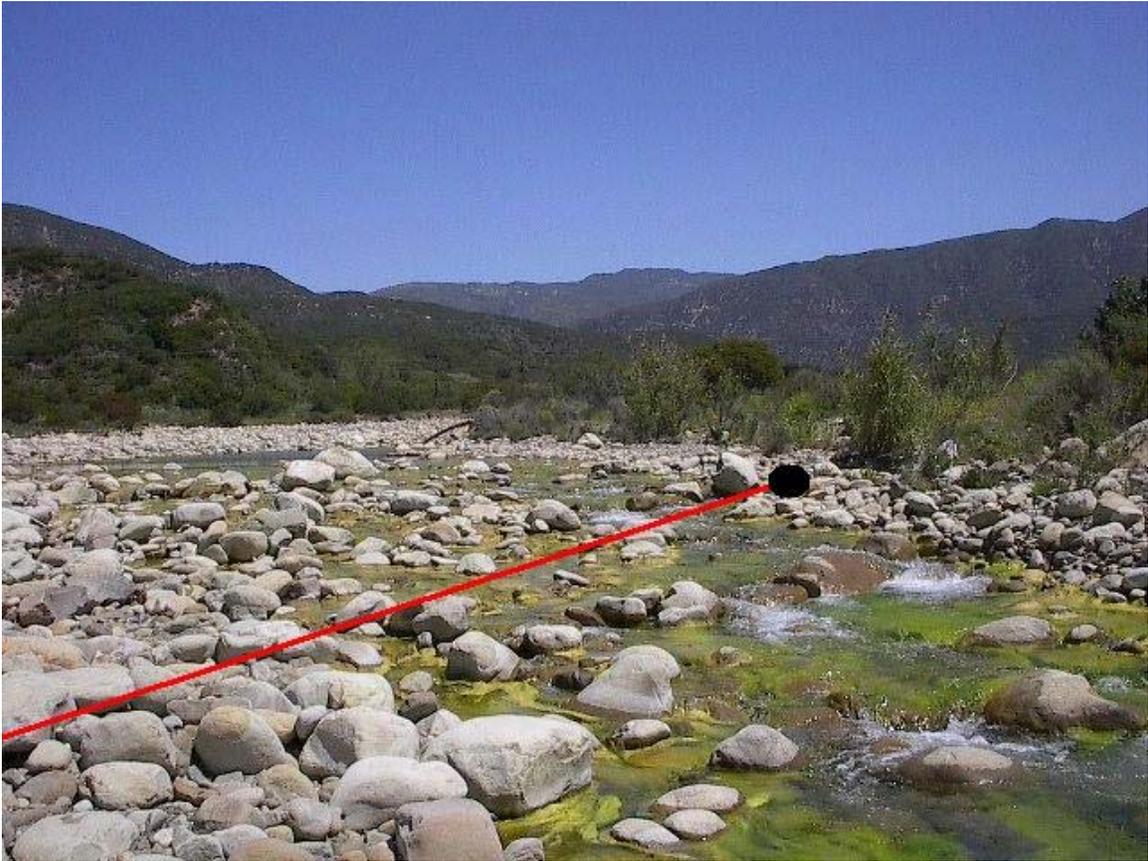
Figure 7.3: Photo of Mark 5 looking upstream, approximate transect location is marked in red.

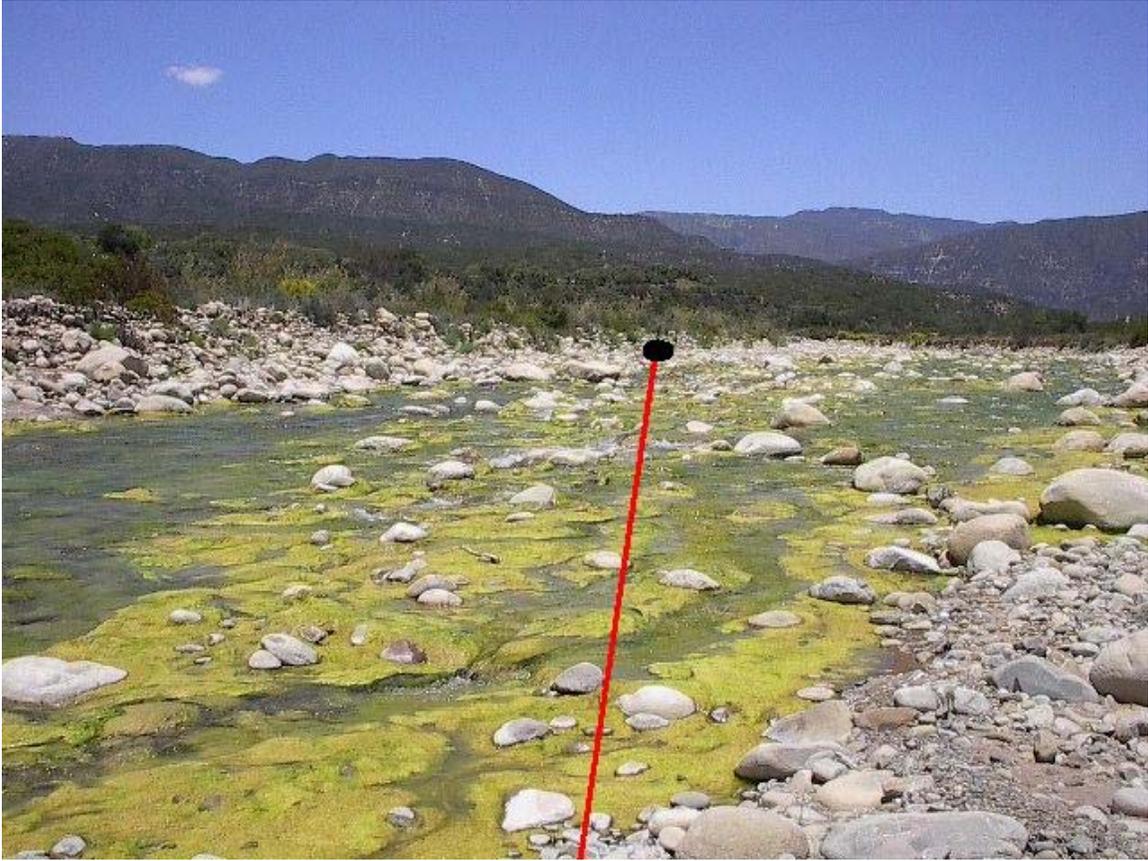
Figure 8.3: Photo of Mark 6 looking upstream, approximate transect location is marked in red.

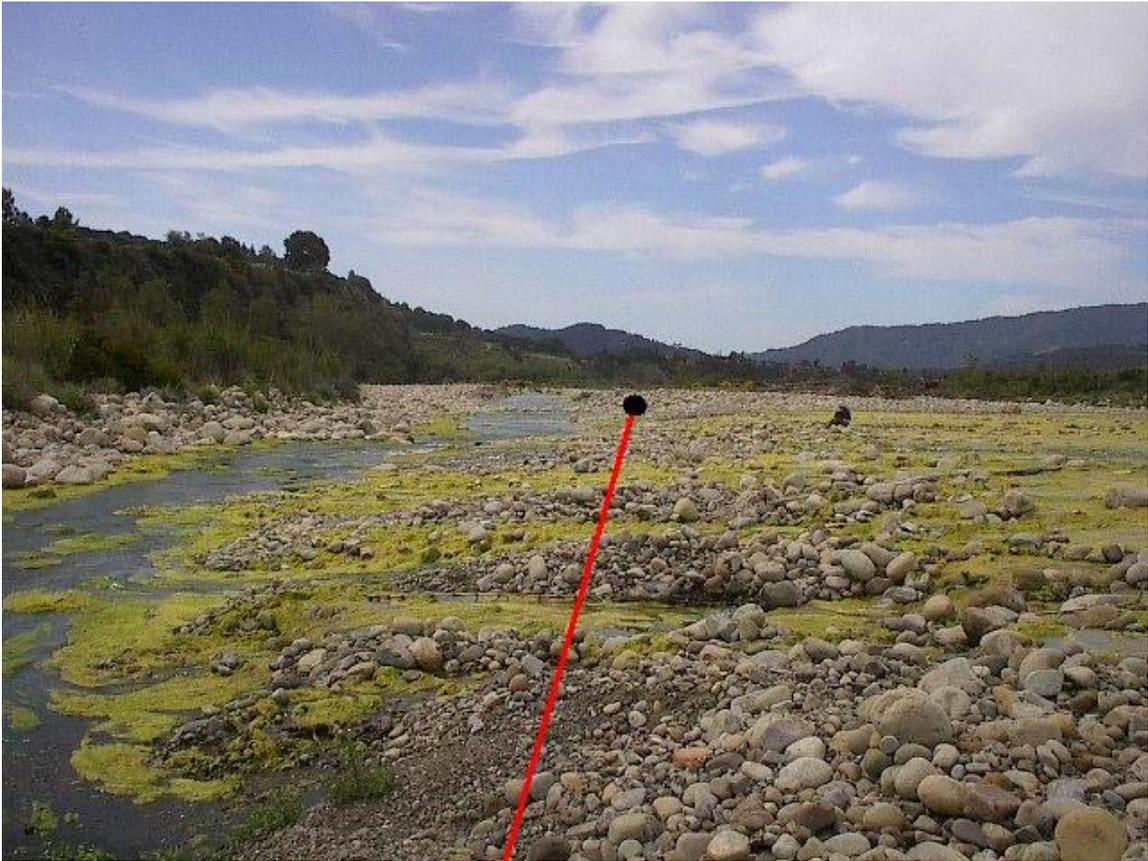
Figure 9.3: Photo of Mark 9 looking downstream, approximate transect location is marked in red.

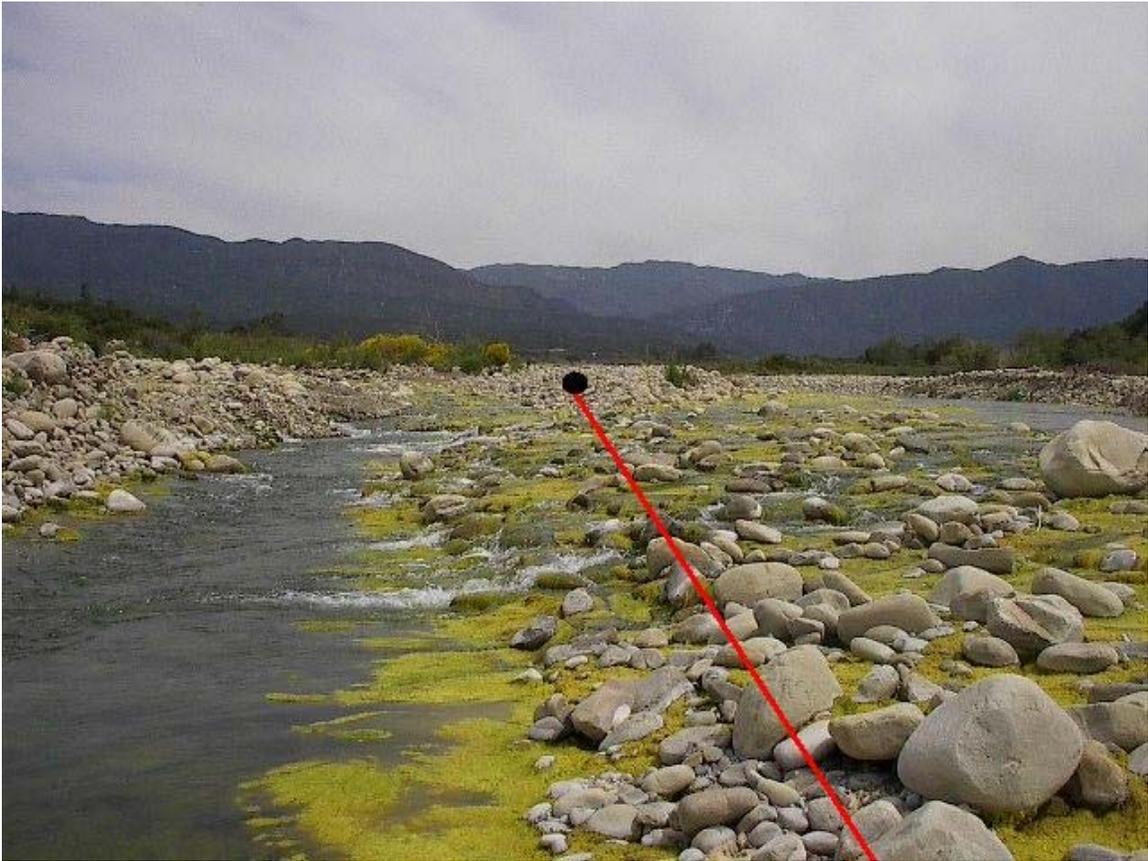
Figure 10.3: Photo of Mark 10 looking upstream, approximate transect location is marked in red.

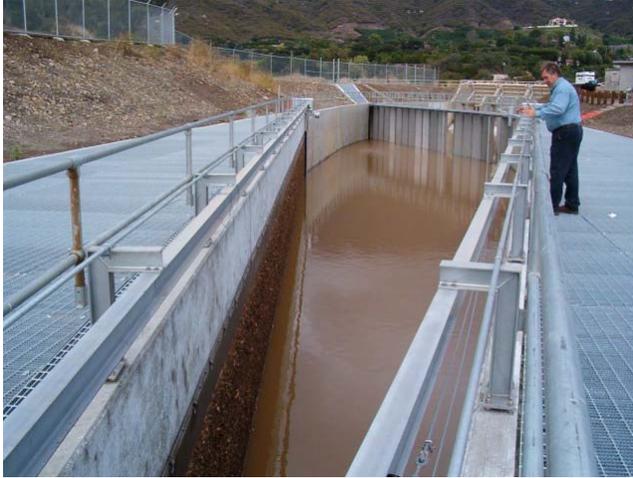
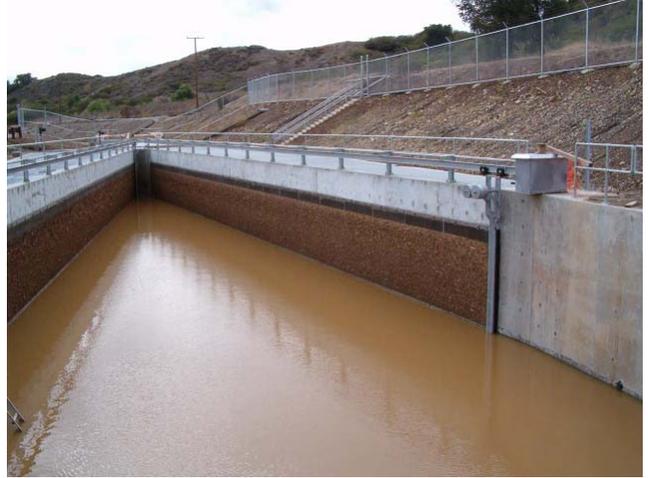
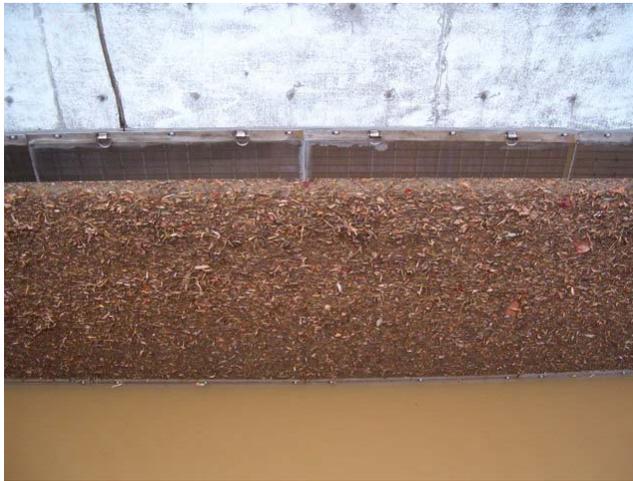
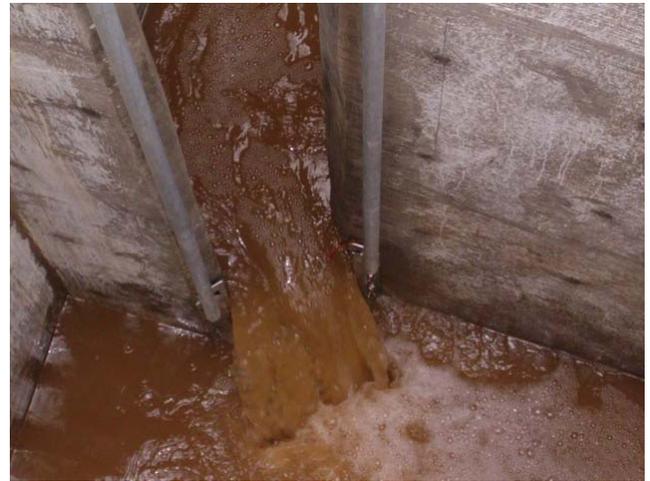
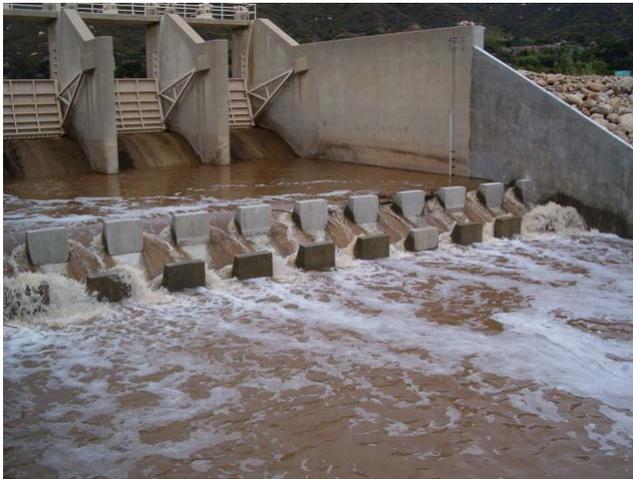
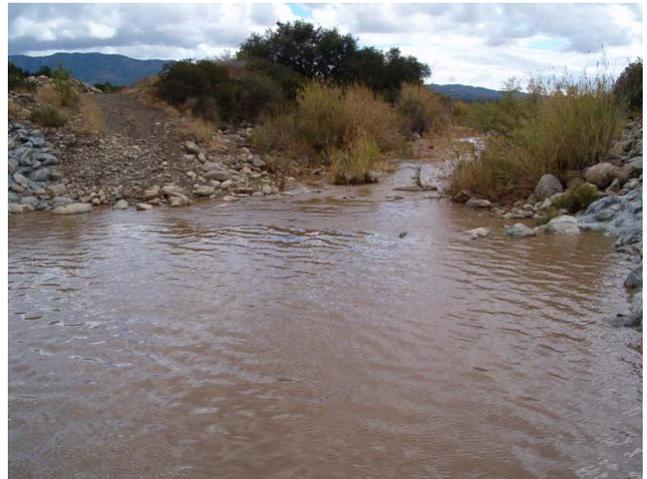
10/20/04 – Early storm runoff that caused a collection of vegetation debris on the face of the fish screens (middle left), near complete plugging of screens. Flow filled the upstream basin and caused overflow at the cutoff wall. When discovered, release made through spillway gates (bottom left) to downstream channel (bottom right).

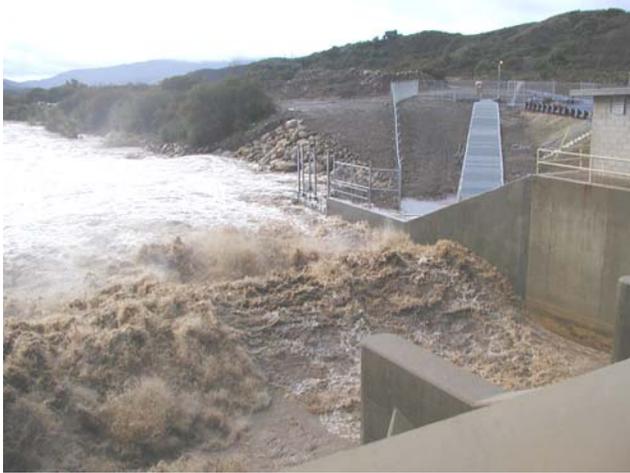
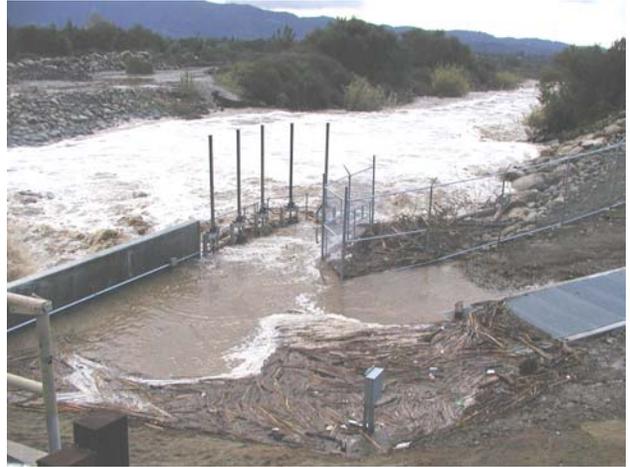
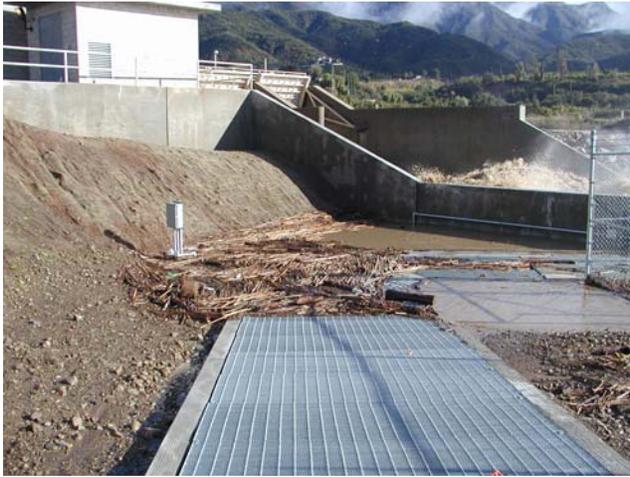
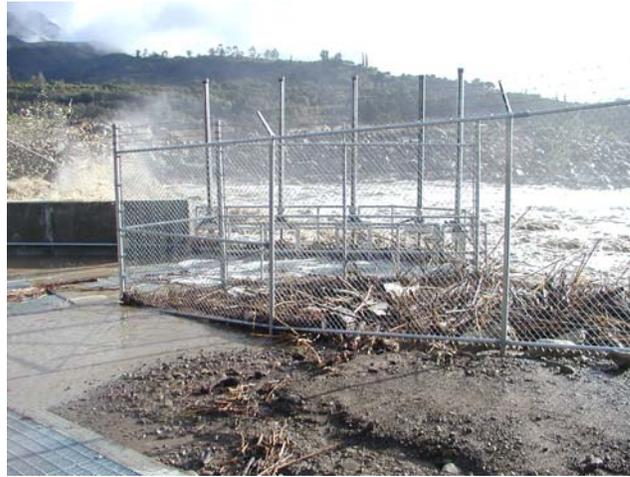
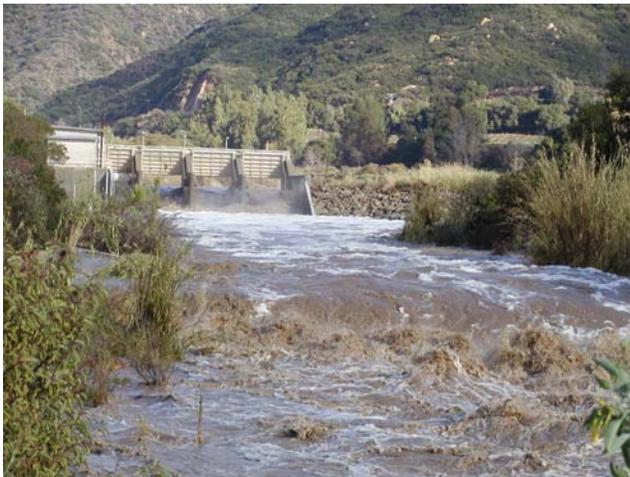
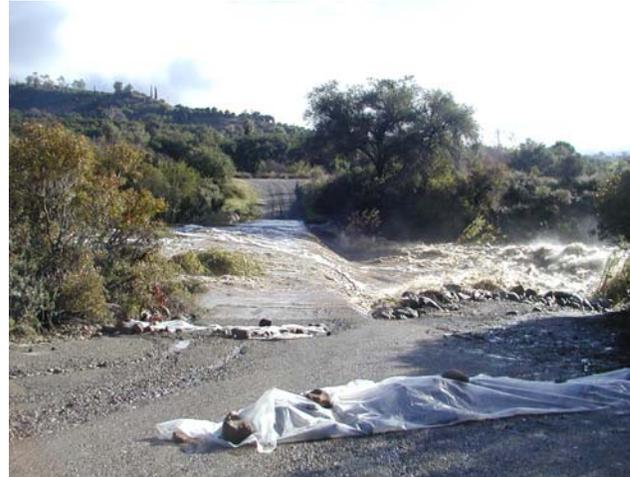
12/31/04 – Conditions at the Fish Entrance Structure (top and middle), downstream of Robles at the measurement weir (bottom left and right).

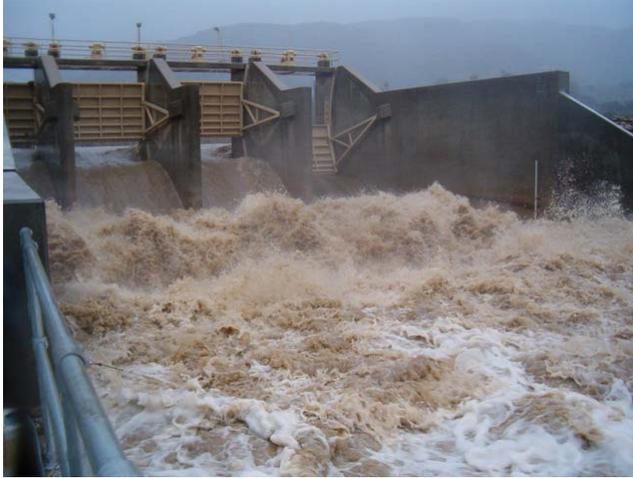
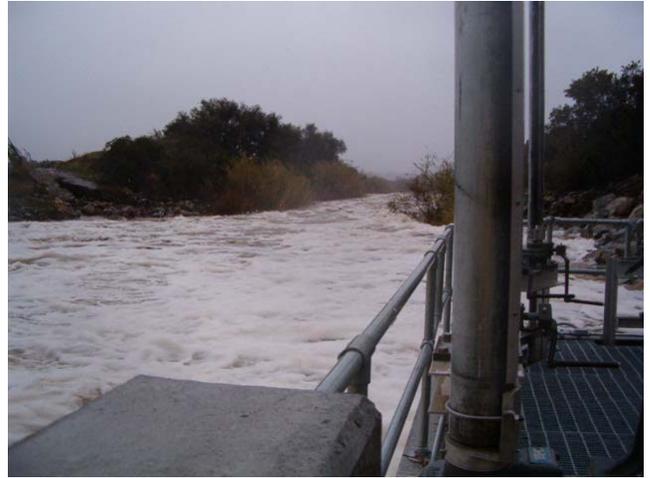
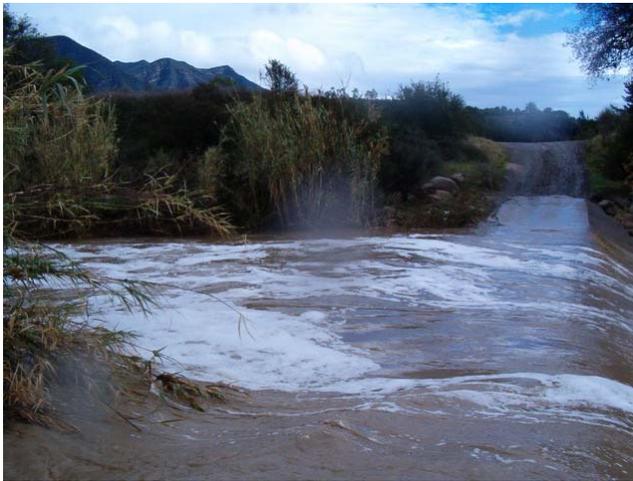
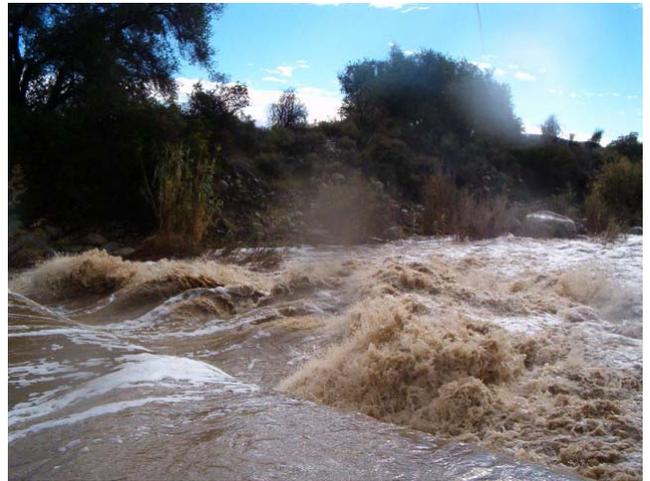
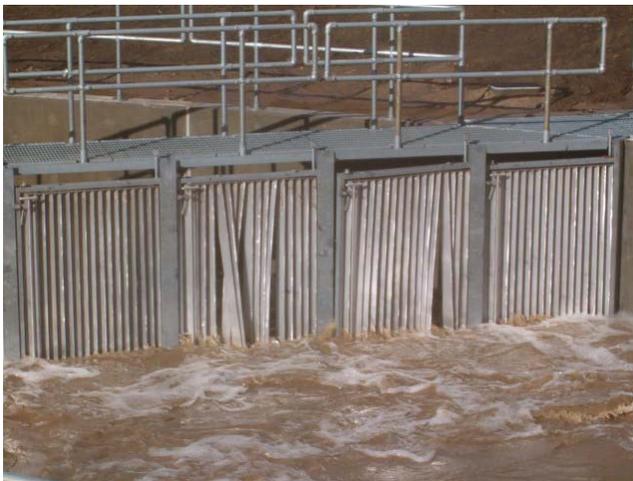
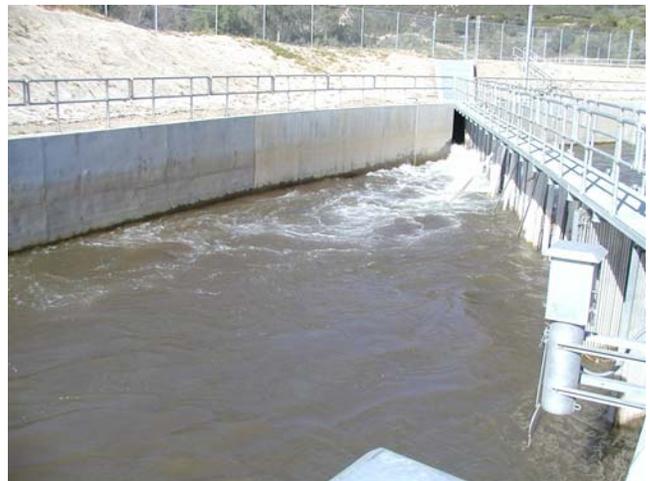
1/3/05 – Storm flows through Robles spillway gates and downstream channel (top), over the measurement weir (middle) and damage to fish guidance device (bottom).

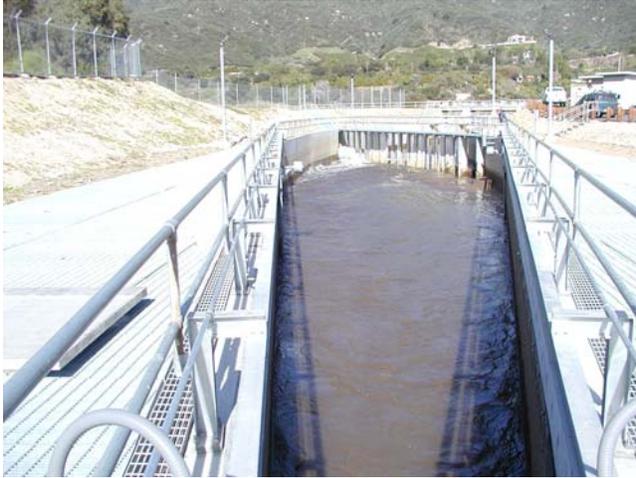
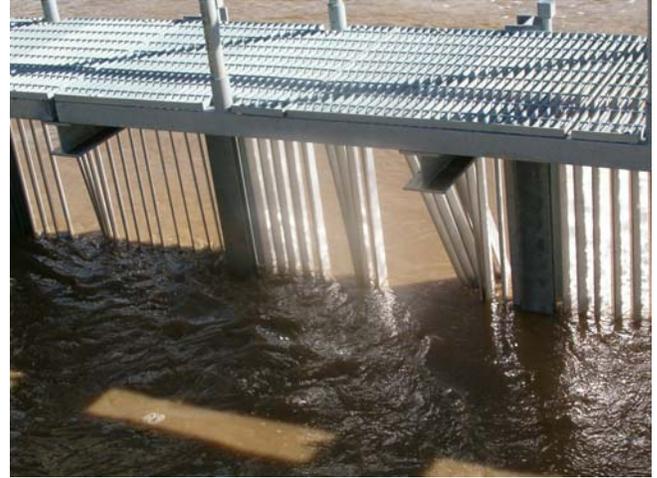
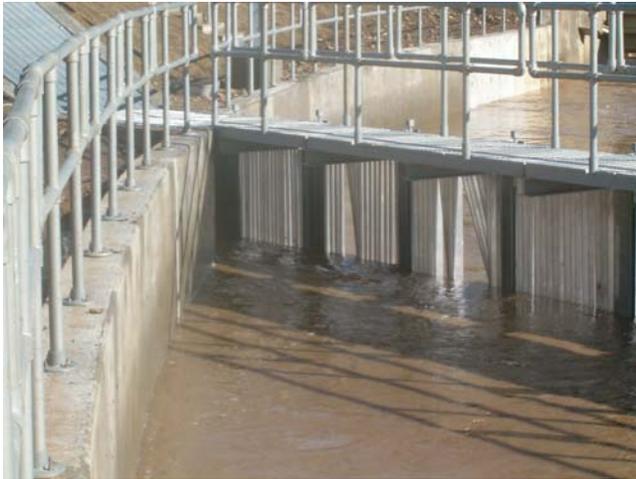
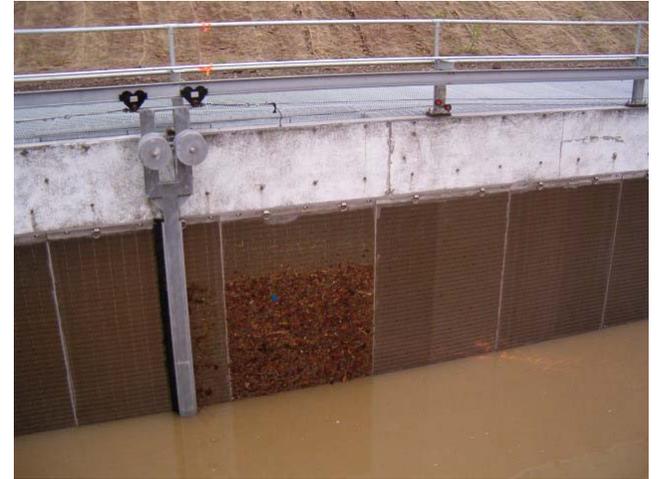
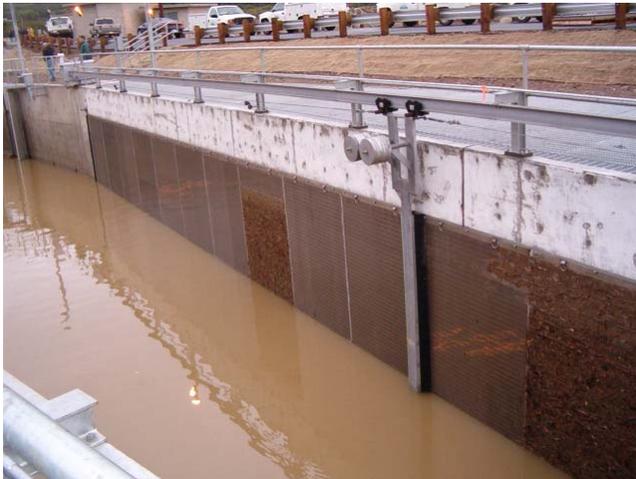
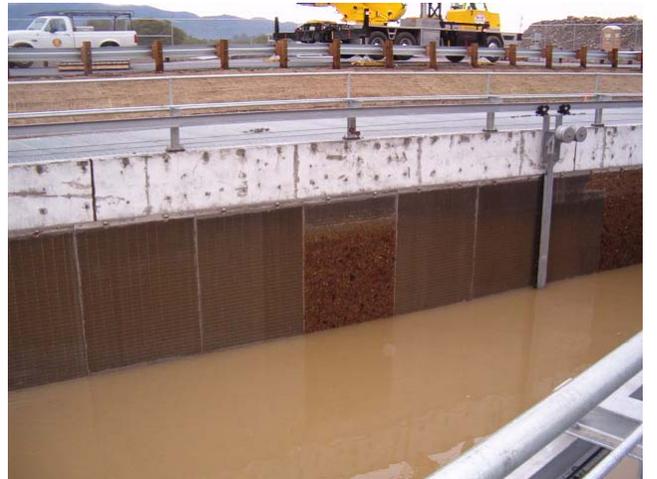
1/03/05 – Damage to fish guidance device resulting from flow entering facility and the collection of plant debris on the facing of each fish screen. Brush system failed to operate during this storm event.

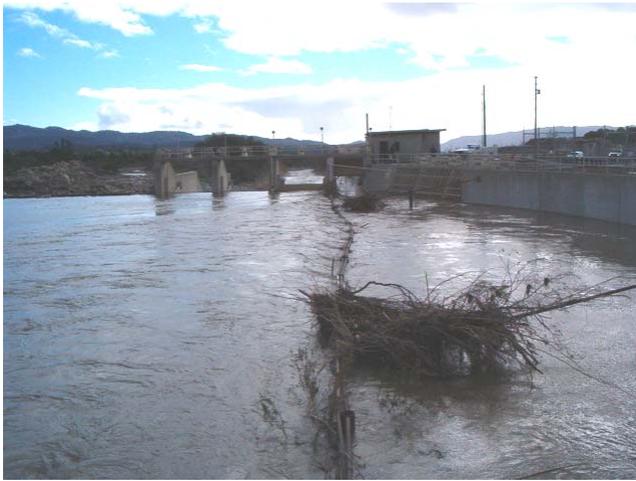
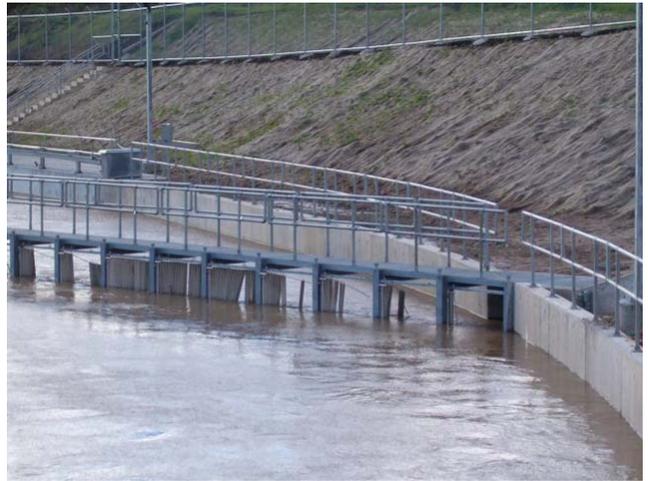
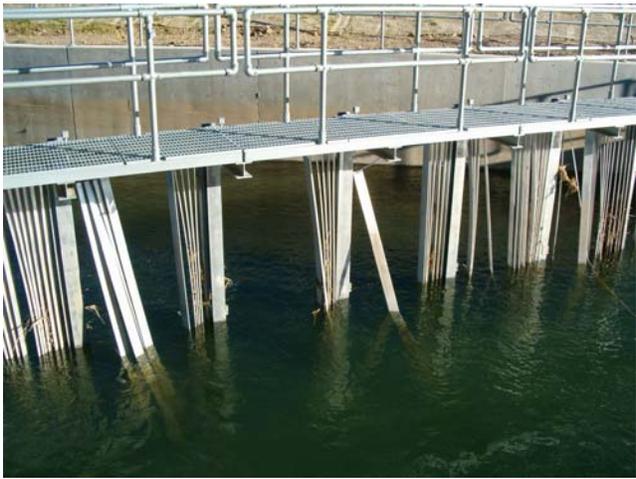
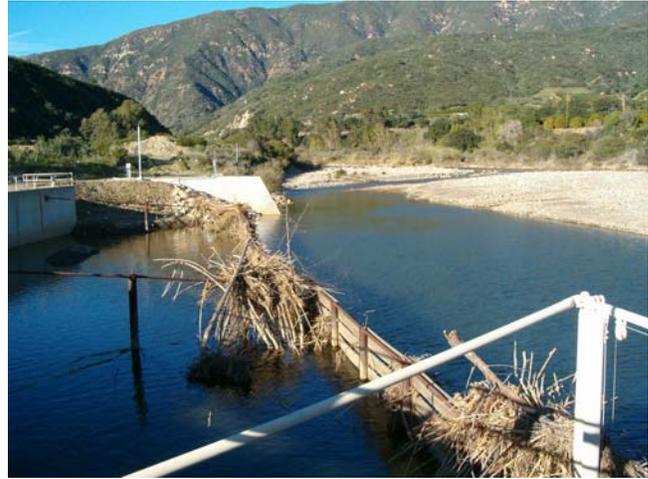
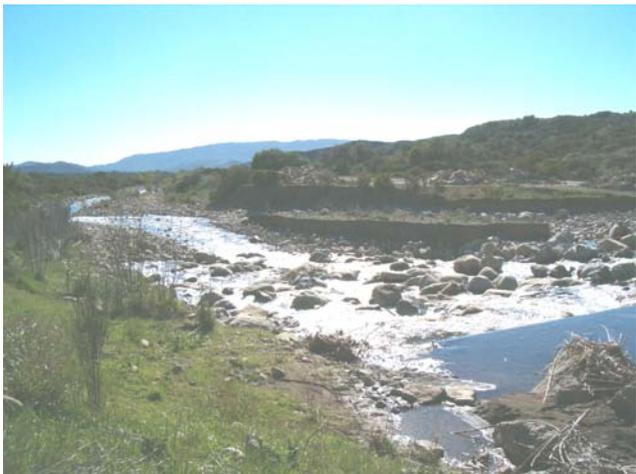
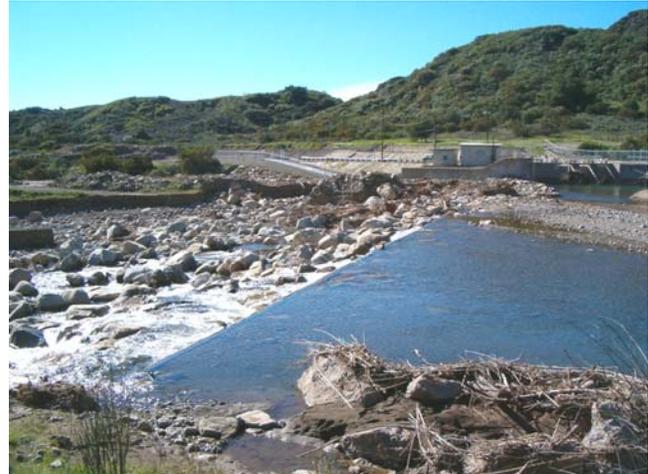
Aftermath of 1/10/05 storm event – damage to fish guidance device, sediment loading in the upstream basin that cut off flow to Fish Passage Facility. (Photos not taken during the peak event due to emergency in other areas.)

- Installation of interim weirs below the measurement weir.
- Damage restoration of the fish guidance panels after the 2005 storm.
