CHECKPOINT INSPECTION SERVICE

SUMMARY REPORT

Client: Keith Filegar / County of Ventura Watershed Protection Dept.
Inspection Address: Matilija Hot Springs Sanctuary PC 65000002881, Ventura County California
Inspection Date: 2/23/2009 Start: 9:00 am
Inspected by: George Blair

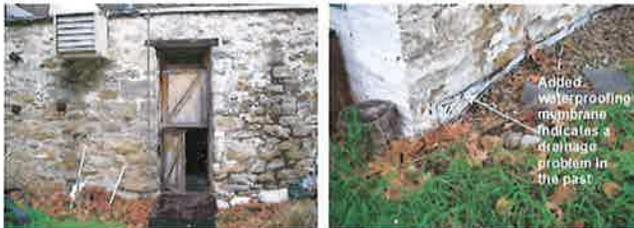
The walls at the post office and kitchen appear to be un reinforced stone, which is a seismic hazard that should be investigated further.

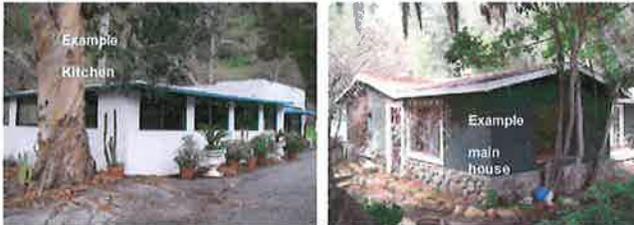
There is a large tree adjacent to the slab that does not appear to have affected it as yet, but you may wish to have an arborist predict its growth or root movement, which could adversely affect the slab in the future.

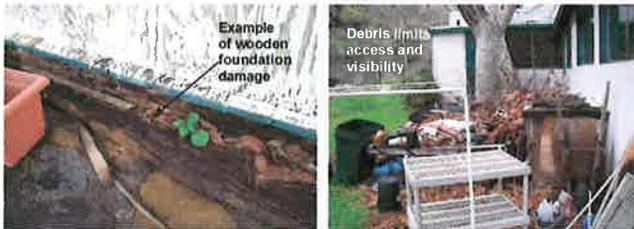
The foundation is in poor condition, damage should be evaluated by a foundation specialist. At the kitchen and cabin 2

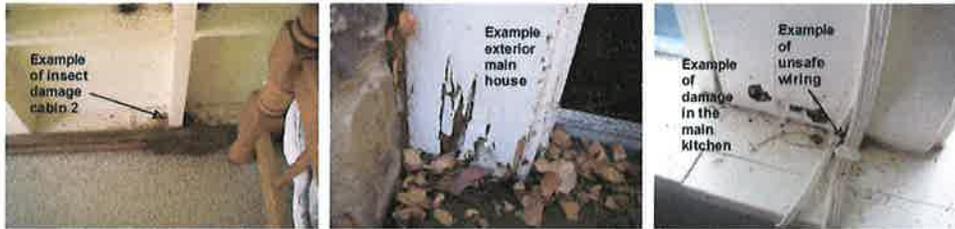
The structure and its components are significantly moisture damaged, and will require a thorough and extensive evaluation by a termite inspector.

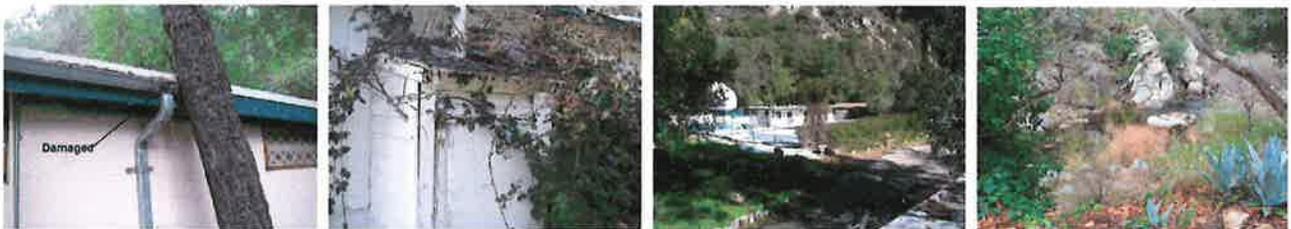
Vegetation is encroaching on the structure, and should be kept a minimum of twelve inches away for the general welfare of the walls and foundation.

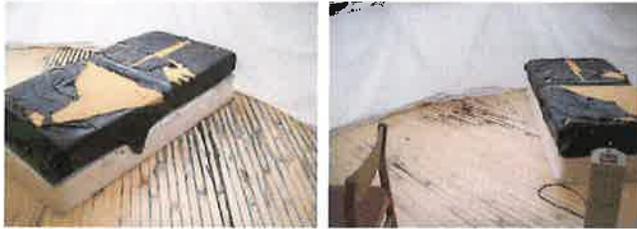
The dome tent floor is damaged and should be evaluated by a contractor to determine the extent of damage and costs to repair. Evidence of pest presence.

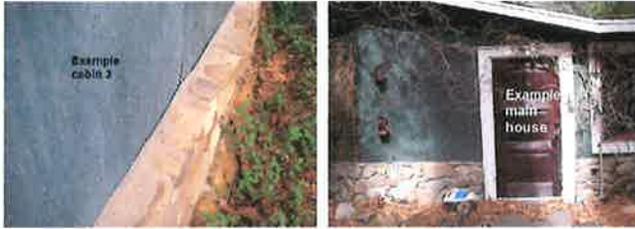
Worn and or missing caulk should be serviced, to prevent moisture intrusion.
There is no flashing at the masonry veneer , which could allow moisture intrusion. At Cabin 3.
At the main house.

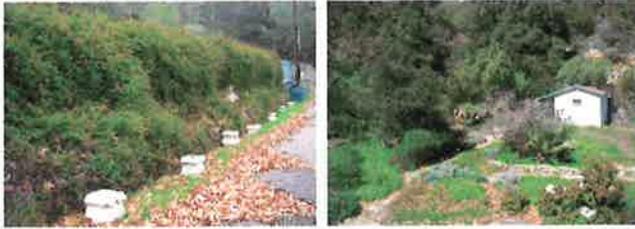
Damage was visible at the stone walls, Loose pieces, loose mortar.

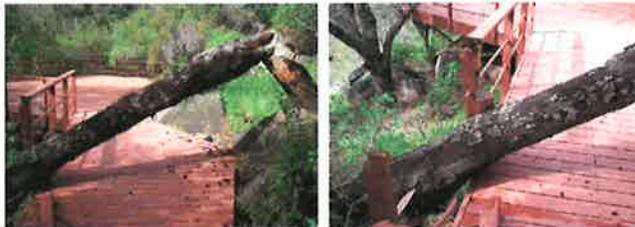
There is damage to the wood deck that should be evaluated by a termite inspector and a contractor.

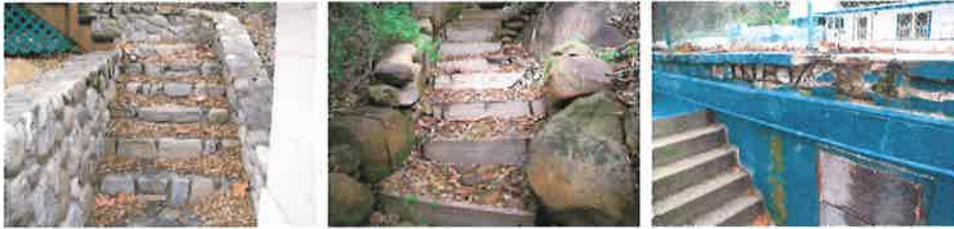
Earth wood contact was noted at the exterior stairs which will lead to premature decay.

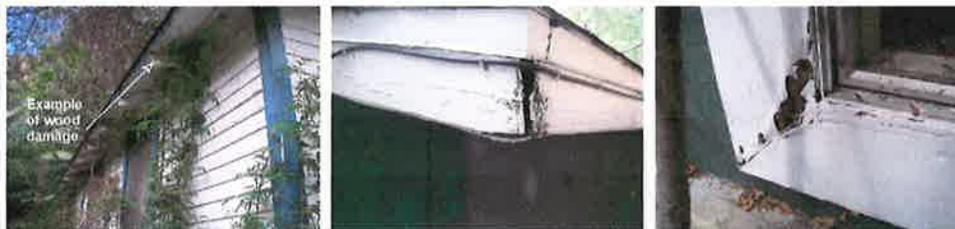
The termite report should identify any damage to portions of the fascia board and wood trim.

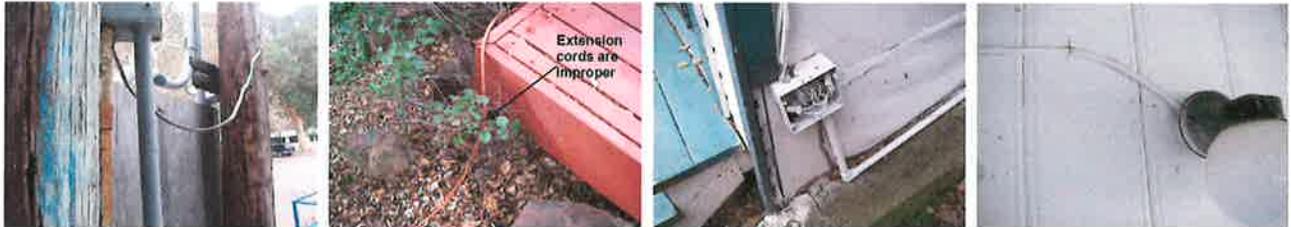
Some of the yards lights are not functional and are not wired to electrical safety standards, and should be evaluated for safety.

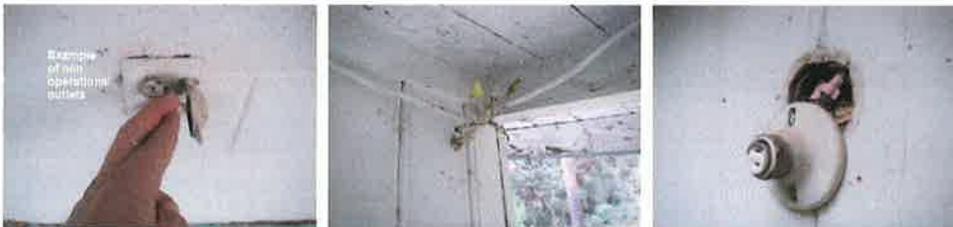
The outlets are an obsolete, ungrounded type that should be upgraded to have ground-fault protection.
All of the exterior outlets should be upgraded to have ground fault protection.

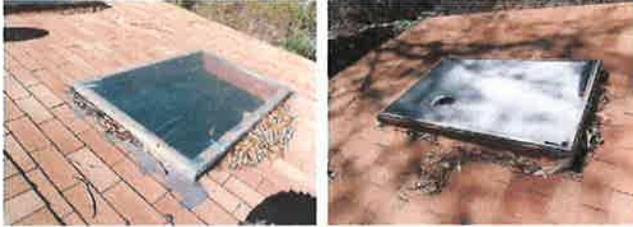
The skylight on the composition shingle roof is an amateur installation that could leak. Standard skylights are curb-mounted, sit several inches above the roof surface, and are sealed with metal flashings to prevent leaks, and any skylight without these features is suspect and should be replaced or monitored.

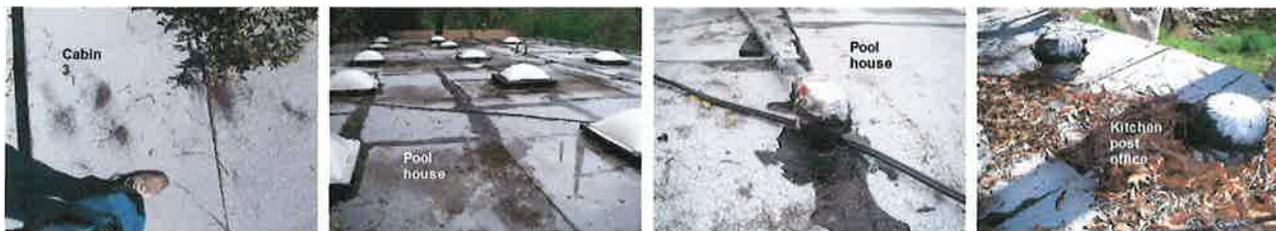
The roof needs to be cleaned to drain effectively.

There are moisture stains within the property, which we will identify, that imply that the roof leaks. However, leakage can be difficult to confirm, and you should ask the sellers about this.

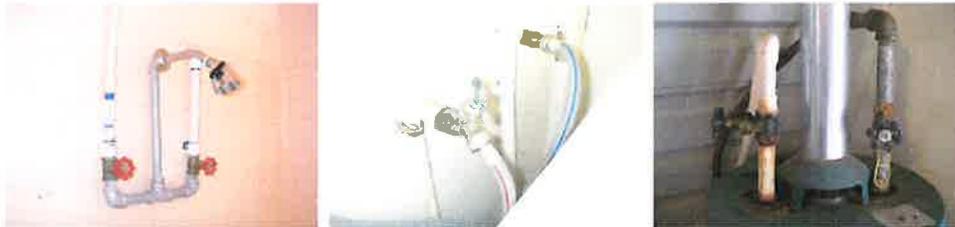
PVC water pipes were noted in the system which is improper, we recommend further evaluation of this system by a qualified plumbing specialist.

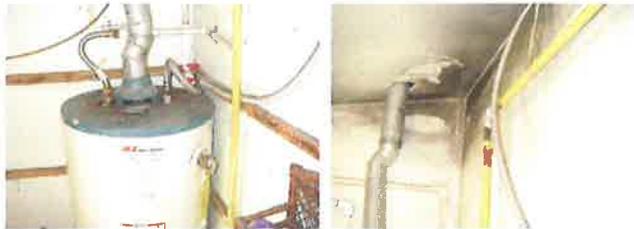
Soot on the walls in the bathhouse closet indicate back drafting that should be evaluated prior to use.

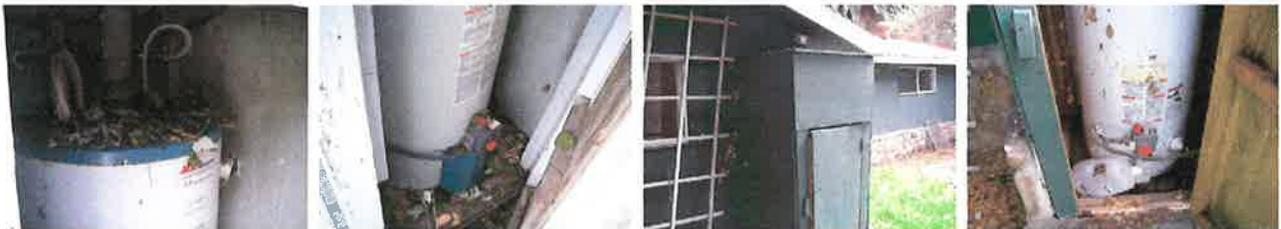
Moisture stains, mold like stains and or damage visible in the closets / platform that should be investigated further.

Rodent presence noted in multiple water heater locations, this is a fire and venting safety issue that should be addressed prior to use.

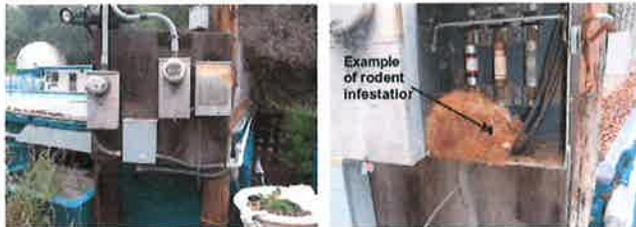
The residence is served by a 100 amp, 120/240 volt panel, located in the front.

We recommend you consult with an electrician to determine adequacy of the older existing system in light of planned changes in building use.

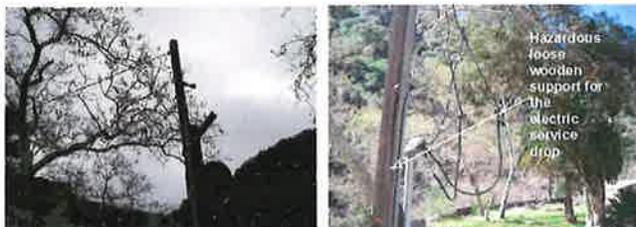
The utility company's overhead conductor lines may be stressed by tree limbs that should be trimmed away. The service entrance mast is made of wood and is loose, and not fully visible. At the post office kitchen building.

The service mast is bent at the bath house.

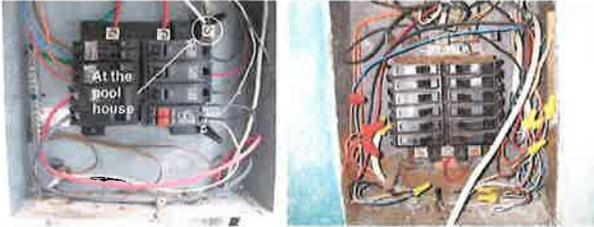
Improper wiring was noted in the sub panel, which should be investigated and repaired as needed by a qualified professional.

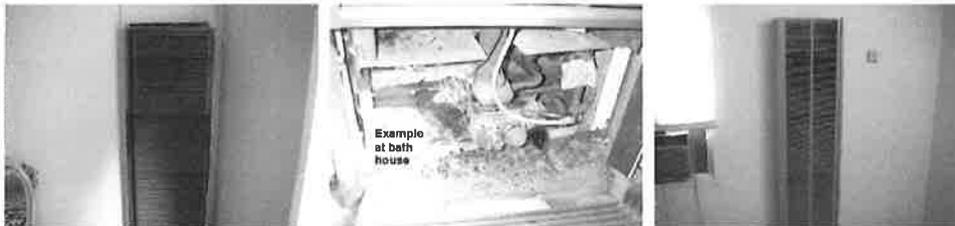
Heat is provided by wall furnaces. However, many pilots are off, which prevented them from being tested. They should be serviced and evaluated by an HVAC contractor.

Rodent infested and altered in the bathhouse.

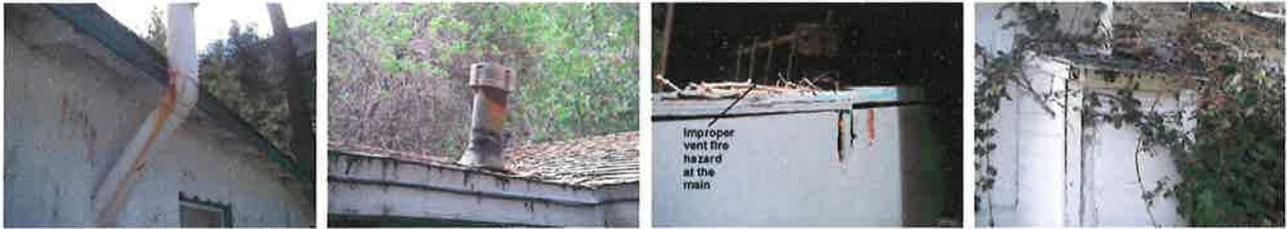
The rusty vent pipes on the roofs should be evaluated further and or replaced to improve safety.

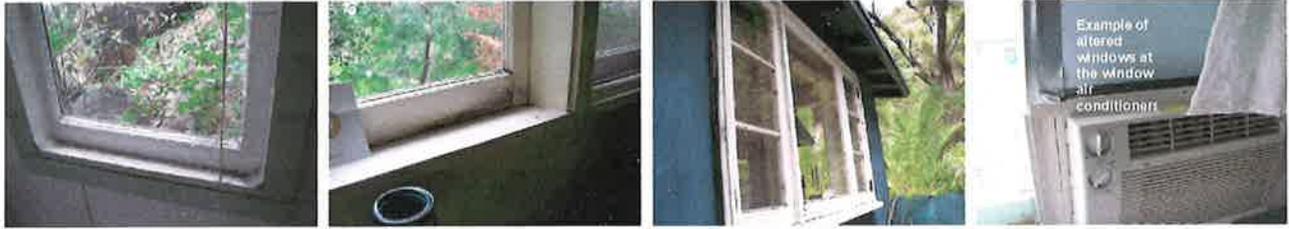
Several windows were moisture or insect damaged, and should be evaluated by a termite inspector. Post office / kitchen, main house.

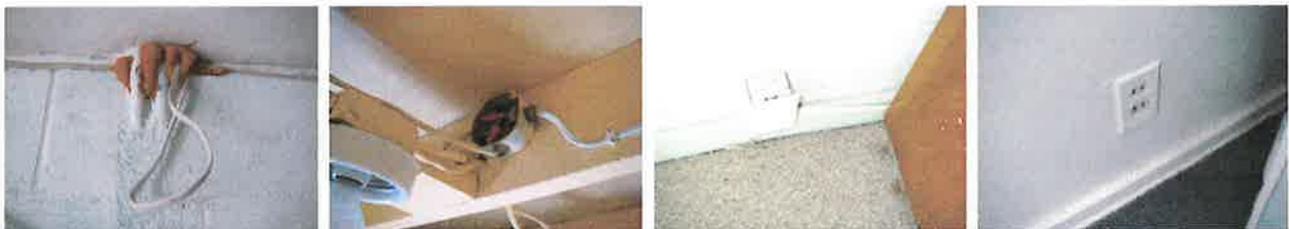
Some outlets were improperly wired and should be evaluated or repaired by qualified specialists.

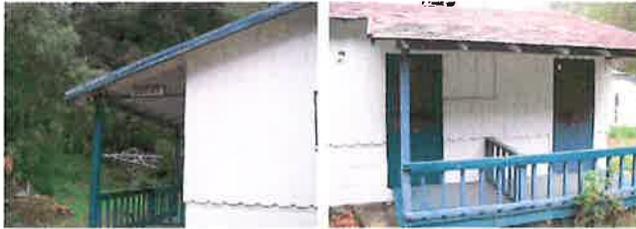
Some deficiencies were noted.

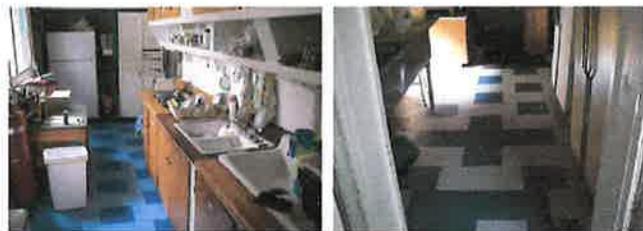
We did not inspect the kitchen equipment. Wear and tear were noted.
The gas appliance in Cabin 1 were shut down and not tested.
