**Summary Report on Biological Surveys, Permit Compliance
Monitoring, and Inspection, Matilija Creek
Giant Reed Re-Treatment Project,
Ventura County, California**

**Re-Treatment No. 18 (28 May 2019 – 18 June 2019)
Specification No. WP19-08(1), Project 41652**

10 July 2019

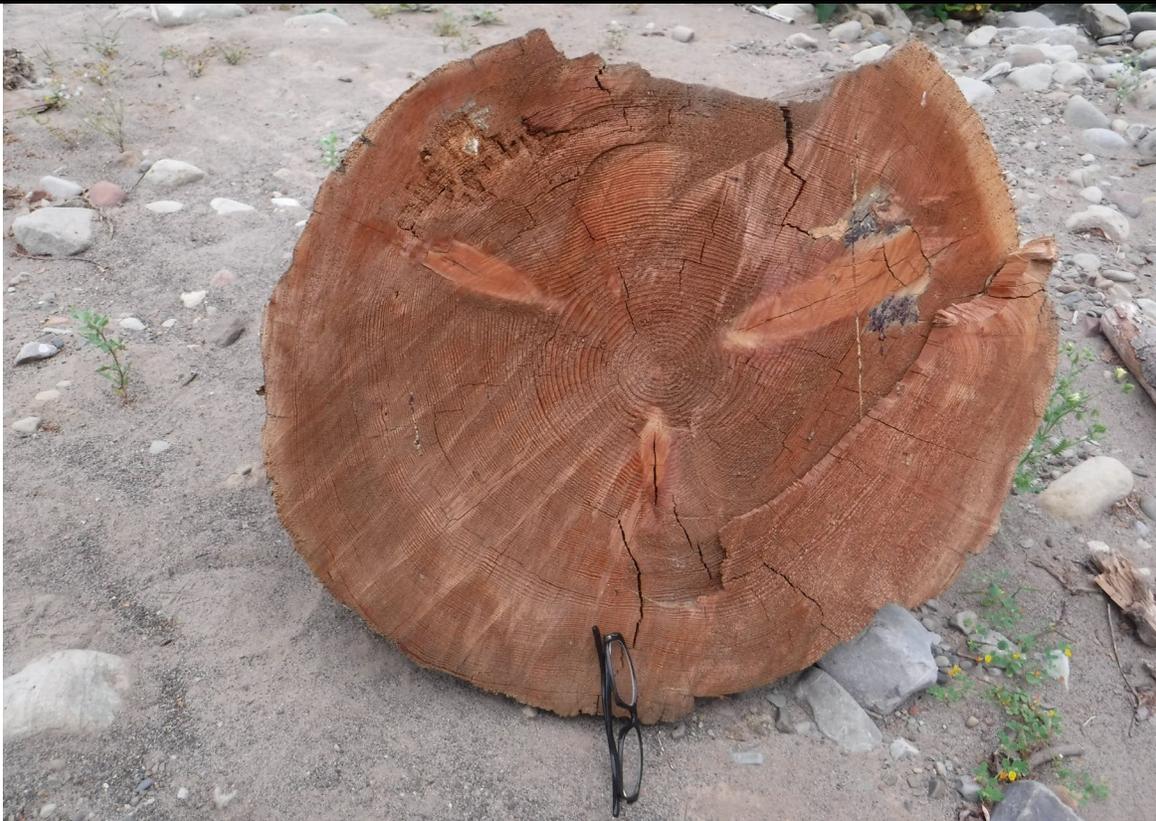
Bigcone spruce (Pseudotsuga macrocarpa) trunk transported deposited onto Matilija Creek floodplain in Reach 7a from adjacent ridgeline. This 23-inch diameter log has at least 133 annual rings.

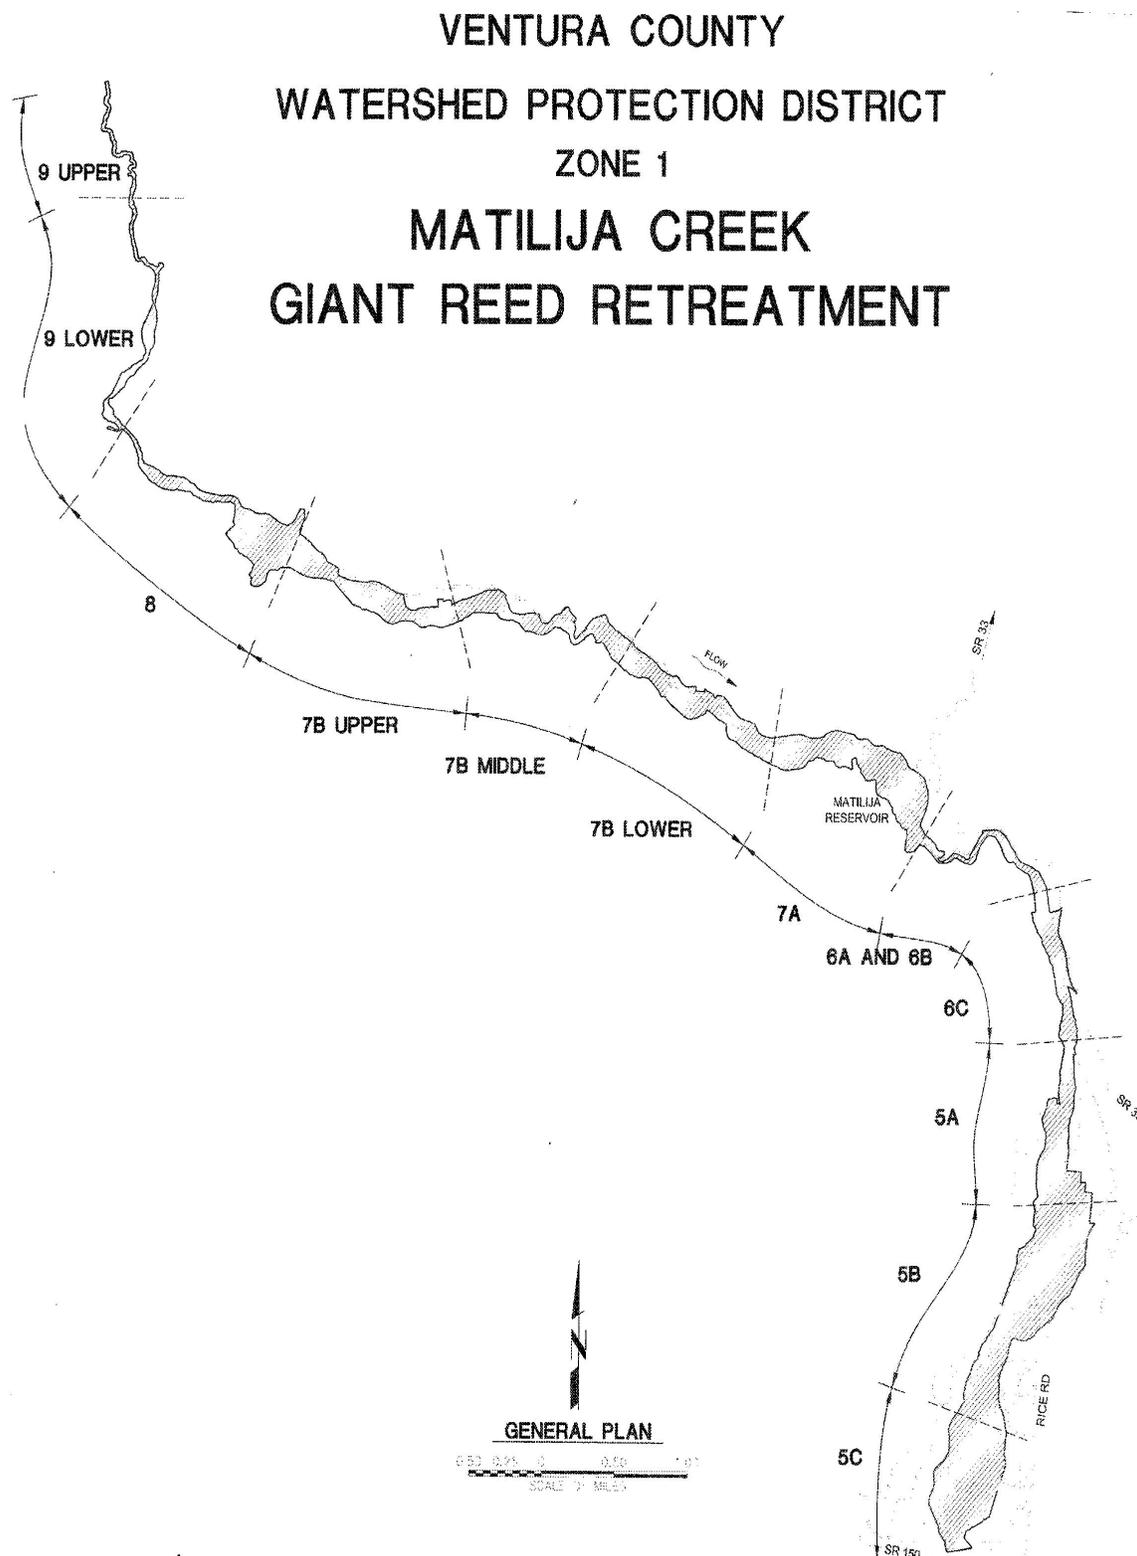
Figure 1. Project area reaches in the Ventura River and Matilija Creek watersheds. Highway 150 bridge is at bottom of figure. The main stem of the Matilija Creek sub-watershed begins in Reach 6a/6b, about 3,200 feet below Matilija Reservoir.

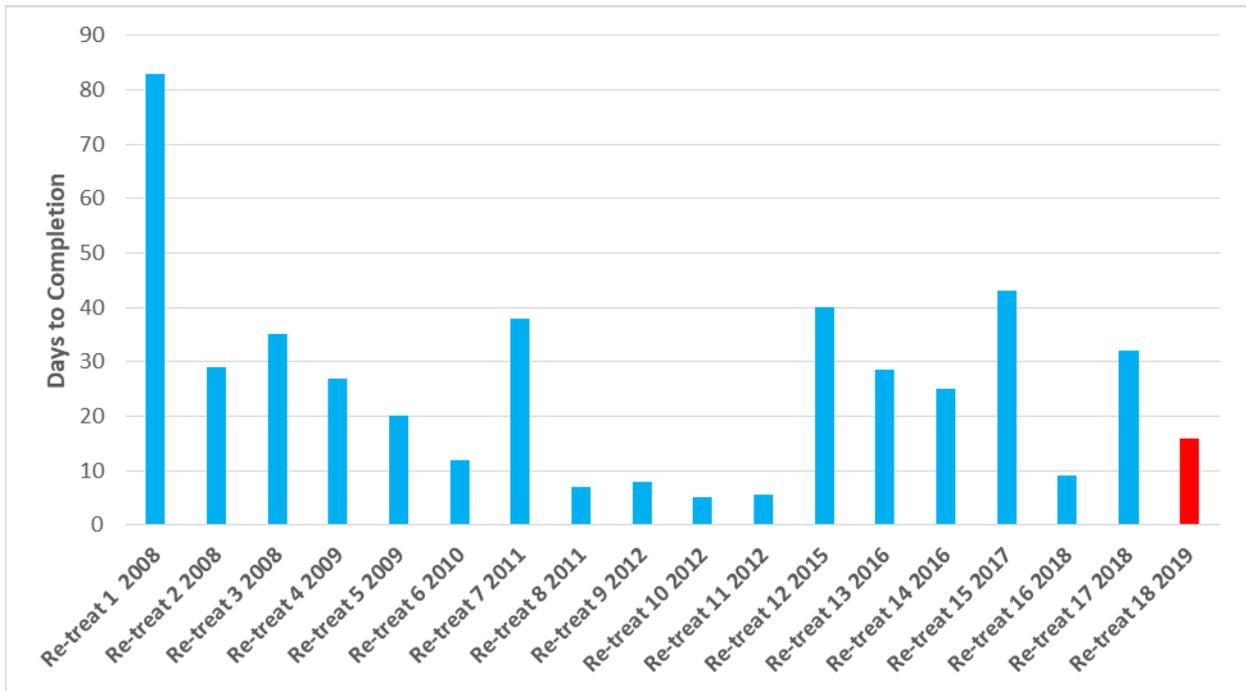
Figure 2. Time required to complete re-treatments. Initial removal of target species in 2007/2008 took 202 work-days and the first re-treatment afterwards took 83 work-days to complete. The average time to complete the other 11 re-treatments to date since the 1st re-treatment is 30.4 work-days (excluding Re-treatments 6, 8-11, and 16 because they did not involve entire project area or are otherwise unrepresentative of a typical re-treatment).

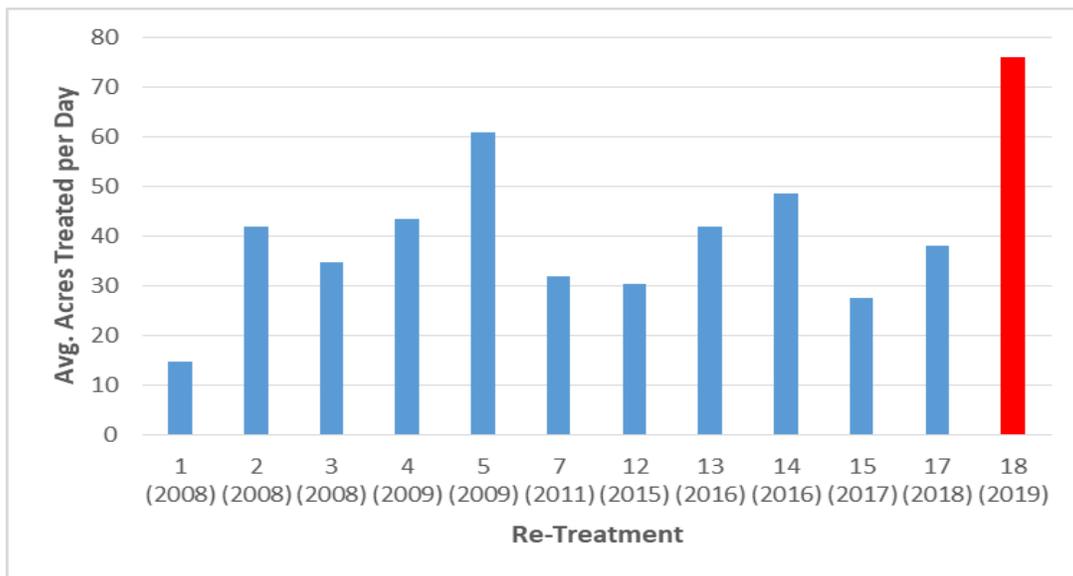
Figure 3. Average acreage treated/day (Re-treatments 6, 8-11, and 16 are not shown because they either did not include the entire project area or are otherwise unrepresentative of a typical re-treatment session).

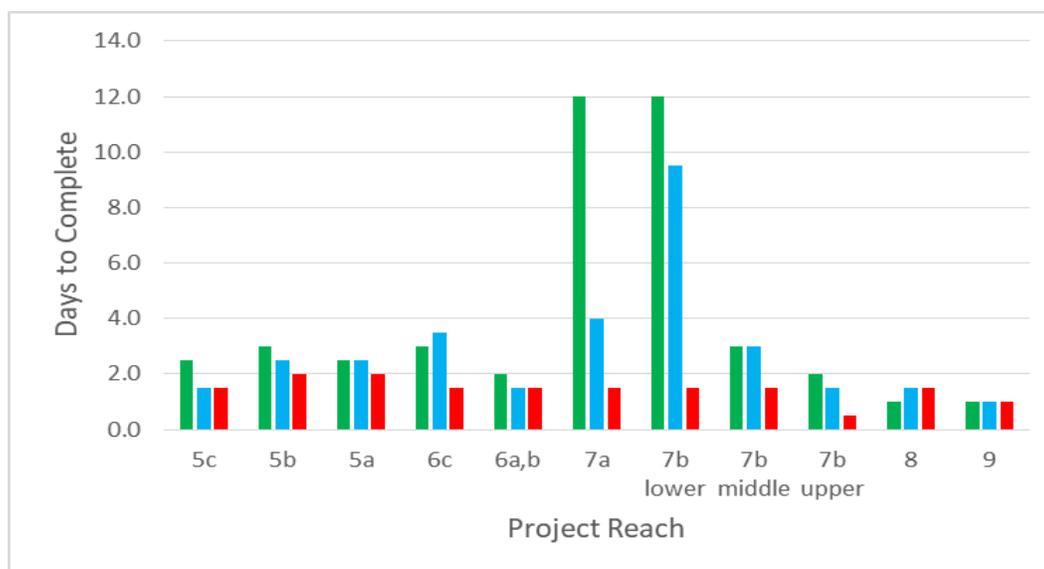
Figure 4. Work progress by project reach during Re-treatments 15 (Sep-Nov 2017) (green) and 17 (Sep-Dec 2018) (blue), compared to Re-Treatment 18 (May-Jun 2019) (red). See text for explanation.

Work progress varied widely between reaches, primarily due to magnitude of infestation of target species (Fig. 4), but also because of the strategy adopted by the contractor to make two sweeps in some reaches, one to focus only on hand-pulling tamarisk seedlings and another to cut-daub all other target species. Reach-specific variation in effort during Re-treatment 17 mirrored the effort required for Re-treatment 15 (Fall 2017--the last full re-treatment of the project area prior to the current re-treatment). In both re-treatments, Reaches 7a and 7b Lower required the most effort, although re-treatment of Reach 7a took significantly less time compared to 2017 because the frequency of re-sprouting giant reed was much reduced (Fig. 4).

The amount of time required to complete various project reaches was significantly lower during this re-treatment compared to re-treatments in 2017 and 2018 (Fig. 4), probably due to the combined effects of the Thomas Fire and subsequent storm flows in opening up the project area. This was particularly evident in Reaches 6c, 7a, and 7b, where target species such as giant reed, castor bean, and Scotch broom were abundant in previous years, but were only sparsely evident during this re-treatment. The seasonal timing of the re-treatment early in the growing season also may have contributed to the relatively short amount of time required for this re-treatment.

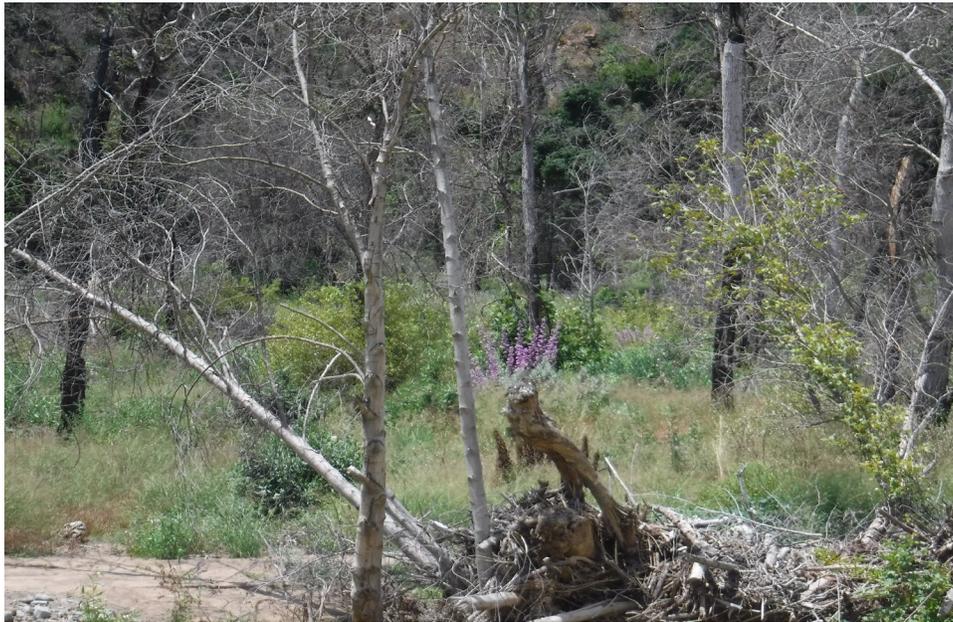
Condition of floodplain along main stem Matilija Creek in Reach 7b Lower. Prior to the Thomas Fire in December 2017, this reach supported closed-canopy riparian woodland and riparian scrub vegetation. Aspect after fire and storm flows is now very open. Note trunks of riparian trees burned in the fire, now re-sprouting from base, saplings of arroyo willow (*Salix lasiolepis*) and Fremont cottonwood (*Populus fremontii*) colonizing stream terrace, as well as sedimentation and woody debris piles deposited by storm flows during 2018/2019 rainy season on stream terrace in foreground. Poodle-dog bush (*Eriodictyon parryi*), a fire/disturbance-following species, is flowering in center of photo (purple flowers). 12 June 2019.

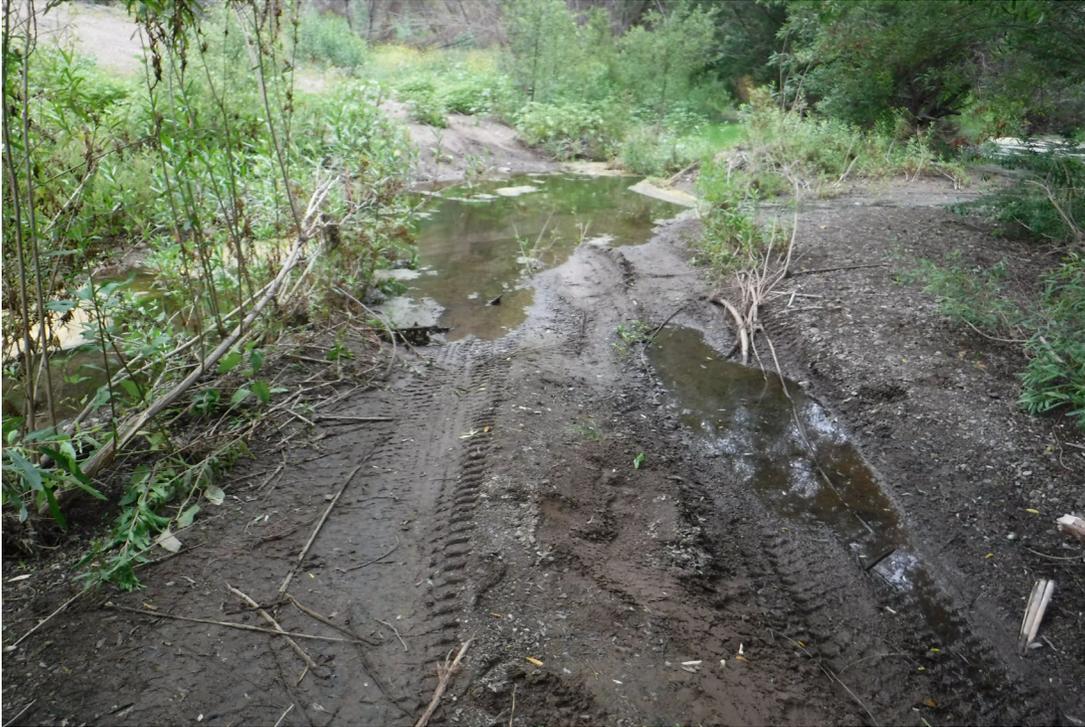
Damage to wetlands and riparian woodland in Reach 7a by vehicles accessing streambed from Matilija Canyon Road at confluence of Rattlesnake Canyon with Matilija Creek (former K-Rail Trail™). 17 June 2019.

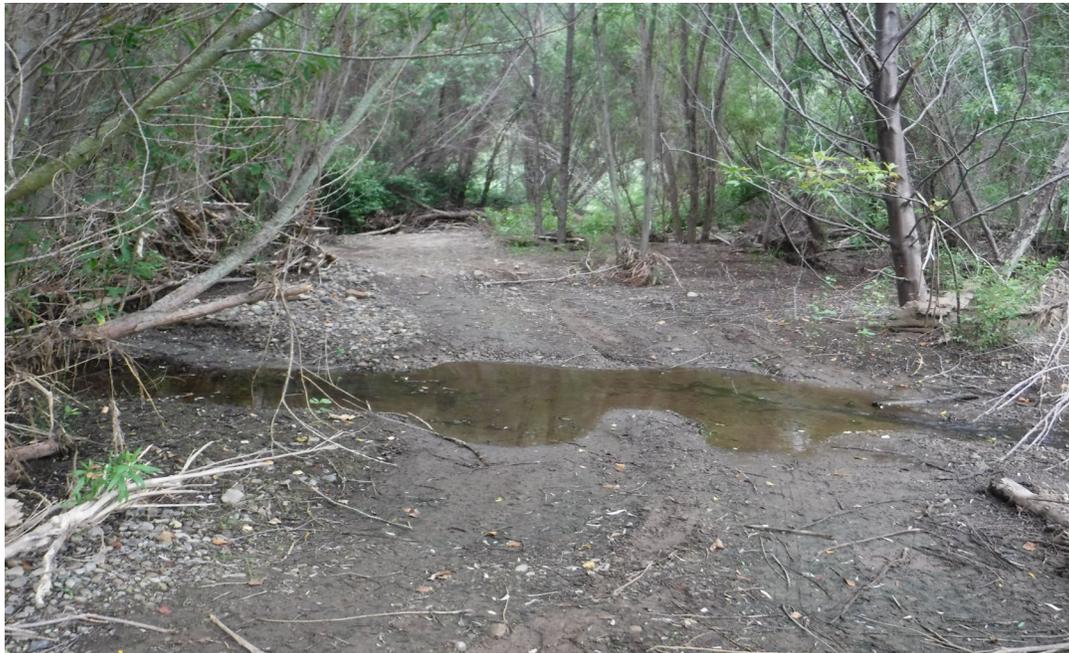
Vehicular damage to wetlands and vegetation in Reach 7a. Adult California red-legged frogs (*Rana draytonii*) were found here on 17 June 2019.

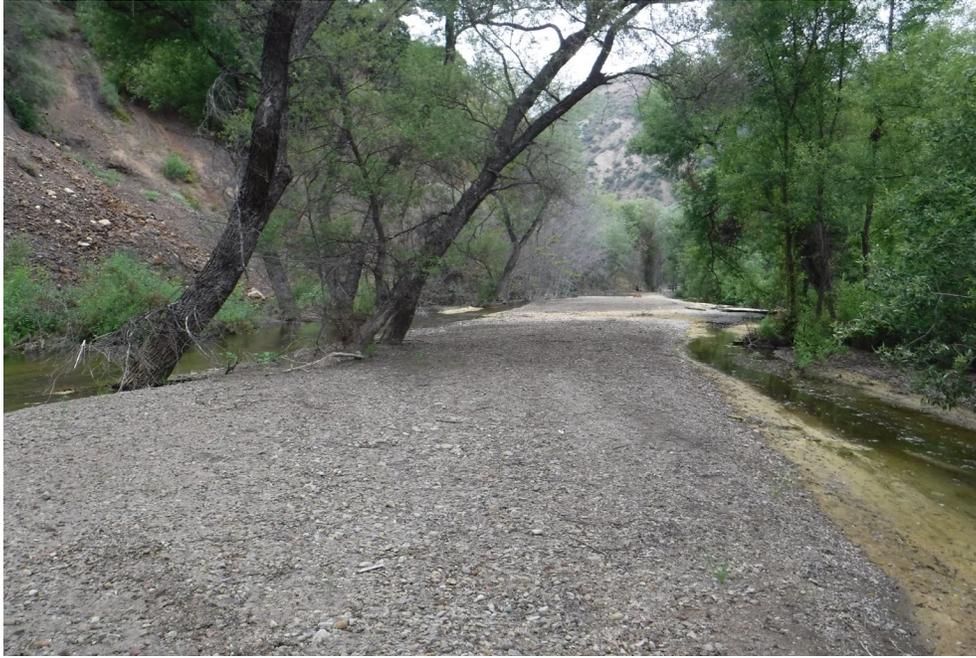
Vegetation removal and sedimentation along primary channel of Matilija Creek on S edge of floodplain, looking east (upstream) due to winter 2018/2019 storm flows). Bed elevation has been raised at least three feet along this reach. This area formerly supported dense colonies of giant reed that were removed during previous re-treatments, allowing a dense native understory to form, now removed. 17 June 2019.

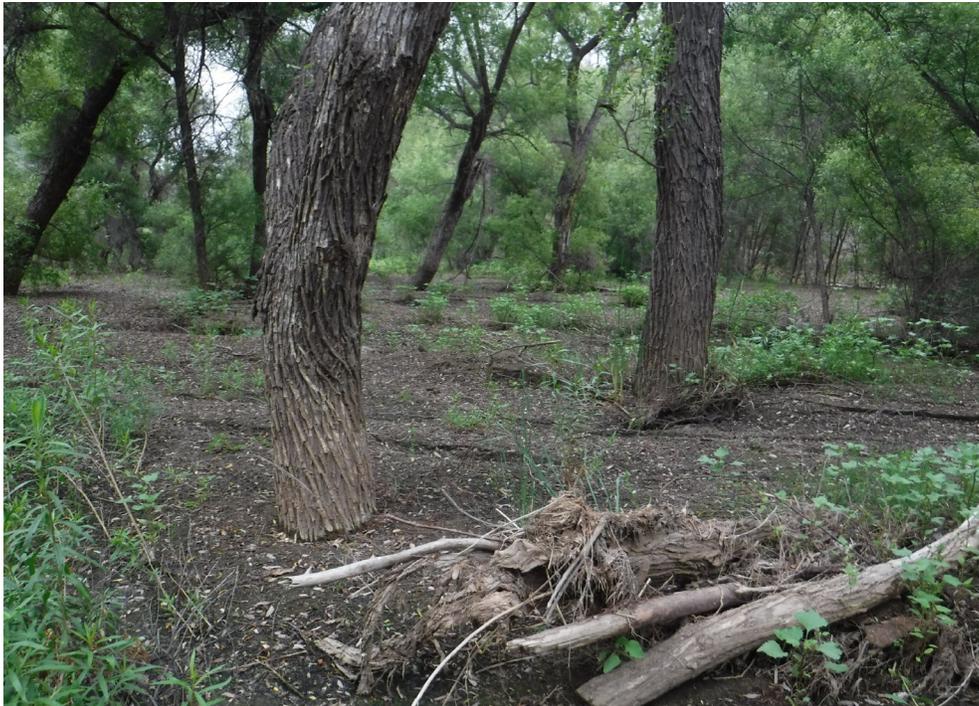
Burial of riparian trees in Reach 7a by sediment transported during 2017/2018 rainy season. Formerly dense understory vegetation has been all but removed by storm flows. 17 June 2019.

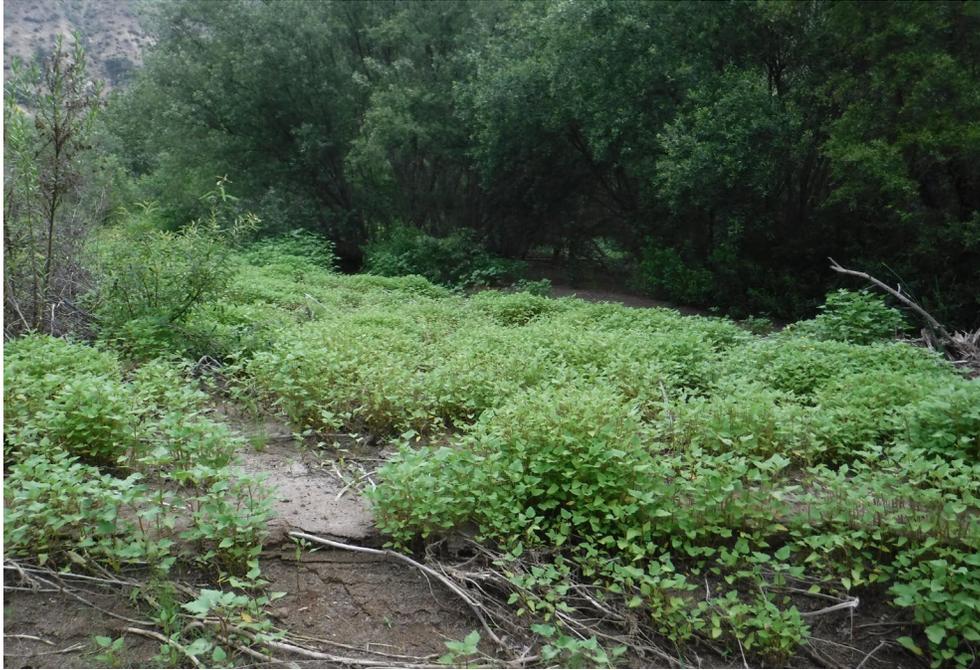
Former closed-canopy riparian woodland in Reach 7a where dense understory of native riparian trees and shrubs was removed by storm flows during the 2018/2019 rainy season. Cocklebur (*Xanthium strumarium*), a native shrub, is colonizing bare substrates here. 17 June 2019.

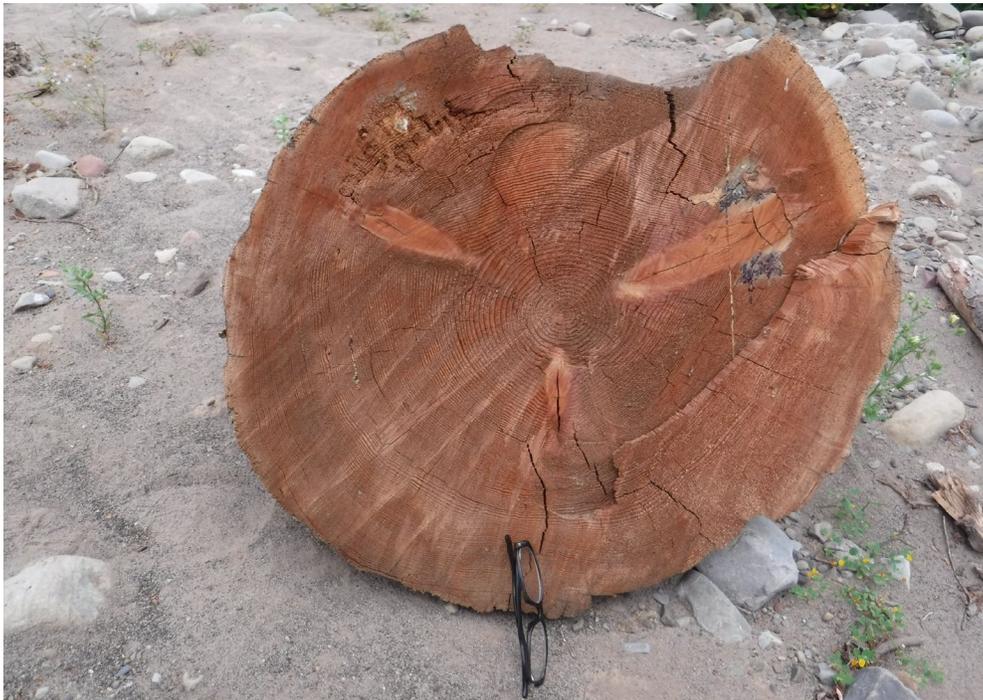
Bigcone spruce (*Pseudotsuga macrocarpa*) log (23 inches in diameter) transported by 2018/2019 winter storm flows into Matilija Creek streambed in Reach 7a from adjacent ridgelines. Twenty-two inch diameter log shows at least 133 annual rings. 17 June 2019.
