**MATILJA ROAD
 STORM DAMAGE REPAIR MP 2.25**

**MATILIJIA CANYON ROAD
SLOPE REPAIR MP 0.30 TO 0.52**

FIELD EXPLORATION PLAN

PROJECT NAME: MATILIJIA CANYON STORM DAMAGE Ojai, CA	PLATE 1
PROJECT NUMBER: 223-274	REVISION DATE: 7.10.2024

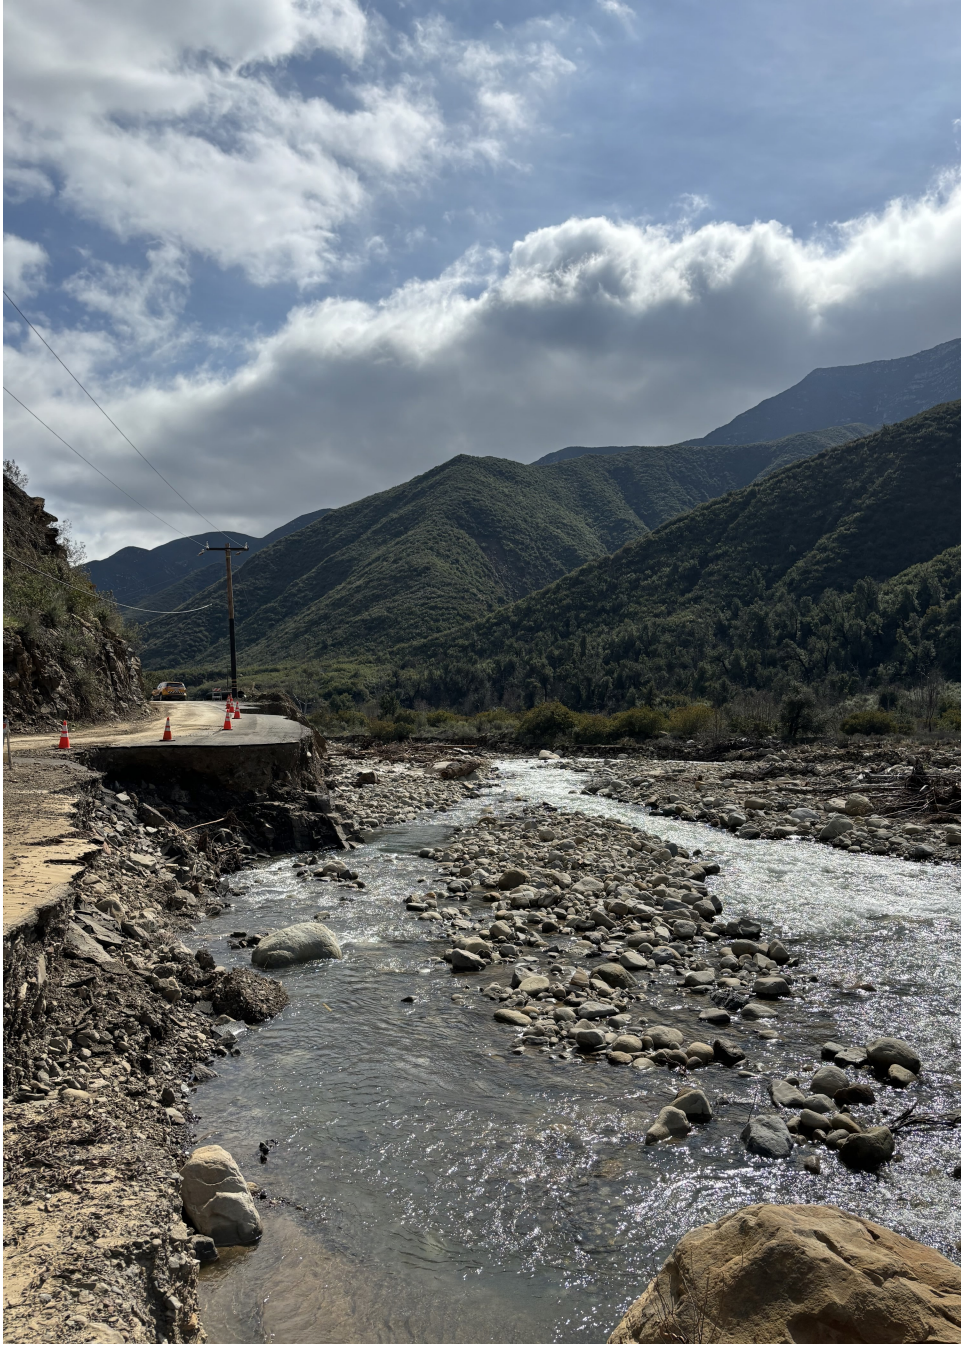
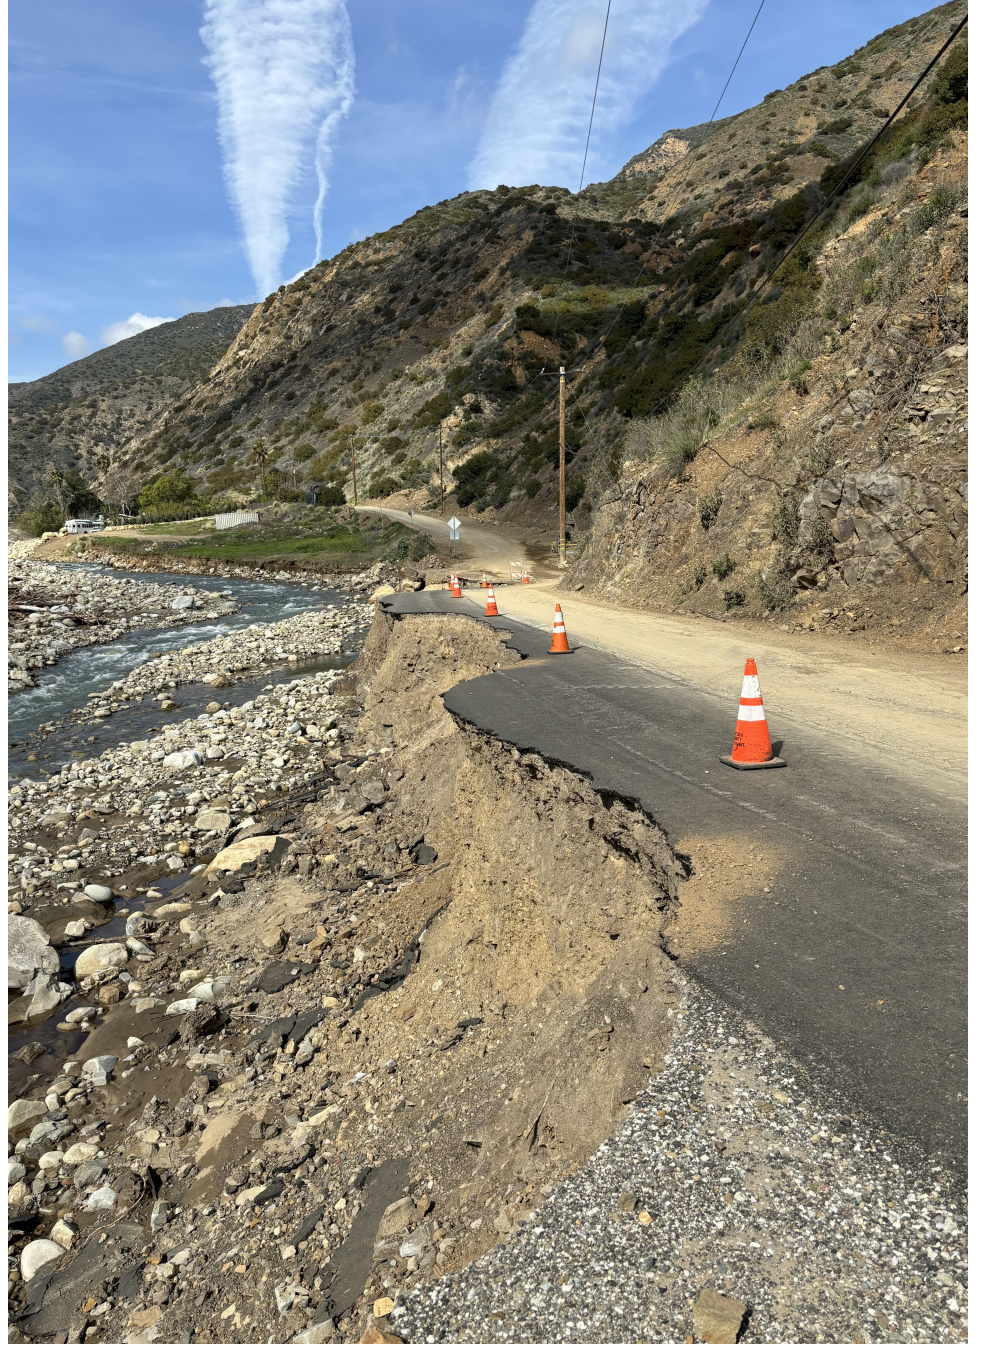
**PROPOSAL: BUILD
UP ROADWAY AND
ARMOUR BANK
WITH LARGER
ROCK-RIPRAP**

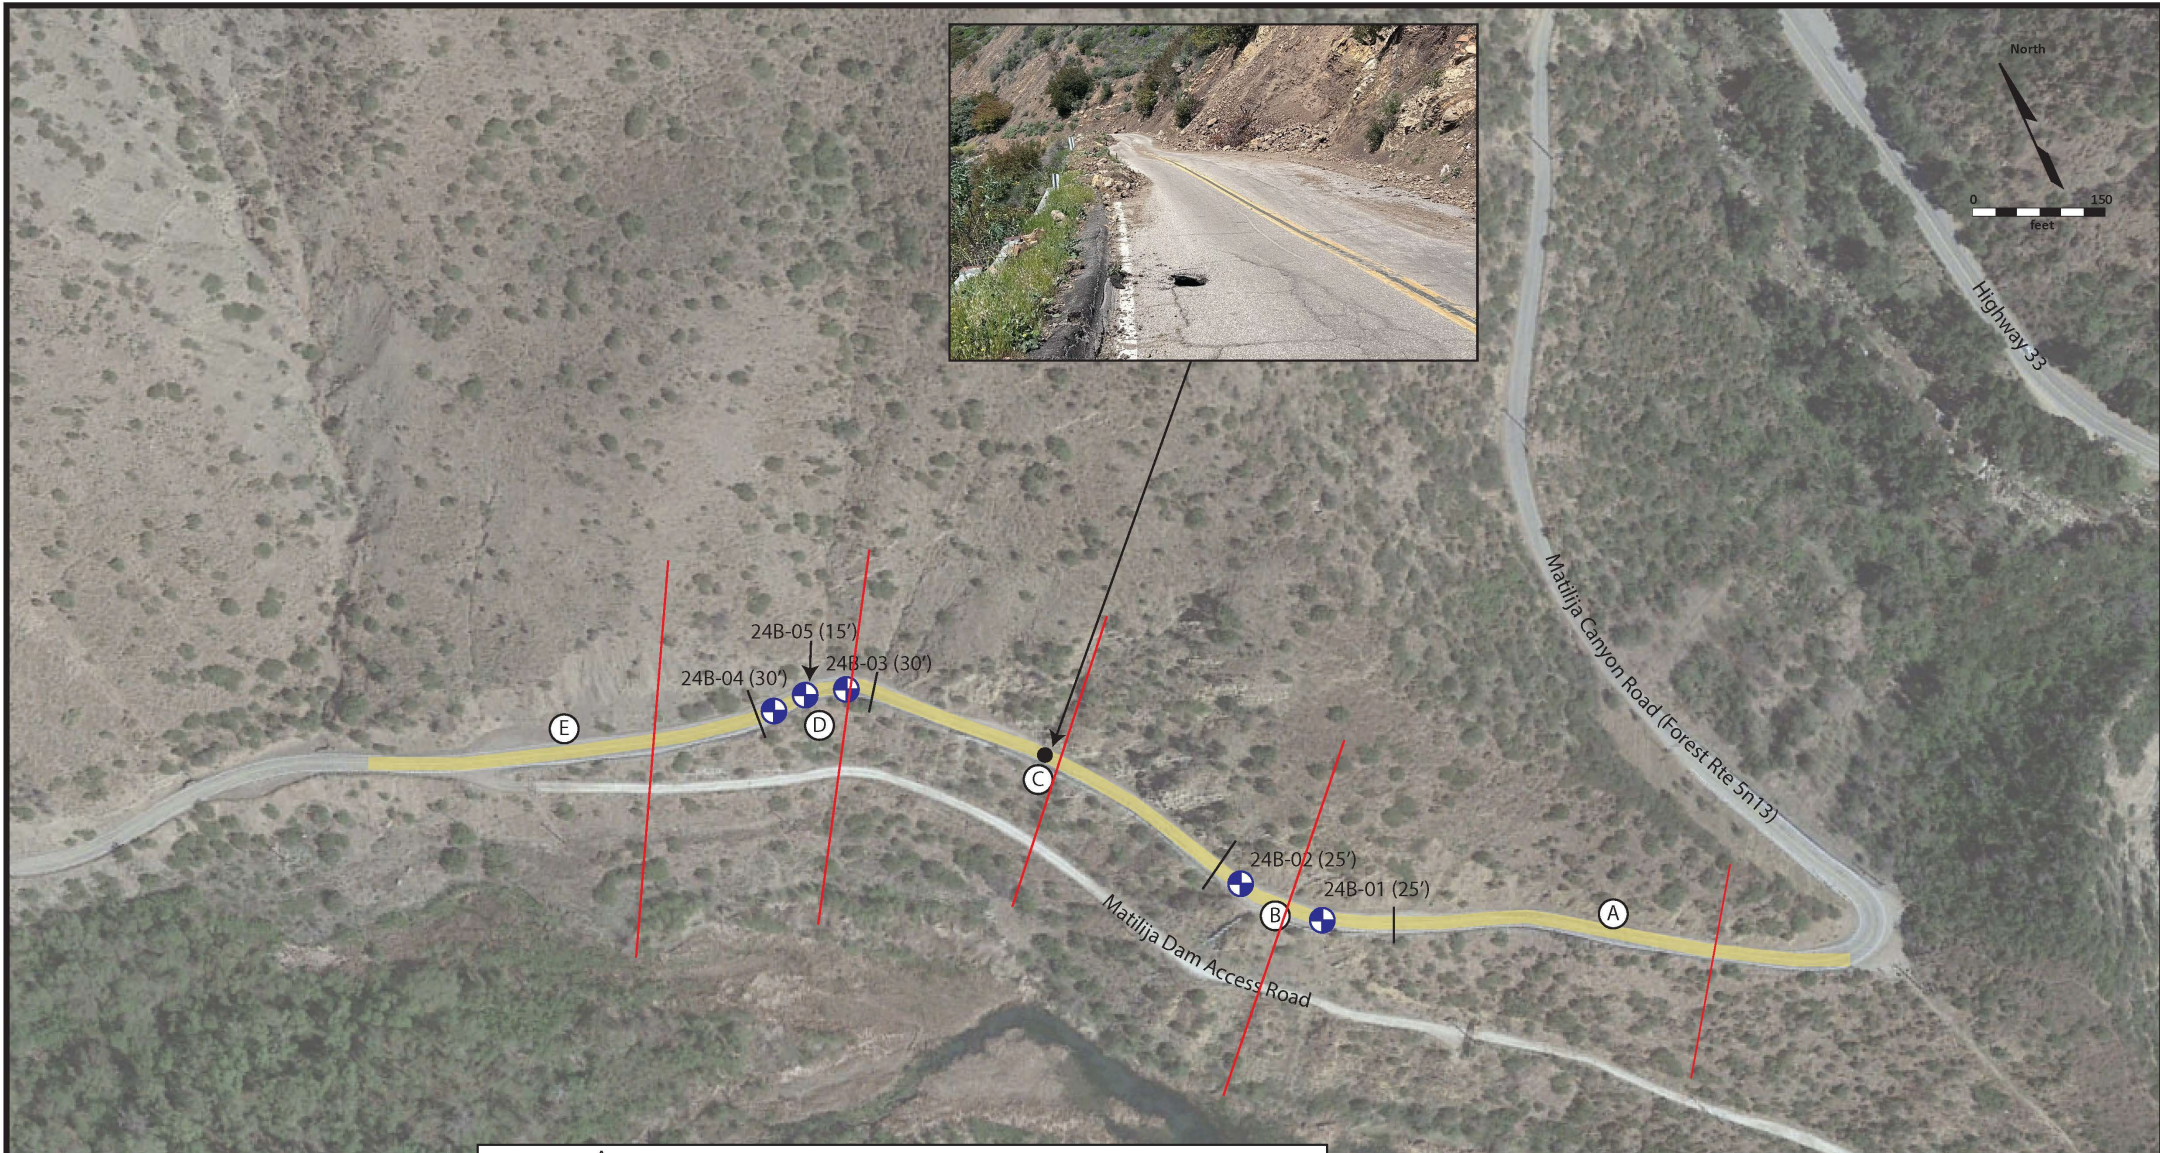
Segment	Approx. Length (feet)	Mile Post	Segment Details
A	460	0.36 - 0.45	loss of outer shoulder
B	160	0.45 - 0.49	undermined outer lane
C	460	0.49 - 0.57	existing steel crib wall, minor erosion
D	150	0.57 - 0.60	undermined outer lane, rockfall, slide debris on inner lane
E	330	0.60 - 0.68	slide debris and rockfall on inner lane

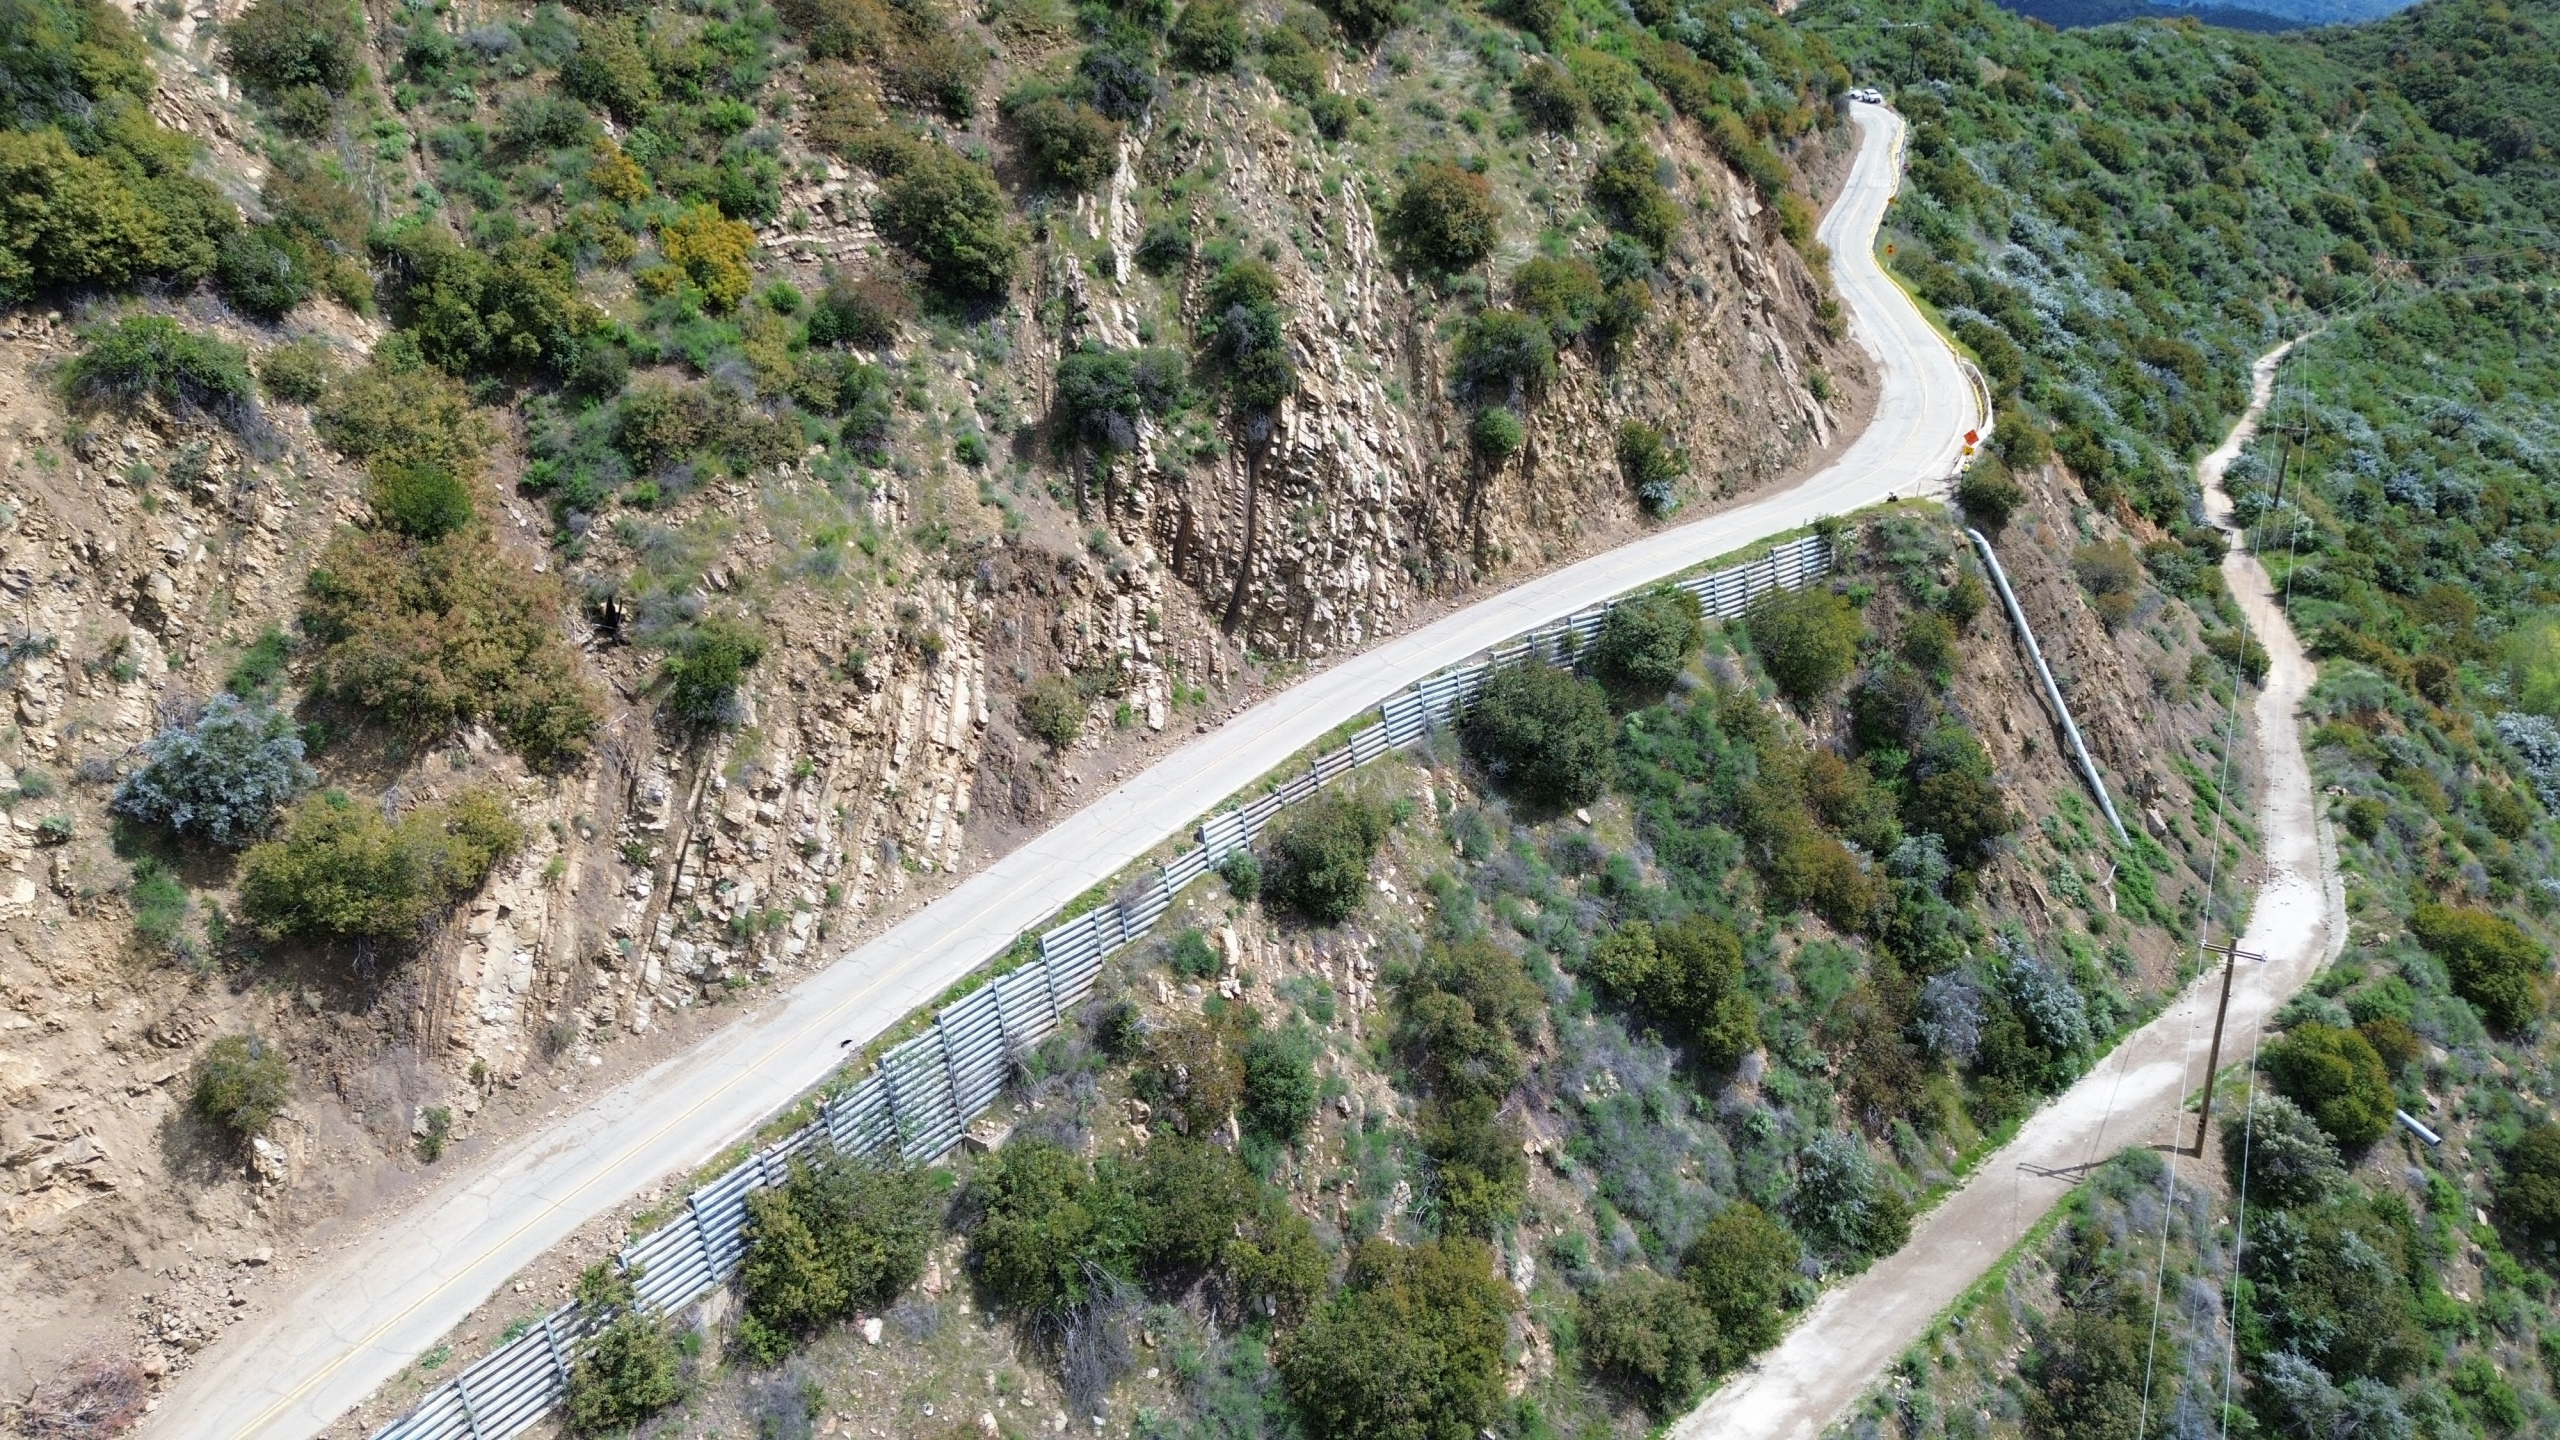
Segment C
Existing Curb wall

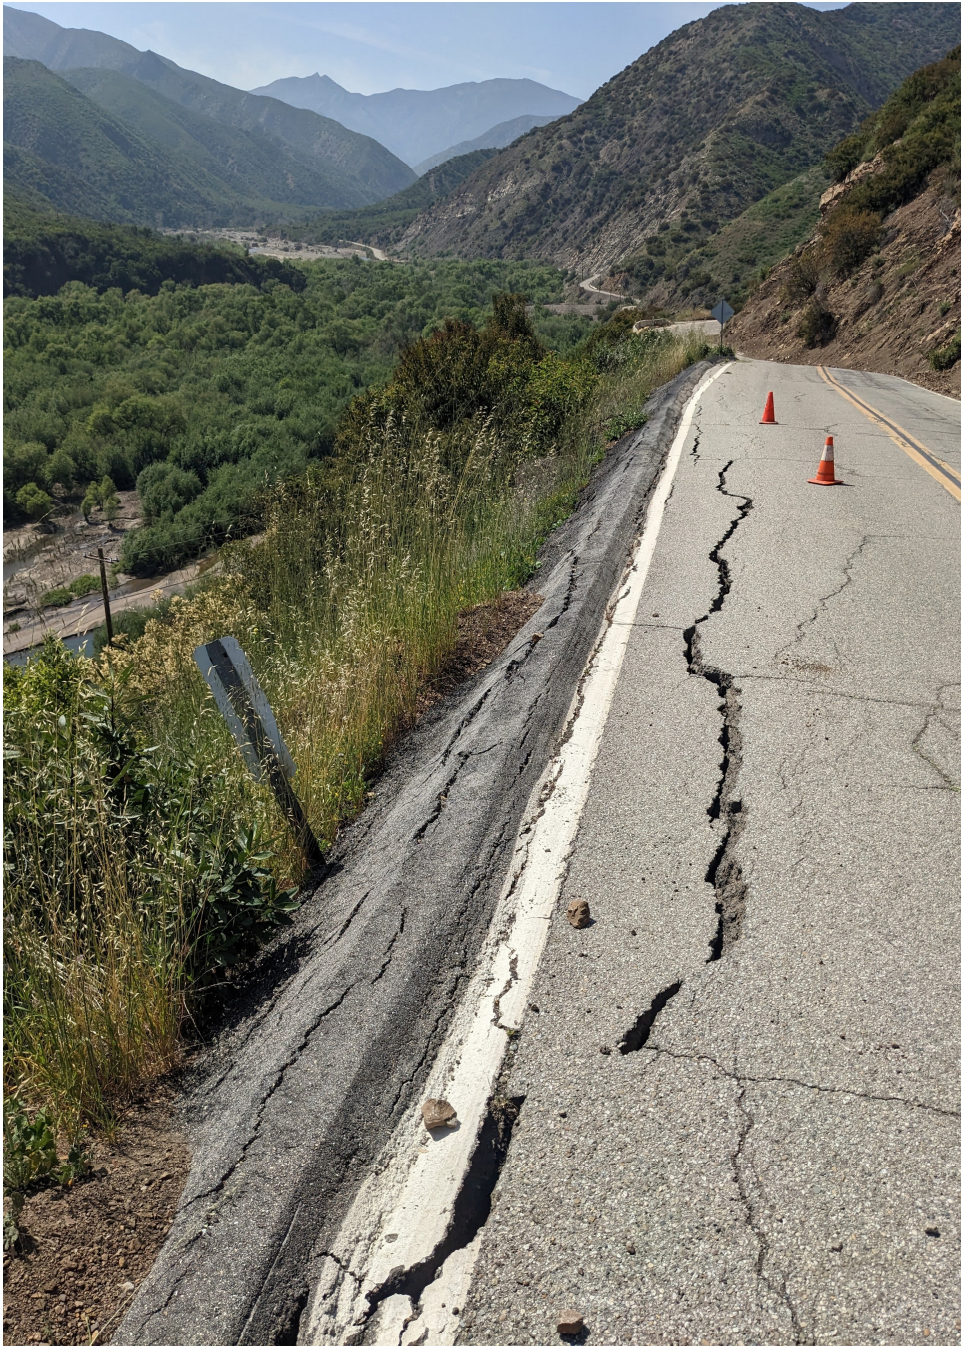
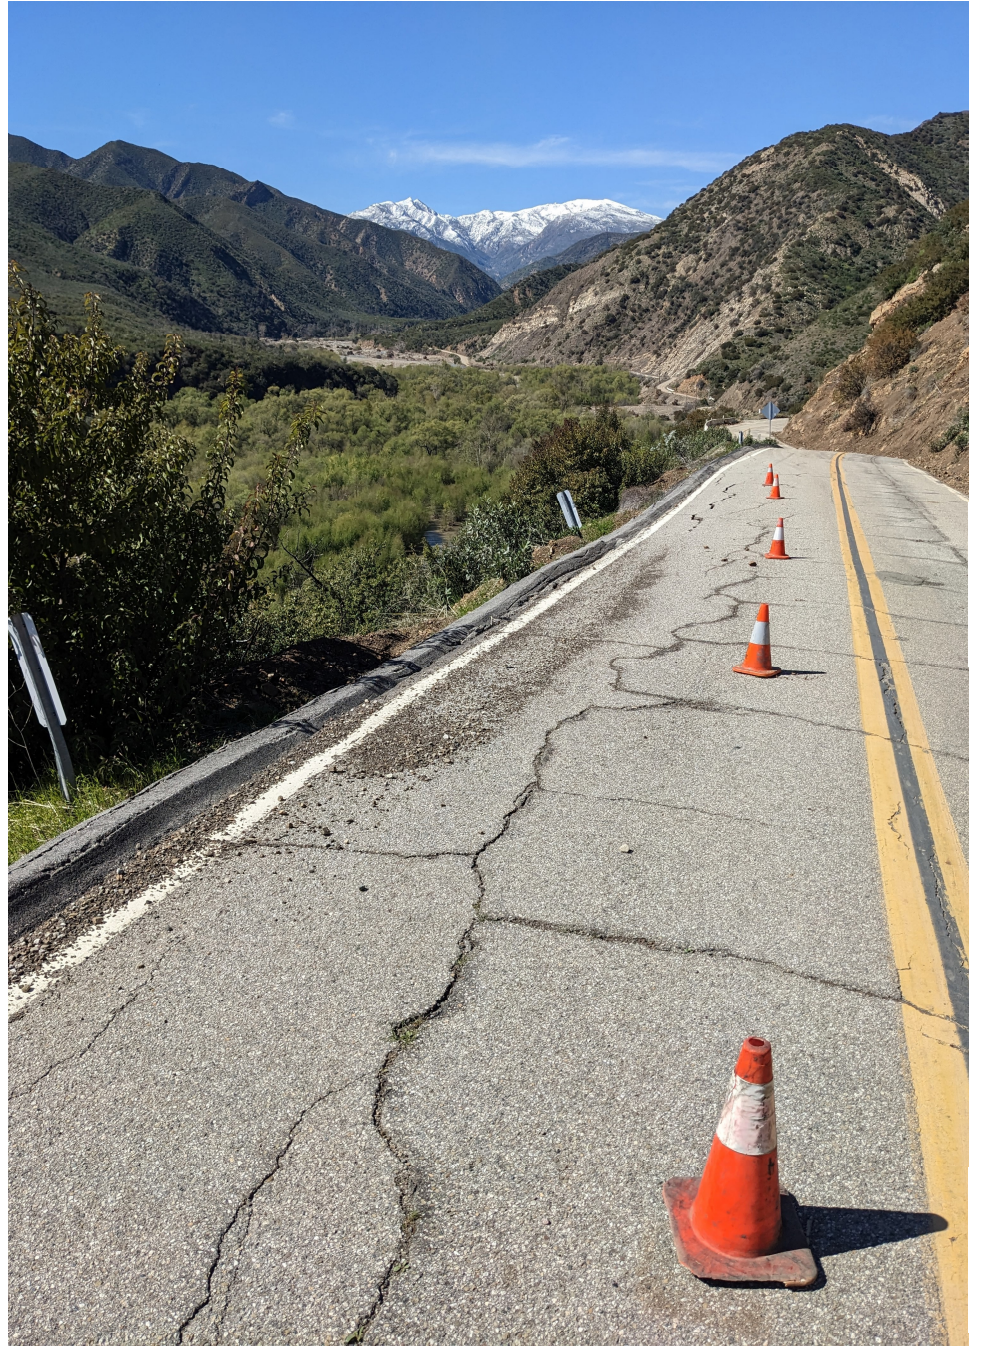
**INSTALL ROCKFALL
NETTING**

**RECONSTRUCT
SLOPE. BUILD UP
WITH CRIB WALL
OR SOLDIER PIPE
WALL**
