DAMS

California Project Tests Removal Strategies

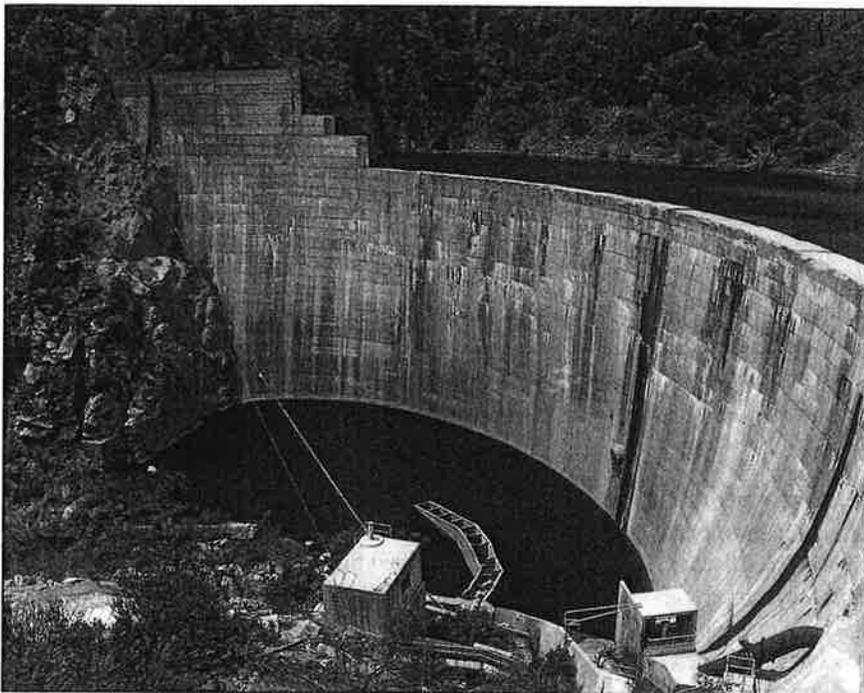
THE MATILAJA Dam, near Ventura, California, has already been notched to increase the stability of the structure, but sediment has nearly filled the reservoir and eliminated any flood protection potential.

Additionally, an alkali-silica reaction has caused cracks to form in the dam, and in the 1960s and 1970s a 358 ft (110 m) wide, 30 ft (9 m) deep section was removed from the top of the dam to increase the stability of the structure. The notched section now acts as a spillway during high flows.

The structure, which is owned by the Ventura County Flood Control District, has a crest length of 620 ft (190 m) and is among the largest of the dams in the country scheduled for demolition. It was built in 1948 to control floods, but the reservoir behind it is now so full of sediment that more than 90 percent of its flood
