## Hydrology, Hydraulics, and Sediment Studies for the Matilija Dam Ecosystem Restoration Project, Ventura, CA – DRAFT Report

U.S. Department of the Interior  
Bureau of Reclamation  
Technical Service Center  
Denver, Colorado

November 2006

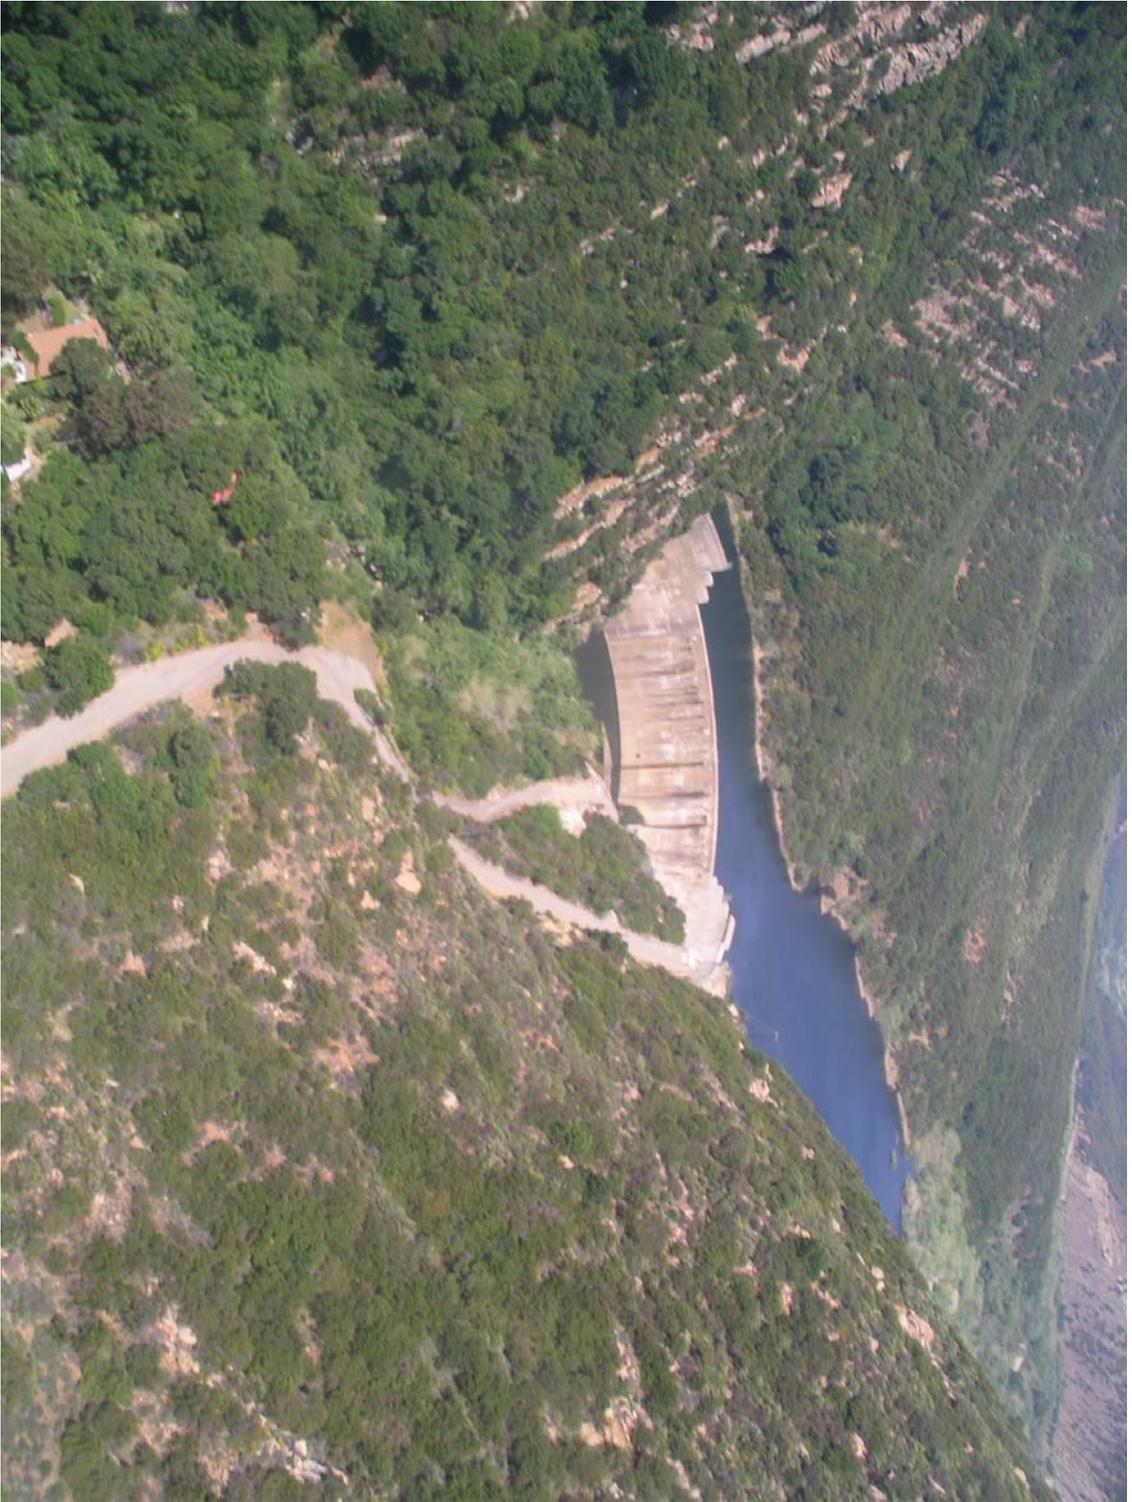
Figure 1.4. Aerial View of Matilija Dam (taken April 2004).

An Aerial view of Matilija Dam taken from a Helicopter in April of 2004 is given in Figure 1.4 and a Figure 1.5 shows an oblique view of the Upper Ventura River downloaded from Google Earth in November 2006.

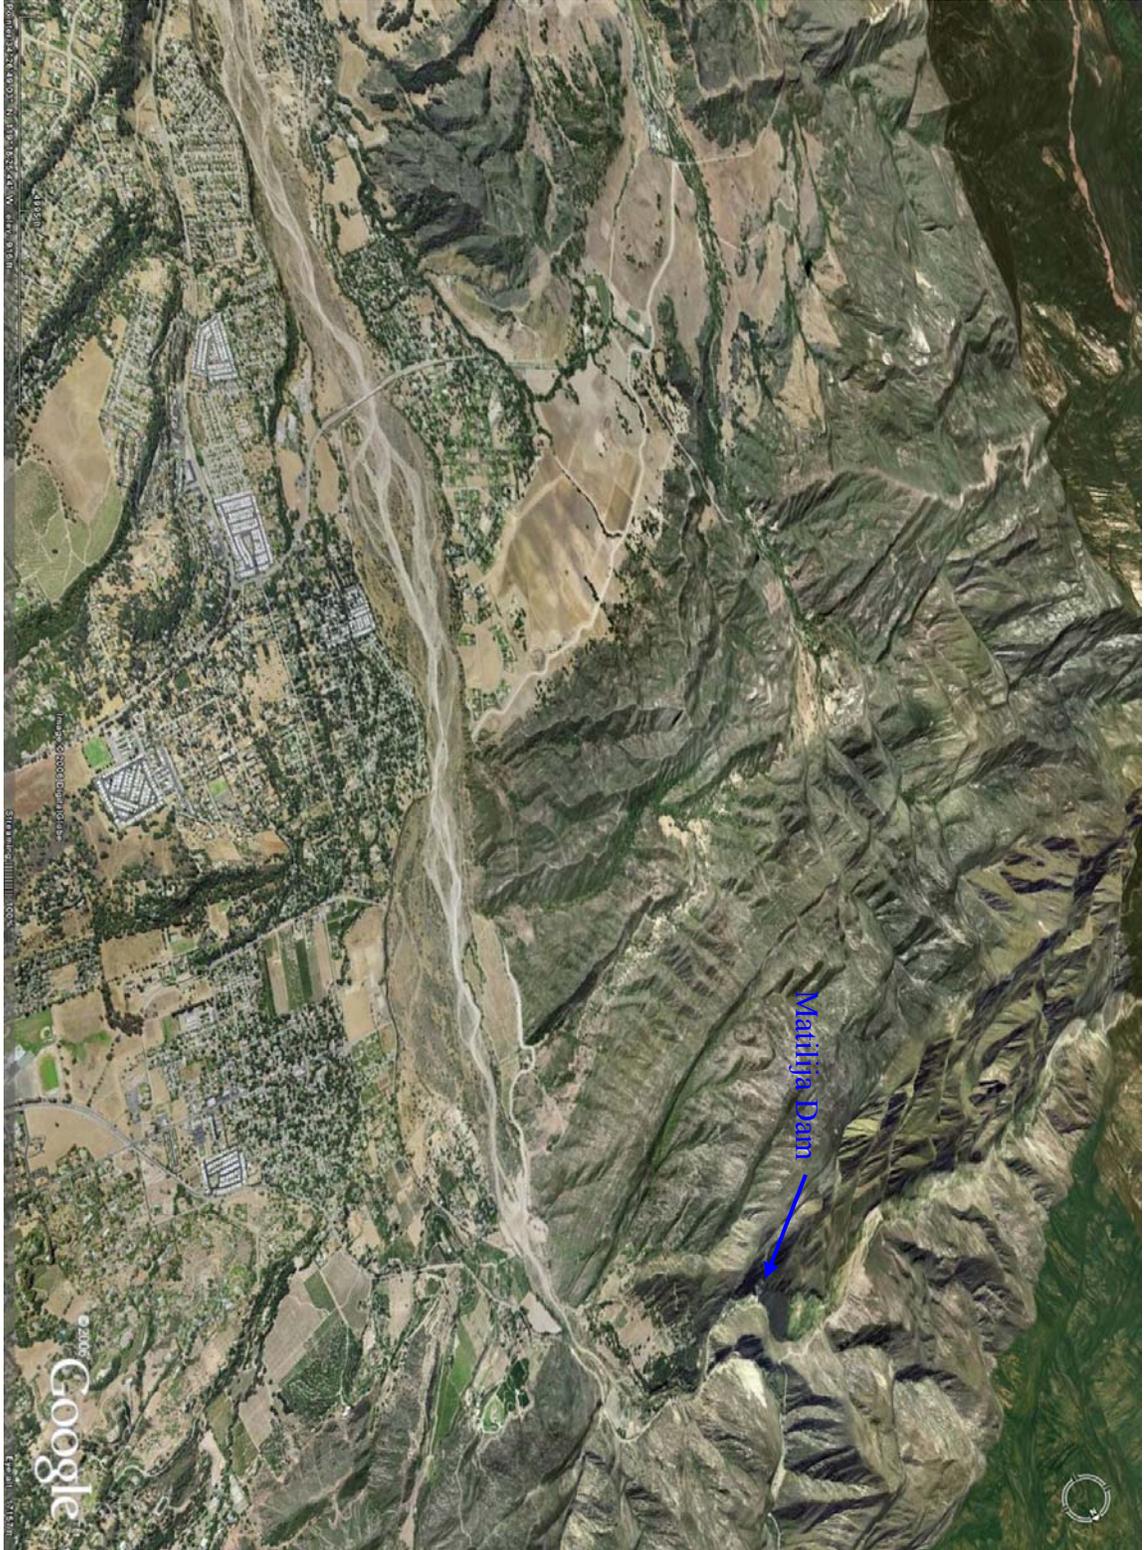
Figure 1.5. Oblique View of Matilija Dam and Upper Ventura River (From Google Earth, 2006).

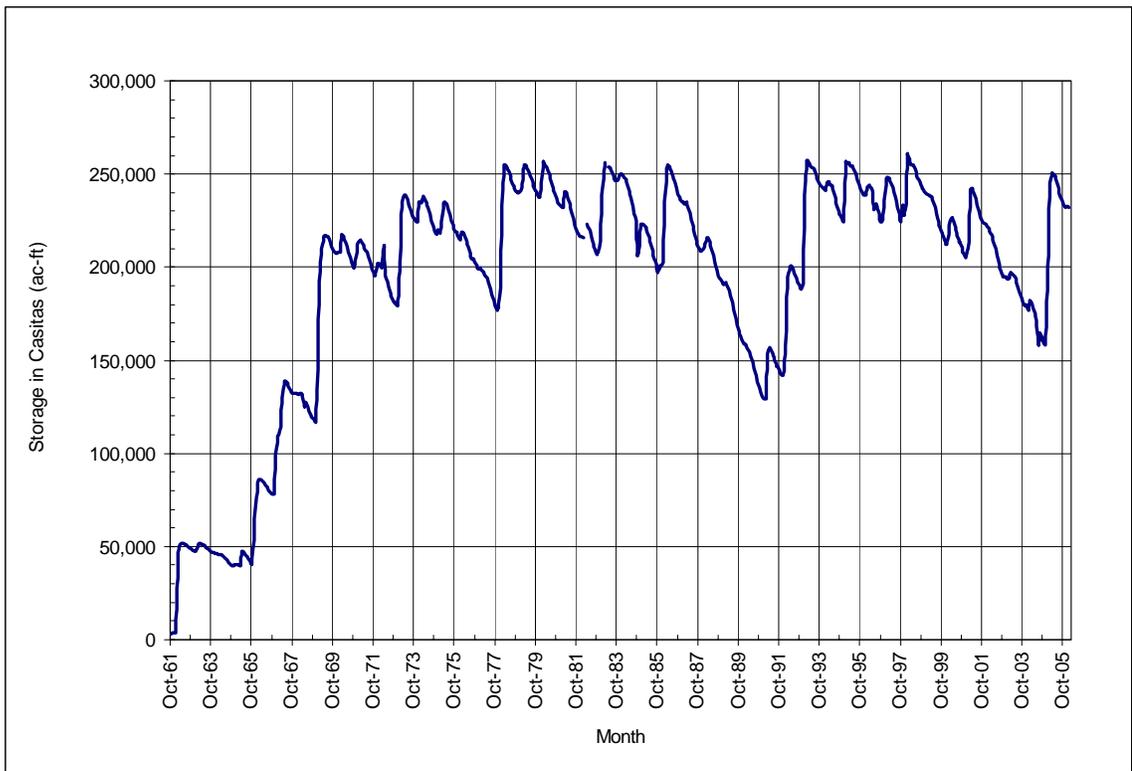
Figure 1.9. Storage in Lake Castitas.

A report summarizing the safe yield from Casitas Reservoir is found in Entrix (2002). According to that report, Casitas Reservoir yields approximately 21,500 ac-ft/yr of water and an additional 8,000 ac-ft is lost to evaporation and seepage. Based on this, the average detention time of water in the reservoir is 8.5 years. A record of the storage in Casitas Reservoir is given in Figure 1.9. Note that the storage in the lake dropped below 150,000 ac-ft only once since its original filling.

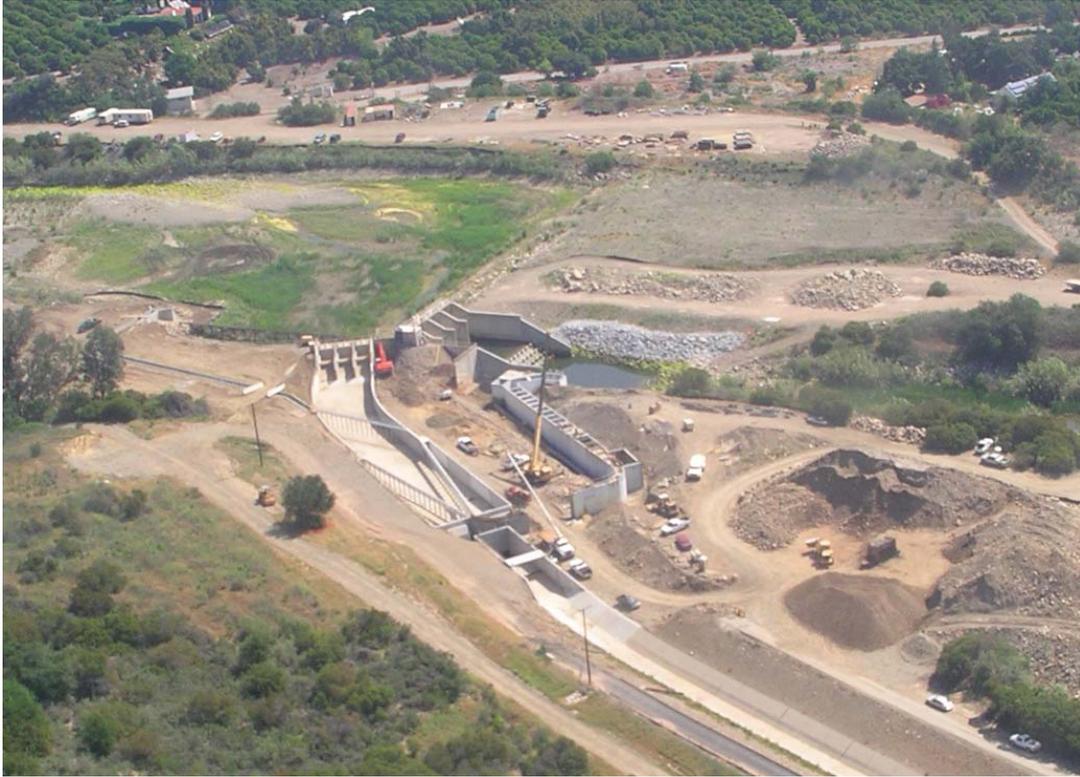
Figure 1.11. Aerial View of Robles Diversion Fish Passage Facility under Construction in April 2004.

A fish ladder was completed in the fall of 2005. An aerial view is given in Figure 1.11 showing the ladder under construction. A photograph of the fish screens is shown in Figure 1.12.

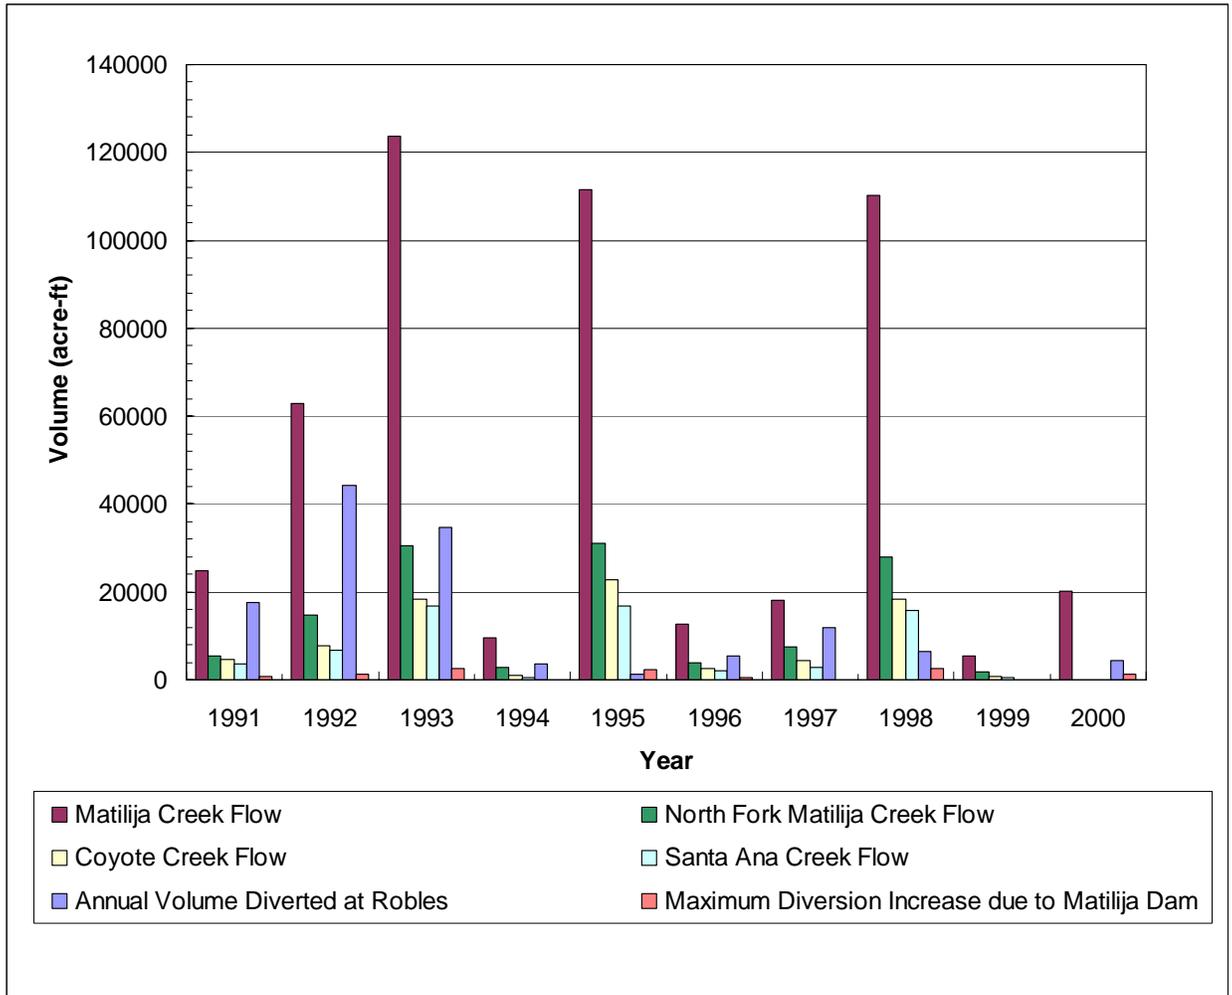
Figure 2.13. Annual Flow and Diversion Volumes for Period 1991 to 2000.

Based on the available diversion flow data for the years 1991 to 2000 there appears to be no set date for the diversion to be shut down each year. Diversions will occur as late as August 7 or July 16 in wet years such as 1992 and 1993. In normal years, the diversion appears to be shut down by the end of May. It appears that diversions can occur during all summer months if water is available for diversion.

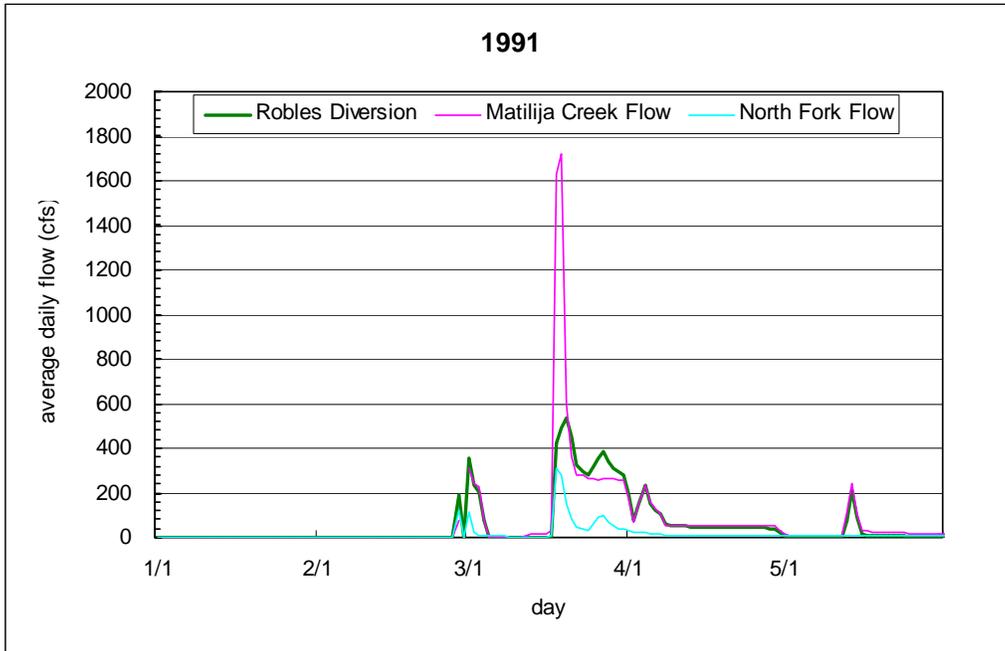
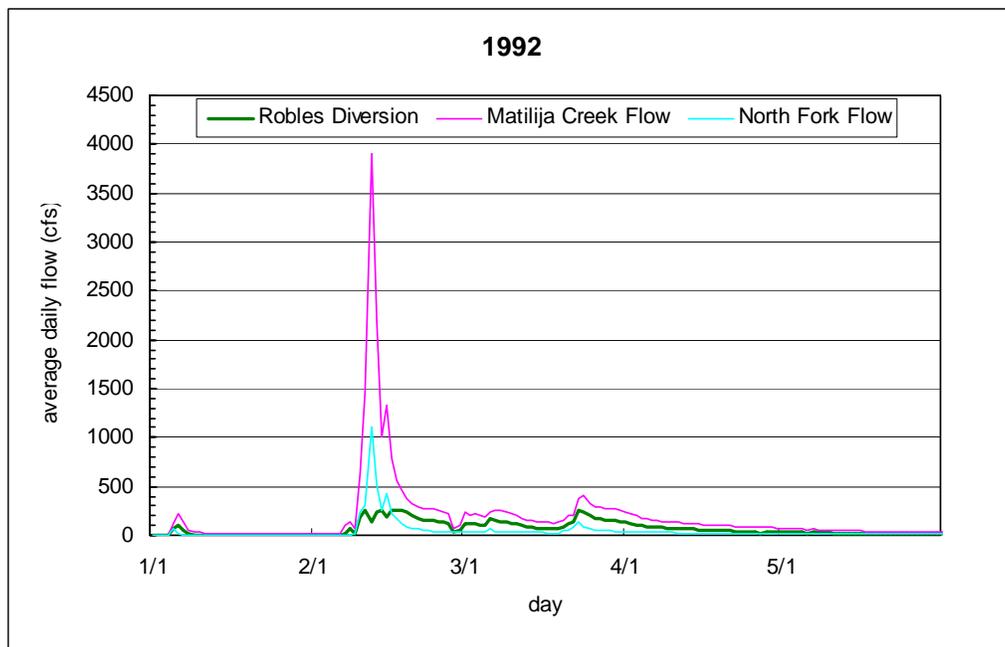
The actual daily average flow diversions for the period of 1991 to 1998 are shown on the following pages (Figure 2.14). It should be noted that there are large variations in the flow for a given year and as a result, there are large variations in the diversion at Robles. For example, in 1997, 47% of the flow of North Fork and Matilija Creek was diverted into Robles Canal.

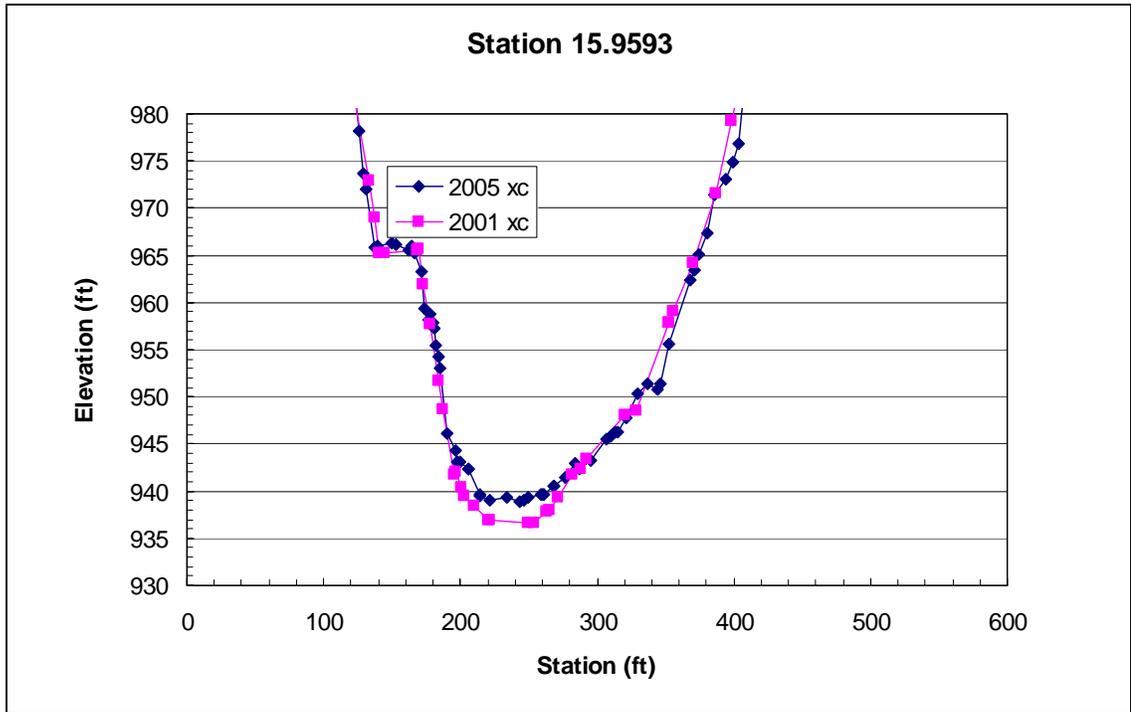
Figure 4.1. Comparison between 2001 and 2005 aerial surveys at Station 15.9593.

The 2005 LiDAR survey was compared against the 2001 Photogrammetry survey. In general, the comparison between the surveys found little inexplicable change. Major differences between the surveys could generally be explained by changes in river plan form, bank erosion or differences in the methods used to eliminate vegetation from the aerial survey. However, one important difference in the two surveys was found in the Hot Springs reach (RM 16). The 2005 survey showed the bed approximately 3 to 4 feet higher than the 2001 survey in this reach. Two example cross sections are shown in Figure 4.1 and Figure 4.2. However, subsequent ground surveys confirmed that the 2001 survey was more accurate in this reach and therefore the 2005 cross sections were corrected within HEC-RAS before the hydraulic computations were performed.

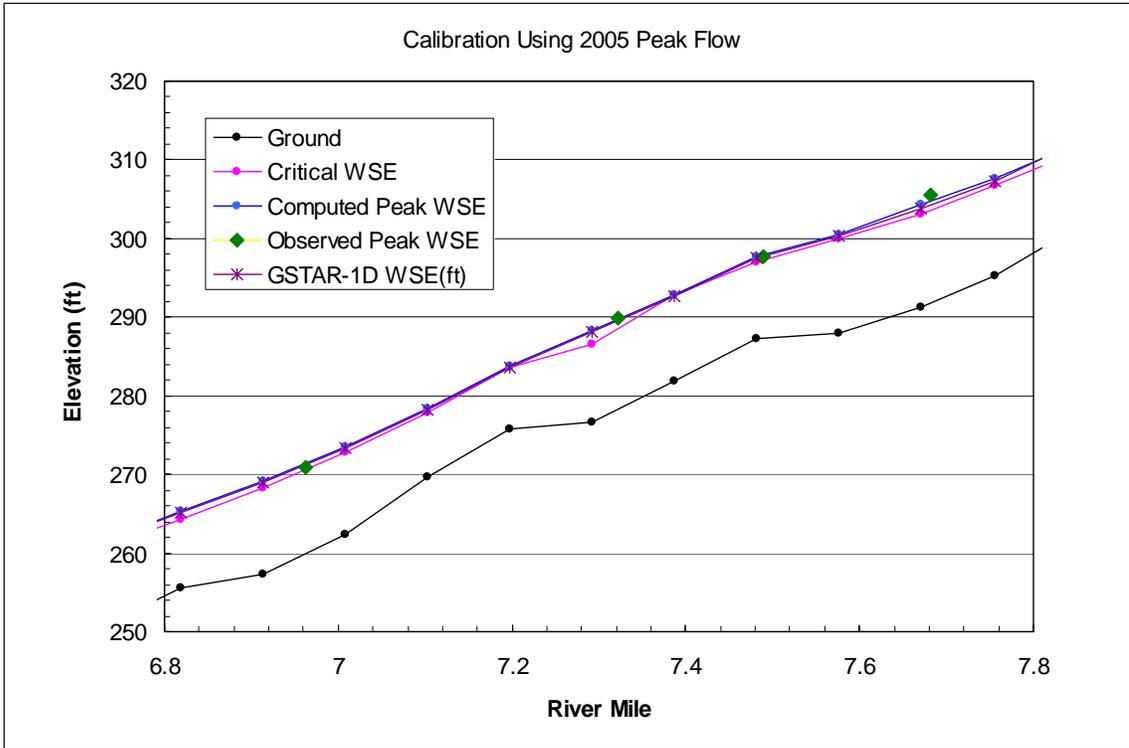
Figure 4.3. Plot of observed and computed peak water surface elevations at the Levee near Casitas Springs.

The best-fit Manning's  $n$  value was 0.04 for the entire river below Robles Diversion Dam. The comparison between all measured water surface elevations (WSE) and computed WSE is shown in Figure 4.3, Figure 4.4, and Figure 4.5. All computed WSE matched the observed to within 0.5 feet except for the observed water surface near RM 13.59 (Figure 4.5). The measured water surface at RM 13.59 was approximately 1 foot lower than computed. It is uncertain why there is this discrepancy and future field surveys will investigate this site. Excluding the RM 13.59 point, the average difference showed computed WSE 0.1 feet lower than the measured WSE. The channel roughness upstream of Robles, in Matilija

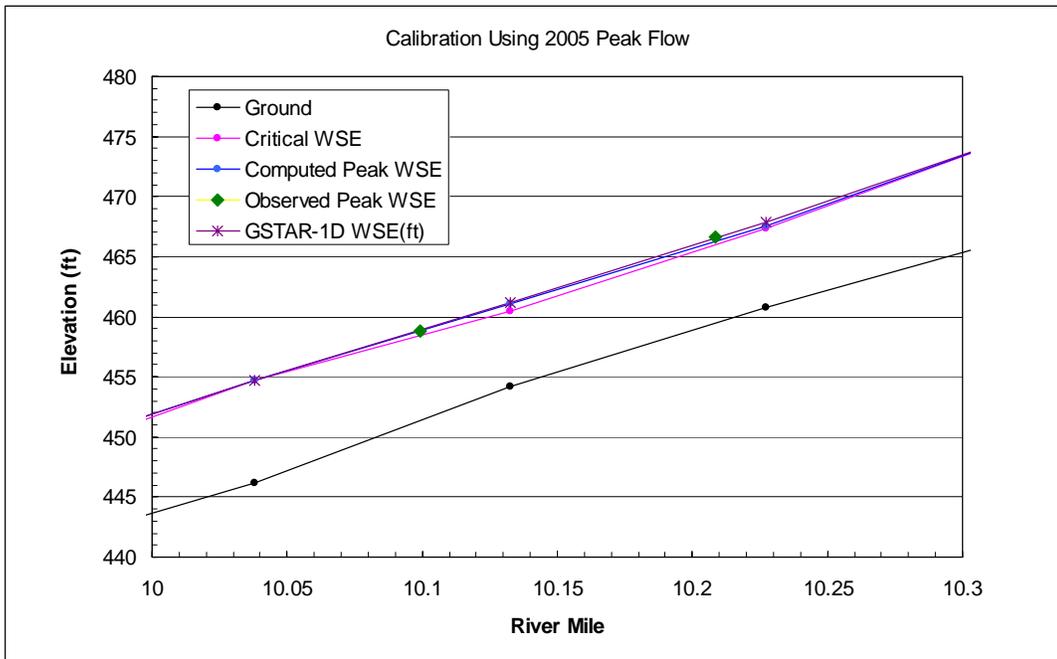
Figure 4.4. Plot of observed and computed peak water surface elevations at the Levee near Live Oak.

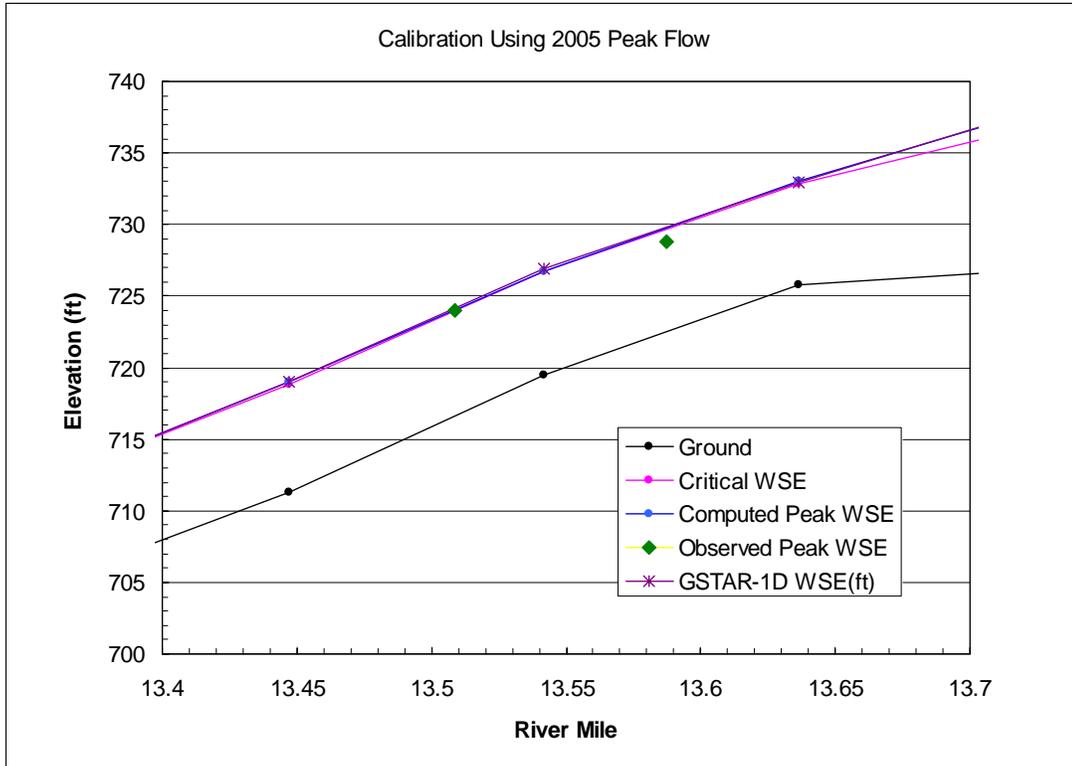
Figure 4.5. Plot of observed and computed peak water surface elevations just downstream of Robles Diversion.

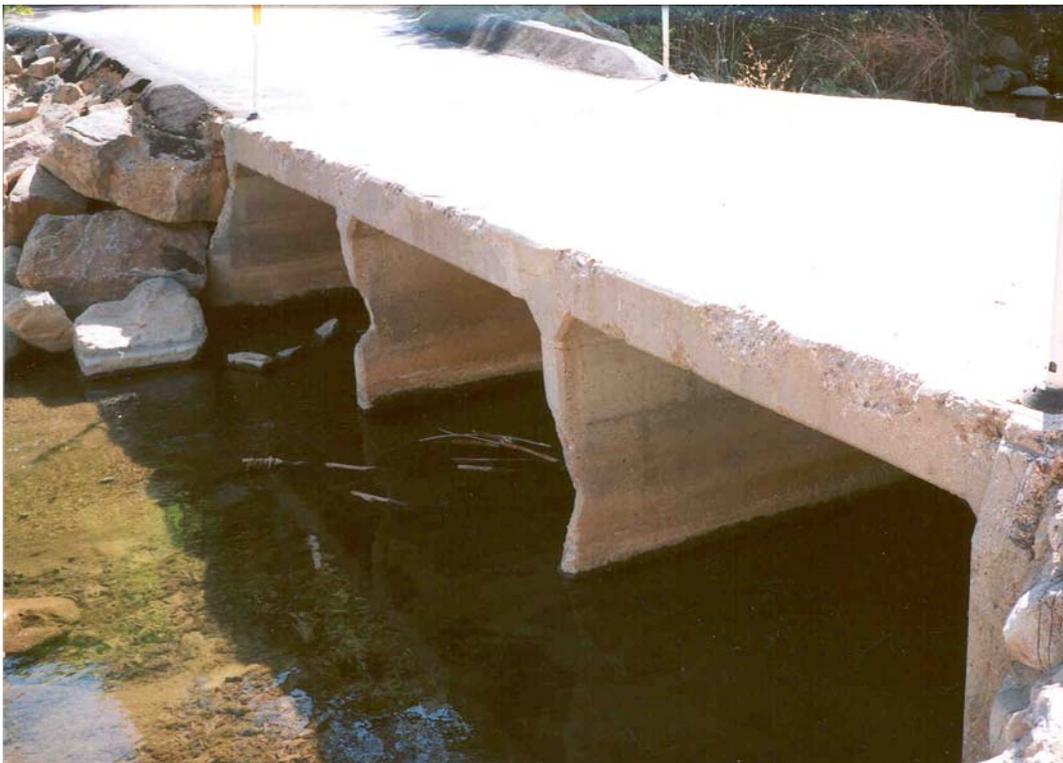
Figure 4.6. Downstream side of Camino Cielo.

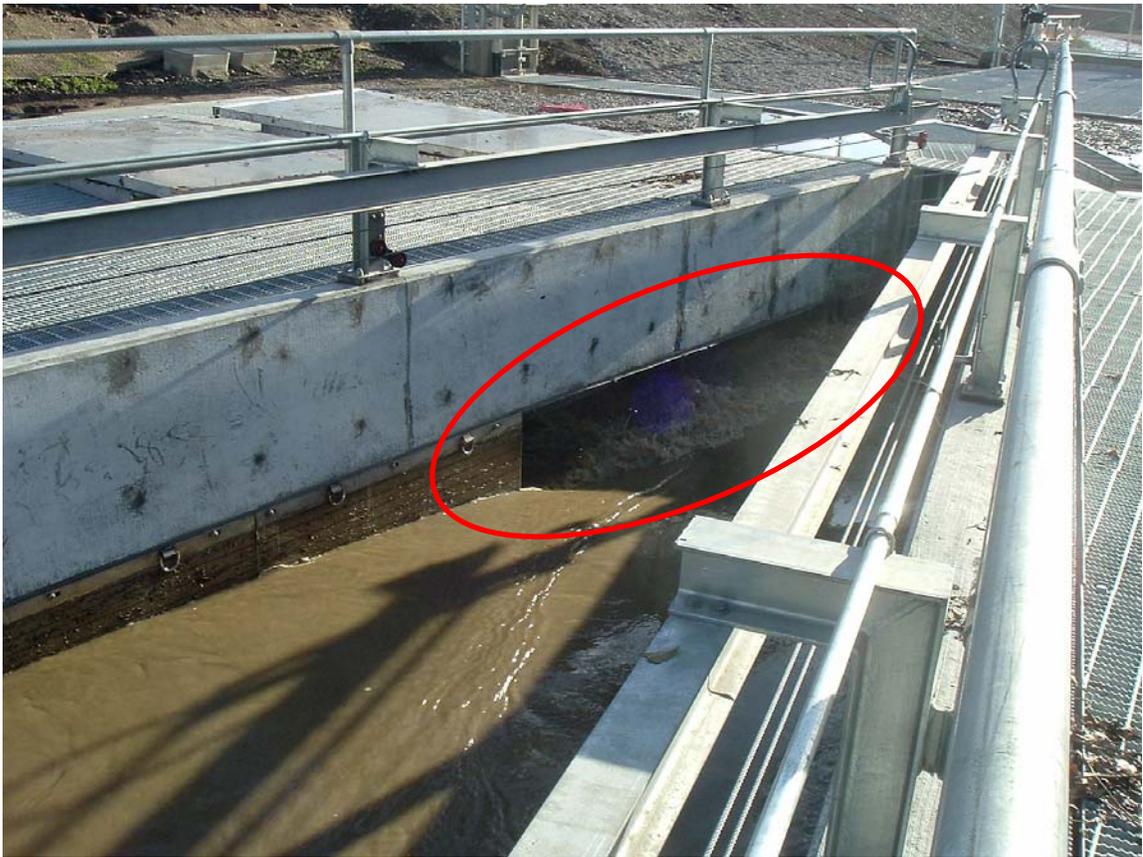
Figure 4.7. Picture Taken During January 2005 Flood Showing Fish Screens Removed in Robles Canal.

Floods can cause a variety of problems at Robles Diversion. One such problem is associated with the fish screens that were placed in the canal as part of the fish passage facility constructed in 2004. These fish screens can become plugged with sediment and debris and prevent flows from passing down the canal. The screen cleaning equipment in current use is not adequate to keep the screens clean during floods (see Figure 4.7).

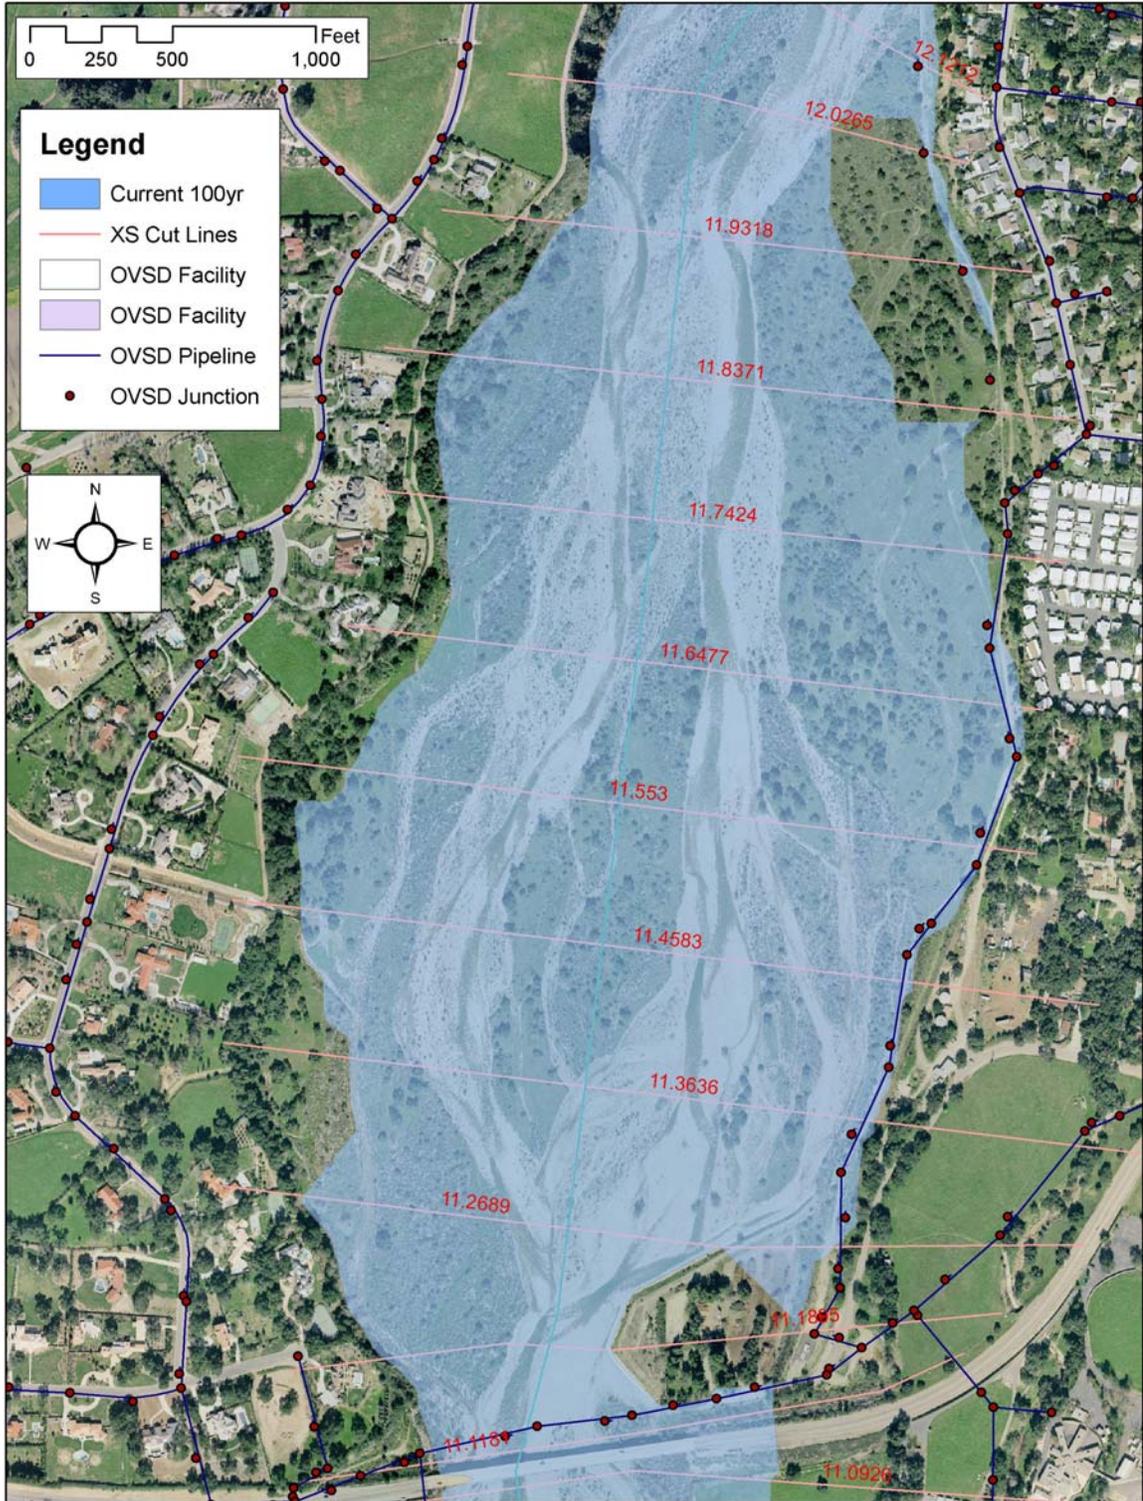
Figure 4.8. 100-yr floodplain from RM 12 to RM 11. Showing location of OVSD pipelines

There are also OVSD sewer lines that are along the east side of the river from RM 12.12 to Baldwin Road Bridge. Much of the sewer line is within the 100-yr floodplain. Some of the sewer line just upstream of the Burn Dump is also within the historical channel migration zone. One OVSD pipeline is buried beneath the Ventura River upstream of Baldwin Road.

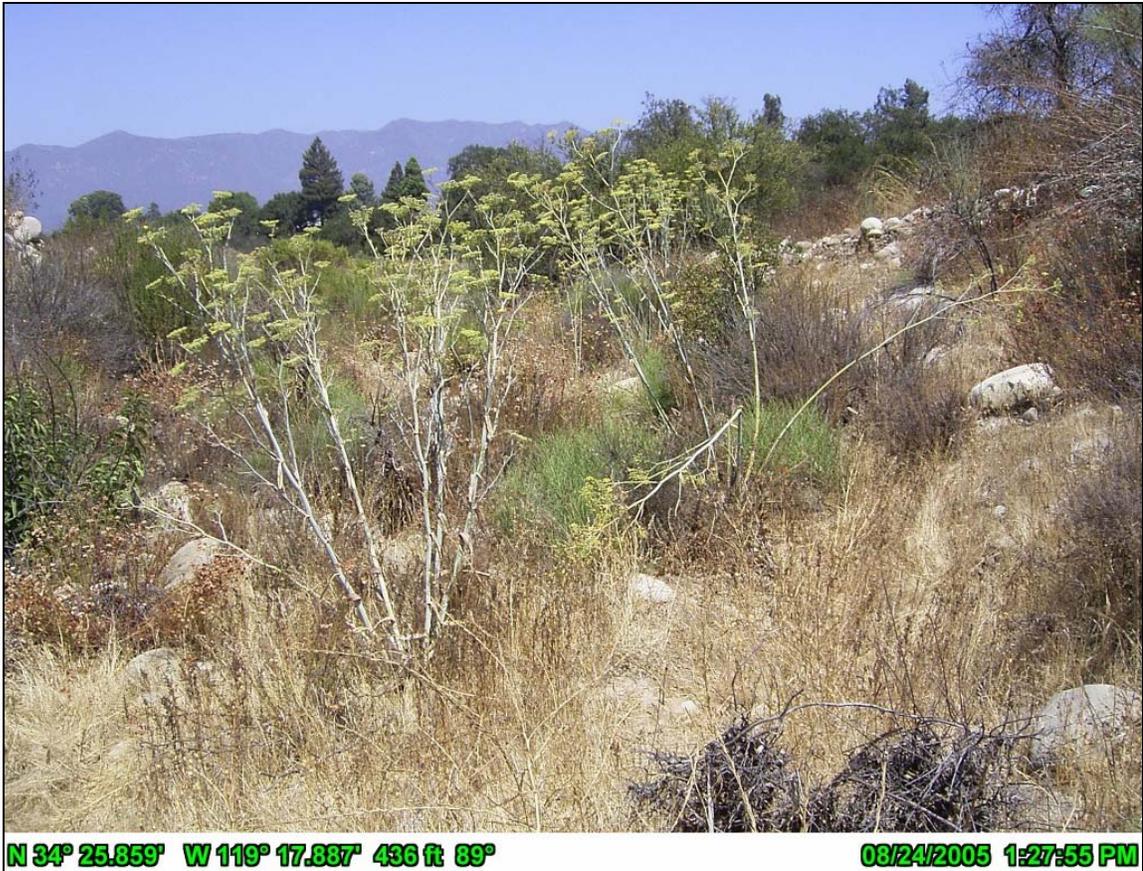
Figure 4.9. Levee located upstream of “Burn Dump” on east side of Ventura River at approximately RM 11.54.

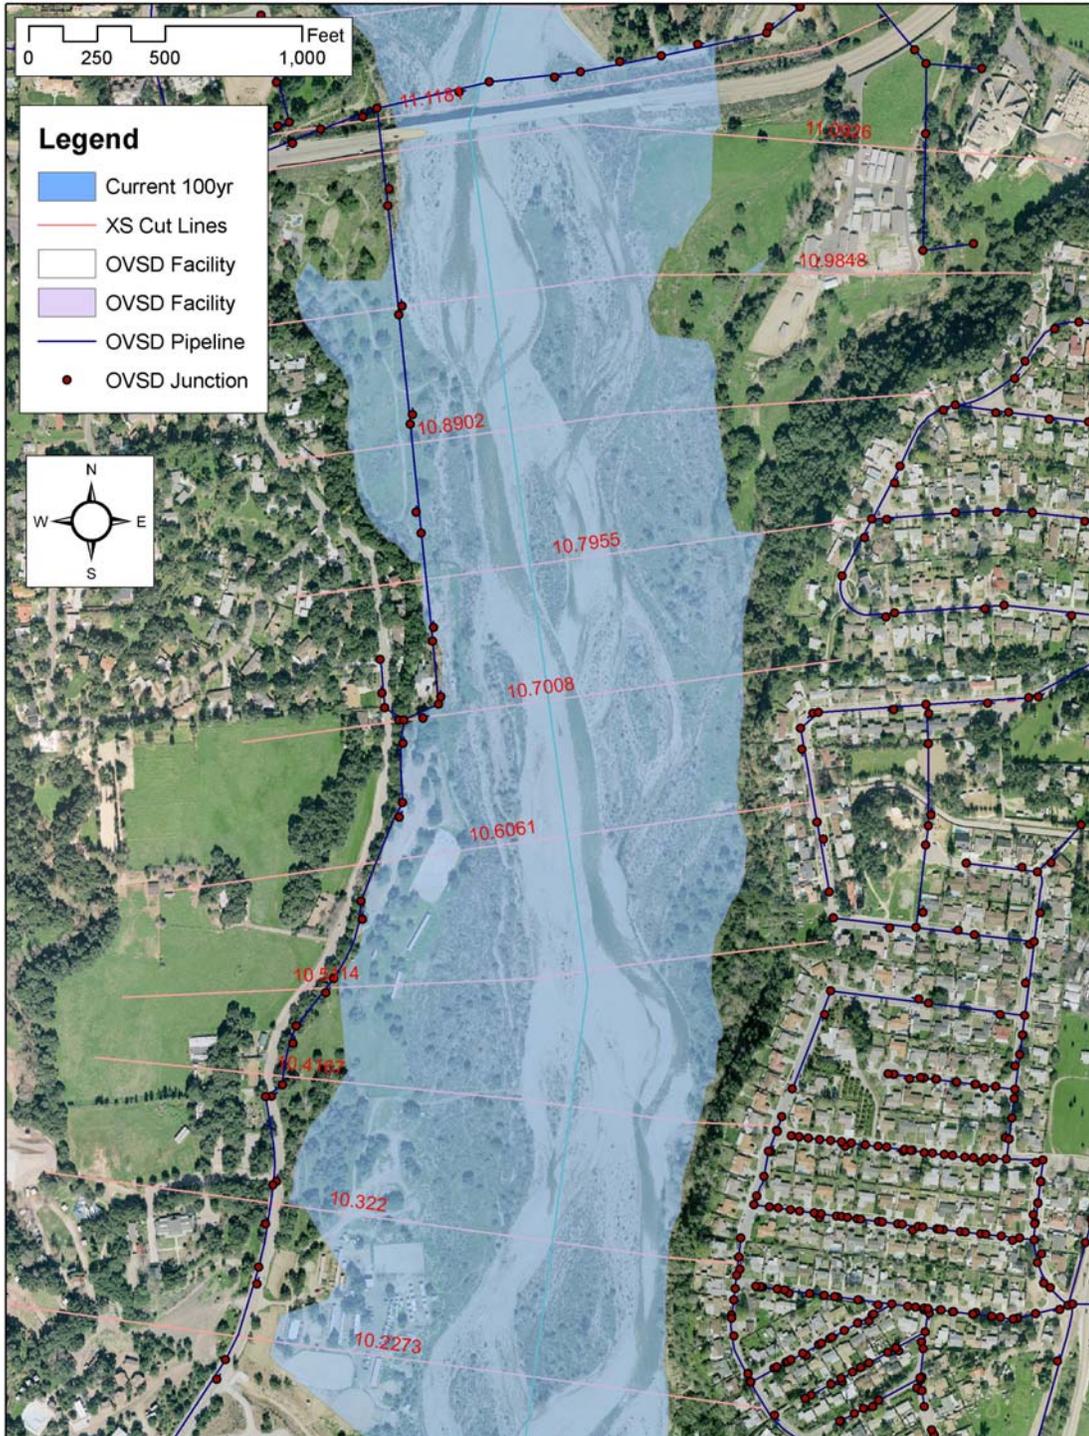
Figure 4.10. 100-yr floodplain from RM 11 to RM 10 Showing location of OVSD pipelines.

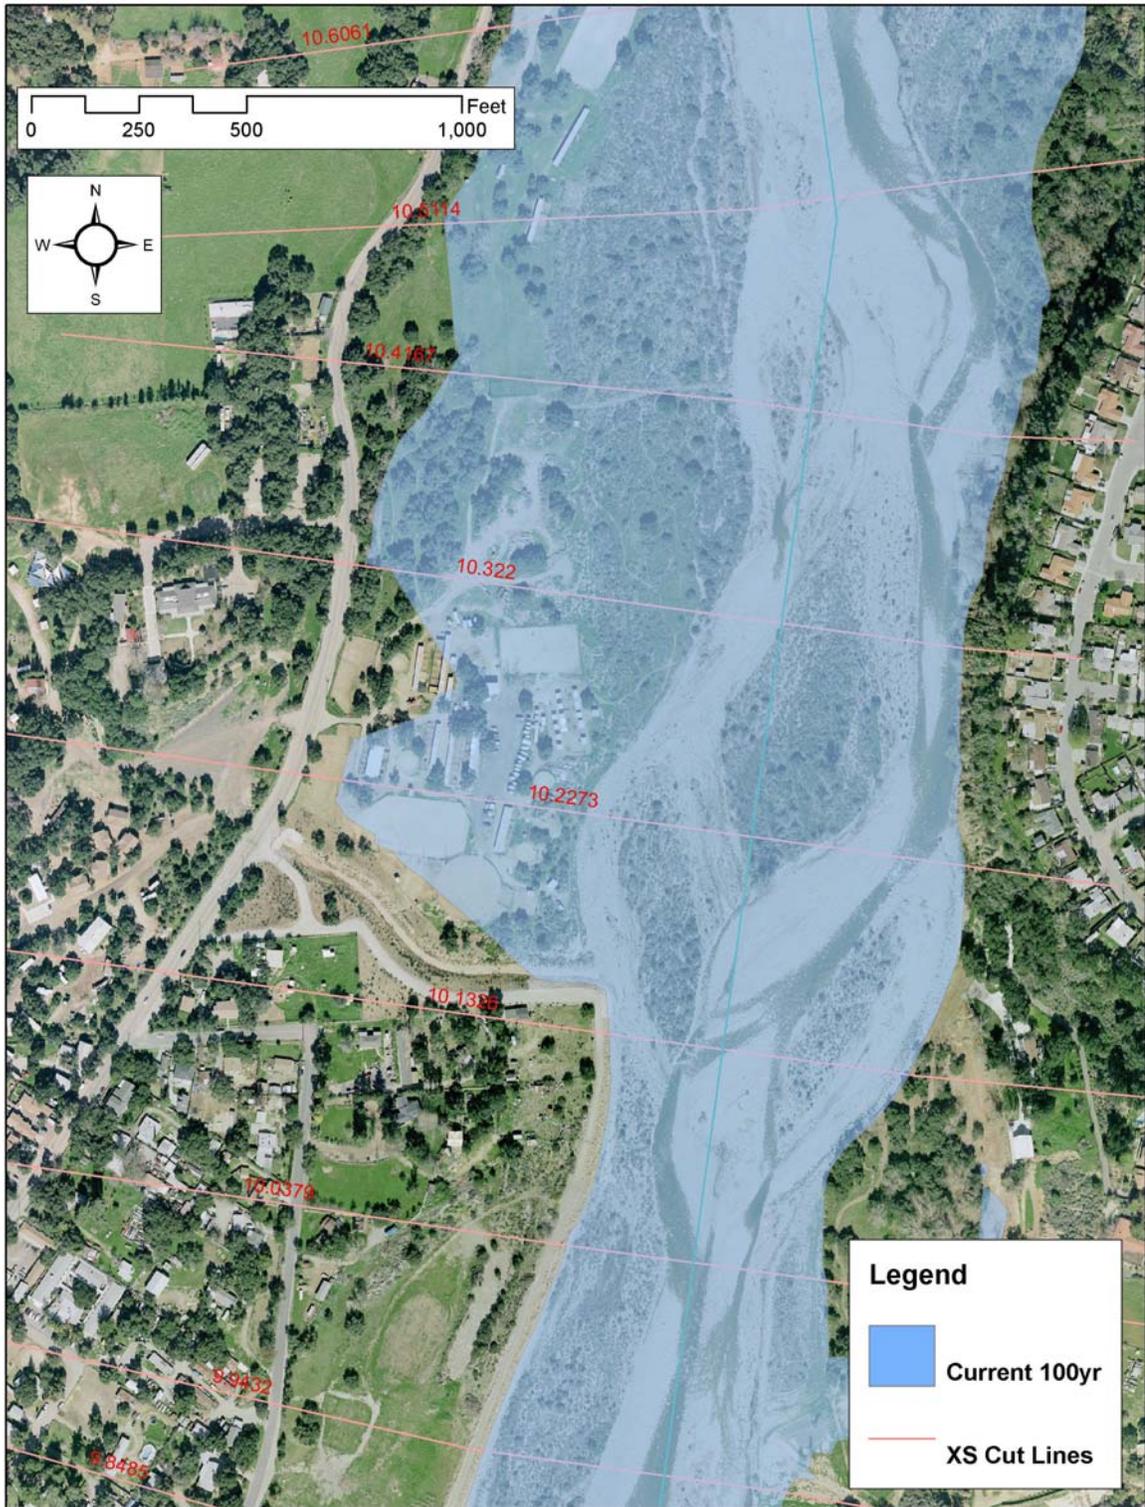
Figure 4.11. 100-yr Floodplain in Vicinity of Live Oak Drain.

depth of approximately 5 feet at a slope of 0.0009. However, the designed assumed a elevation of 456.5 feet at the drain exit. Since that time, the drain exit has aggraded to 458 feet. Therefore, there is now essentially no slope to the drain from Burnham Road to the Ventura River, a distance of approximately 860 feet. The 100-yr flood elevation of the Ventura River at this location is approximately 462 feet. The levee elevation along the drain is approximately 469.5 feet. Because there is no slope to the drain, it is likely that it will continue to experience aggradation.

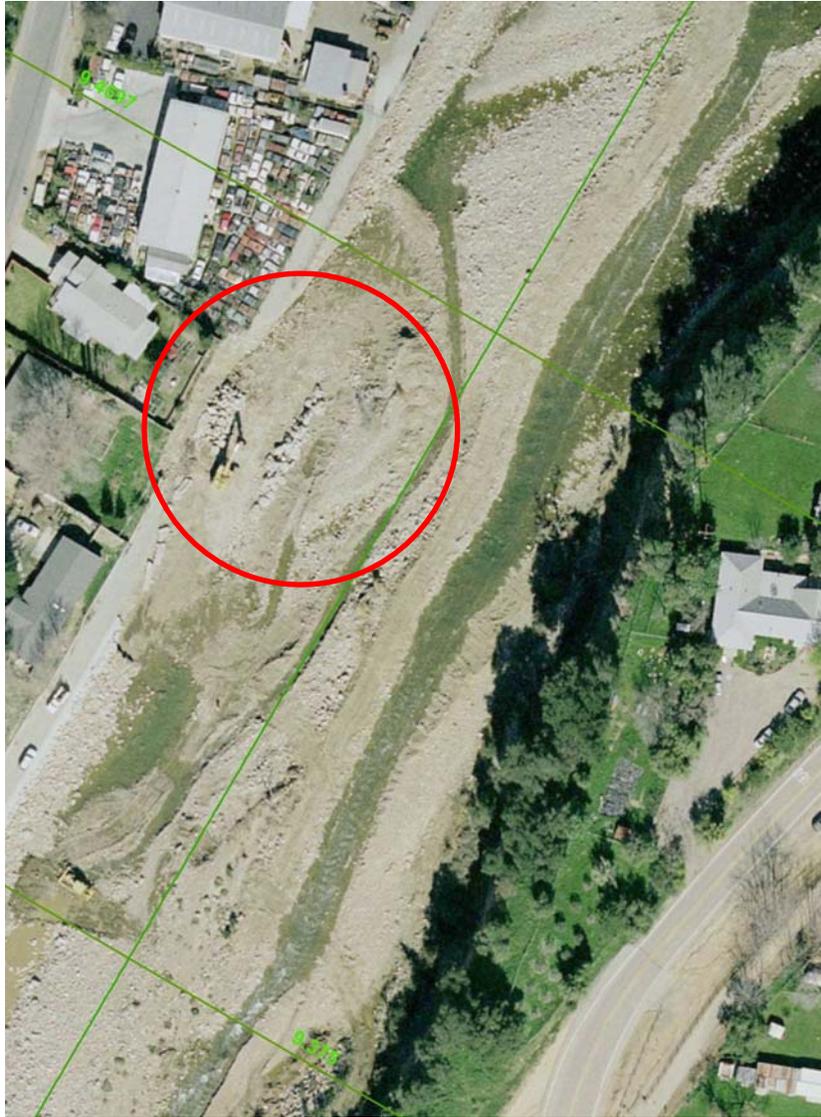
Figure 4.12. Aerial photo taken in February 2005 showing erosion of Live Oak Levee between XC 9.375 and 9.4697.

The Live Oak levee may be subject to erosion as evidence by the damage caused by the Jan 2005 flood shown in Figure 4.12 at approximately RM 9.4. There is backhoe shown in the photo repairing the damage caused by the Ventura River eroding the riprap protection along the West bank. The riprap placed along the Live Oak Levee is approximately ½ ton based upon the County records. From the Santa Ana Bridge to RM 9.5, it is estimated that rock weighing at least 0.8 ton would be required to prevent erosion up to the 100-yr flood. The levee will continue to erode at flood flows with a return period of 20-yr and greater. Smaller flows may also erode the levee if the river is directed at the levee as occurred in 2005.

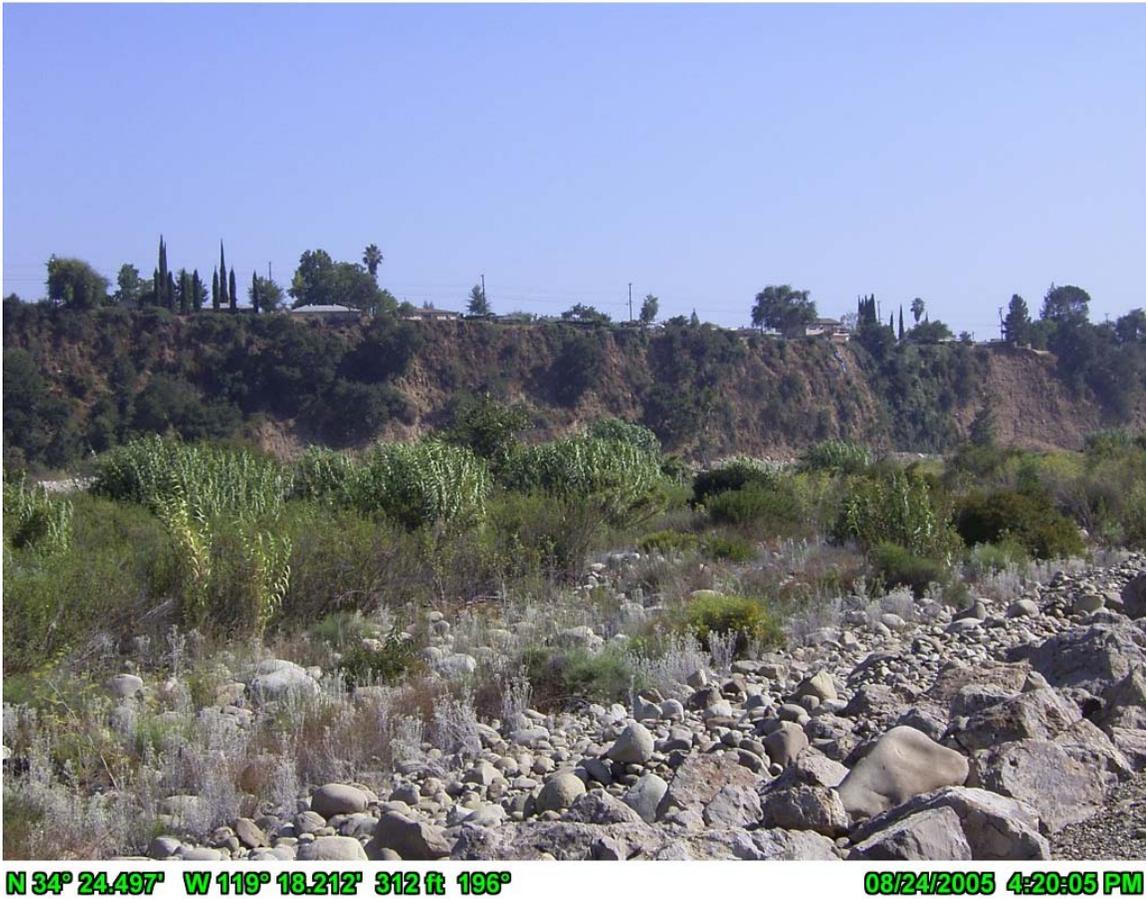
Figure 4.13. Picture of Looking at East Bank of Ventura River at Taken at Approximately RM 9.8. Notice houses, utility lines, and Properties Located near Terrace.
