## Hydrology, Hydraulics, and Sediment Studies for the Matilija Dam Ecosystem Restoration Project, Ventura, CA – DRAFT Report

U.S. Department of the Interior  
Bureau of Reclamation  
Technical Service Center  
Denver, Colorado

November 2006

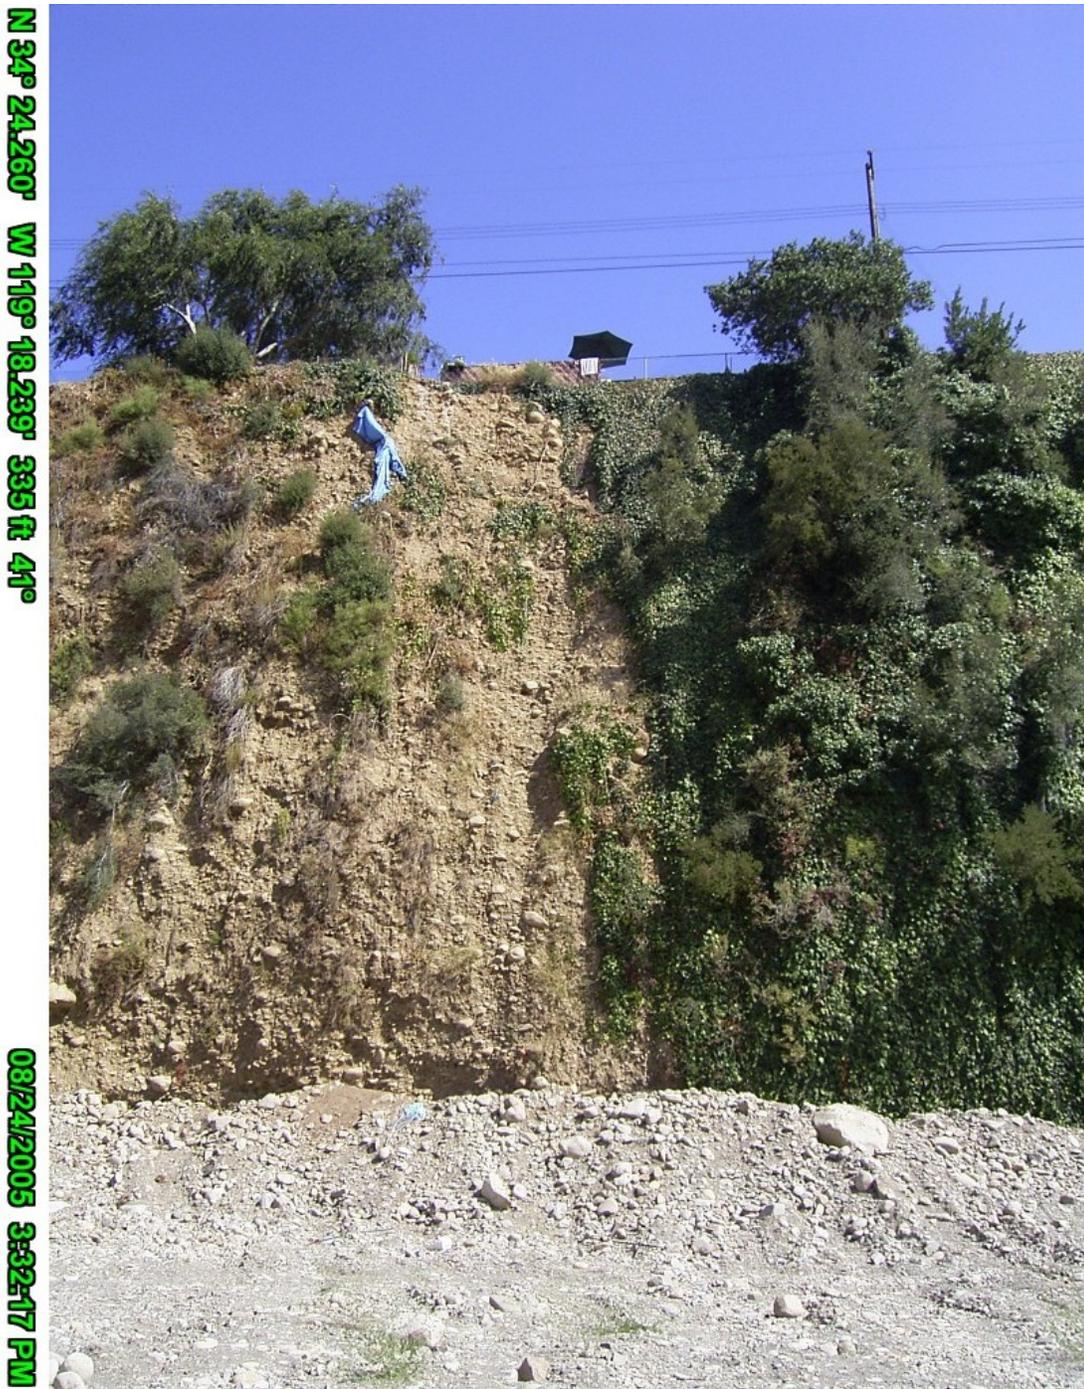
Figure 4.14. East Bank of Ventura River Located at RM 9.6 Showing Alluvial Material of Terrace and Some Recent Bank Failure.

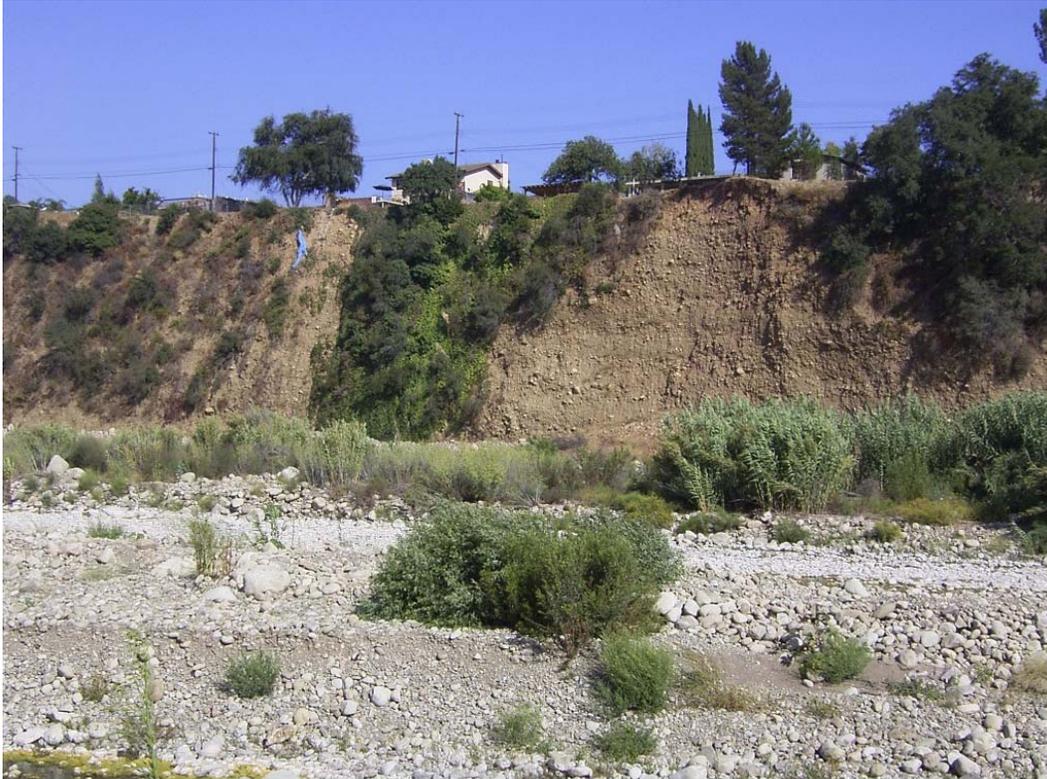
Figure 4.15. East Bank of Ventura River Located at RM 9.6 Showing Some Recent Bank Failure,

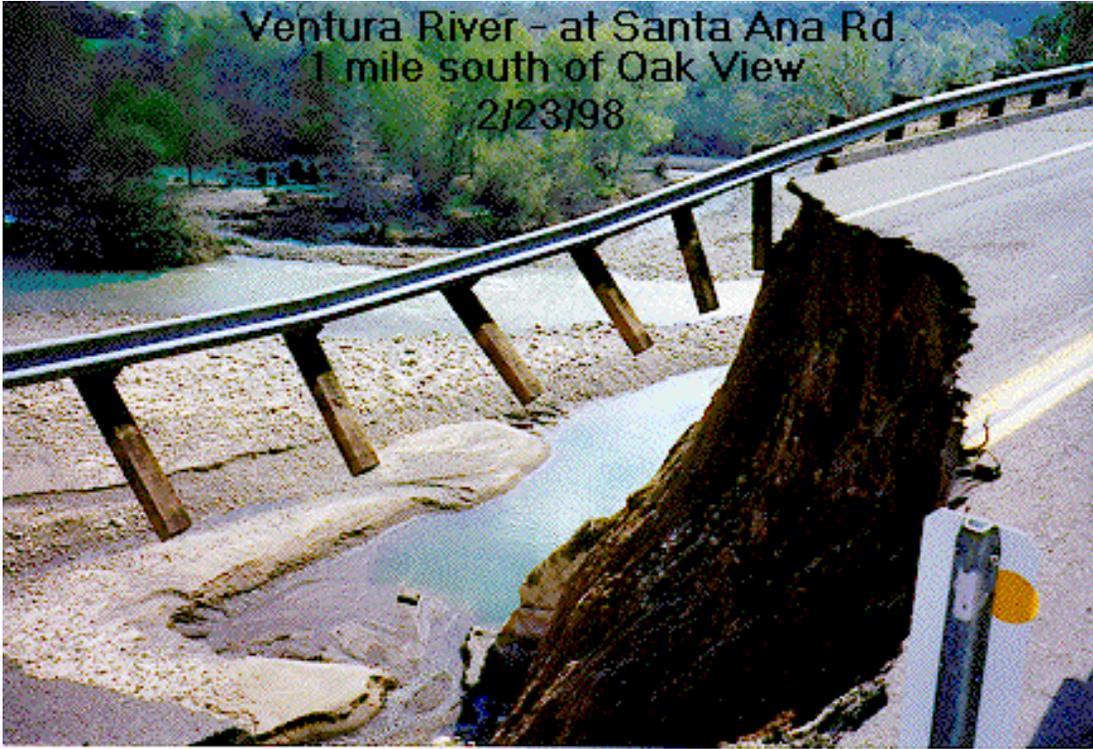
Figure 4.16. Picture of the looking downstream at the Ventura River from the East Abutment of Santa Ana Bridge. Picture was taken after the 1998 flood on 2-23-1998.

The Santa Ana Bridge is on the downstream end of the levee and this bridge passes the 100-yr flood, but the flood elevation is only about 1 foot below the bridge soffit. There is historically deposition on the upstream side of this bridge and the County has a program to excavate the riverbed at the Santa Ana Bridge to maintain flow capacity. The bridge is a constriction on the river, and one repercussion of the bridge constriction is that the scour around the bridge abutments is increased, as evidenced in the photo taken after the 1998 flood (see Figure 4.16).

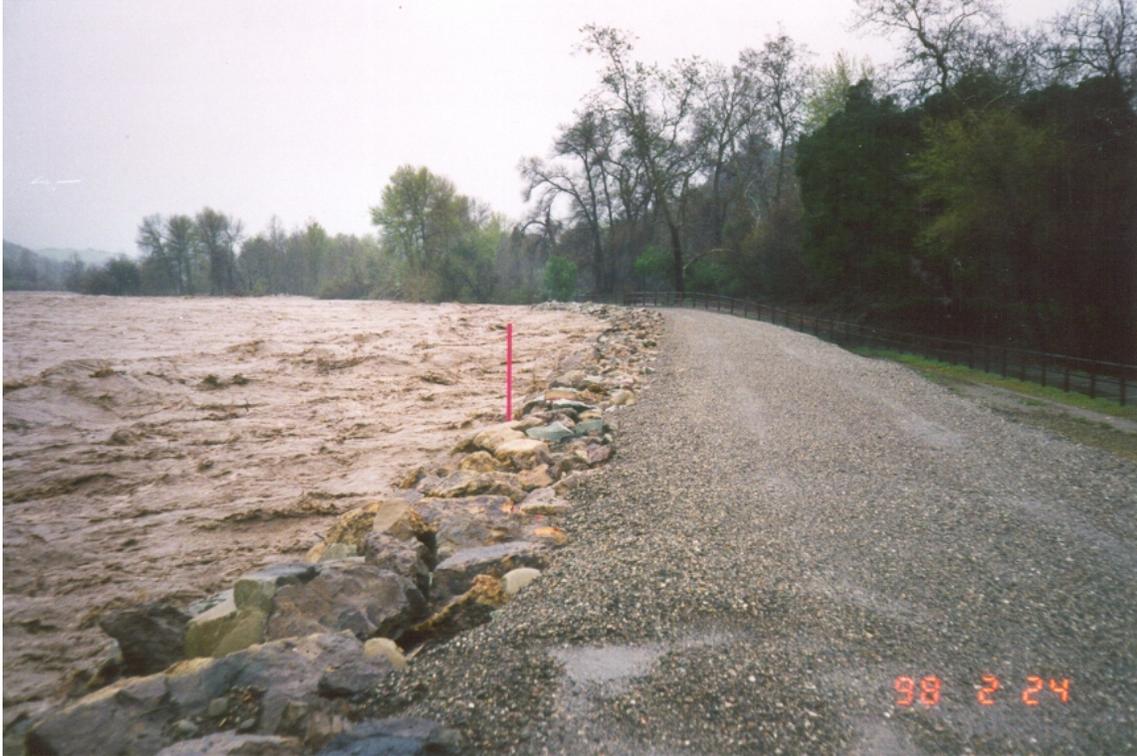
Figure 4.17. Picture of the Ventura River at the Casitas Levee on 2-24-1998. Picture was taken by William Carey of the Ventura County Watershed Protection District.

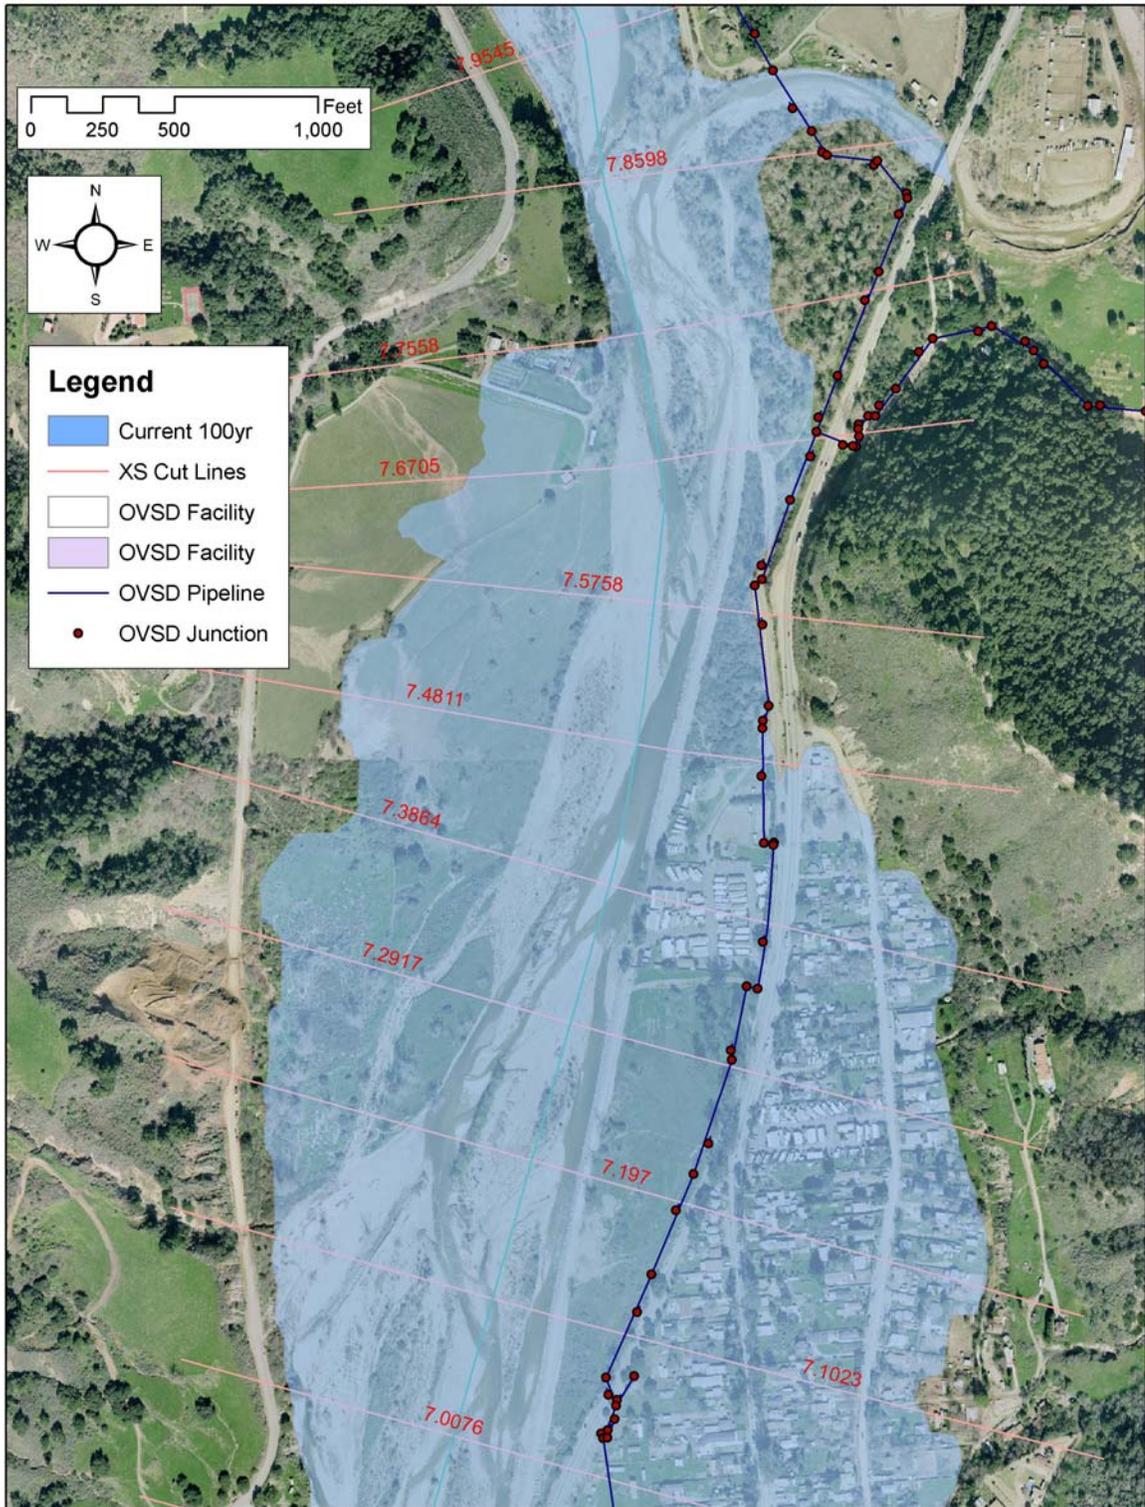
Figure 4.19. 100-yr floodplain from RM 8 to RM 7. Locations of OVSD Pipelines are shown.

There are several OVSD pipelines in the 100-yr floodplain in this reach (Figure 4.19).

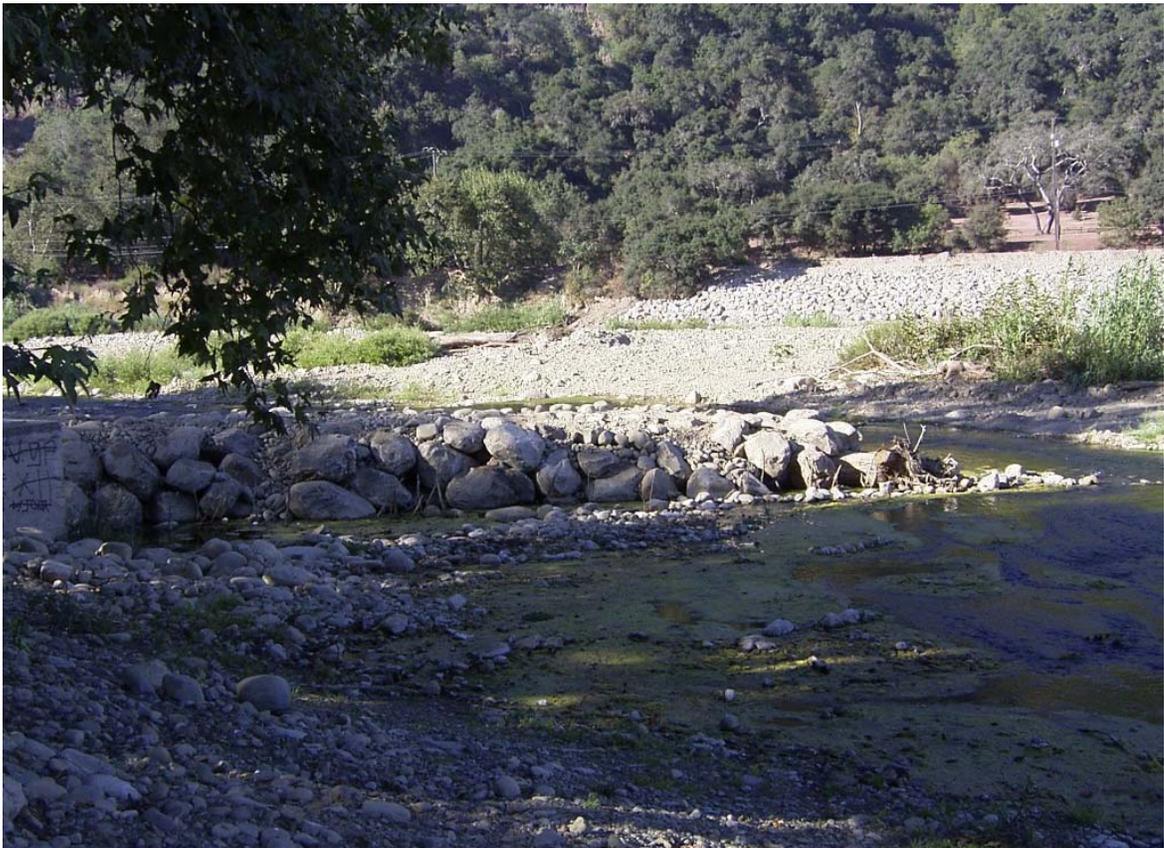
Figure 4.20. Groins installed after 2005 flood along east side of river at Foster Park.

Foster Park is located on the east side of the river upstream of Casitas Vista Bridge and is within the 100-year floodplain. In the summer of 2005, the County installed groins to protect the park from bank erosion (Figure 4.20).

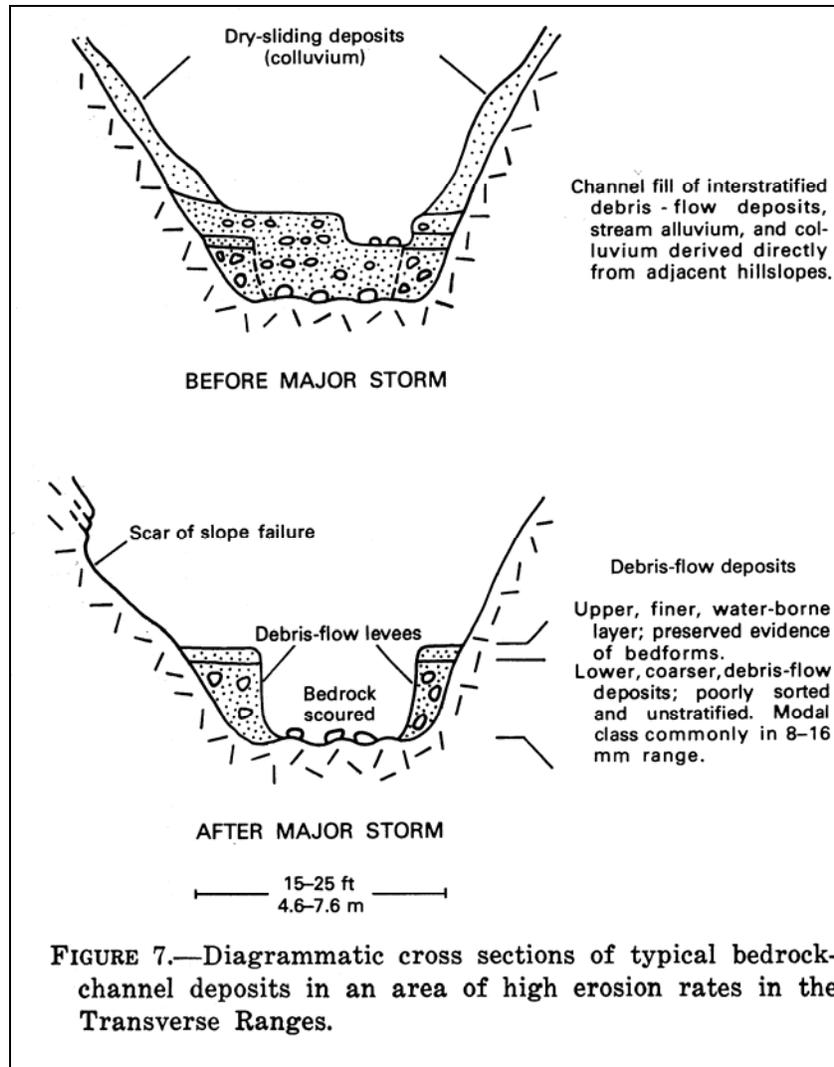
Figure 5.1. Figure 7 from Scott and Williams. The figure shows cause of sediment transport in small watersheds being dependent upon the previous hydrology.

The stream channels in the watershed may experience periods of filling and entrenching. Figure 5.1 (Scott and Williams, 1978) shows a conceptual model of how dry sliding of sediments from the hill slopes can be an upland supply of sediment. This is illustrated by showing sediments depositing in a stream prior to a flood and the degradation that occurs subsequently. However, the periods of filling and entrenchment will be much more pronounced in the upper watershed and smaller tributaries. The main stem of the Ventura River receives relatively little sediment directly from the hill slopes compared to the inputs from the tributaries. Therefore, the main stem of the Ventura River will show smaller elevation changes before and after floods than the upper watershed and small tributaries. Scott and Williams (1978) only studied watersheds smaller than 10 mi<sup>2</sup> and therefore their conclusions may not necessarily scale up to the larger watersheds.

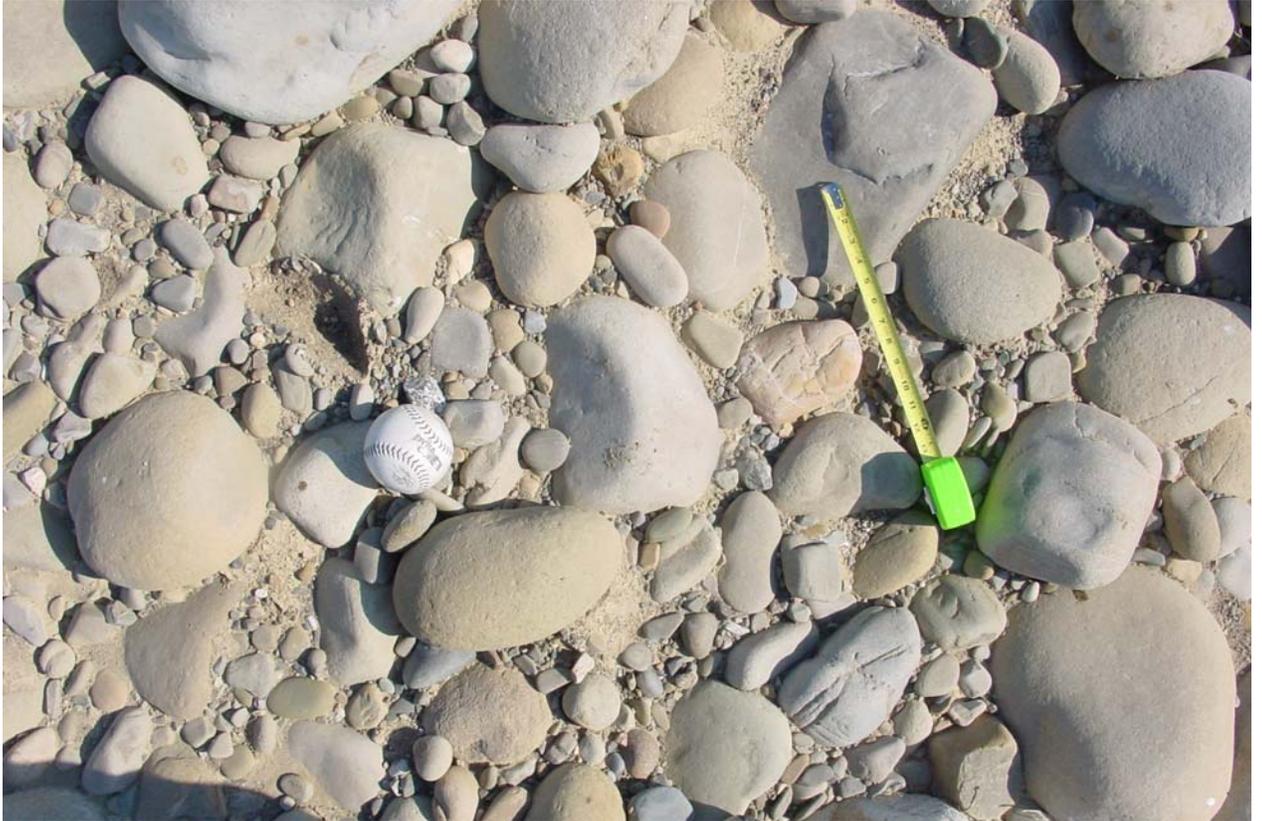
Figure 5.3. Typical Surface Bed Material in Ventura River. Note Large Range of Sizes. A Softball and Tape Measure are shown in Figure for Scale.

The bed is mostly dominated by cobbles, but it contains a large range of sediment sizes. Throughout the entire reach there were sands interspersed between the larger rocks. In the upper reaches near the dam, particles larger than 3 m in diameter were recorded. A top view of typical bed material is shown in Figure 5.3. This photo is near sample site #8, at RM 2.5.

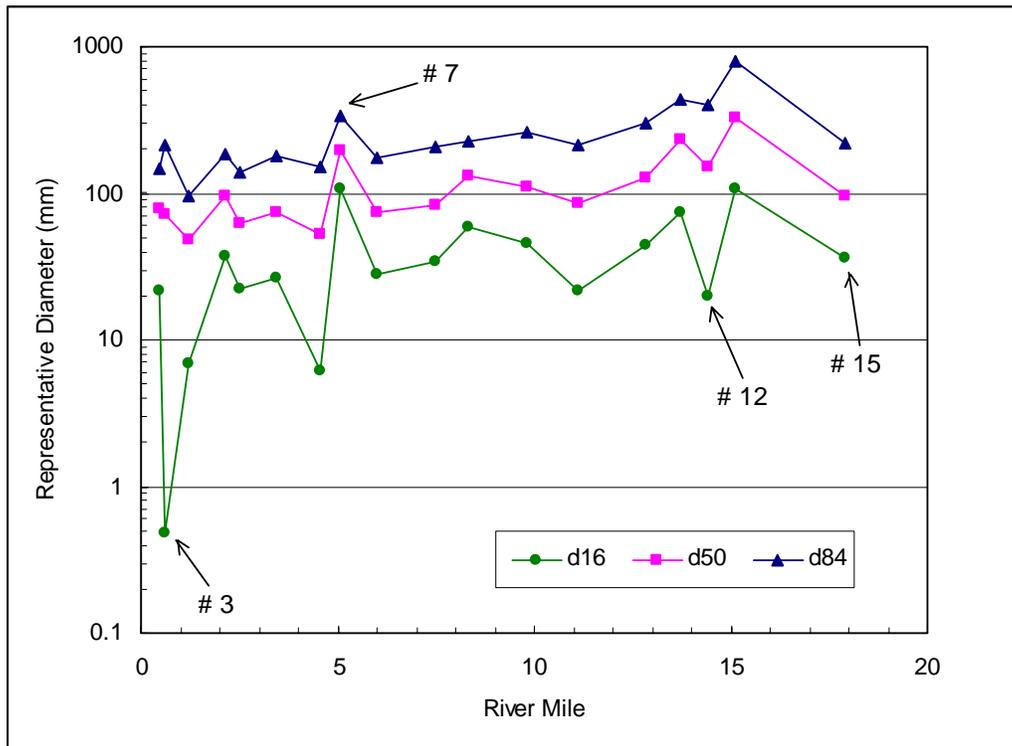
Figure 5.4. Measured representative diameters of surface bed material samples.

- Sample #15 is approximately 1.5 miles upstream of Matilija Dam (RM 17.9). The reservoir is approximately 2500 ft in length and the sample site was far enough upstream so that the dam did not affect the bed material size. The bed material upstream of the dam is finer than downstream because the dam traps all the coarse sediment.

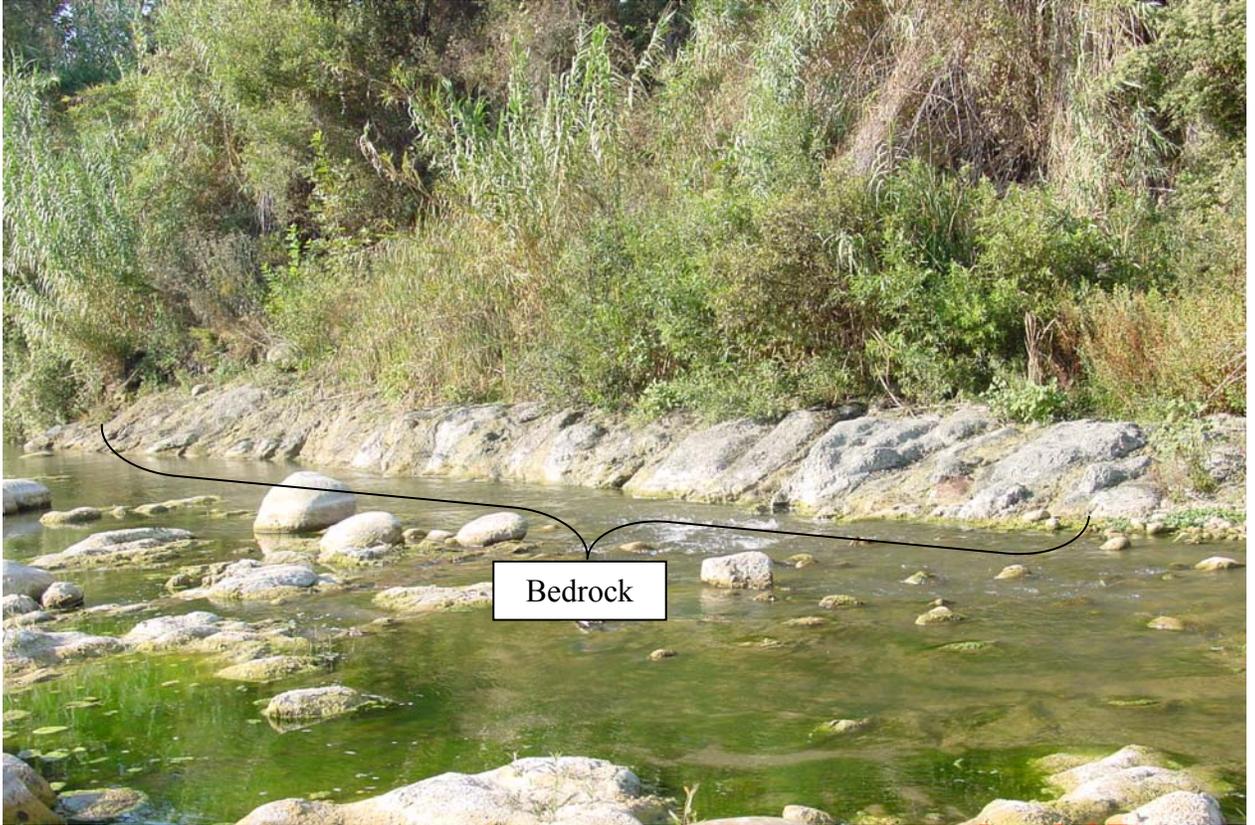
Figure 5.5. Bedrock Outcrop at Sample Site #7.

- Sample #7 (RM 5.1) is just downstream of the confluence with Coyote Creek and downstream of a more constricted part of the river. Bedrock outcrops control the bed elevation at this location as shown in Figure 5.5 and Figure 5.6. There is only a thin covering of cobbles on top of the bedrock at this site.

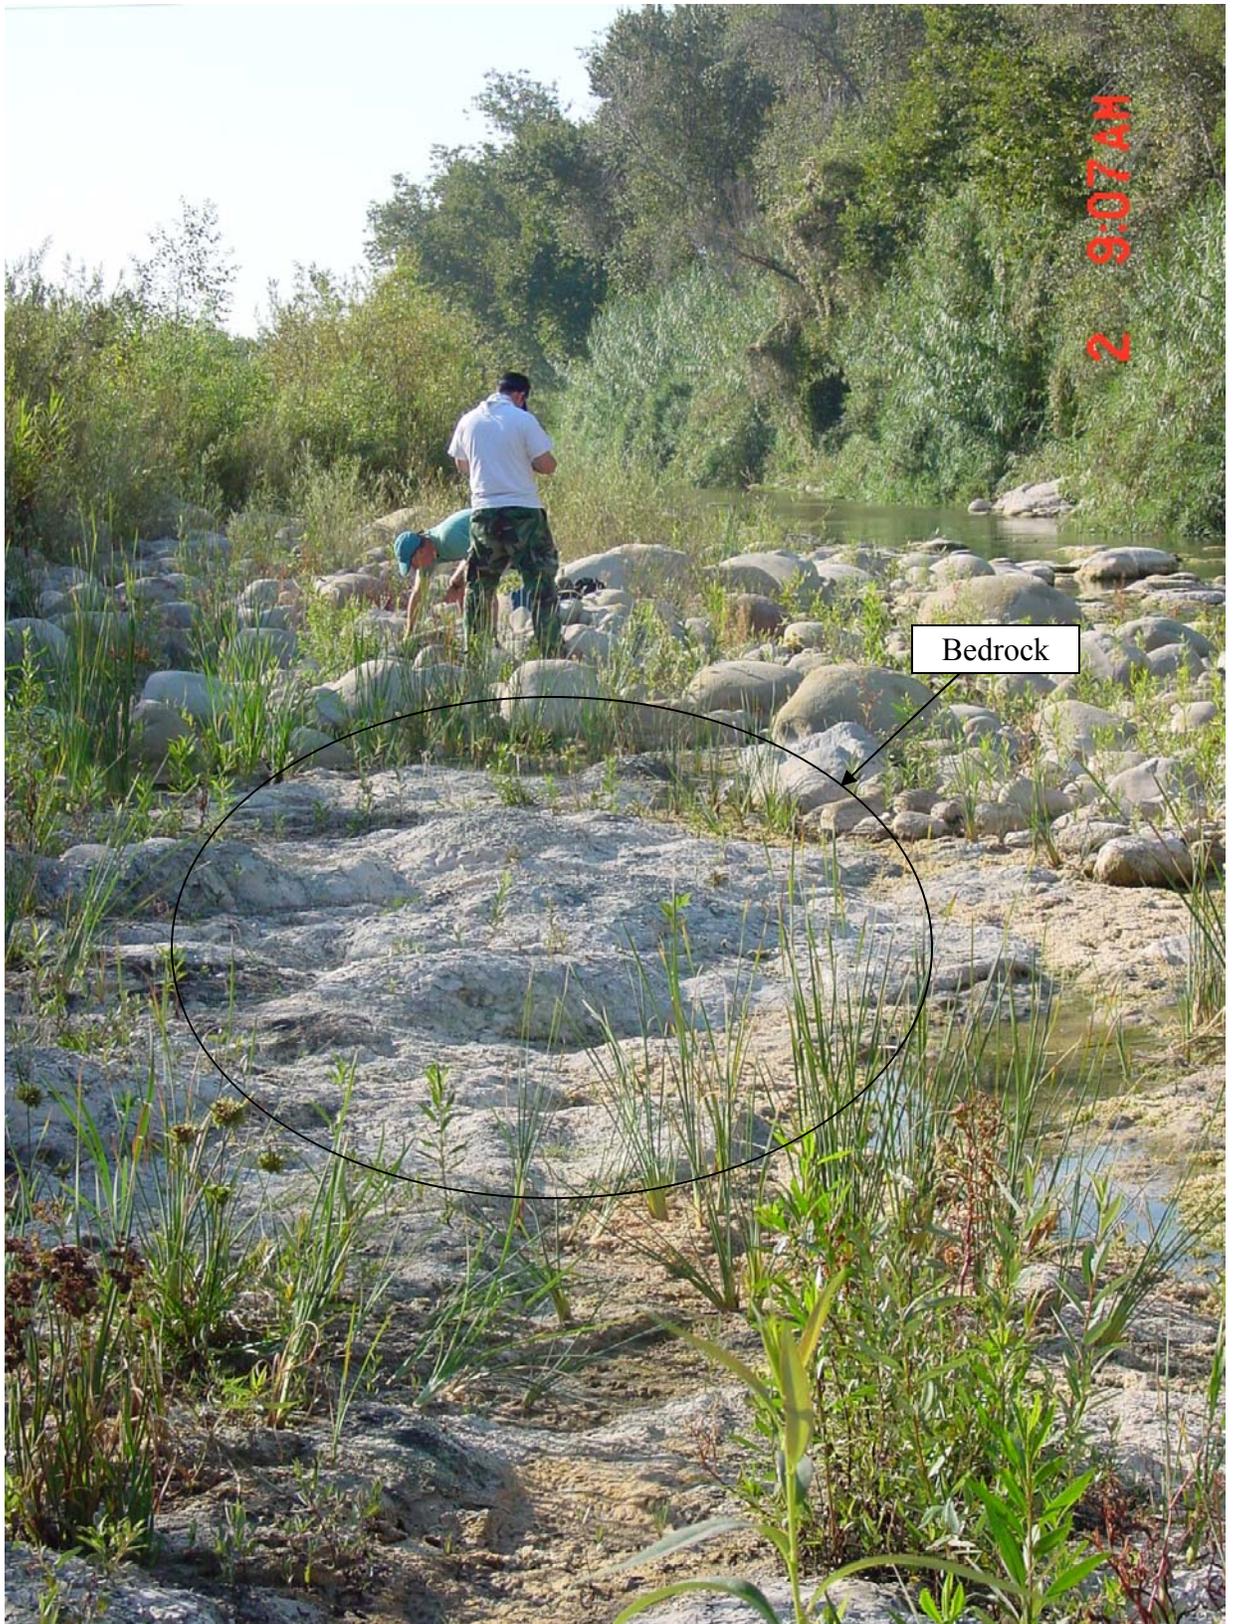
Figure 5.6. Bedrock Outcrop at Sample Site #7.

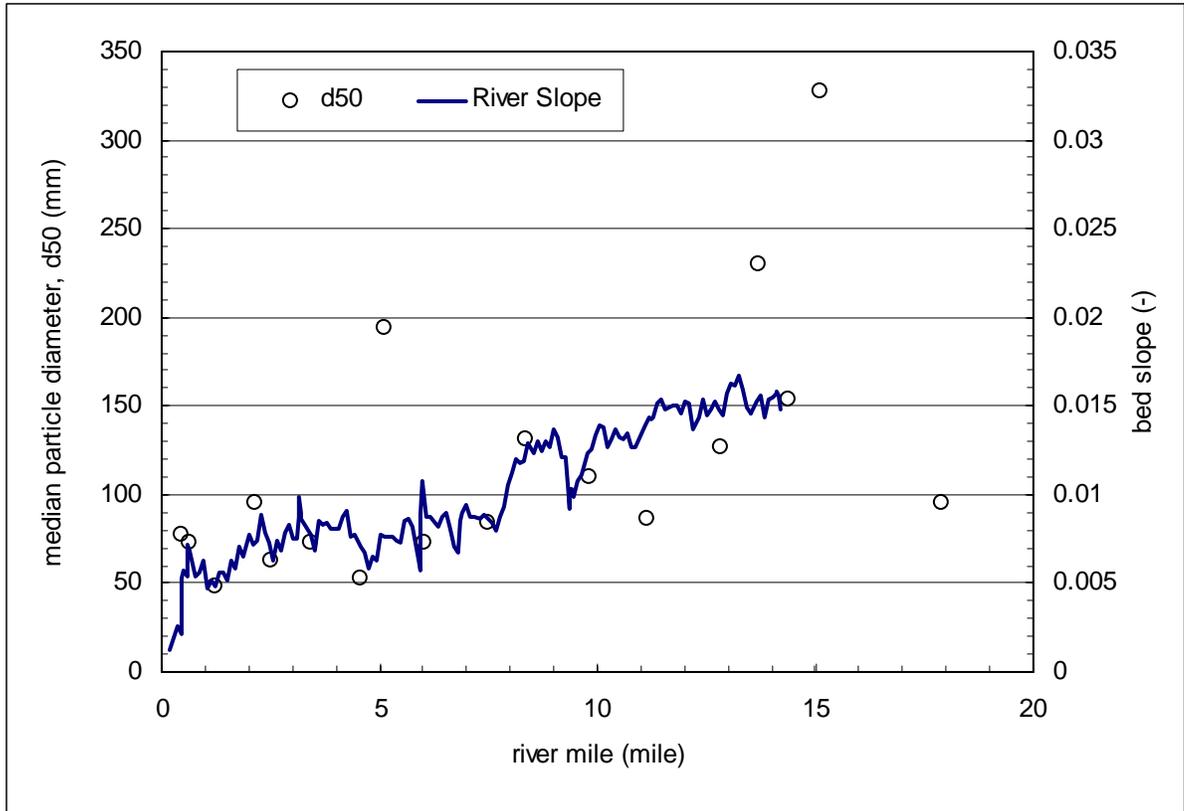
Figure 5.7. Average Bed Slope and  $d_{50}$  of Bed Material Samples.

Downstream of Matilija Dam, the average particle size is directly related to bed slope as shown in Figure 5.7. As the bed slope increases in the upstream direction, so does the average particle size in the bed. The few exceptions to this correlation between slope and particle size were stated previously.

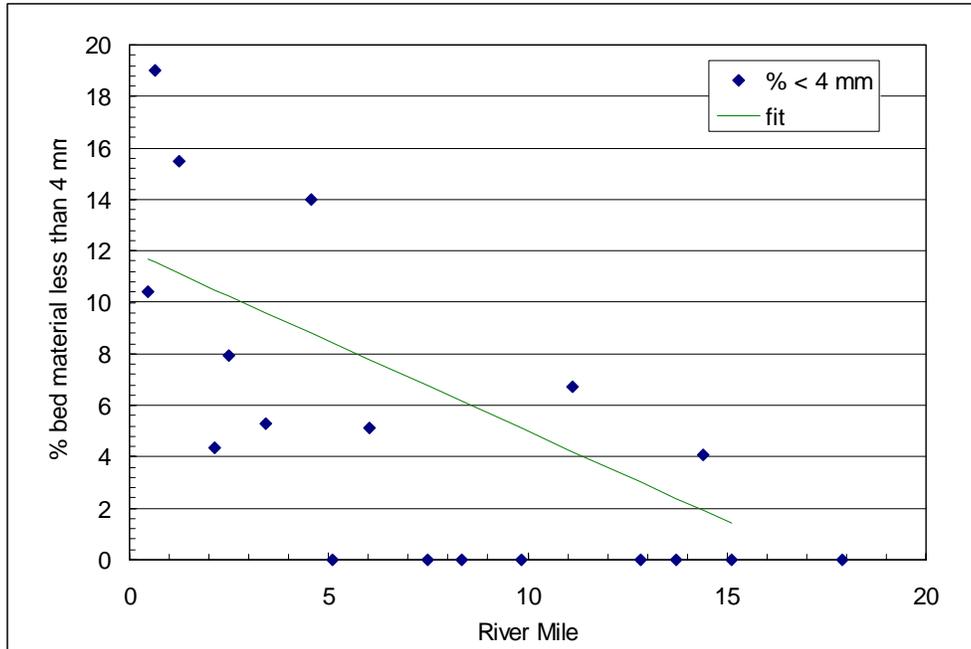
Figure 5.8. Fraction of Bed Material Less than 4 mm.

There is gradually less sediment finer than 4 mm found in the bed as river progresses upstream (see Figure 5.8). There are probably two reasons for this. First, most natural river channels become coarser in the upstream direction because the slope is steeper and the river is able to transport coarser material. Second, Matilija Dam traps most coarse sediment and therefore downstream of the dam the bed may have become starved of fine material. Most of the fine material passes through the upper reaches of the Ventura River without depositing on the bed.

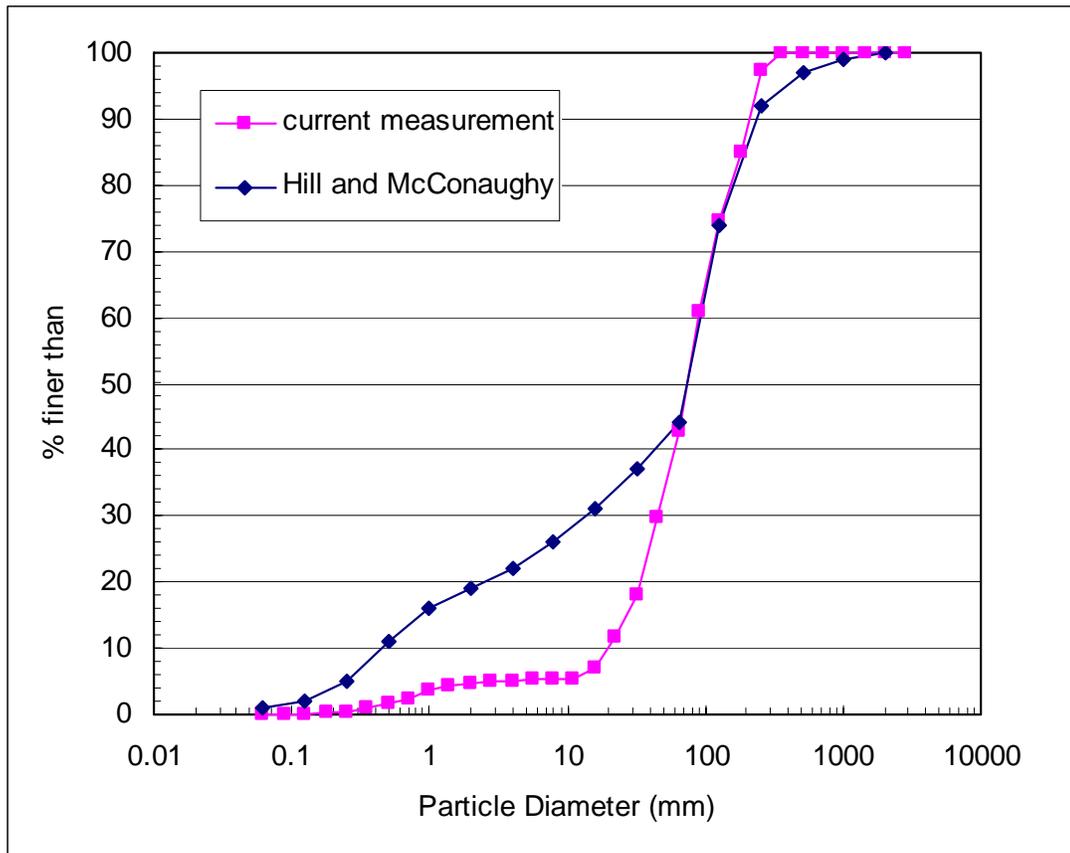
Figure 5.9. Comparison between USGS Composite Sample and Current Measurements of Bed Material near USGS Gage on the Ventura River near Foster Park.

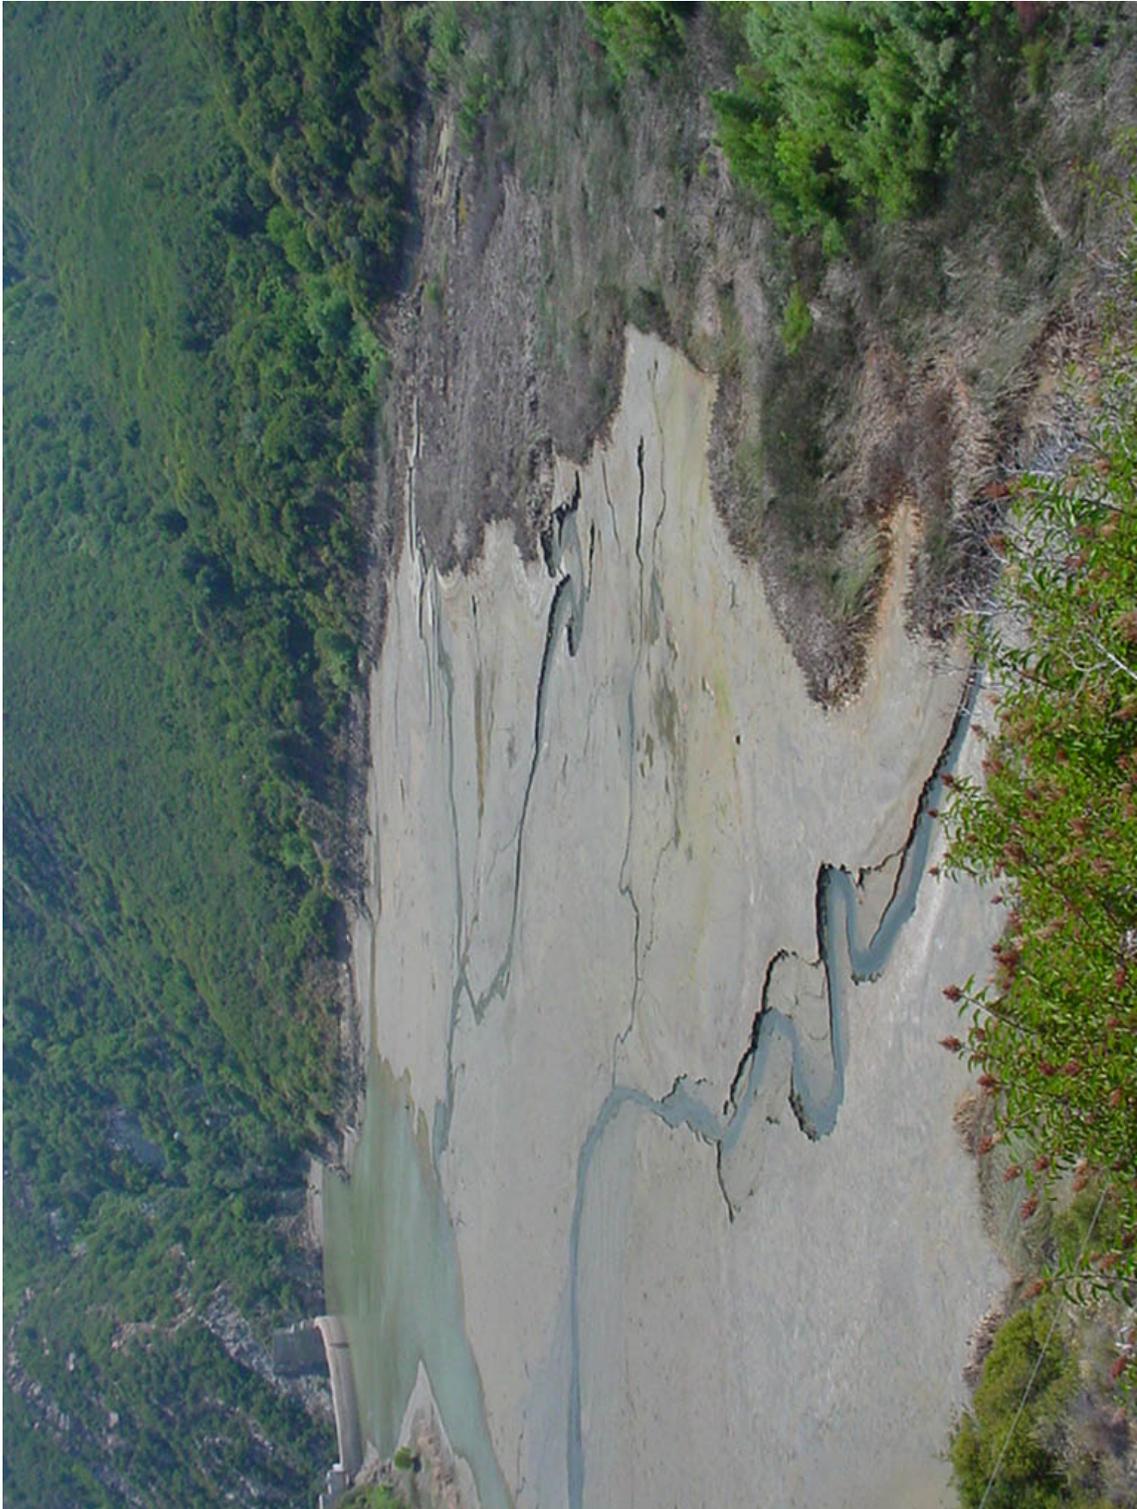
Figure 5.11. Picture of Sediment Trapped behind Matilija Dam While the Reservoir was Drawn Down. Picture was taken in July 2003 by Paul Jenkin of the Surfrider Foundation.

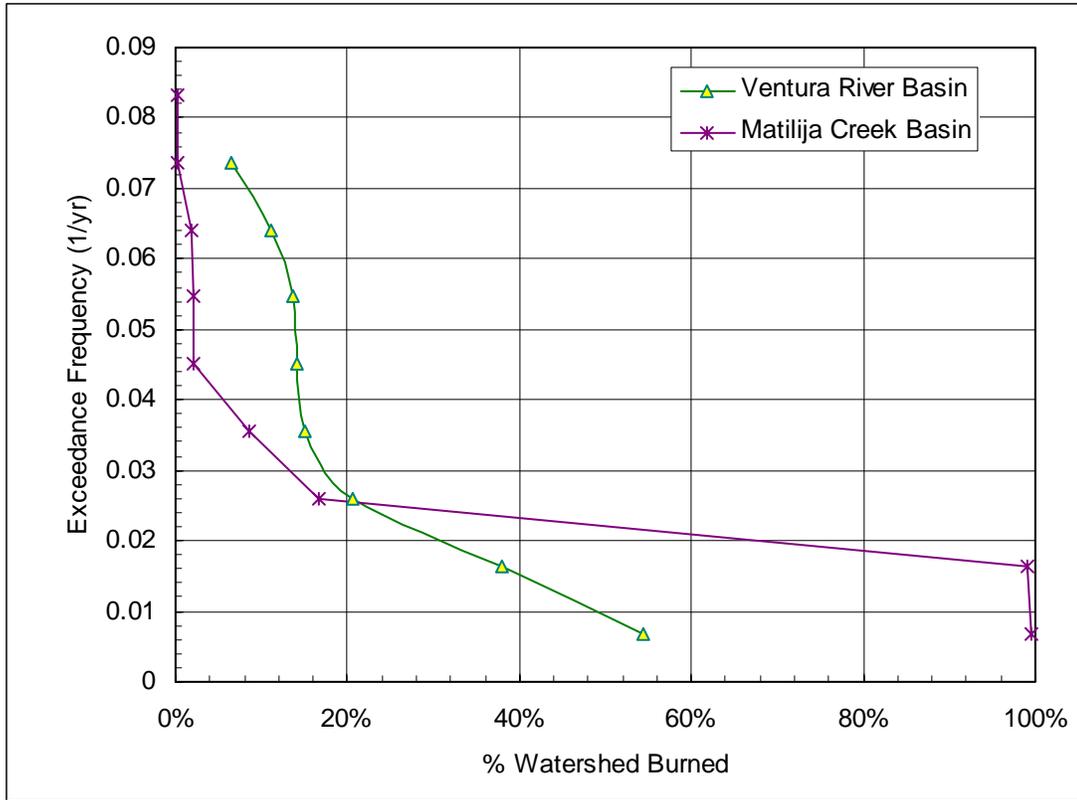
Figure 5.24. Fire frequency in the Matilija Creek and Ventura River Watersheds.

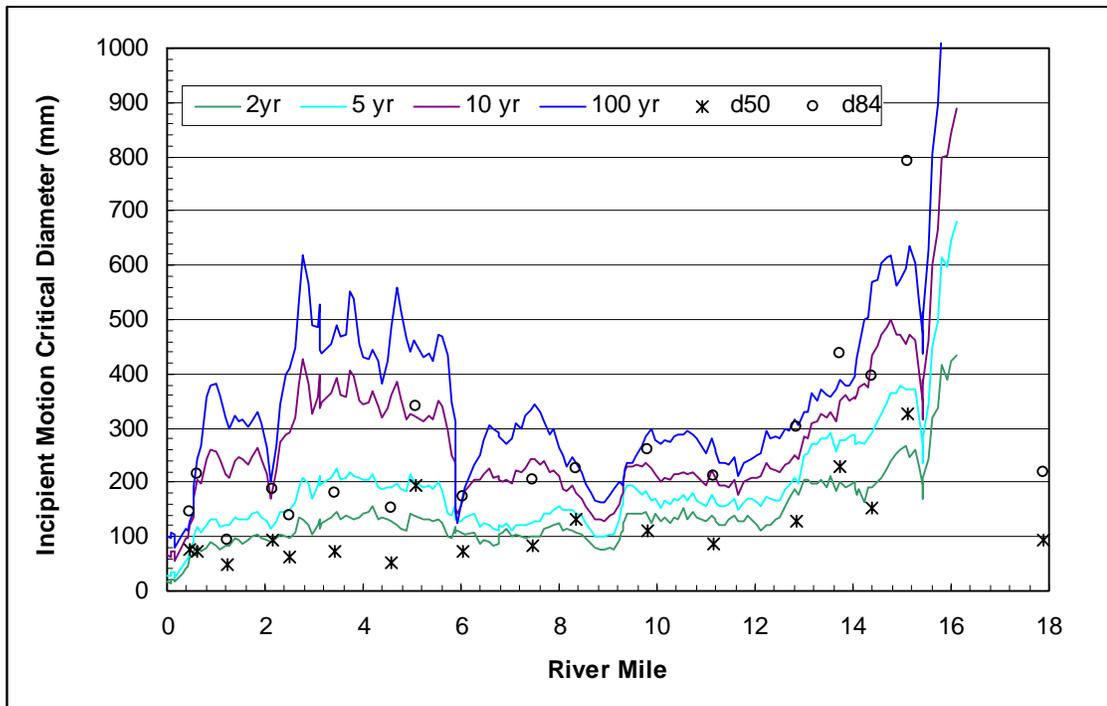
Figure 5.25. Incipient motion critical diameter for the Ventura River and comparison with the  $d_{50}$  and  $d_{84}$  of the bed material.

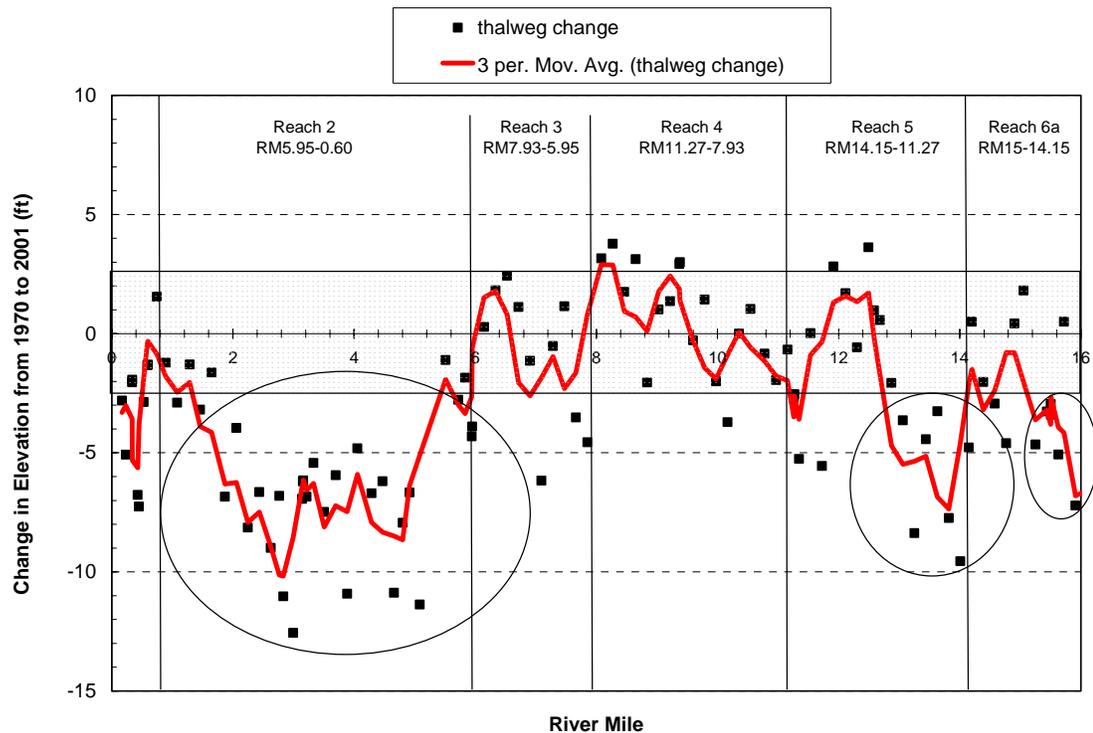
Figure 5.31. Comparison of change in thalweg elevation between 2001 and 1970. Negative changes indicate areas of degradation in the channel bed. Positive changes indicate areas that have aggraded. Areas within 2.5 feet of change are considered to be within the error range of the 1970 data.

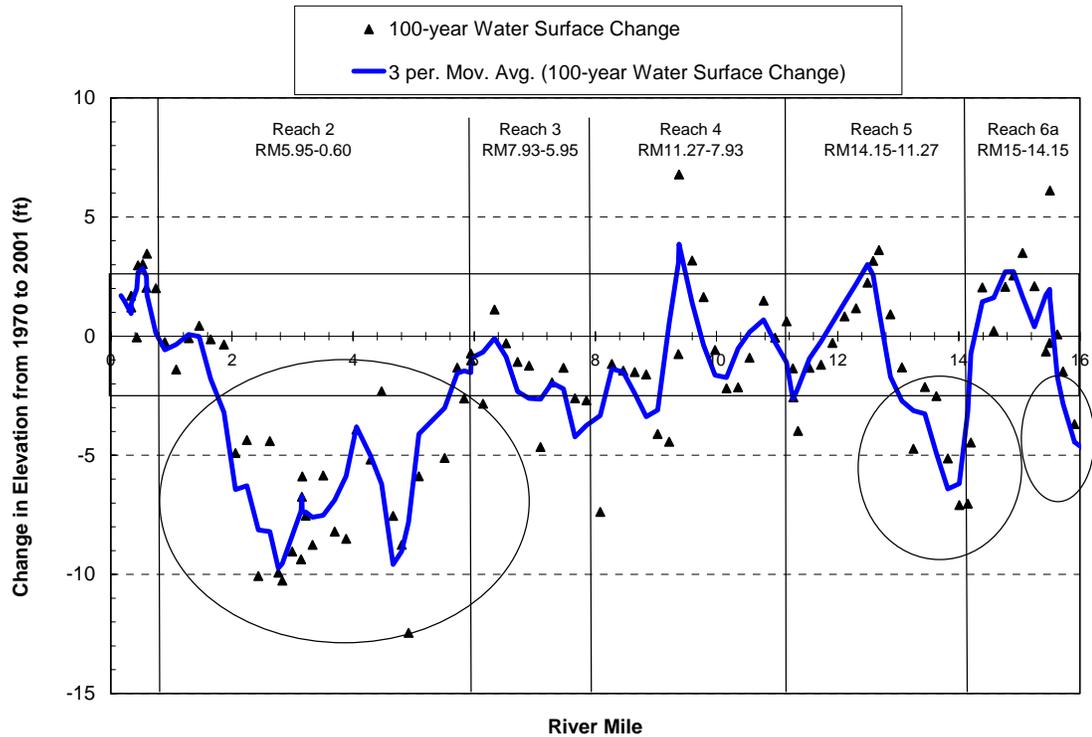
Figure 5.32. Comparison of change in 100-year flood stage between 2001 and 1970. Negative changes indicate areas where the flood stage has lowered. Positive changes indicate areas where the flood stage has increased. Areas within 2.5 feet of change are considered to be within the error range of the 1970 data.

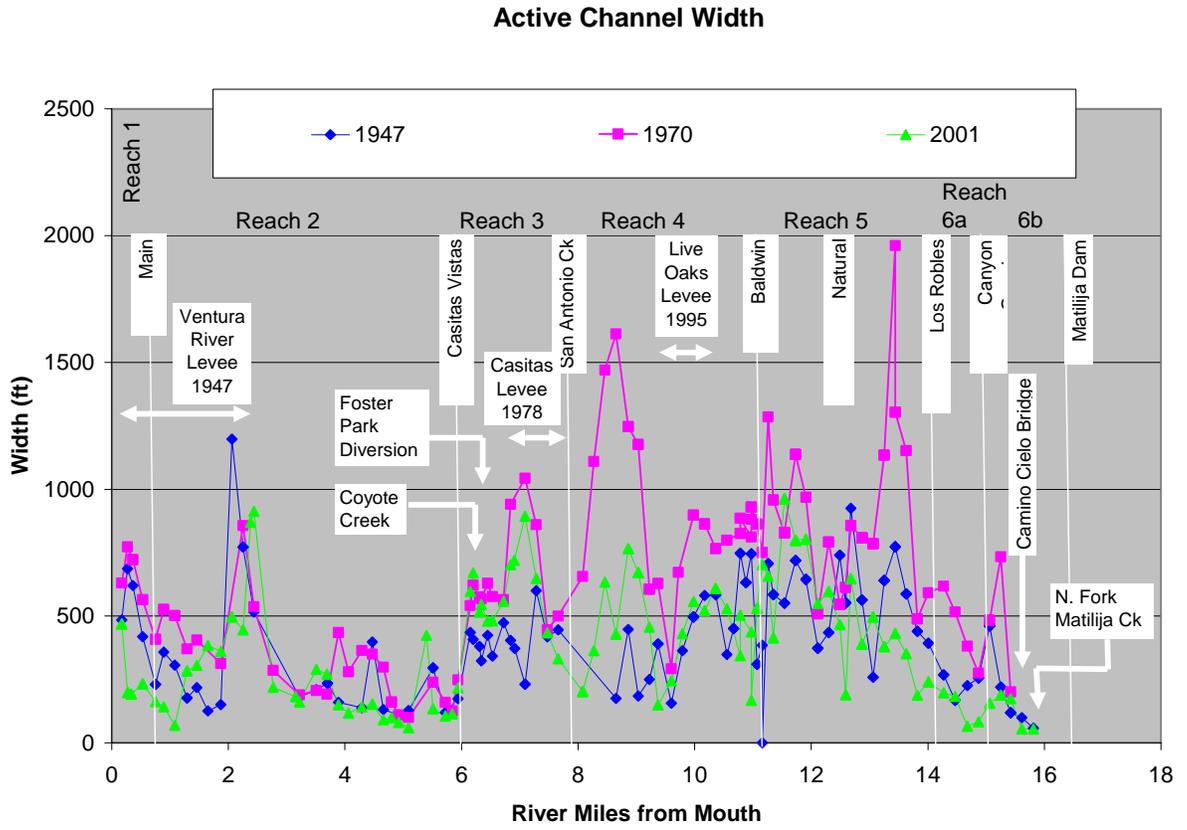
Figure 5.33. Historical Active Channel Widths of the Ventura River in 1947, 1970, and 2001.
