## Hydrology, Hydraulics, and Sediment Studies for the Matilija Dam Ecosystem Restoration Project, Ventura, CA – DRAFT Report

U.S. Department of the Interior  
Bureau of Reclamation  
Technical Service Center  
Denver, Colorado

November 2006

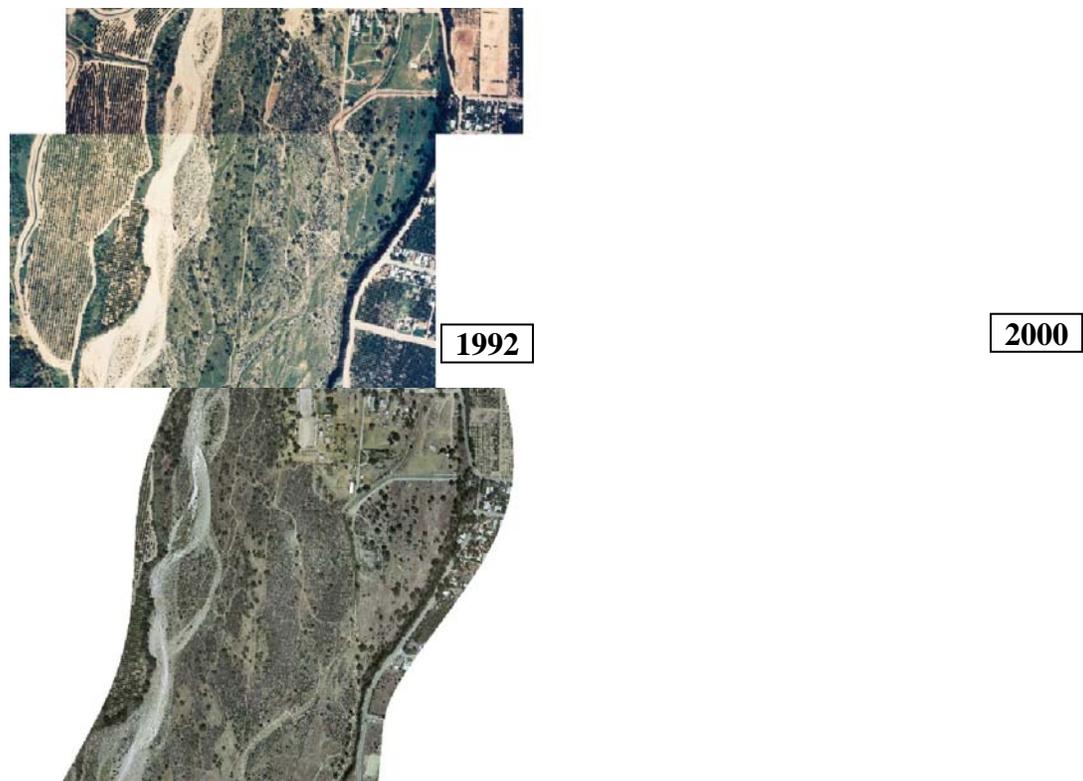
Figure 5.34. Historical Aerial Photograph Comparison at RM 13.5 Downstream of Robles Diversion.

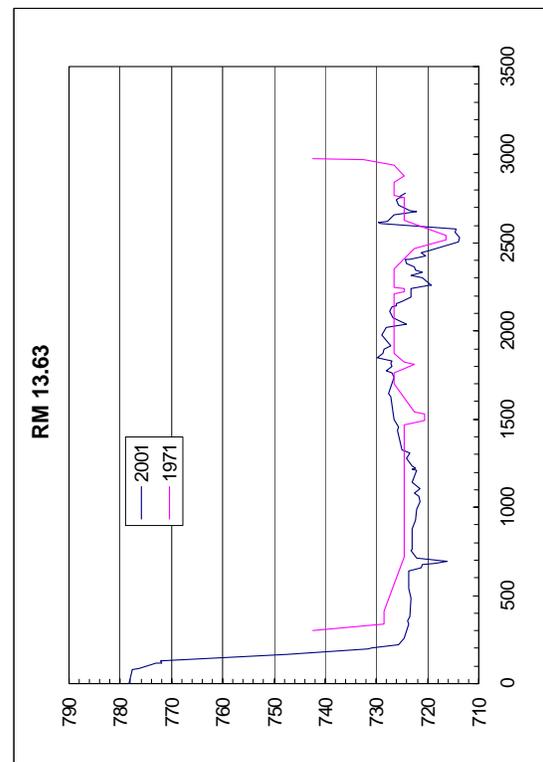
Figure 5.35. Cross section comparison between 1971 and 2001 surveys.

Plots of the cross sections in 1970 and 2001 are given in Figure 5.35. Based on the cross section comparison, the channel has become more entrenched in the reach downstream of Robles Diversion from RM 14 to 13. However, from RM 13 downstream to RM 9, the river has remained relatively stable in the past 30 years. The channel is active, but the average bed elevation and the channel properties have been maintained.

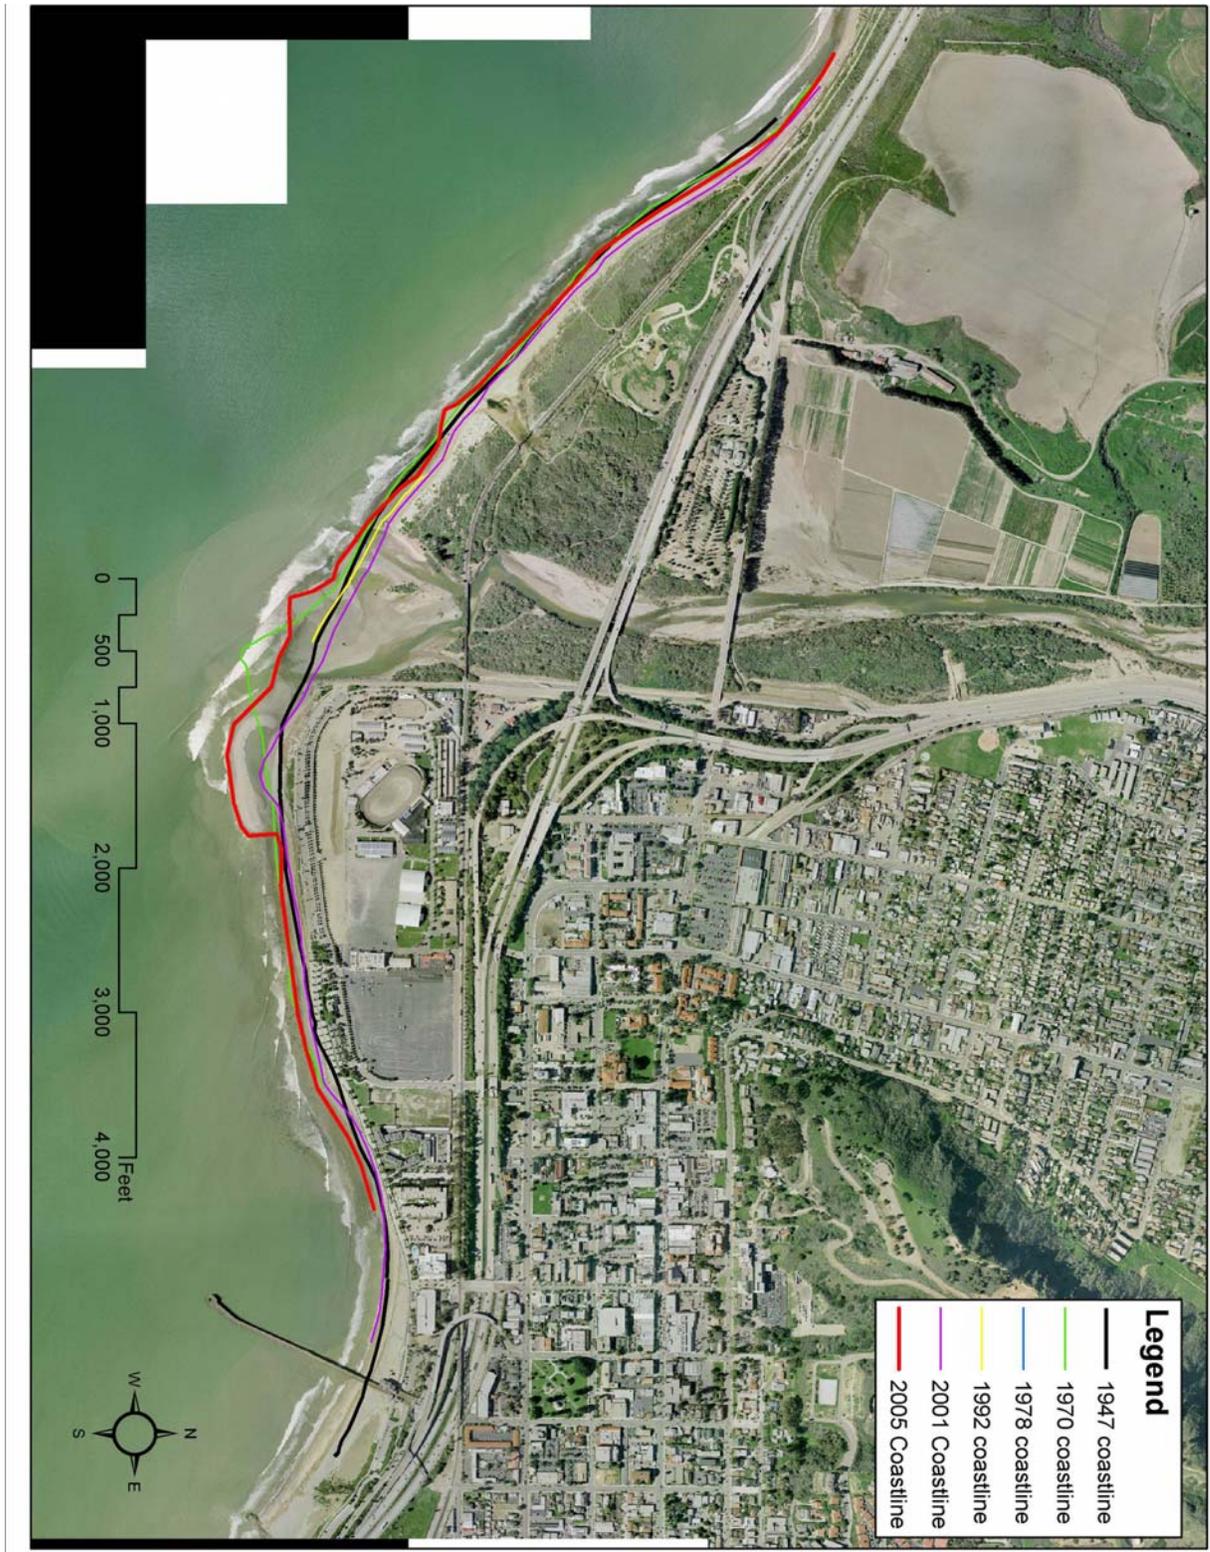
Figure 5.38. Aerial Photograph of Coastline at Mouth of Ventura River.

The 1947, 1970, 1978, 1992, 2001, and 2005 aerial photographs were used to analyze changes to the coastline during that period. The coastline was digitized using the waterline as the estimate of the coastline. The results are shown in Figure 5.38. The 1970 and 2005 coastlines protruded into the ocean the furthest. The 1947 and 2001 coastlines were relatively similar, with the 1947 coastline being slightly further into the ocean. The 1970 photo was taken soon after the 1969 flood which carried over 6 million tons of sediment to the ocean (Figure 5.2) and was the largest annual sediment load since 1929. The photo taken in 2005 immediately after a large flood.

The tidal variation will also affect the location of the coastline. The elevation of the Pacific Ocean can vary between approximately 7 feet based upon the tidal data near Ventura. It is uncertain whether the photos were taken at high tide, low tide or somewhere between. Based on these photos, the natural annual variations of the coastline are quite large and therefore, it is difficult to quantify the effect of Matilija dam on the coastline.

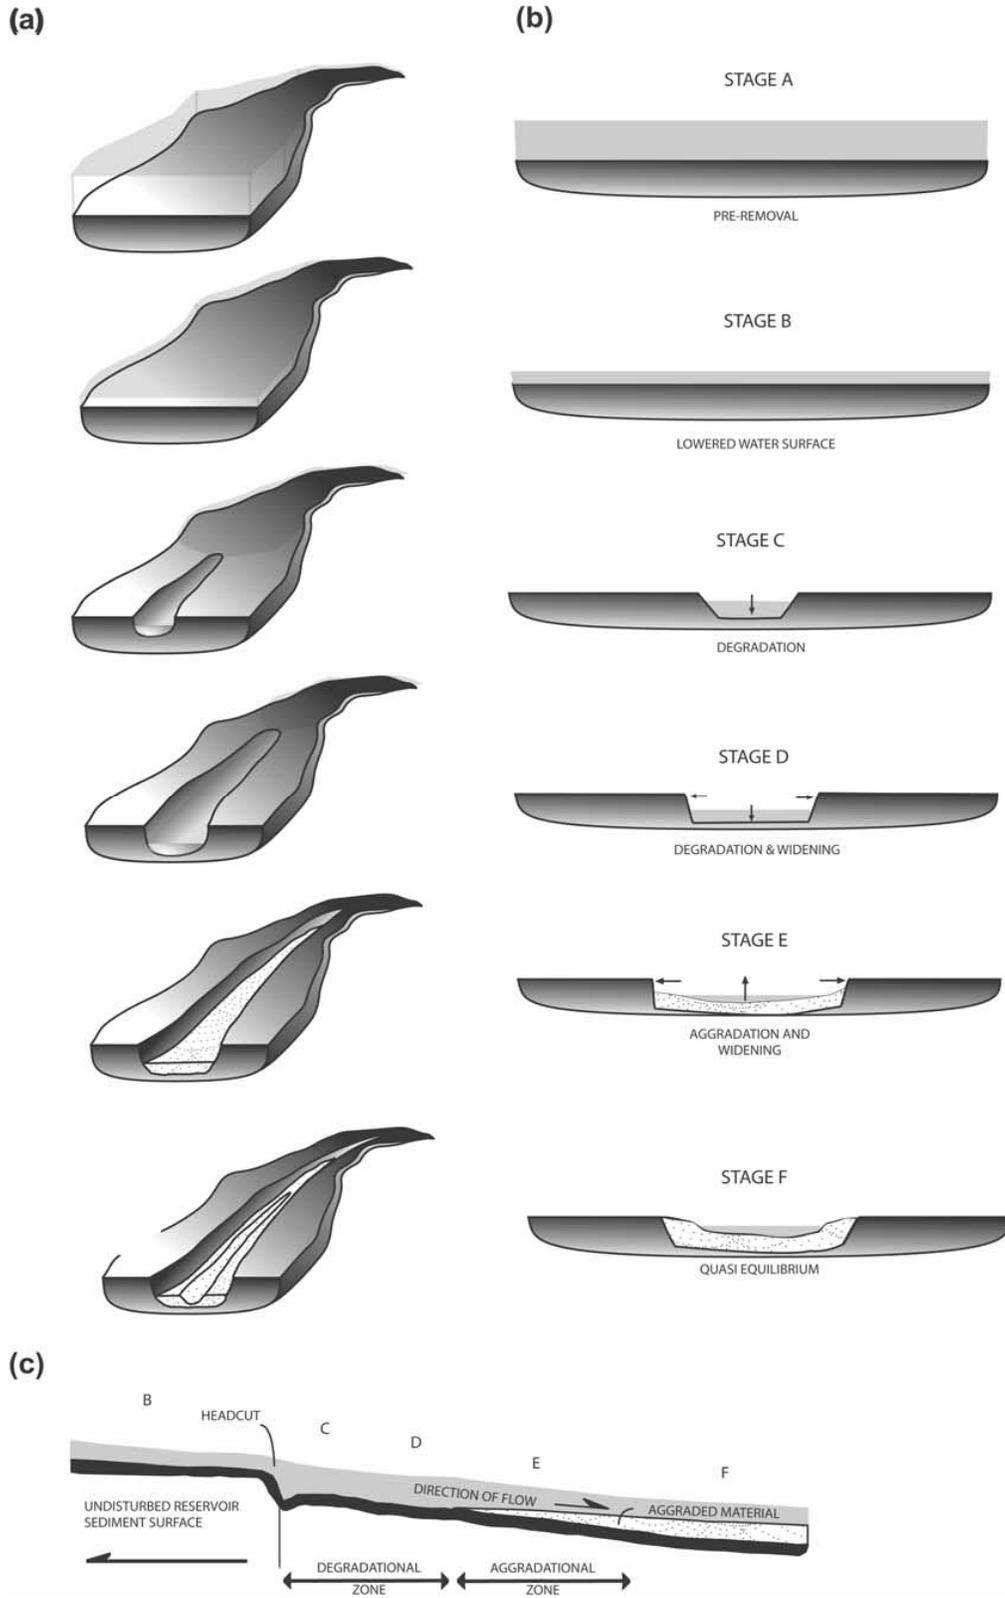
Figure 6.13. Schematic description of reservoir erosion process through delta deposits, from Doyle et al. (2003). (a) oblique view, (b) cross section view, (c) profile view.

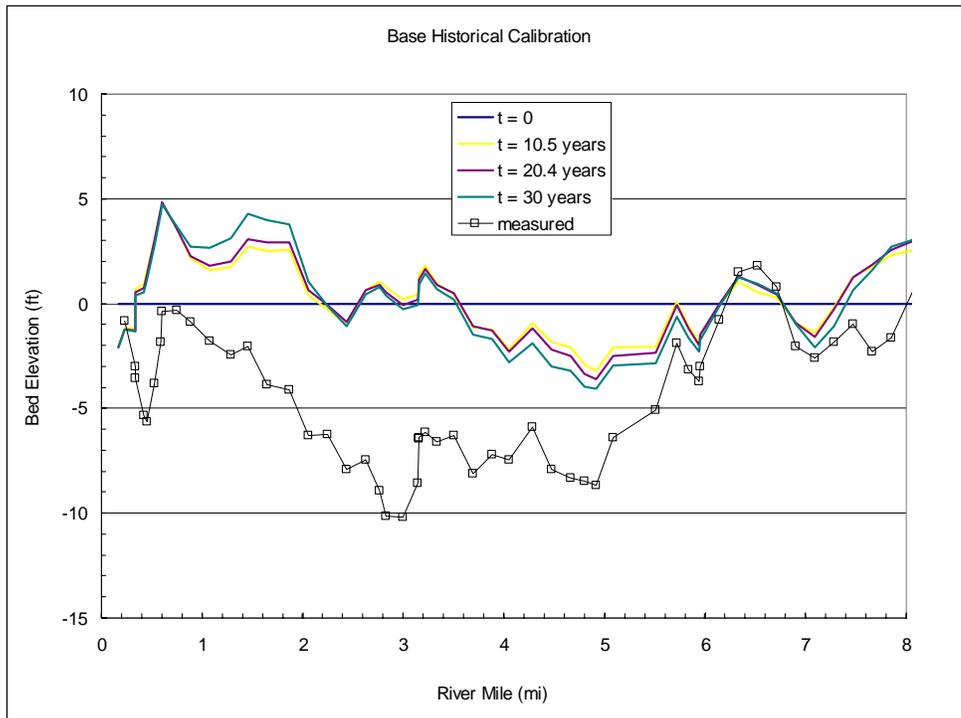
Figure 6.17. Computed Thalweg Elevation Change from 1971 to 2001, RM 0 – 8.

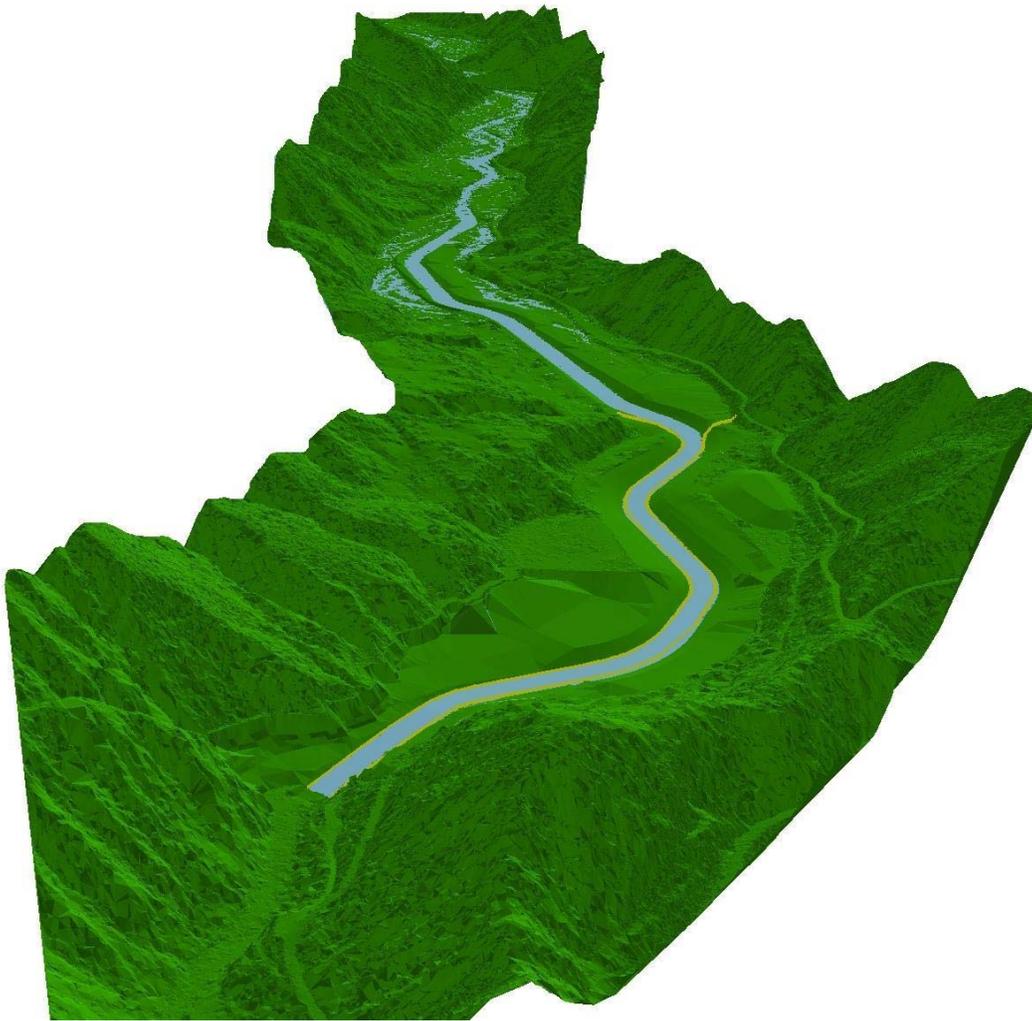
Figure 7.1. Oblique View of Channel Immediately after Dam Removal.

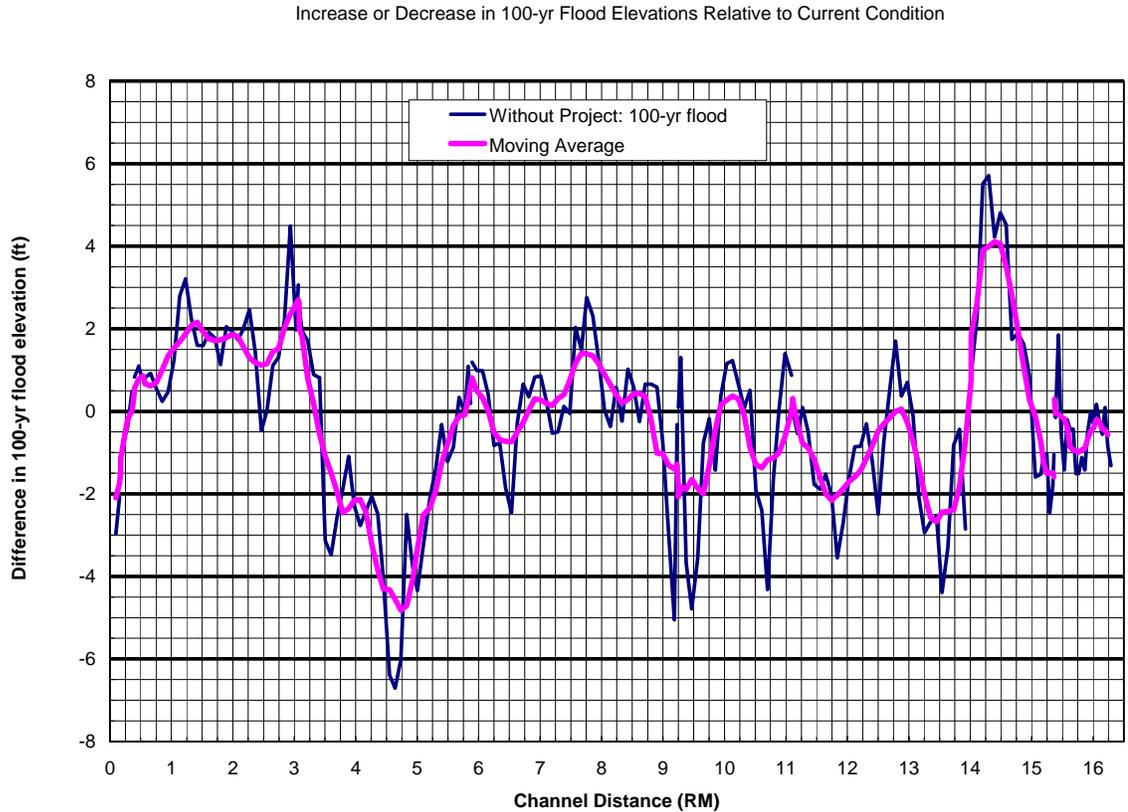
Figure 10.1. Change in 100-yr flood elevations between Current Condition and Future Without-Project Conditions.

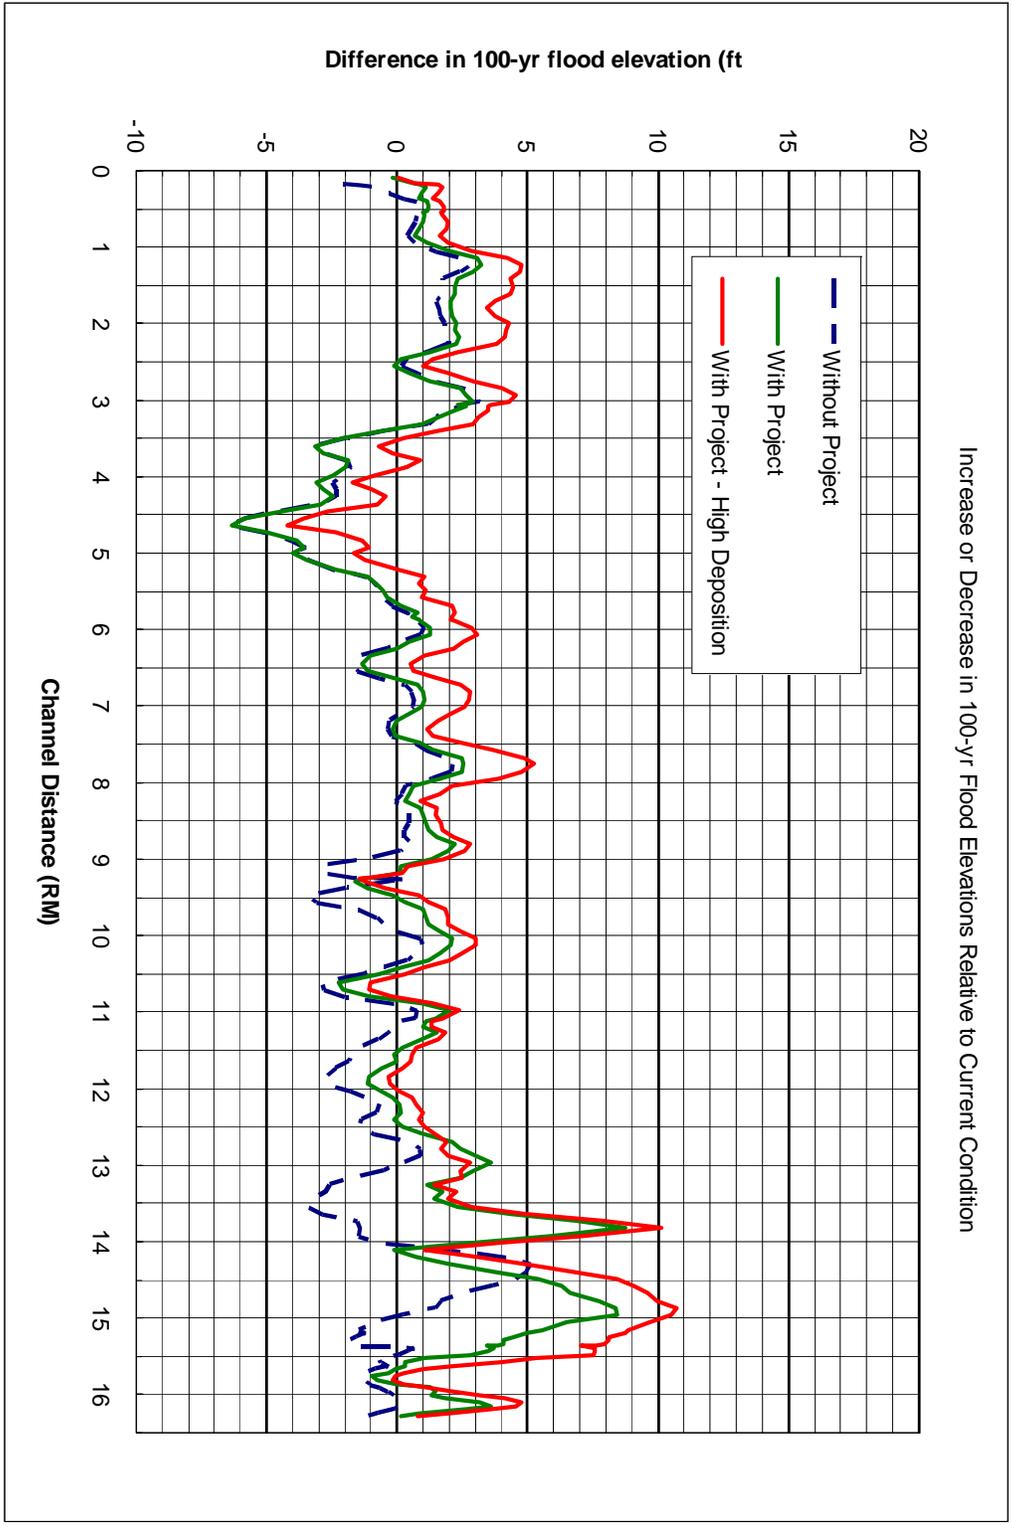
Figure 10.2. Change in 100-yr flood elevations between Current Condition and Future With-Project Conditions.

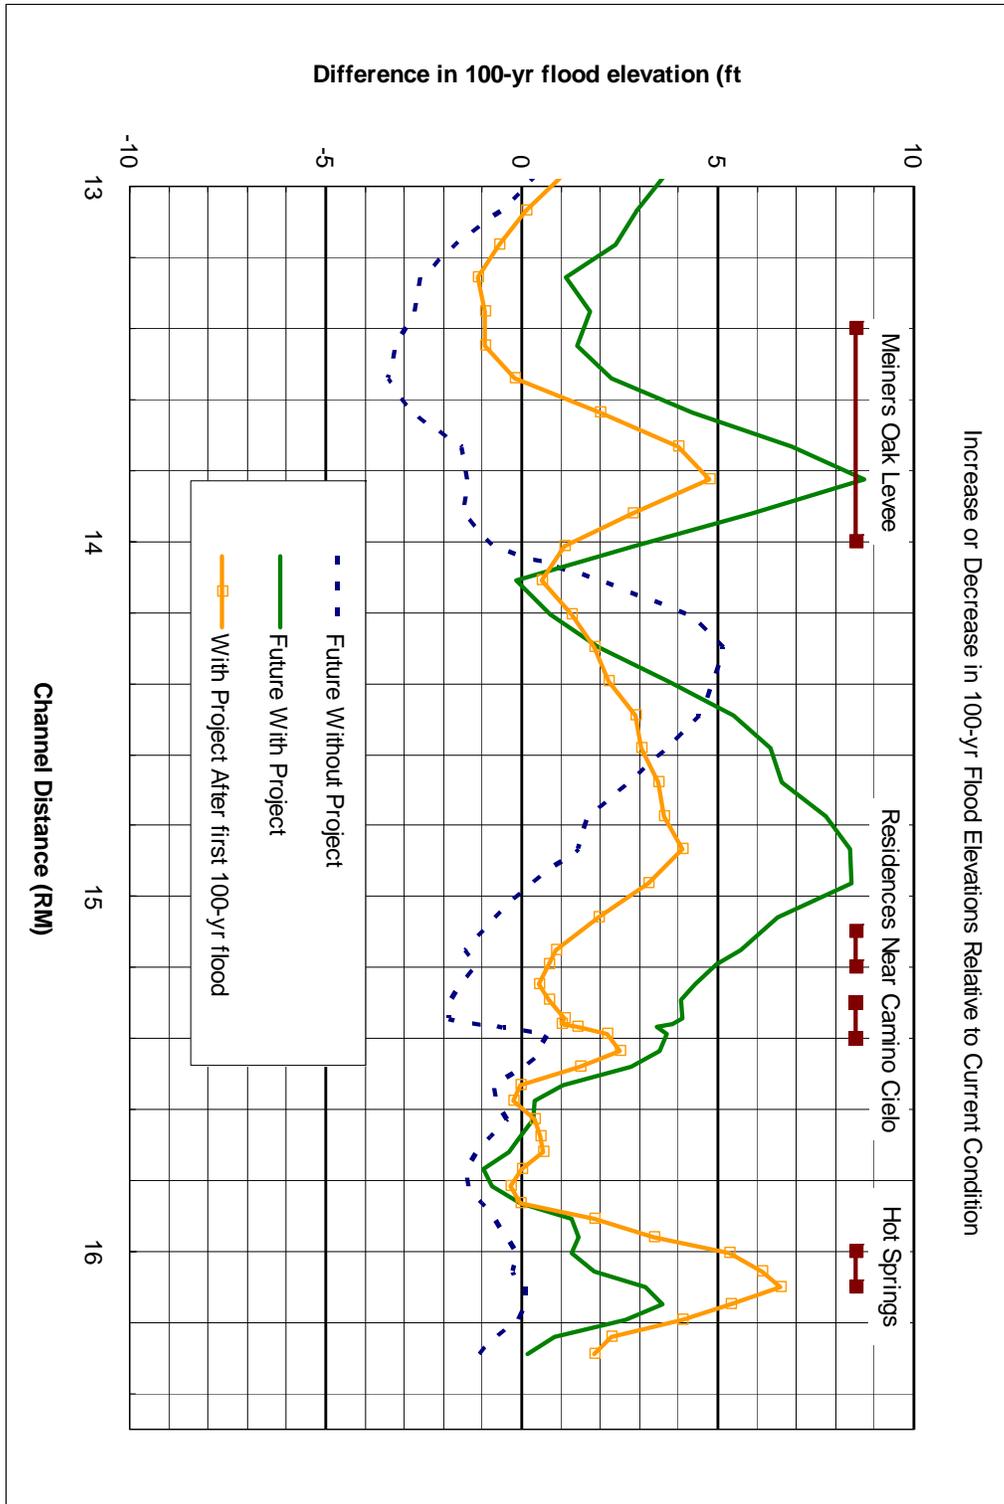
Figure 10.3. Change in 100-yr flood elevations between Current Condition and Future With-Project Conditions from RM 13 to Matilija Dam. Also shows 100-yr flood elevations after first 100-yr flood.

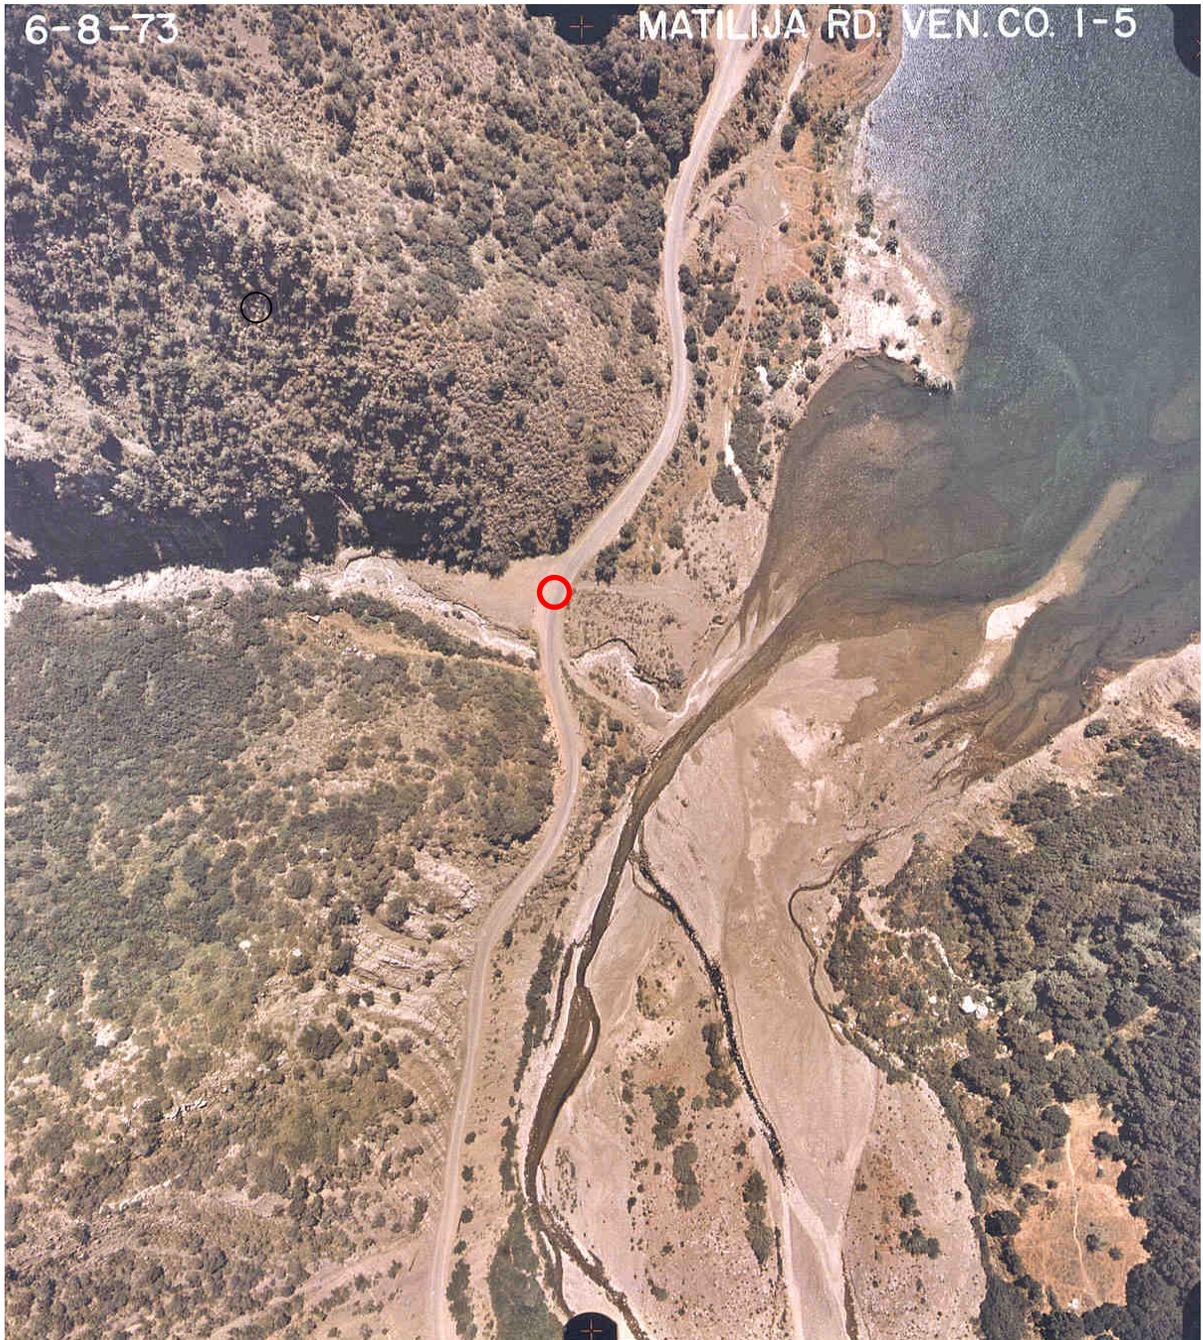
Figure 11.2. 1973 Photograph of Matilija Delta. Note: The red circle is located at the same location in the following pictures of the Matilija Reservoir.

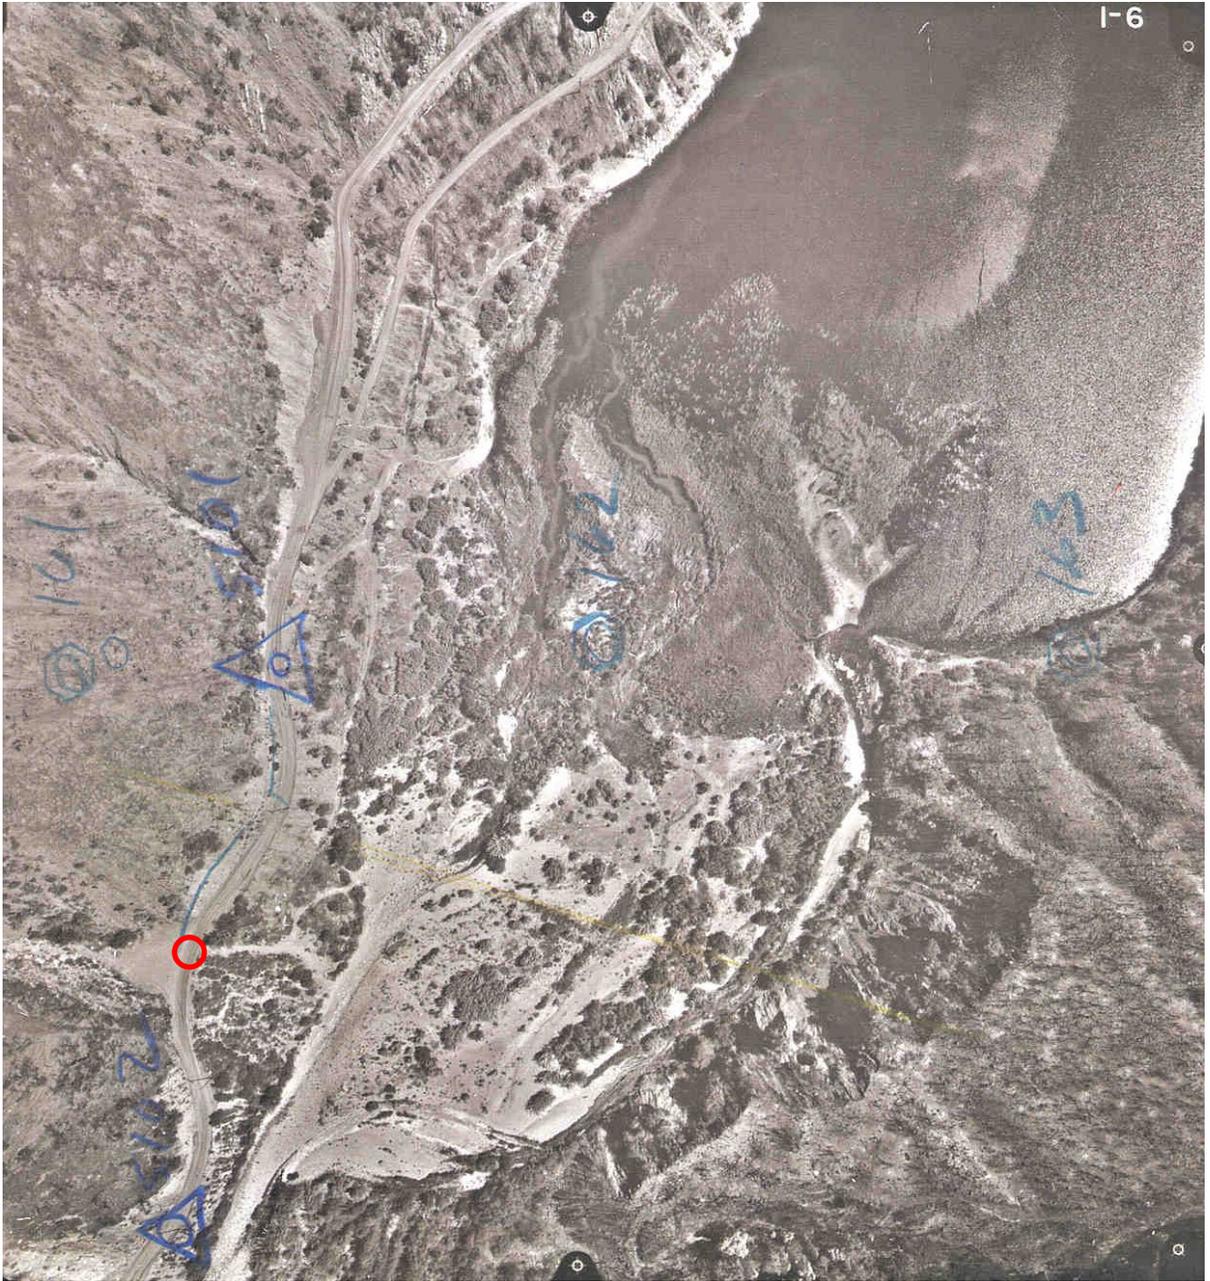
Figure 11.3. 1985 Photograph of Matilija Delta. Note: The red circle is located at the same location in each photo.

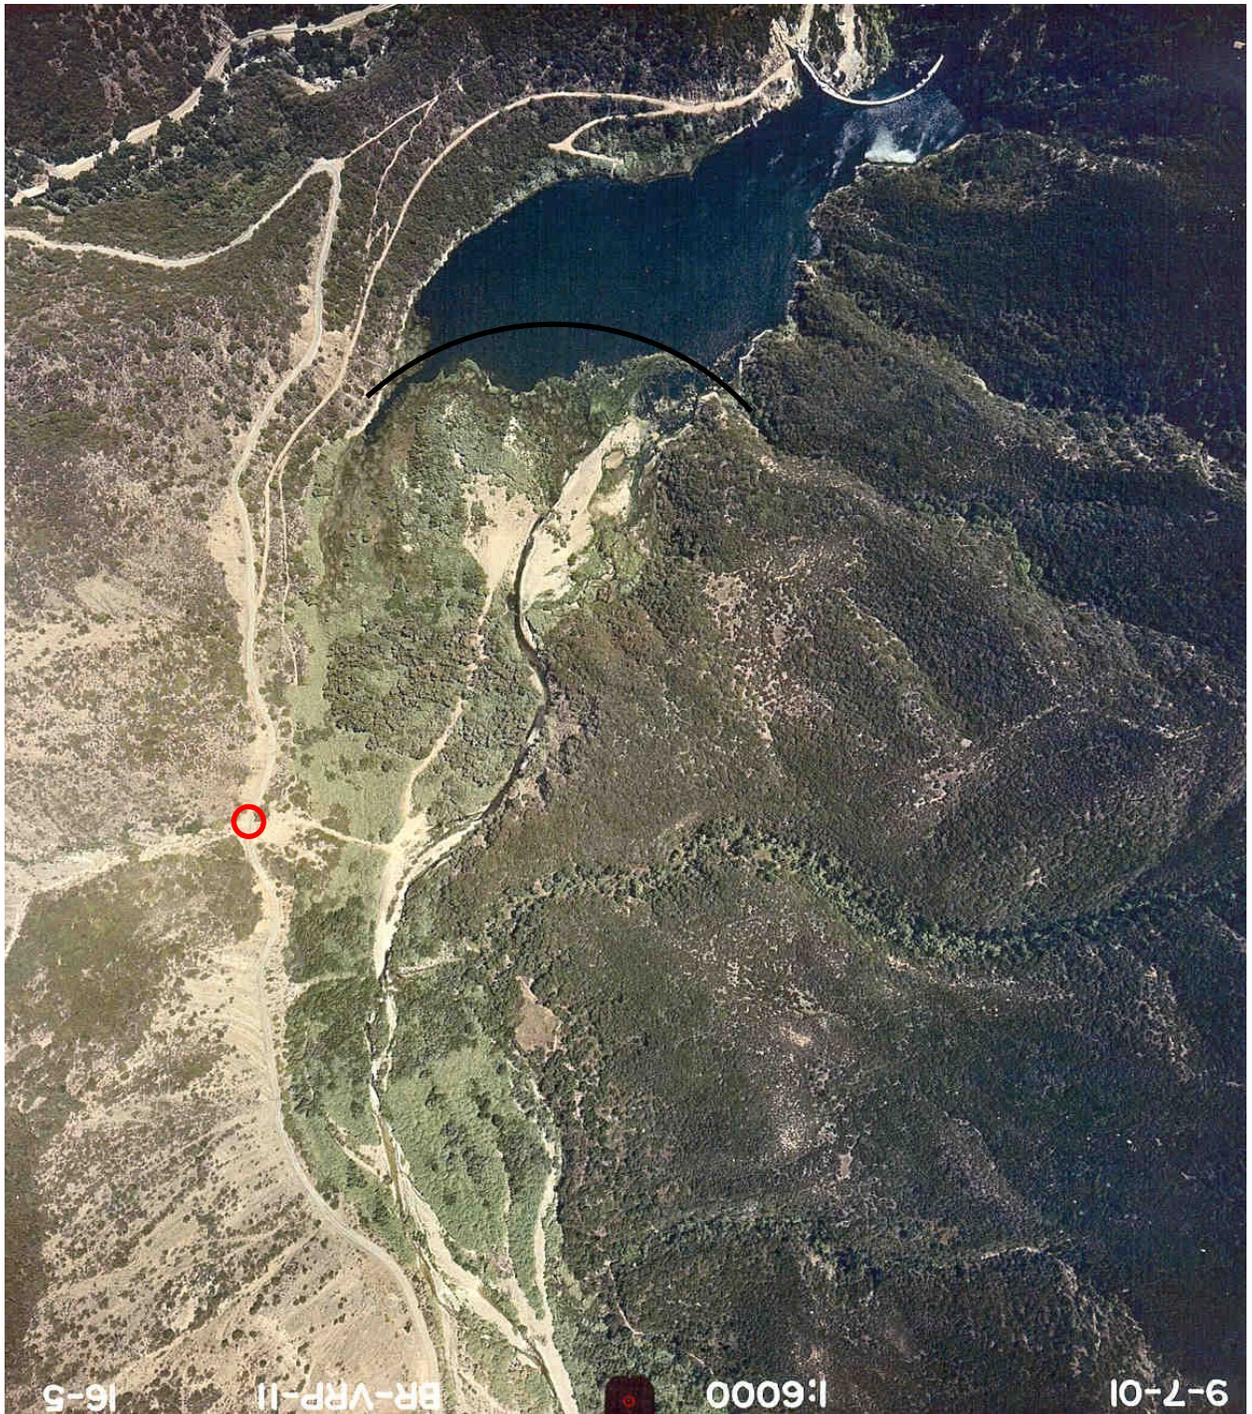
Figure 11.4. 2001 Photograph of Matilija Delta.

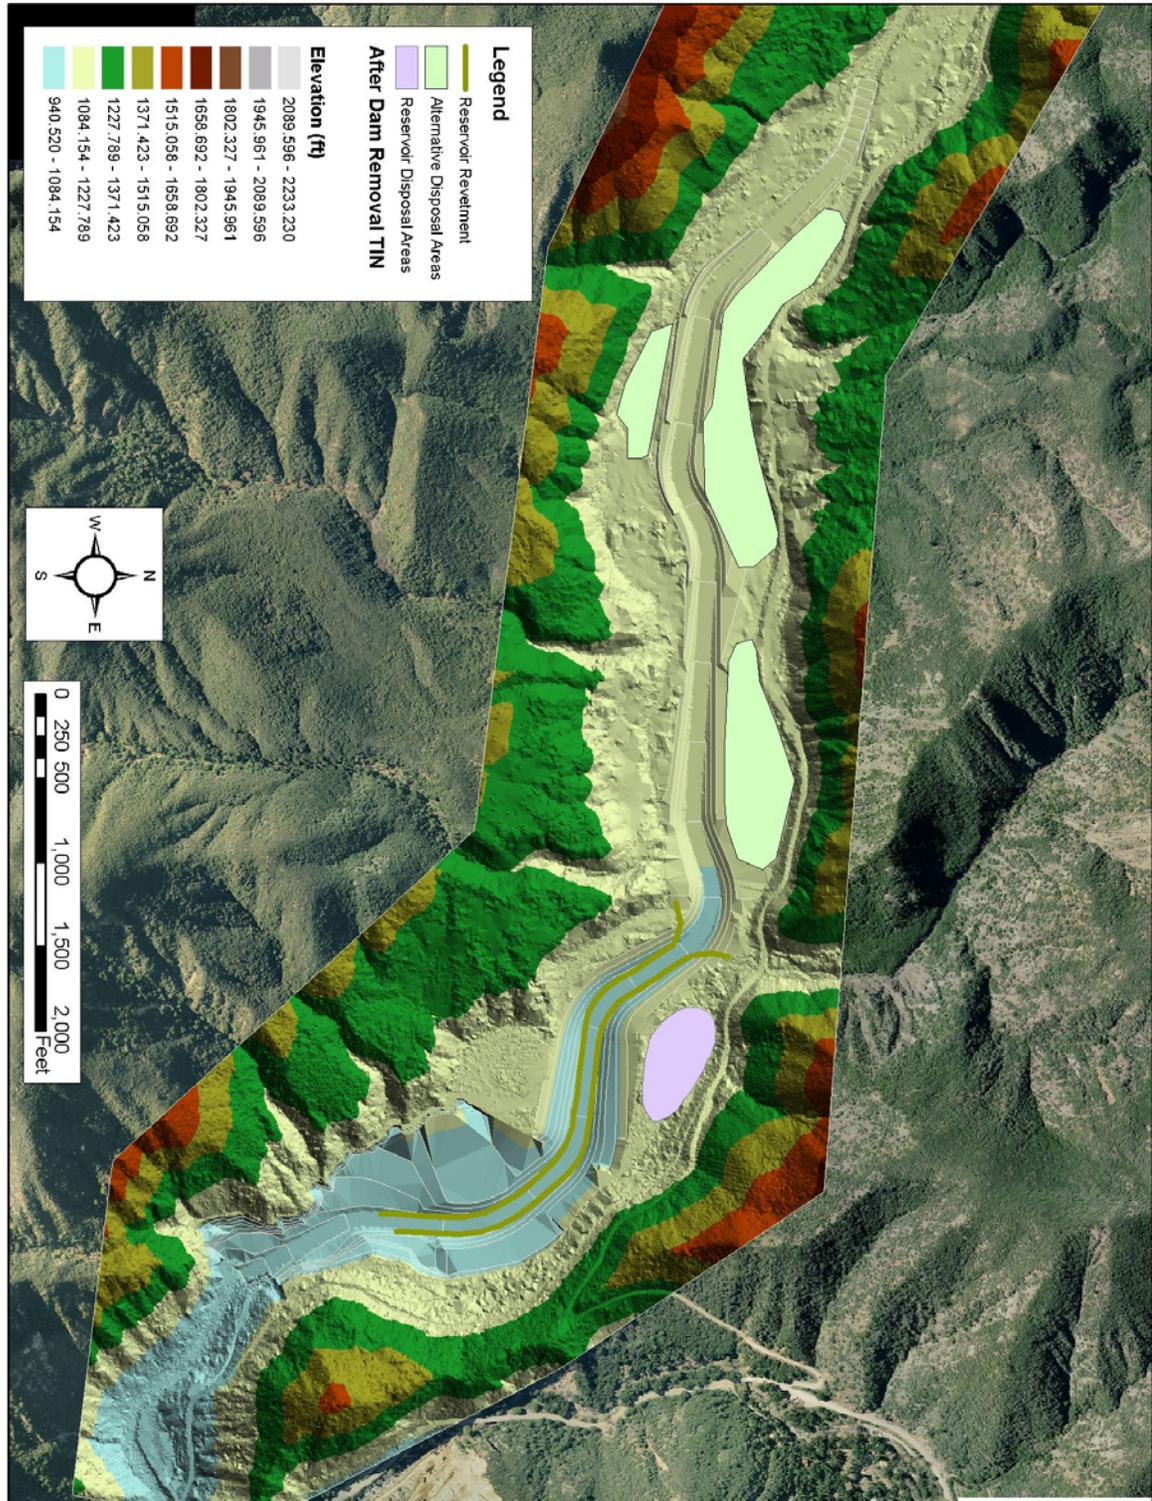
Figure 11.5. Approximate Rendering of Reservoir Area Immediately After Dam Removal.

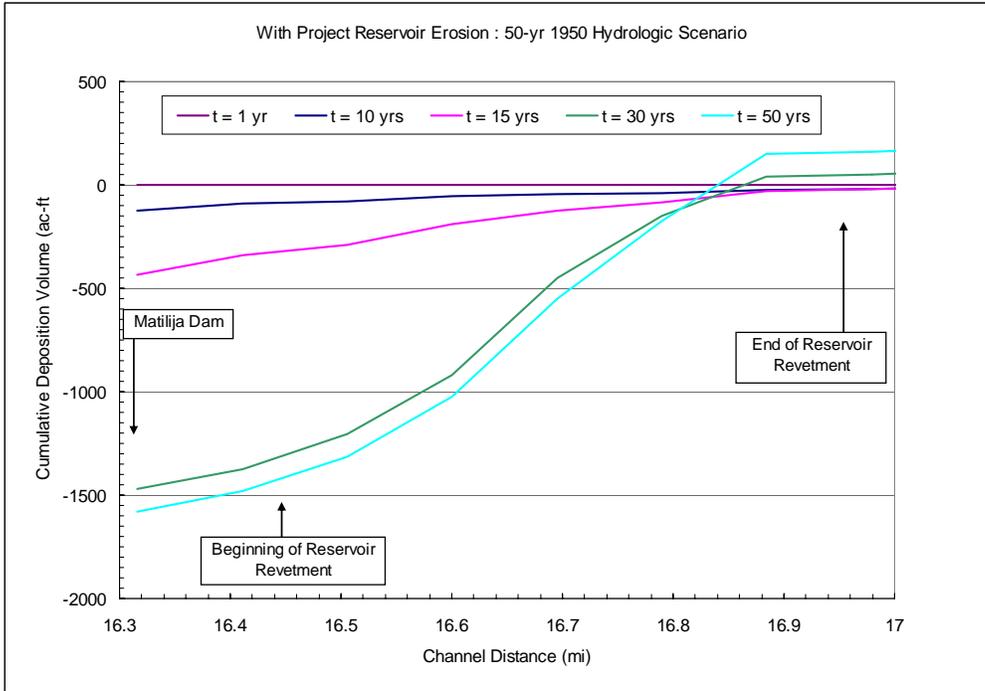
Figure 11.6. Erosion of Sediment from Matilija Reservoir under With-Project Conditions and 50-yr 1950 Hydrologic Scenario.

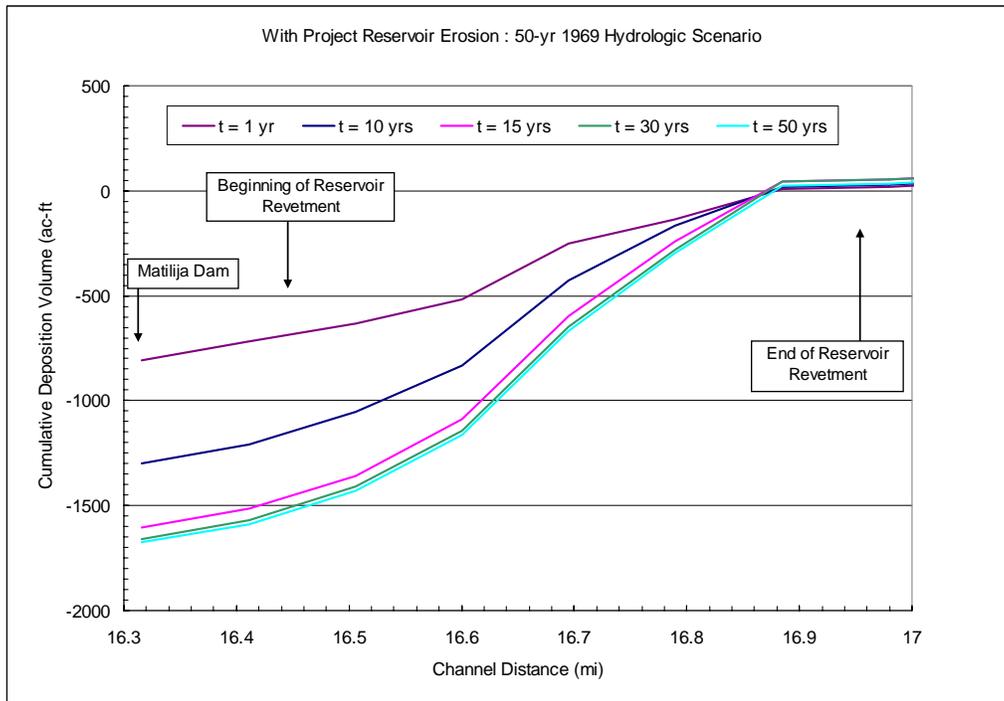
Figure 11.7. Erosion of Sediment from Matilija Reservoir under With-Project Conditions and 50-yr 1969 Hydrologic Scenario.

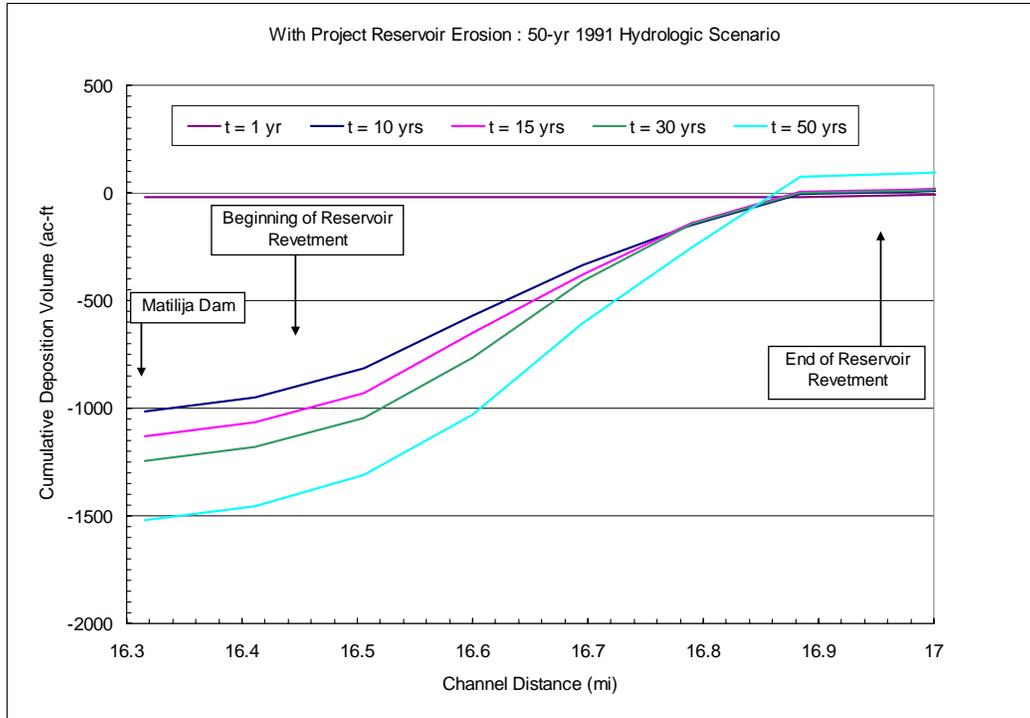
Figure 11.8. Erosion of Sediment from Matilija Reservoir under With-Project Conditions and 50-yr 1991 Hydrologic Scenario

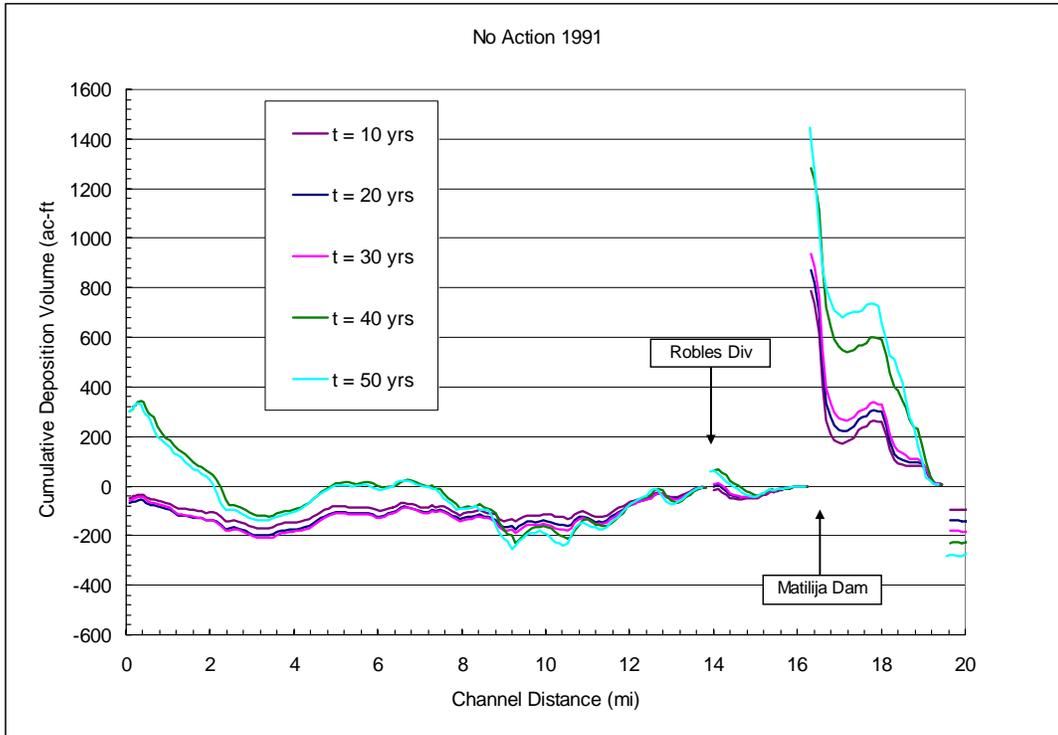
Figure 11.9. Cumulative Deposition for 1991 historical 50-yr hydrograph for Without Project Conditions.

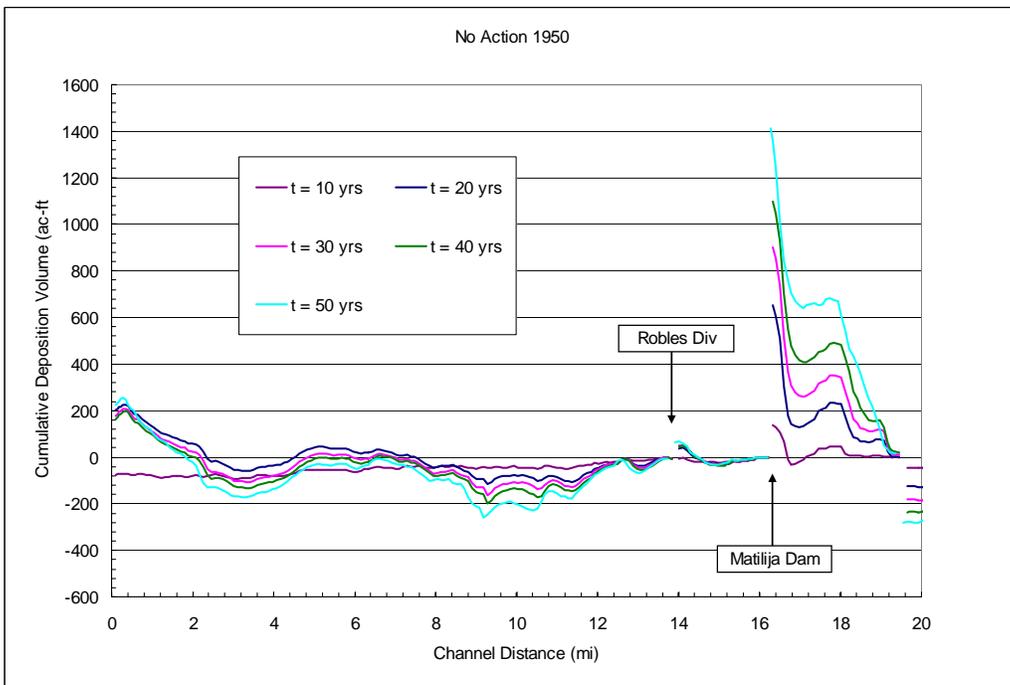
Figure 11.10. Cumulative Deposition for 1950 historical 50-yr hydrograph for Without Project Conditions.

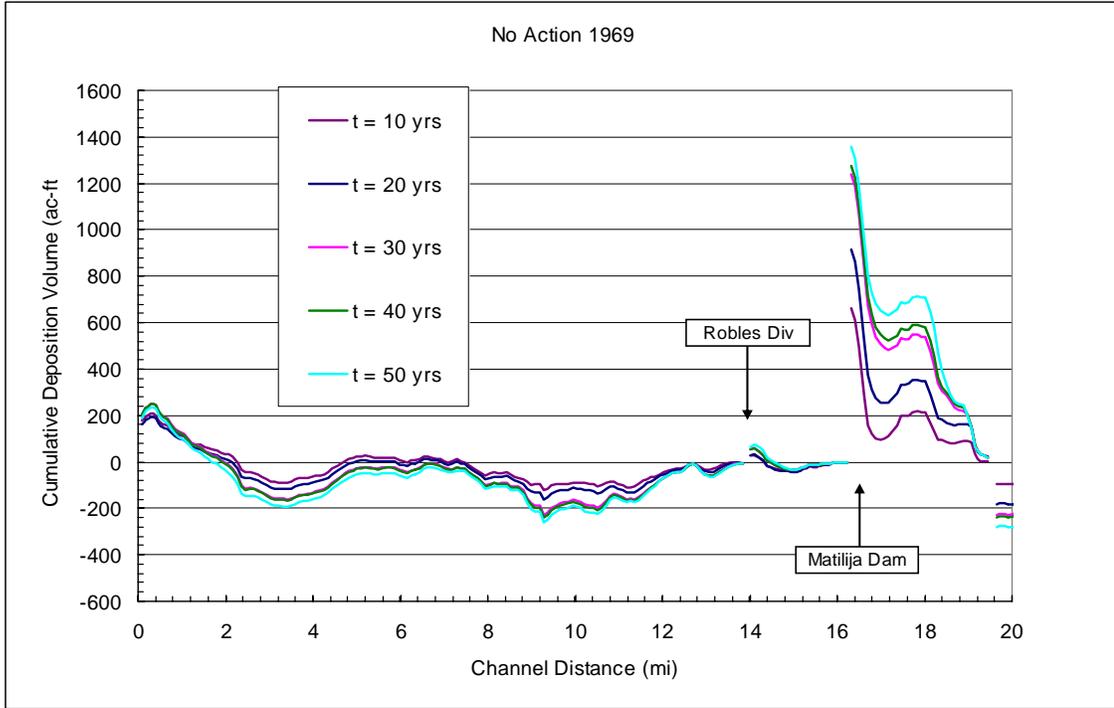
Figure 11.11. Cumulative Deposition for 1969 historical 50-yr hydrograph for Without Project Conditions.

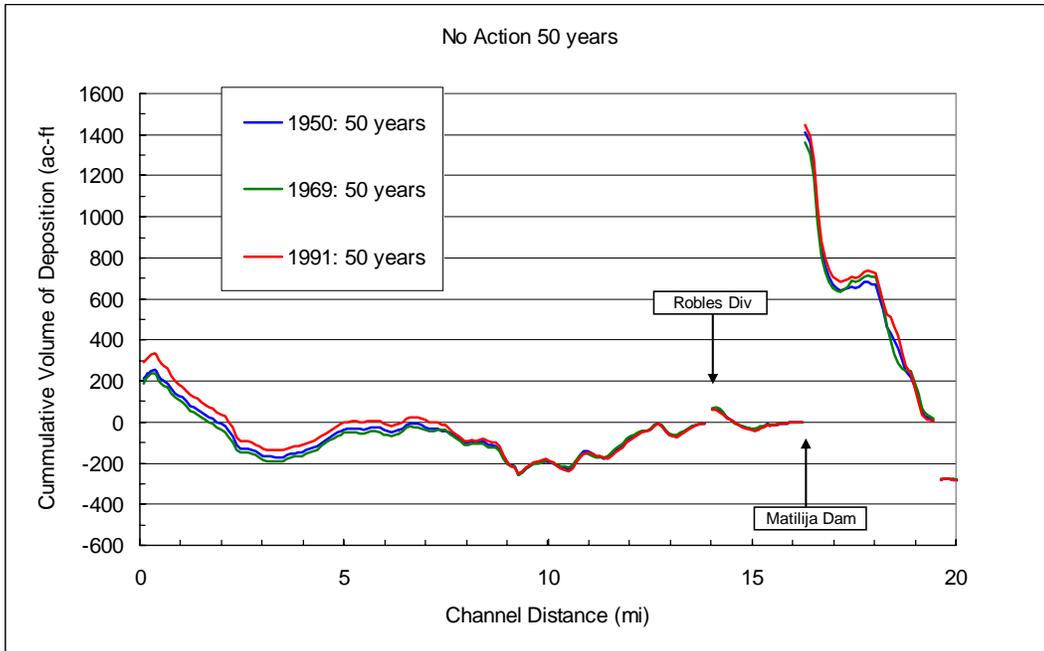
Figure 11.12. Cumulative Deposition in 50 years for Without-Project Conditions for different hydrographs.
