## Hydrology, Hydraulics, and Sediment Studies for the Matilija Dam Ecosystem Restoration Project, Ventura, CA – DRAFT Report

U.S. Department of the Interior  
Bureau of Reclamation  
Technical Service Center  
Denver, Colorado

November 2006

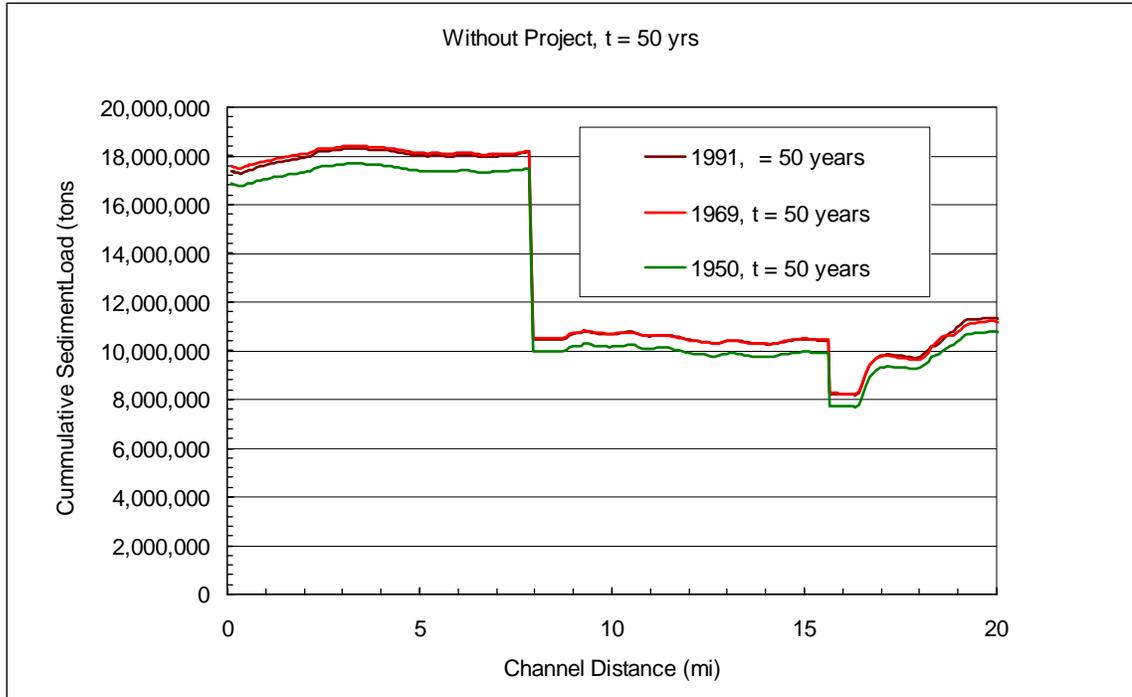
Figure 11.13. Cumulative Sediment Loads at end of 50 year Simulation for Without-Project Conditions for different hydrographs.

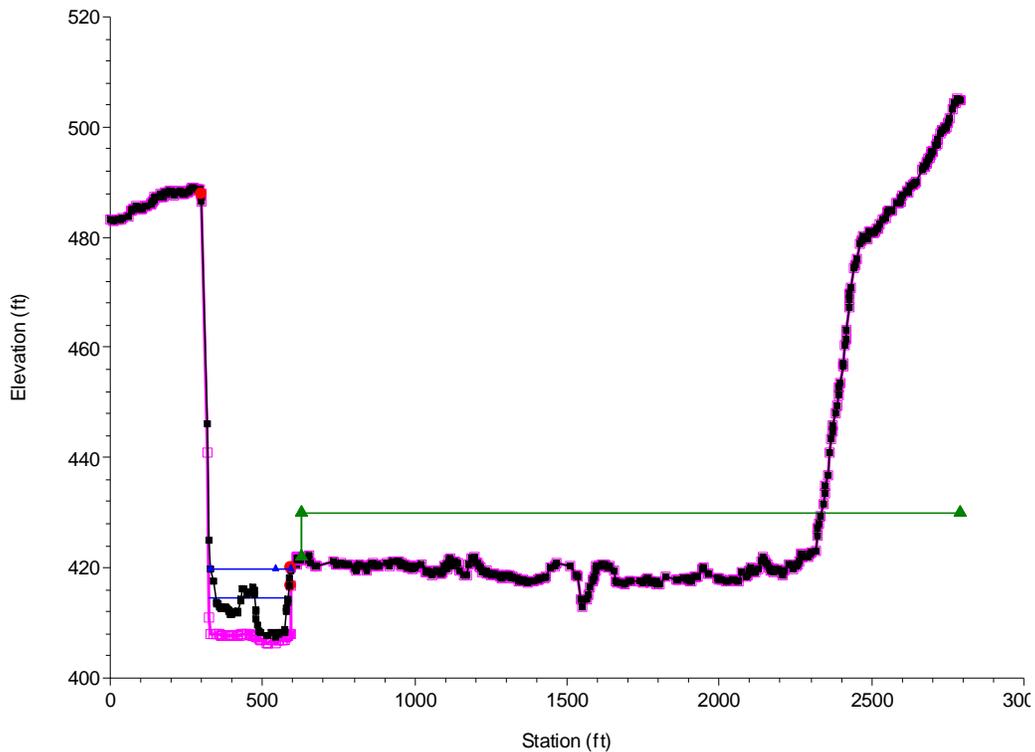
RS = 9.4697

Figure 11.14. Bed Elevation Changes upstream of Santa Ana Bridge under Without-Project Conditions.

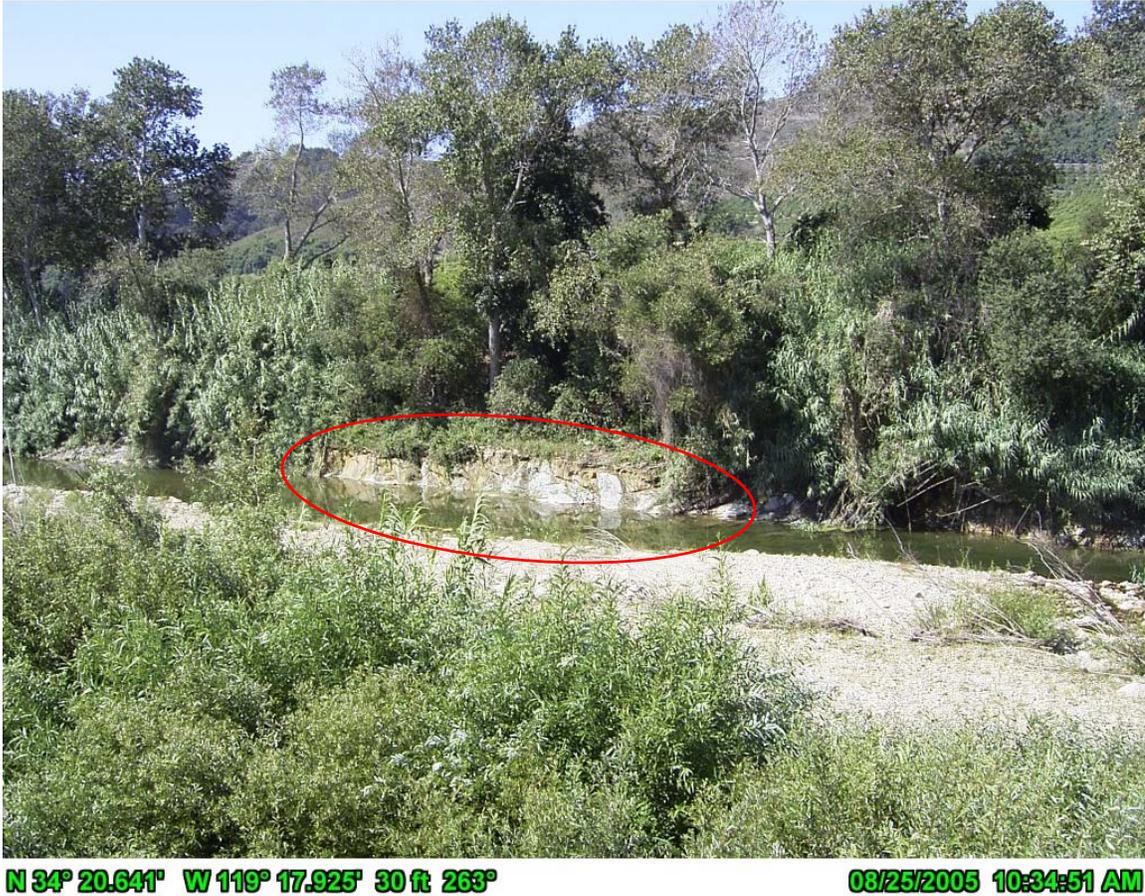
Figure 11.15. Exposed Bedrock along West side of Ventura River near OVSD Facility at RM 5.

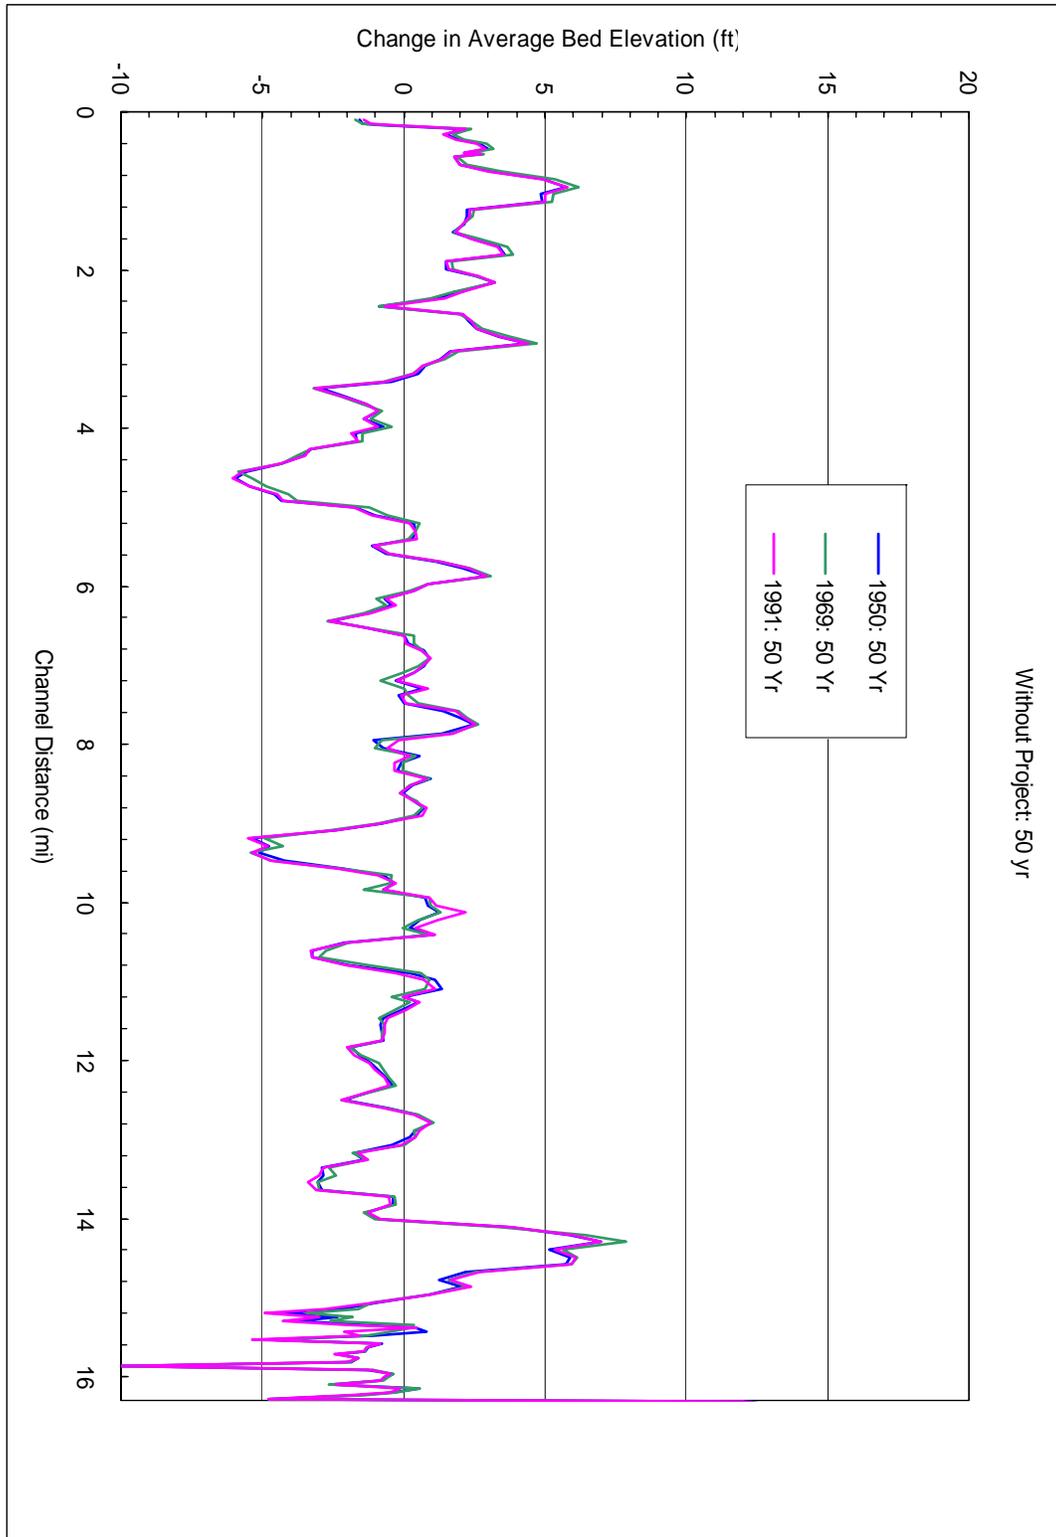
Figure 11.16. Average bed elevation changes at the end of the 50-yr simulations for the 1950, 1969, and 1991 50-yr hydrographs for Without Project Conditions.

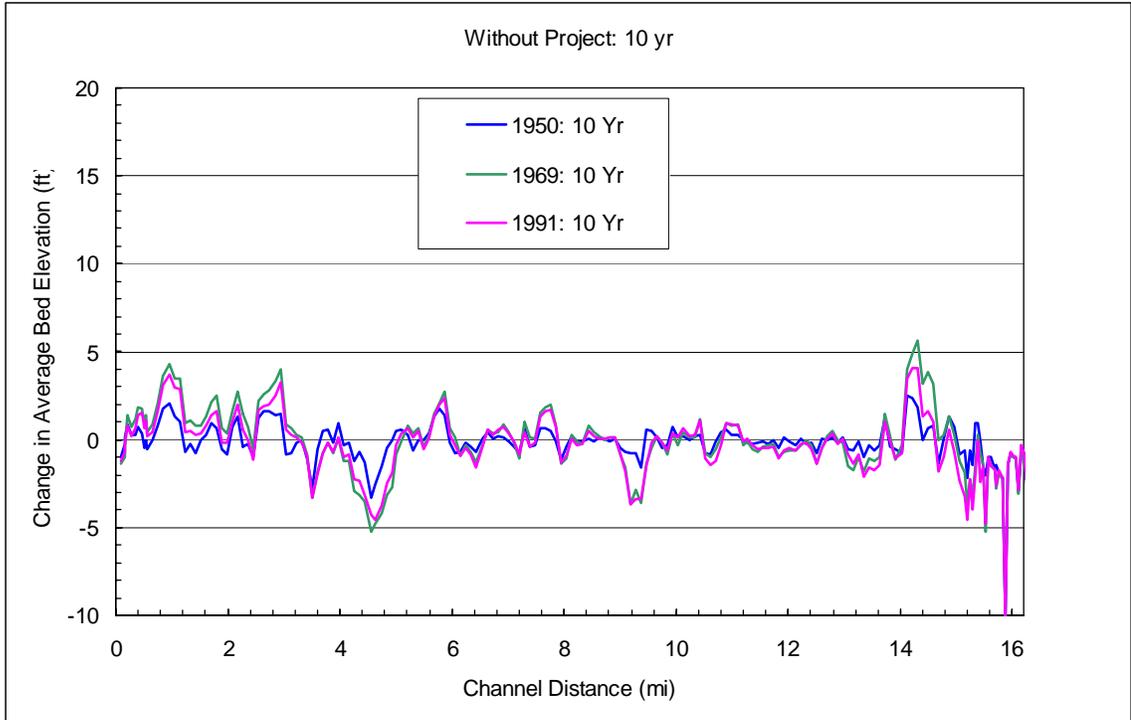
Figure 11.17. Average bed elevation changes at the end of the 10-yr simulations for the 1950, 1969, and 1991 50-yr hydrographs for Without Project Conditions.

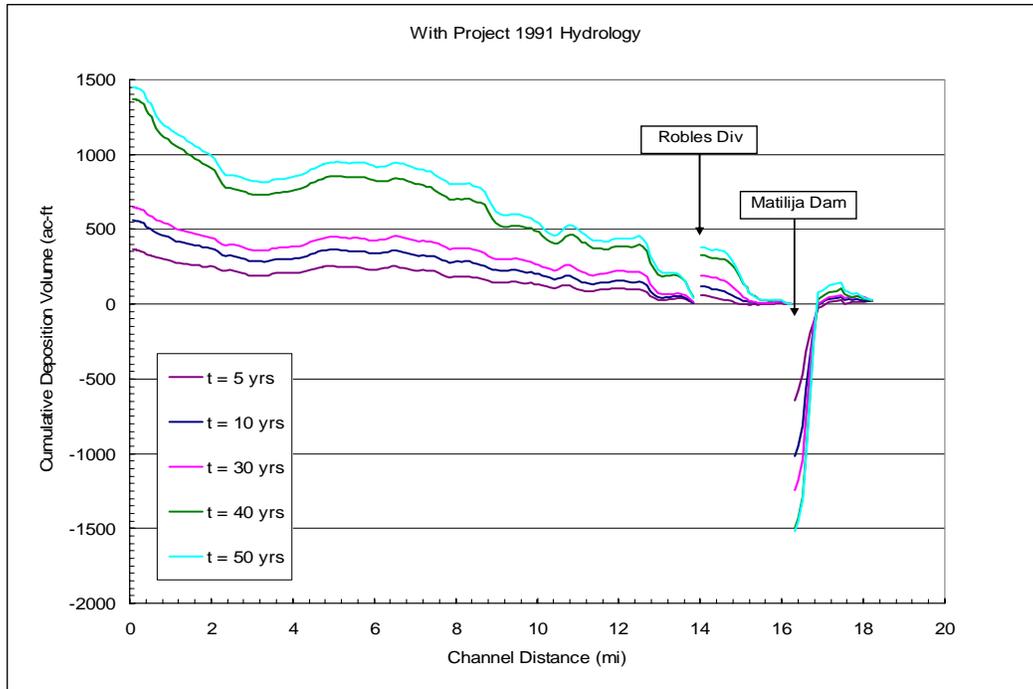
Figure 11.18. Cumulative Deposition for 1991 historical 50-yr hydrograph for With- Project Conditions.

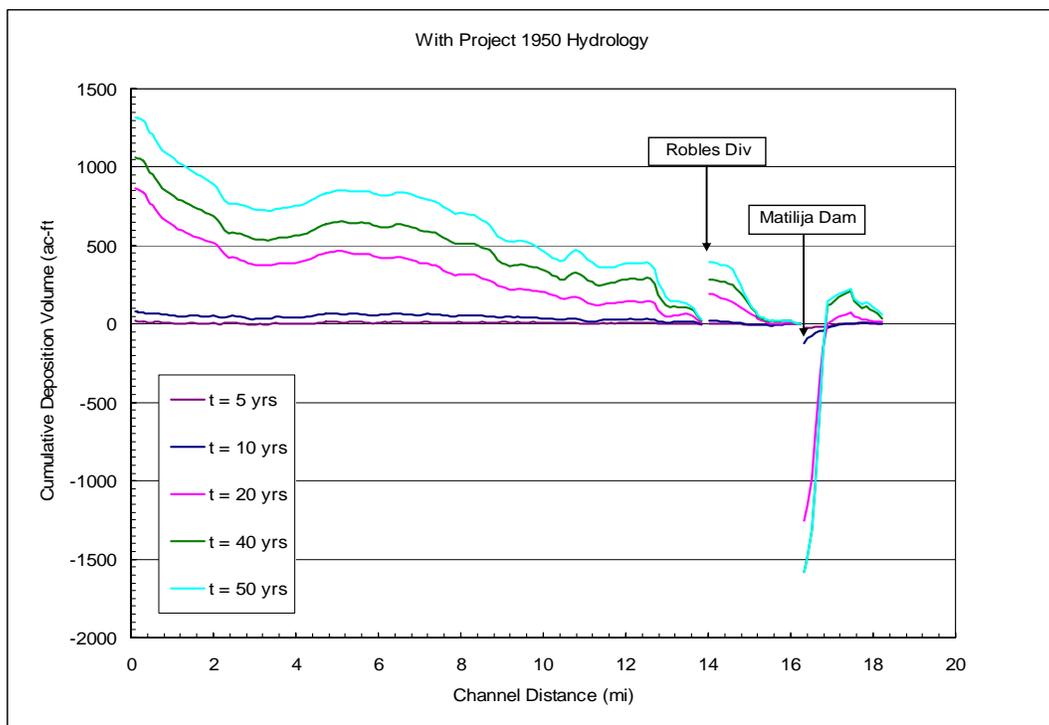
Figure 11.19. Cumulative Deposition for 1950 historical 50-yr hydrograph for With- Project Conditions.

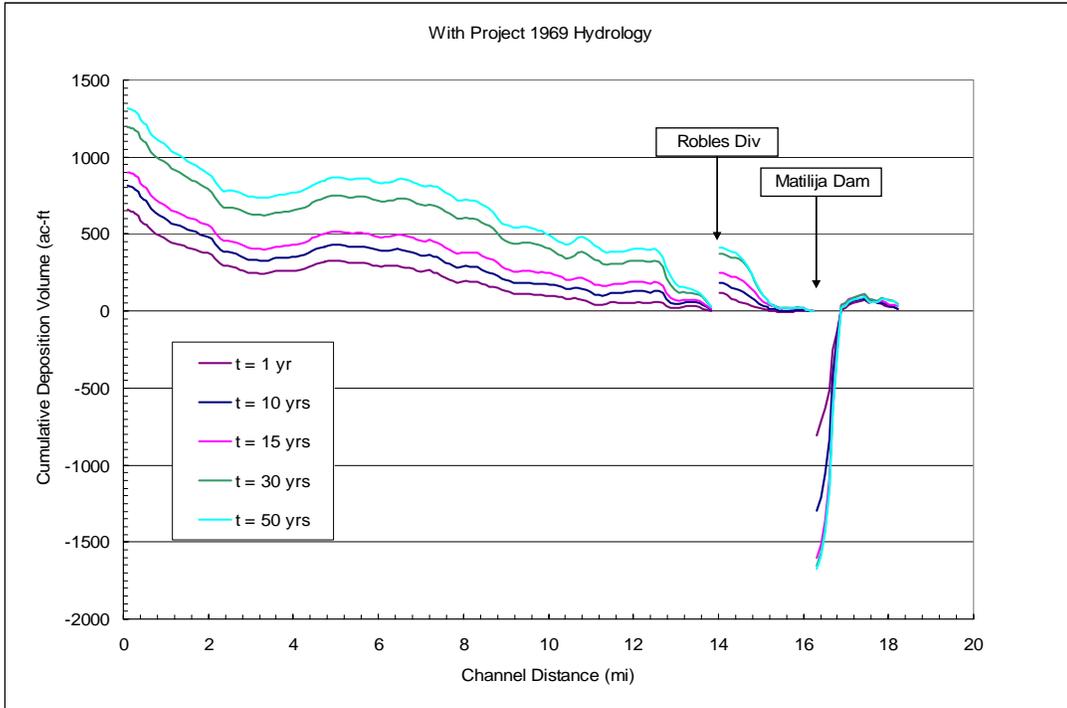
Figure 11.20. Cumulative Deposition for 1969 historical 50-yr hydrograph for With- Project Conditions.

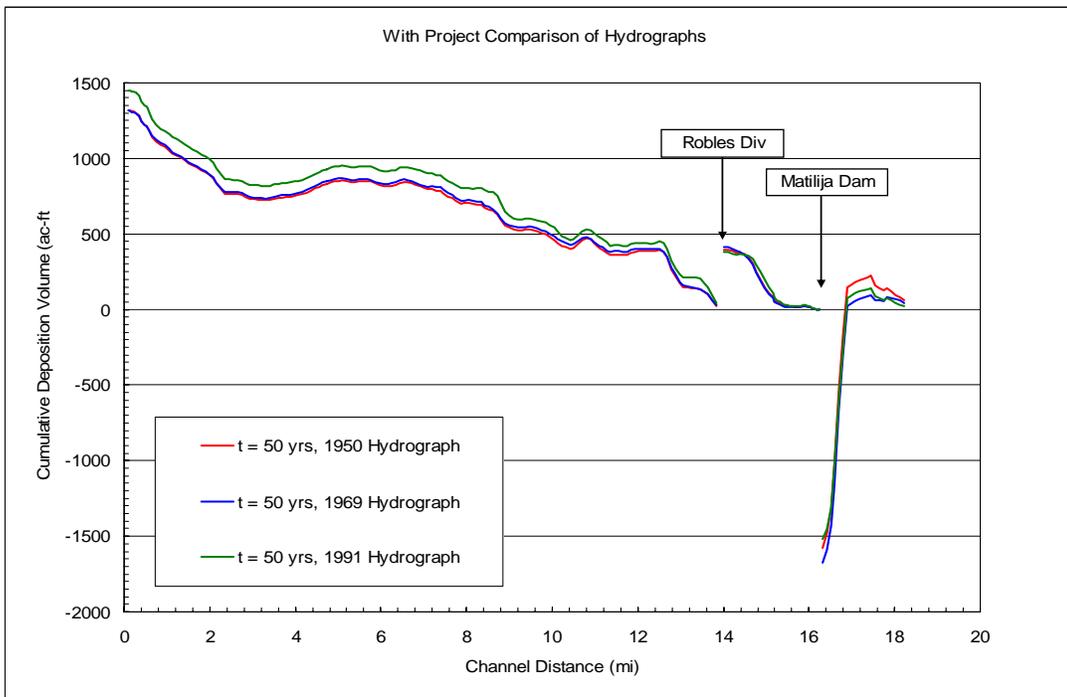
Figure 11.21. Cumulative Deposition in 50 years for With-Project Conditions for different hydrographs.

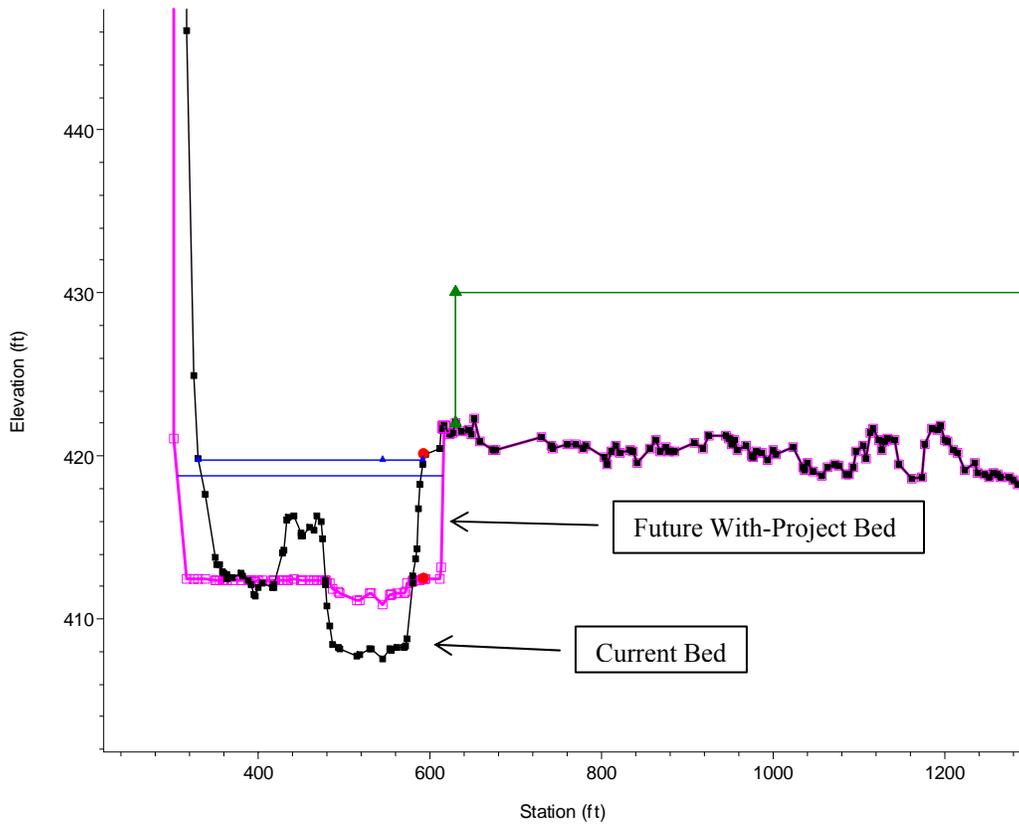
RS = 9.4697

Figure 11.22. Bed Elevation Changes upstream of Santa Ana Bridge under With-Project Conditions.

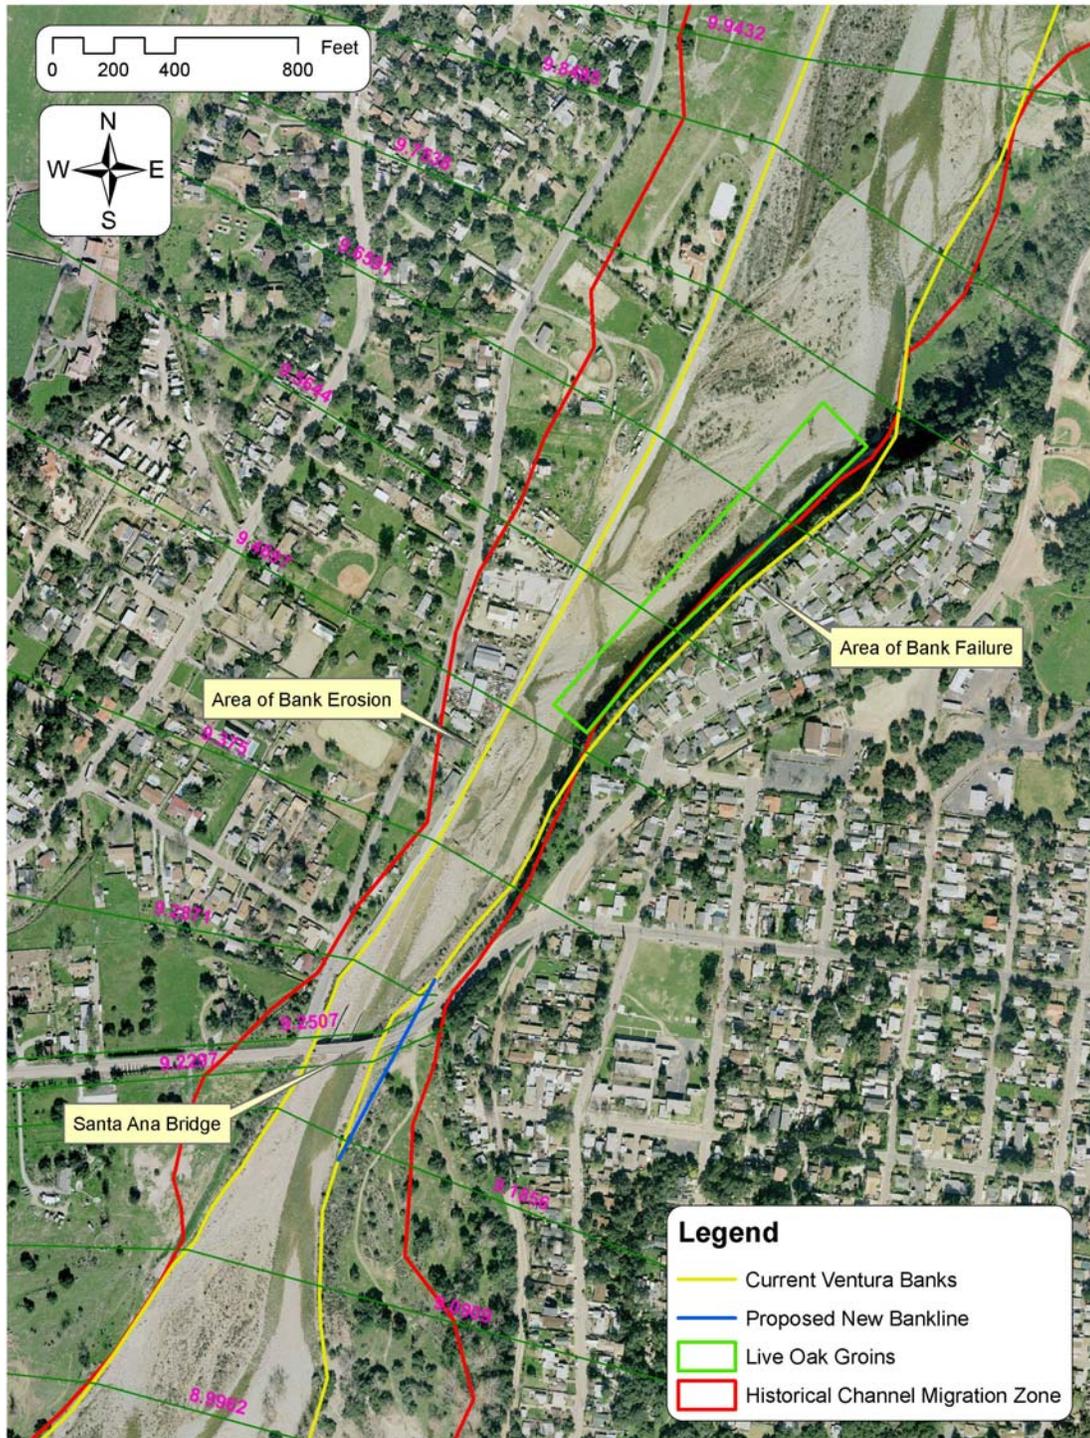
Figure 11.23. Proposed New Bank Link in Vicinity of Santa Ana Bridge. Groins Constructed in 2005 are also Shown.

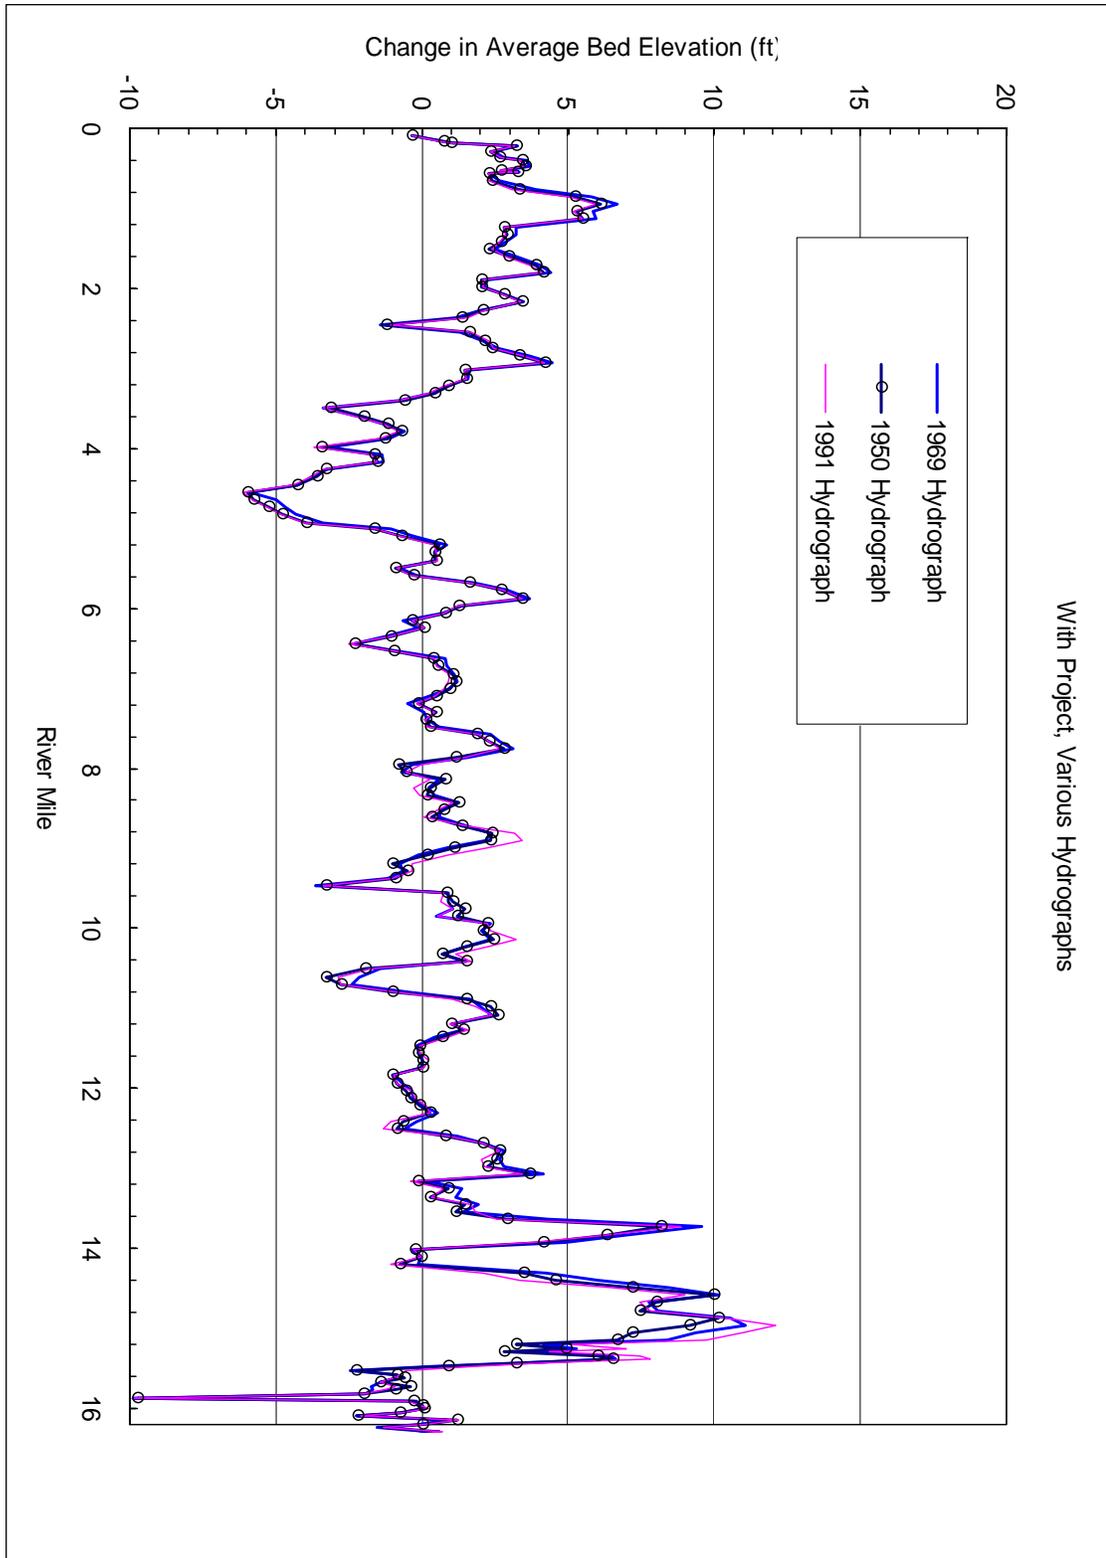
Figure 11.24. Average bed elevation changes at the end of the 50-yr simulations for the 1950, 1969, and 1991 50-yr hydrographs under With-Project Conditions.

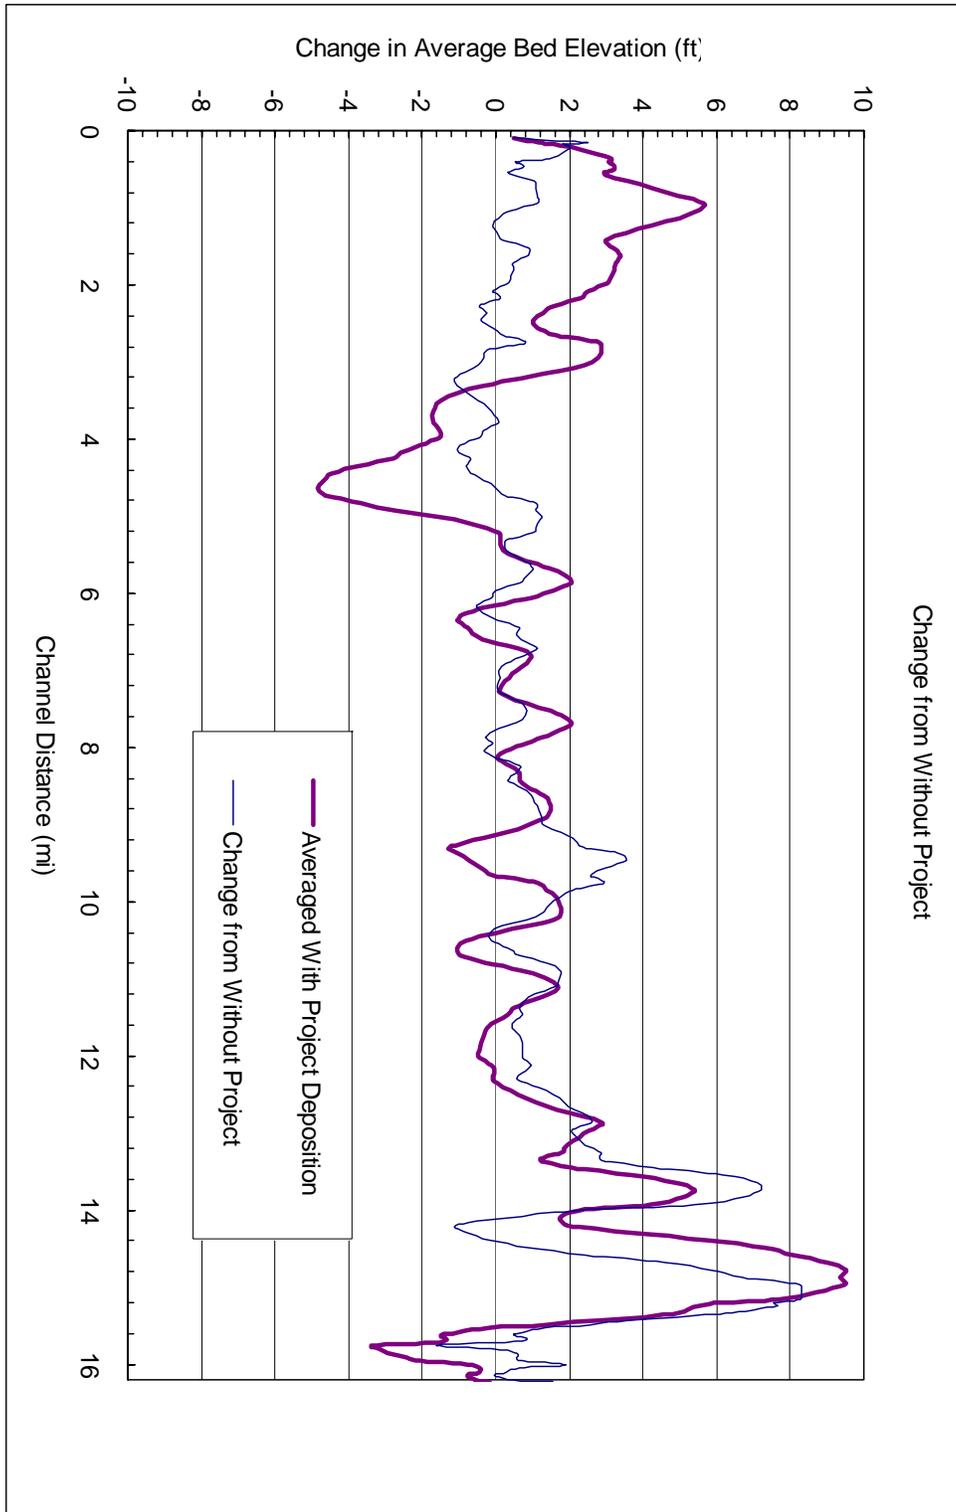
Figure 11.25. Average bed elevation changes at the end of the 50-yr simulations and a comparison with Without Project Future Conditions.

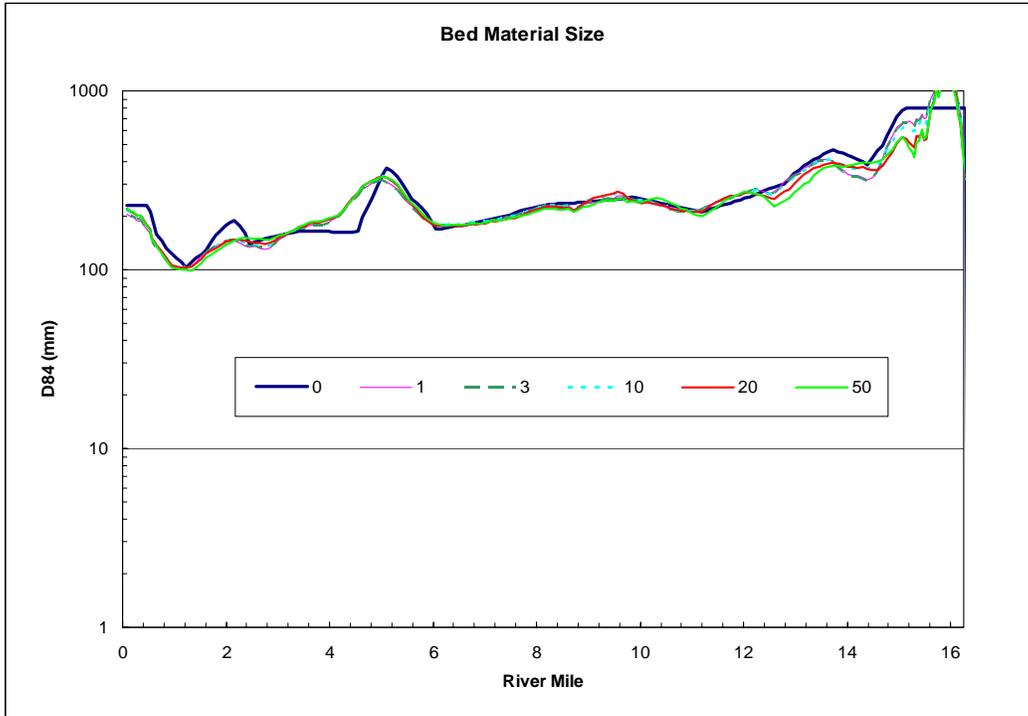
Figure 11.28. Bed Material Size following Dam Removal. D84 is the diameter of which 84% of the bed material is finer.

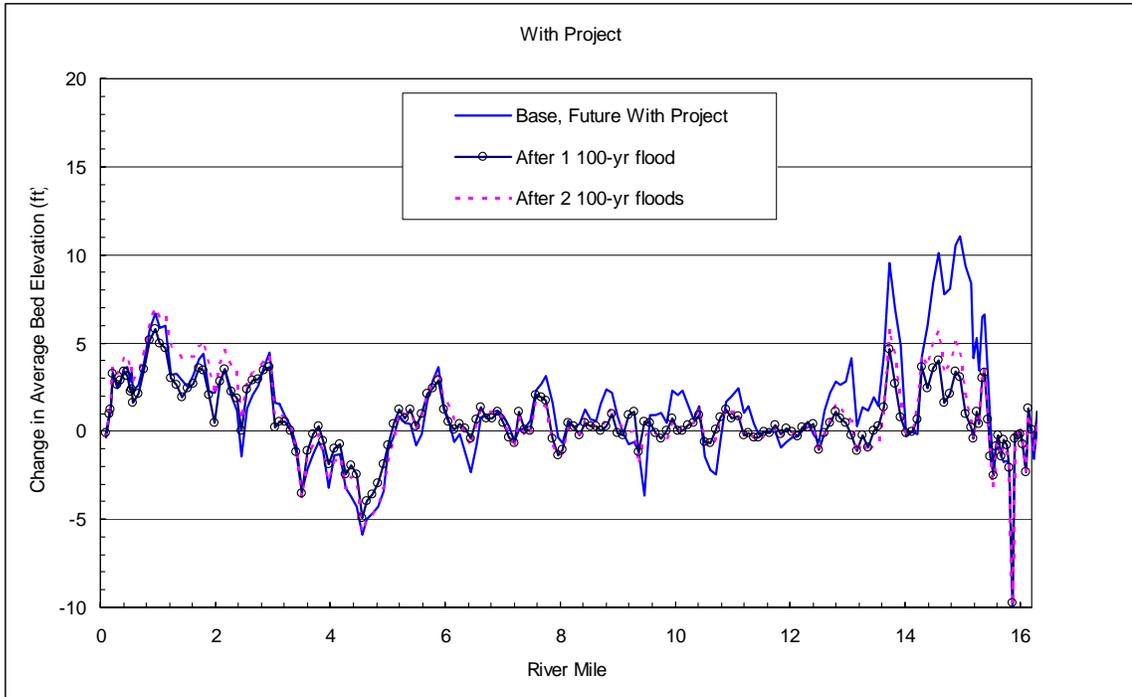
Figure 11.29. Average bed elevation changes at the end of the 100-yr storm and at the simulation end of the 1969 50-yr hydrograph.

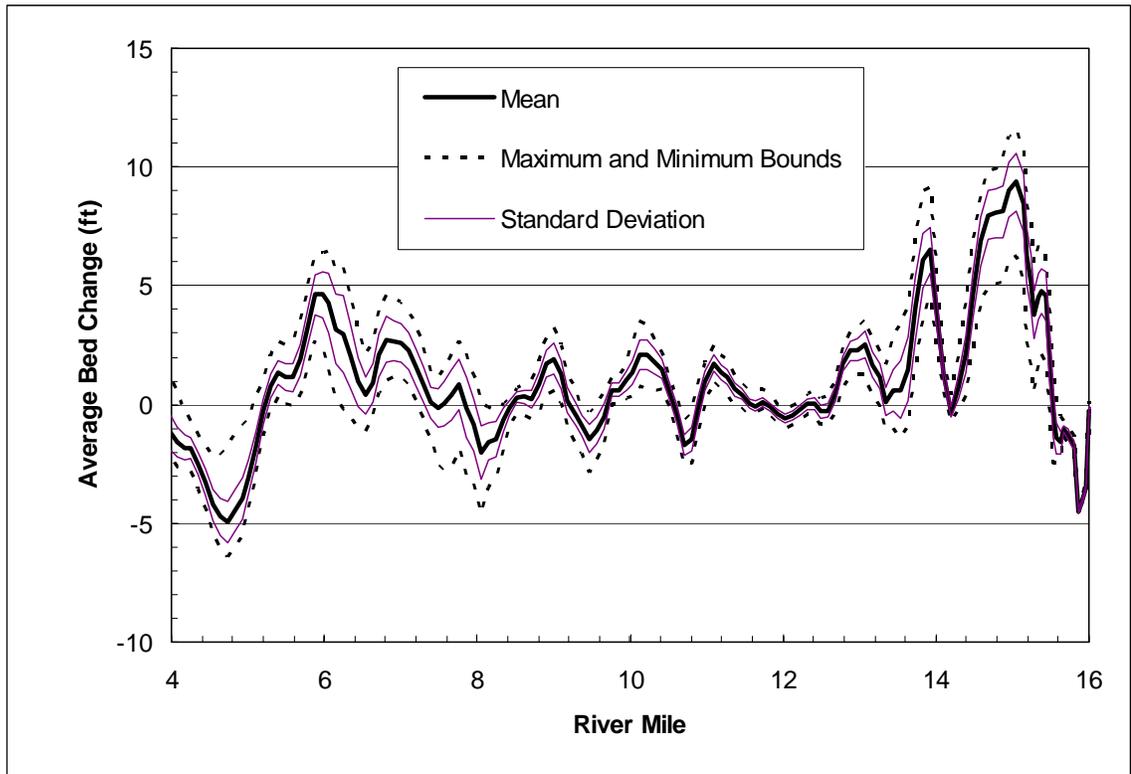
Figure 12.3. Average Bed Deposition for the Range of Stochastic 50-yr Hydrographs under With-Project Conditions

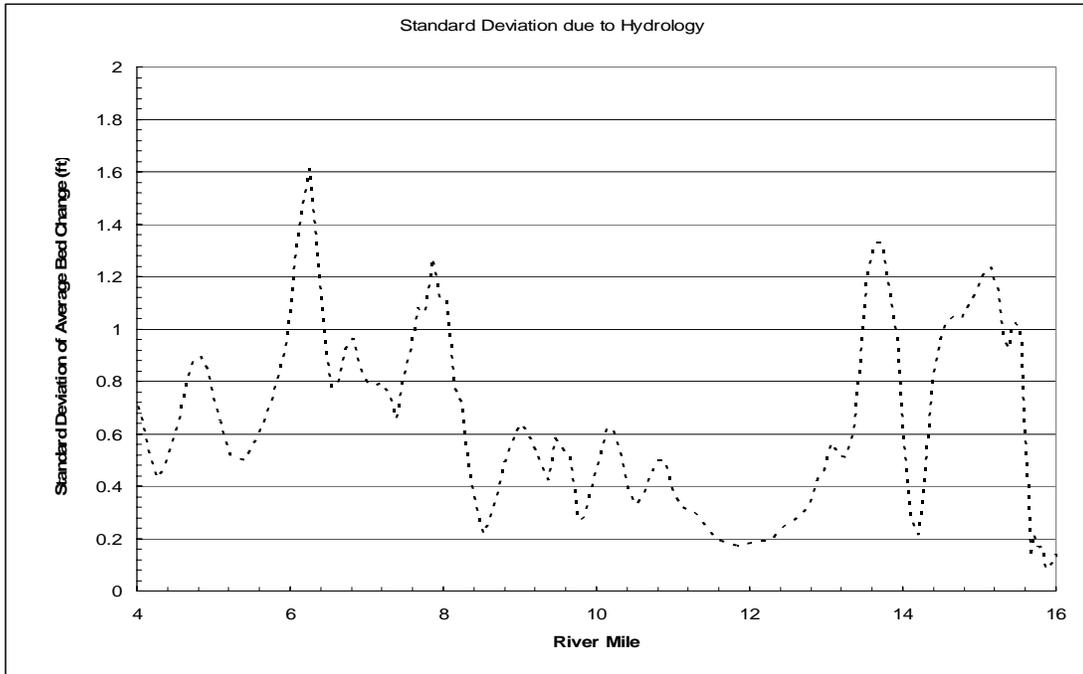
Figure 12.4. Standard Deviation in the Average Bed Elevation Changes due to Hydrologic Variability.

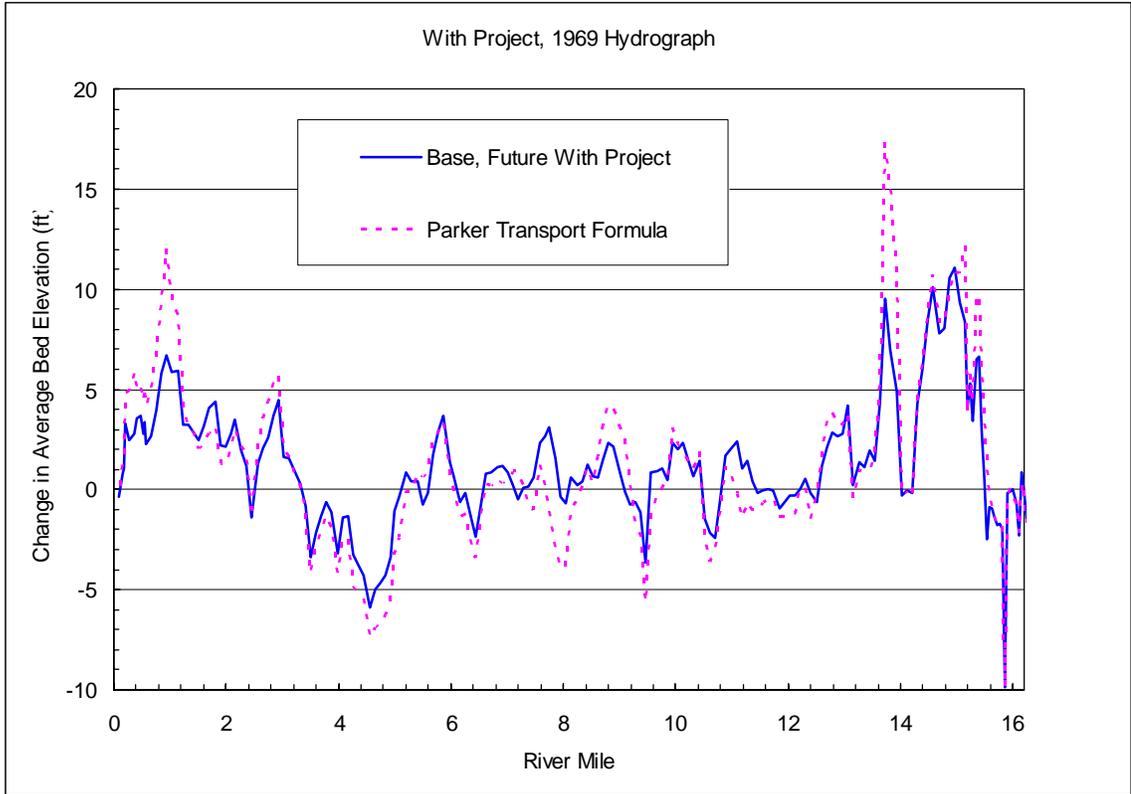
Figure 12.11. Affect of Transport Capacity Formula on Average Bed Elevations for 1969 Hydrograph.
