Arroyo Las Posas Stormwater Diversion Feasibility Study and Percolation Test

Craig Ulrich, Sebastian Uhlemann, Michelle Newcomer and
Peter Fiske

VENTURA COUNTY WATERWORKS DISTRICT NO. 1
MOORPARK

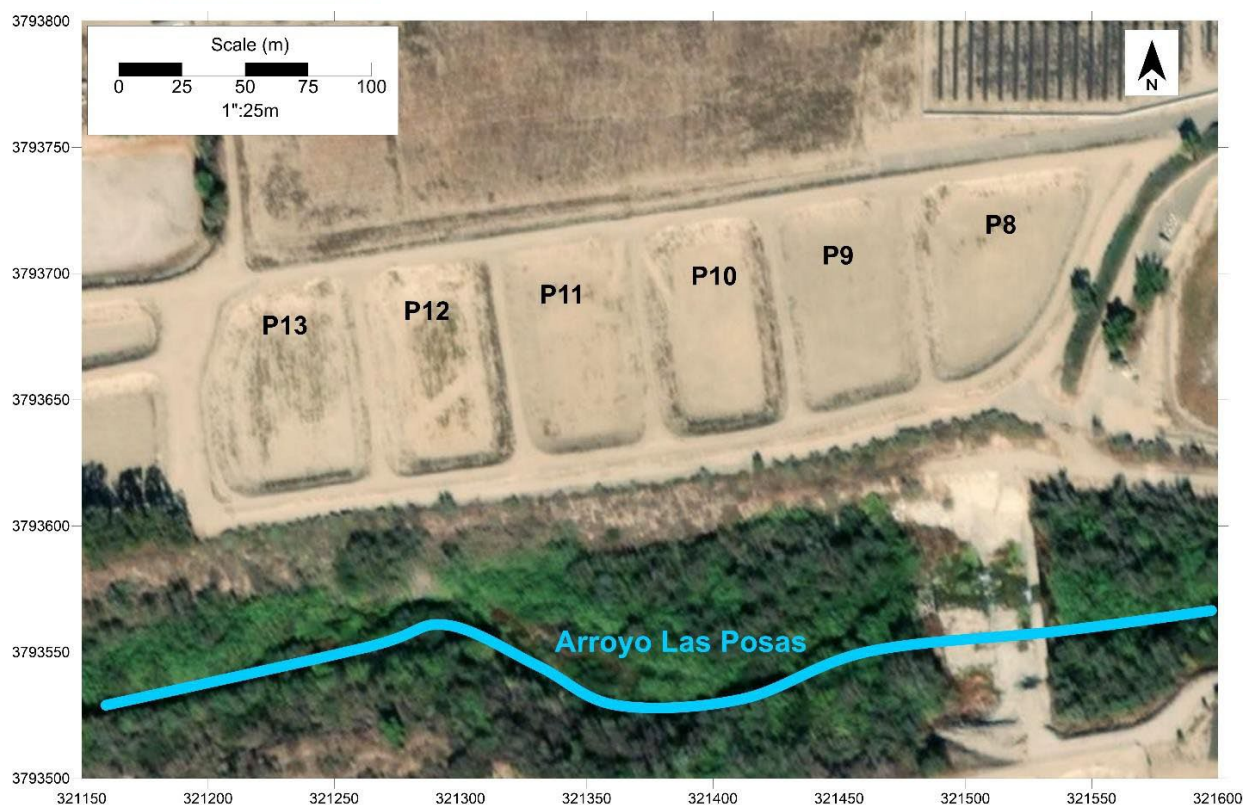
Figure 2. Moorpark Water Reclamation Facility showing Ponds (P) 8 – 13 that will be part of the Percolation Test study adjacent to the Arroyo Las Posas.

The study site is located at VCWWD's Moorpark Reclamation Facility (Facility) in Moorpark, CA (Figure 1). The Facility is located along the Arroyo Las Posas River in the Little Simi Valley between the Arroyo and East Los Angeles Avenue. The Facility contains approximately 32 percolation ponds of which six ponds (#8-13) were selected to be evaluated for the percolation experiment. The layout of ponds 8 – 13 are shown in Figure 2.

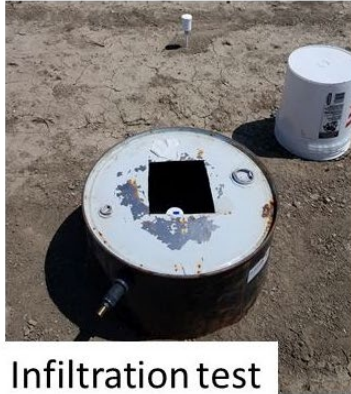
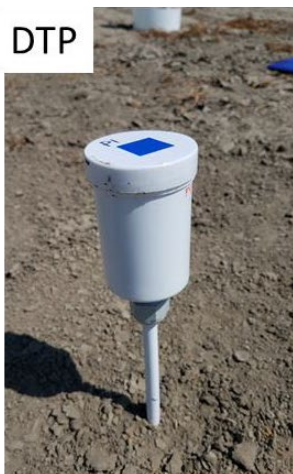
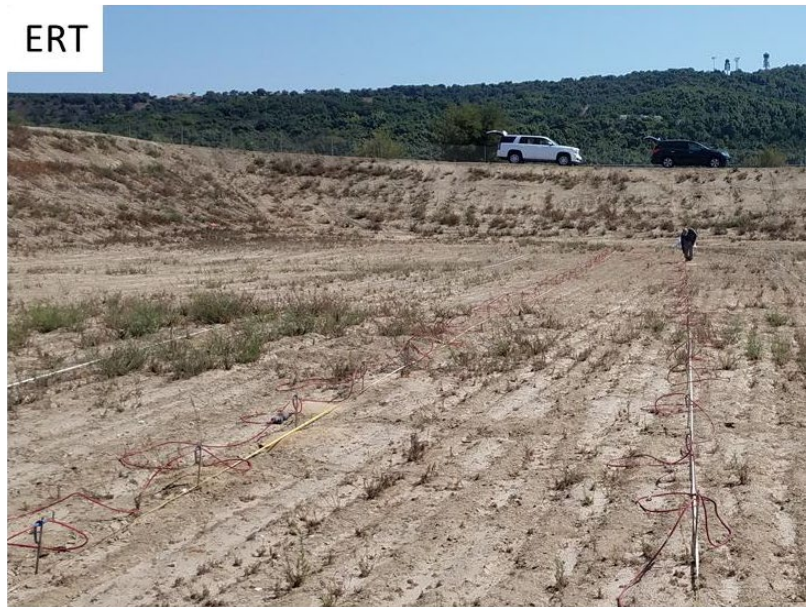
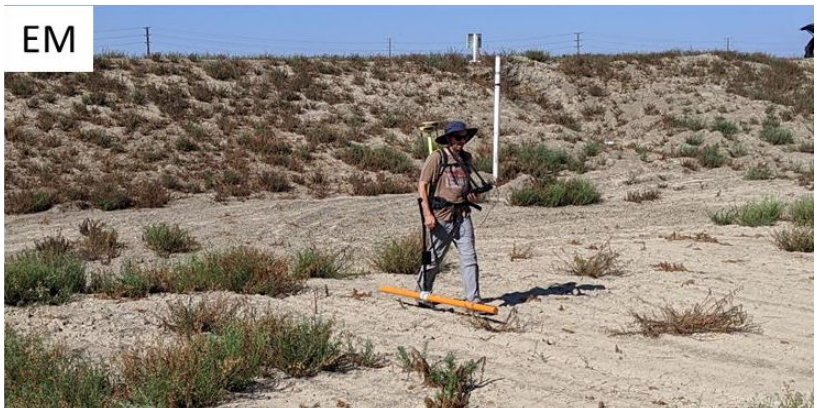
Figure 3. Characterization methods include EMI (EM photo), ERT, DTP, and modified seepage meters for infiltration tests.

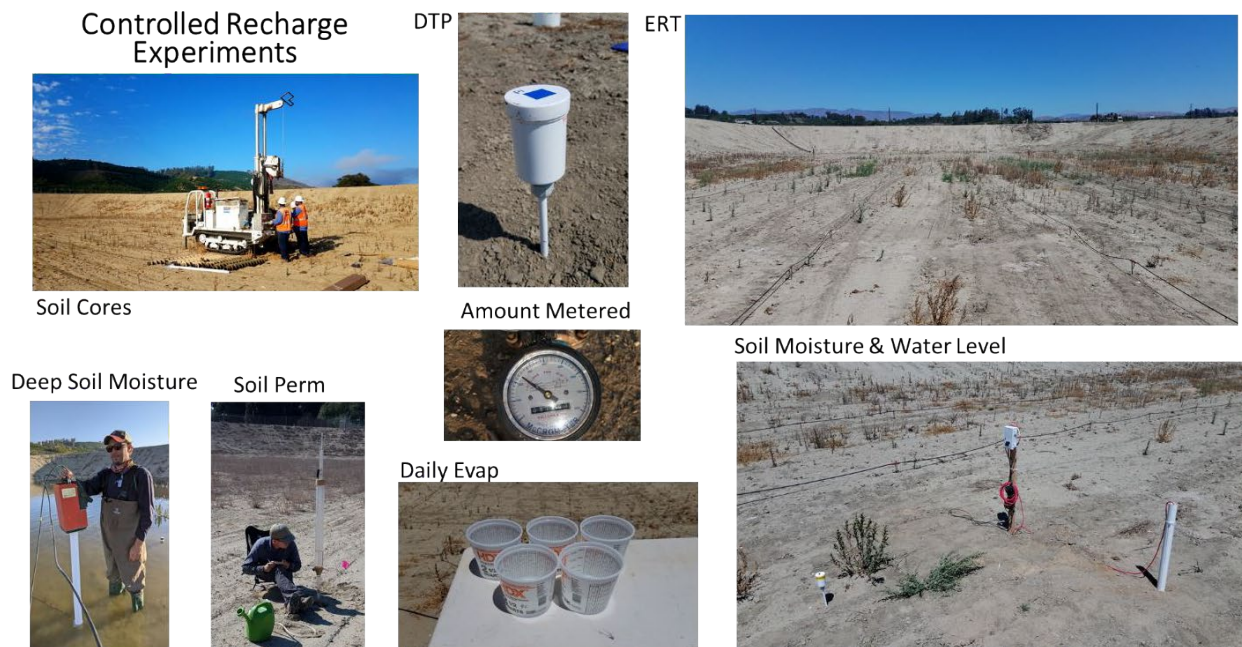
Figure 12. Recharge experiment methods.

The methods used during the Recharge Phase are highlighted in Figure 12 and some are described in the above Sections 1.3 and 3.1.1. Lessons learned from a previous recharge experiment indicated the need to accurately capture the amount of water applied to close the water budget to determine the amount of water infiltrated. Therefore, a flow meter was installed in-line with the piping to measure the amount of water applied on each pond and the evaporation rate was measured for all days at the site. To monitor and quantify recharge, 3D time-lapse ERT, DTPs, soil moisture sensing, and water elevation was collected in each pond before and during water application until after all the water had infiltrated. A single profile of ERT between the Arroyo and the ponds was collected to determine if infiltrated water was leaking back into the Arroyo, essentially short-circuiting. Soil moisture was measured with both METER shallow soil moisture sensors and deep soil moisture was measured with the InstroTek neutron probe.

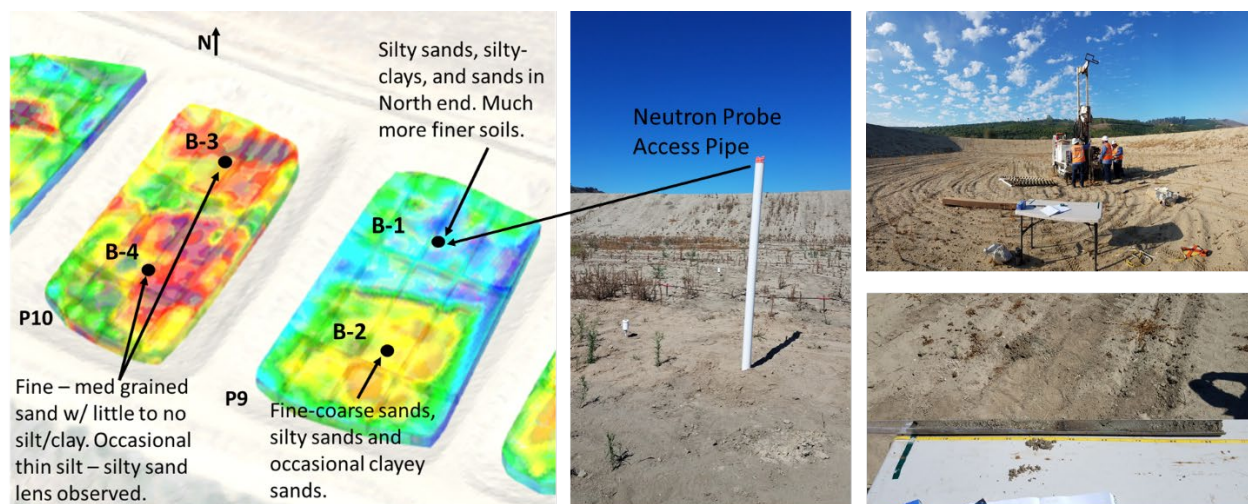
Figure 13. Soils were drilled to 15 m at four locations (B-1 to B-4) chosen from the EMI results. Pond 9 observed a mix of silty sands and clayey sands on the North end and sandy soils on the south end. Pond 10 observed primarily sands with little silt lenses. Examples of the drill rig and core are shown in pictures on the right. After the cores were drilled a PVC pipe was installed as an access pipe for soil moisture measurements with the neutron probe.

Examples of the drill rig and core are shown in pictures on the right of Figure 13. After all four boreholes were completed, solid 2-inch PVC pipe was installed in each borehole as an access pipe for the neutron probe soil moisture measurements (Figure 13, center photo).

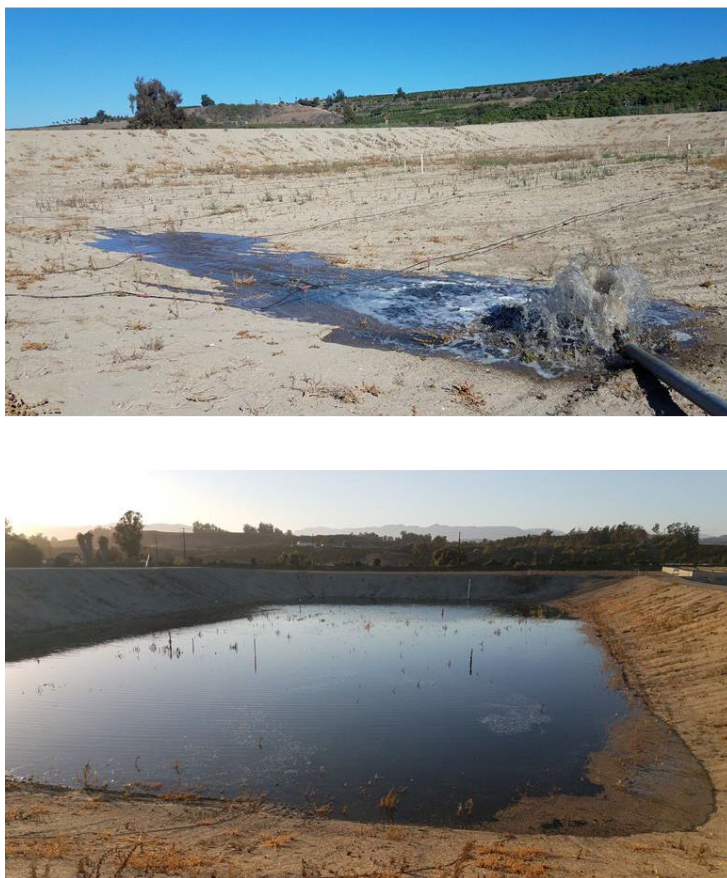
Pond 9 = 230k gallons (0.85 AF)

Figure 14. Pond 9 water application of 230k gallons (0.85 AF) at start (top) and after full (bottom).

Pond 9 was inundated with 230k gallons (0.85 AF) of water (Figure 14). The background ERT dataset was collected prior to any water application for time-lapse comparison (Figure 15, Background Model). As water flowed into the pond from the northwest corner it followed the microtopography across the pond (clockwise) resulting in uneven water application until the pond was completely covered (shown in a composite move at the link above). The time since the start of water application is shown in the bottom left of each image in Figure 15 and the percent change in resistivity ranges from +50% to -50%, with a negative change representing the soil becoming more saturated (decrease in resistivity). In the northwest corner at +6.9 hours no appreciable infiltration is observed in the clayey soils adjacent to the pipe outlet, but other preferential fast flow paths are starting to be observed. At +21.9 hours the pond is completely full and fairly uniform infiltration is observed except in the northern clayey area. The pump was stopped at 24 hours and the ERT captures the bulk of the water moving deeper into the subsurface through the sandier soils in the southern end of the pond (Figure 15, +40.9 hours). After +63 hours, deep infiltration in the southern end of the pond is observed to depths over 15 m. Conversely, the clayey soil zone in northwest corner has yet to infiltrate water (Figure 15, +63 hours). These results highlight infiltration controlled by preferential flow through the coarser sediments and detrimental effects on recharge from fine-grained soils.

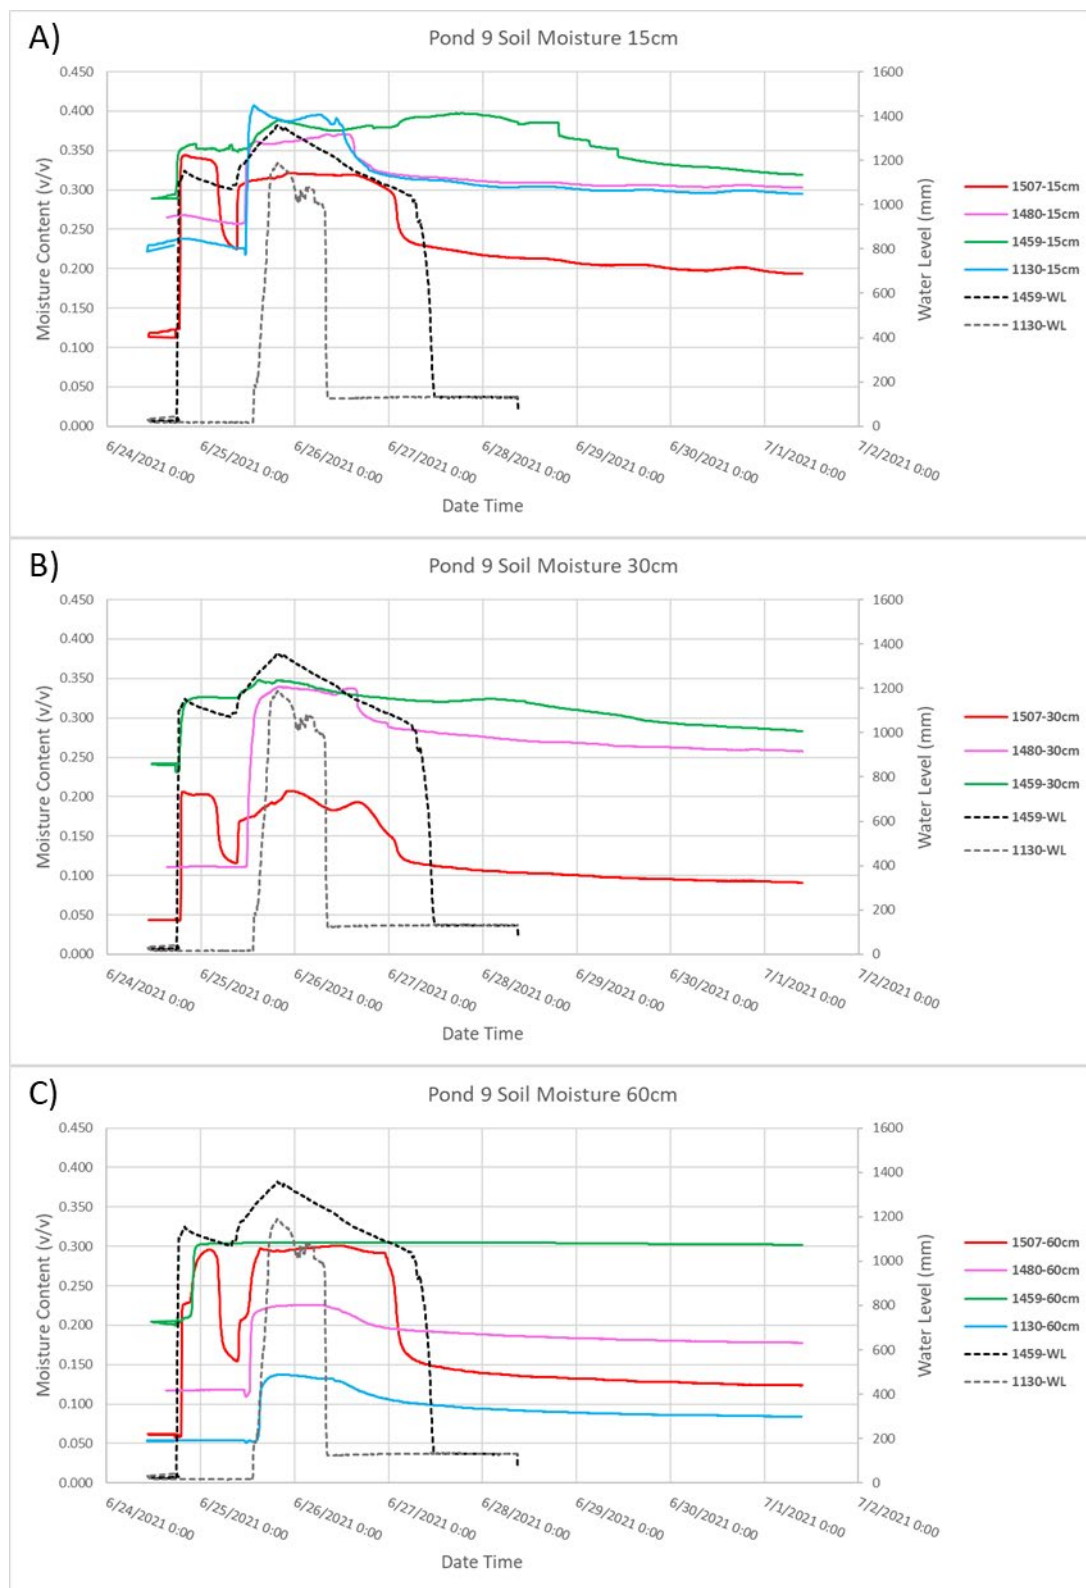
Figure 19. Shows the Pond 9 soil volumetric soil moisture responses at A) 15cm depth, B) 30cm depth, and C) 60cm depth. On the secondary axis is the water levels at two locations.

19). All sensors continued to monitor soil moisture levels for days after Pond 9 had emptied, these soil moisture values beyond June 28th give us an idea of the field capacity of these soils and insight about when the next water application could occur since all soils had drained. These results also highlight the infiltration complexity in different soil types and that most infiltration happens through preferential flow paths controlled by sandy soils. These soil moisture curves can also provide information the porosity of the sediments, after the soil moisture initial increase and all of the soil moisture curves become constant over time. If we assume that during that the plateaued (flat max) part of the curve represents full saturation of the soils then the water content is equal to the porosity. Following this logic, the soils in Pond 9 range in porosity from 30 – 40% for the sandy soils. In some cases, the curves in Figure 19 do not stay constant for very long and those should not be used to estimate the porosity.

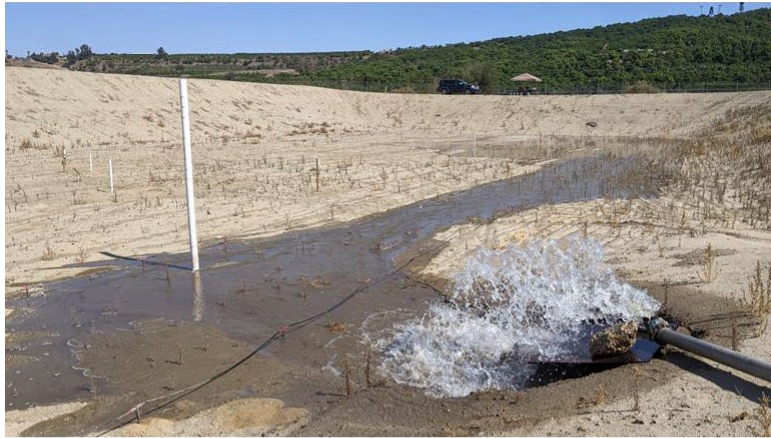
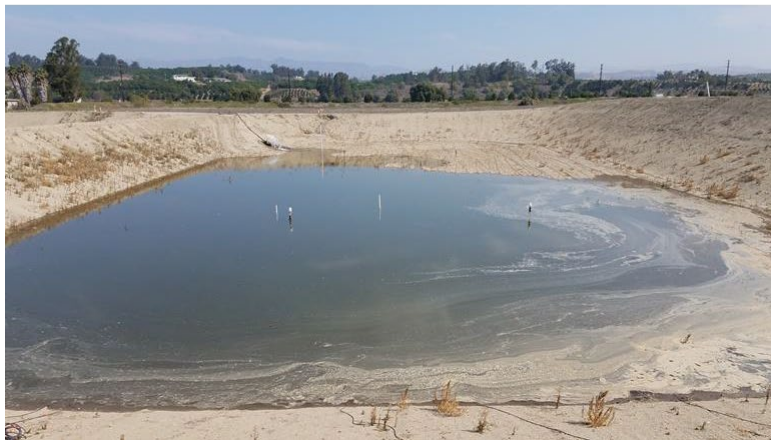
Figure 21. The filling of Pond 10 with 407k gallons (1.5 AF). The pond was never filled due to the high infiltration rates that were similar to the pump outflow rates.
