Hydraulic Laboratory Report HL-2008-07

**Robles Diversion Dam
High Flow and Sediment Bypass
Structure
Ventura, California**

Physical Model Study

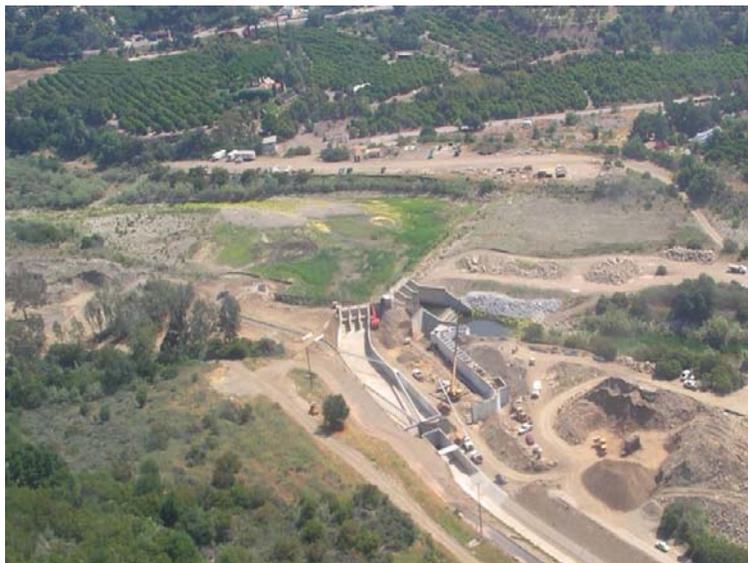
Figure 1 - View of Robles Diversion Dam from above the right bank.

Robles diversion dam is located on the Ventura River near Ventura, California at approximately river mile (RM) 14.16 (figure 1). The diversion supplies water to Lake Casitas by canal. The normal maximum diversion is approximately 500 ft³/s. The existing diversion dam is a low rock weir with a gated spillway, canal diversion headworks and a fish pass located on the right abutment. The diversion weir has a hydraulic height of 13 feet. The fish pass was constructed in 2002 to allow southern California steelhead (*Oncorhynchus mykiss*), a listed species, to migrate upstream of the diversion dam.

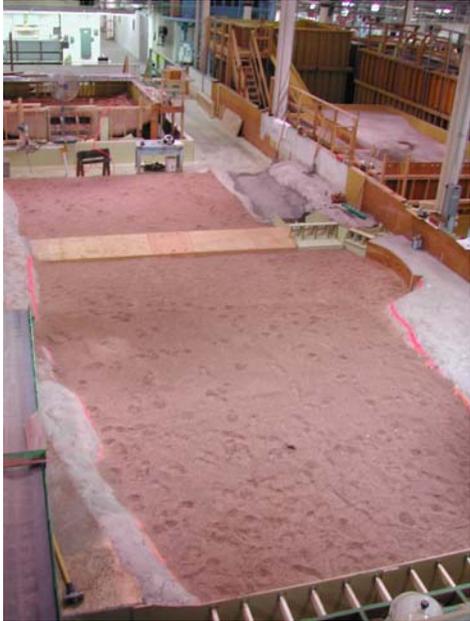
A 1:20 Froude-scale physical model of the river and diversion dam facility was constructed at the WRRL (figure 3). The model was constructed using NAVD 1988

Figure 3 – View of 1:20 scale moveable-bed model of Robles diversion Dam.

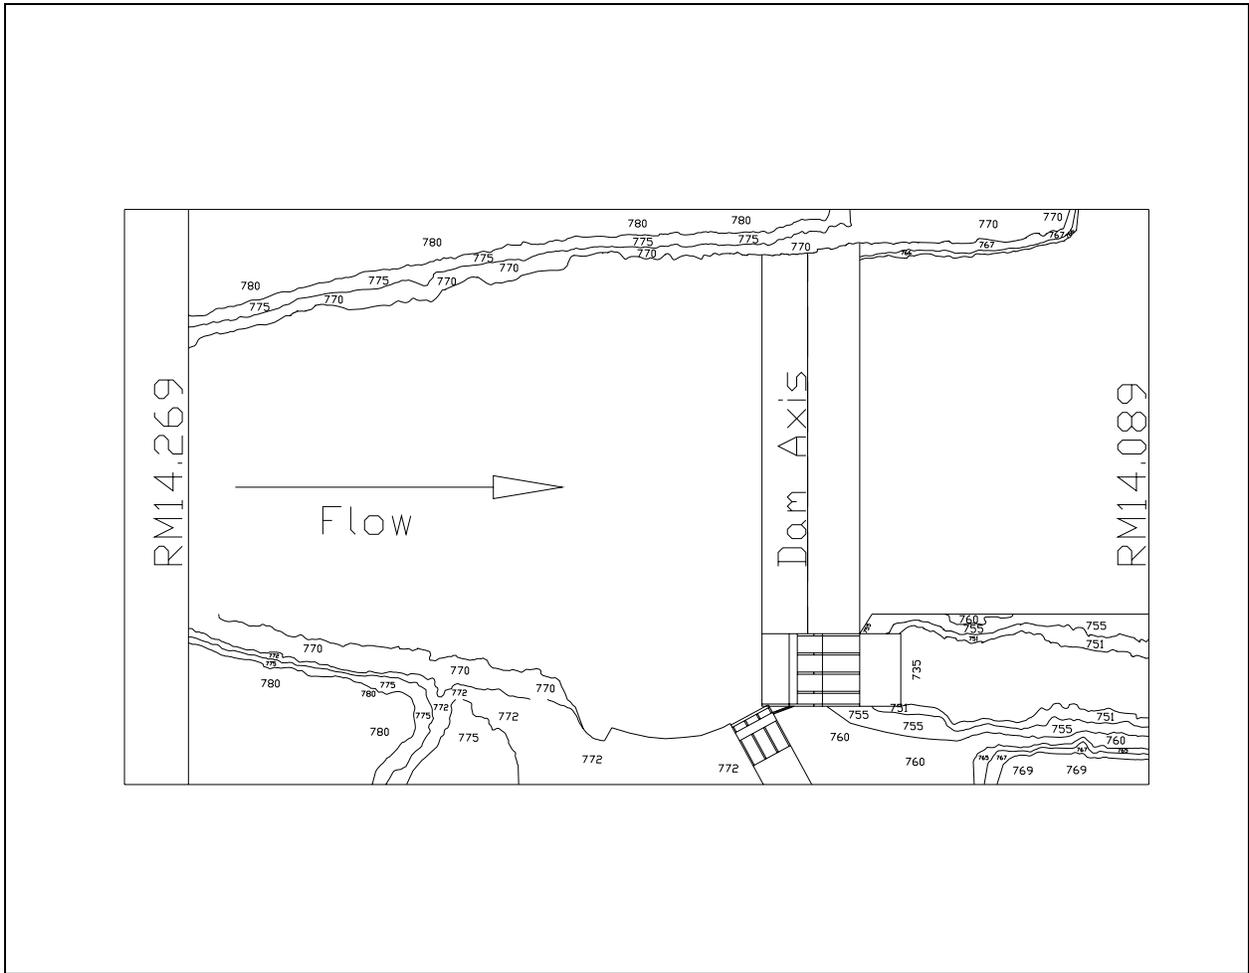
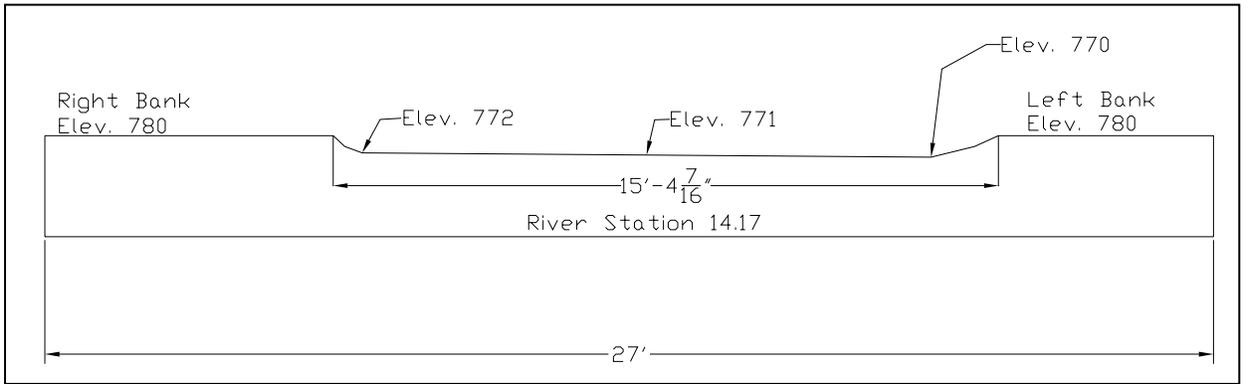
reference for the prototype. This resulted in a vertical datum increase of 2.25 ft from the original structure design drawings. The extent of the model is shown in figure 4. River stationing referenced in this report is based on stationing established by the Corp of Engineers HEC-RAS flood plain modeling conducted as part of the dam removal project. The model represented the bankfull river channel from 575 ft upstream of the dam crest to 325 ft downstream of the crest. Generally, topography between elevations 750 and 780 ft was modeled. The river channel was modeled from LIDAR topography collected in March 2005. The channel upstream of the diversion dam was modeled with a moveable bed. The channel banks and downstream channel were modeled as non-erodible. The area within the diversion pool upstream of the dam was modeled as a plain bed of constant slope in the streamwise direction. The model topography allowed river flows up to approximately the ten-year flood of 14,000 ft³/s to be modeled. Downstream of the dam the channel topography within the model was configured to a constructed channel that conveyed river flow from the dam and spillways to the downstream river channel.

Figure 4 - Plan view of model and section showing model upstream boundary weir.

Flow was provided to the model from a permanent laboratory pump and water measurement facility. Model discharge was measured using laboratory venturi meters. At the head of the model, flow entered a model headbox where it passed through a gravel baffle diffuser and over a fixed weir, (figure 4 - section). Flow distribution across the upstream weir was checked against velocity distributions from 2-dimensional numerical modeling results that included the influence of upstream channel geometry,(7). Model velocity measurements were obtained using a 2-directional acoustic velocity current meter manufactured by Sontek Corporation. Sediment was added to the flow downstream of the headbox using two 8-ft-long sand augers with 0.75- inch-high horizontal paddles for sediment injection. A gear motor was connected to the axle of each hopper to control the feed rate. Sediment added at the upstream end of the model either deposited within the model topography or moved through the model and was trapped in a downstream settling basin. Approximately six cubic yards of sediment was processed for each model test to obtain a particle gradation that scaled similar to the prototype. After each test, material deposited in the model and in the settling basin was collected and reused in subsequent tests. Prior to each test baseline topography within the channel upstream of the diversion dam was re-established. A straight screed was used to achieve a constant slope from the upstream weir (~elevation 770) to elevation 755.5 at the upstream toe of the diversion dam (figure 9). Water-surface elevations were measured using surface-mounted point gages located near the existing fishway exit, upstream and adjacent to the to the dam left of the spillway, 200 ft (prototype) downstream of the dam axis in the spillway channel and in the diversion canal. Additional tailwater control above that provided by downstream model topography was not necessary due to the steep gradient of the channel.

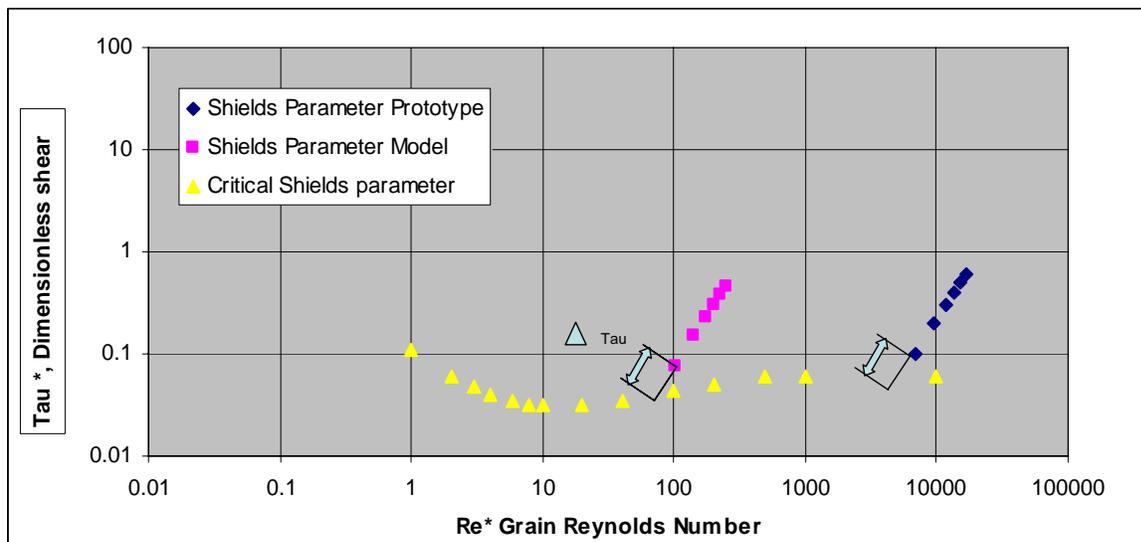
Sediment Modeling - Modeling sediment movement adds complexity to the modeling process and often requires distortion of some model and sediment properties. The riverbed slope, sediment size and specific gravity may require distortion to achieve similarity of sediment transport. Analytic techniques for estimating sediment transport were used to determine distortion ratios and appropriate modeling methods. To achieve similarity of bed load transport between model and prototype the difference of the Shields parameter to the critical Shields parameter should be the same in the model and prototype, (1,5). The Shields parameter, $\tau_o / (\gamma_s - \gamma) D_s$, is the ratio of bed shear force to gravity forces (τ_o = shear stress, $(\gamma_s - \gamma)$ = submerged specific weight of sediment, D_s = particle diameter). The critical Shields parameter, $\tau_c / (\gamma_s - \gamma) D_s$, defines the point of incipient motion of bed material. Sediment scaling can be expressed on a Shield's diagram by plotting dimensionless shear versus the particle Reynolds number for model and prototype material (figure 5). The plot presents bed material scaling for a given particle size covering a range of hydraulic radii typical of the river channel. Similarity of sediment movement is achieved when $\Delta \tau$ (τ) is similar for model and prototype. Similarity of sediment deposition is achieved by similarity of particle settling velocity (1,5). Settling velocity is a function of both particle diameter and density.

Figure 5 – Model and prototype critical shear relationship for sediment.

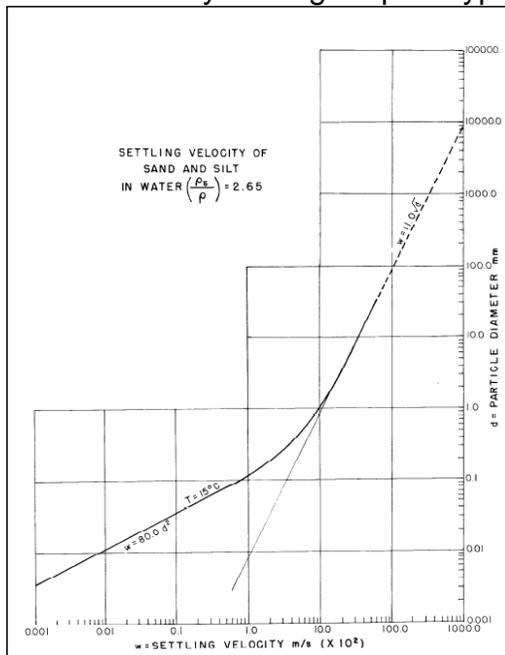
For granitic sand, settling velocity of particles greater than about 1 mm diameter is related to the $D_s^{1/2}$ (figure 6). Therefore, scaling of particle settling velocity in the model follows velocity scaling for prototype particles that scale greater than 1mm diameter.

Figure 6 - Settling velocity for sand particles in water.

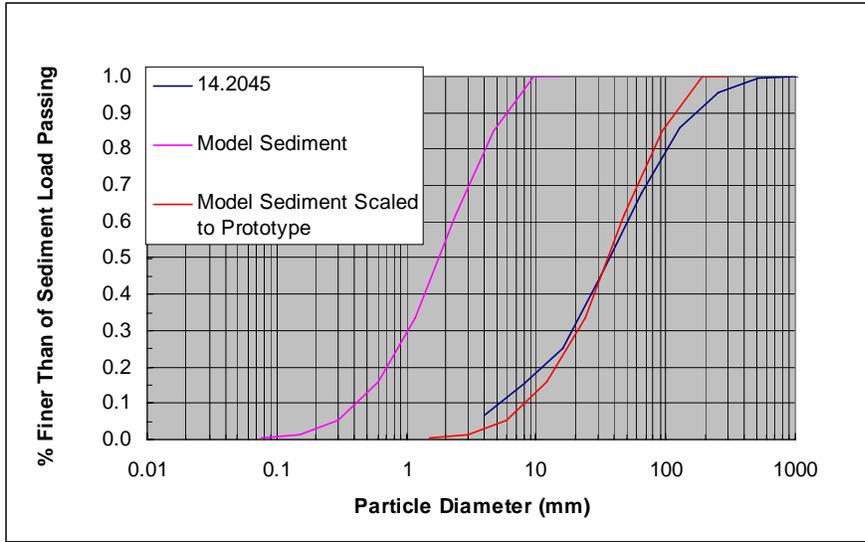
River Sediment - The type of material used in the model to represent prototype sediment depends on model scale, hydraulic characteristics of the channel reach and the type and gradation of sediment found in the river. Estimates of the reservoir sediment supply and gradation are given in the Matilija Dam Removal Appraisal Report (4). Sediment sampling of reservoir deposits found approximately 57 percent of the sediments are sand and 13 percent of the sediments are gravels and cobbles. The remaining 30 percent is silt and clay that will be largely carried in suspension. Silt and clay material was not represented in the model. The sediment size gradation used for the prototype is given in figure 7.

Figure 7 - Comparison of model and prototype bed material gradation.

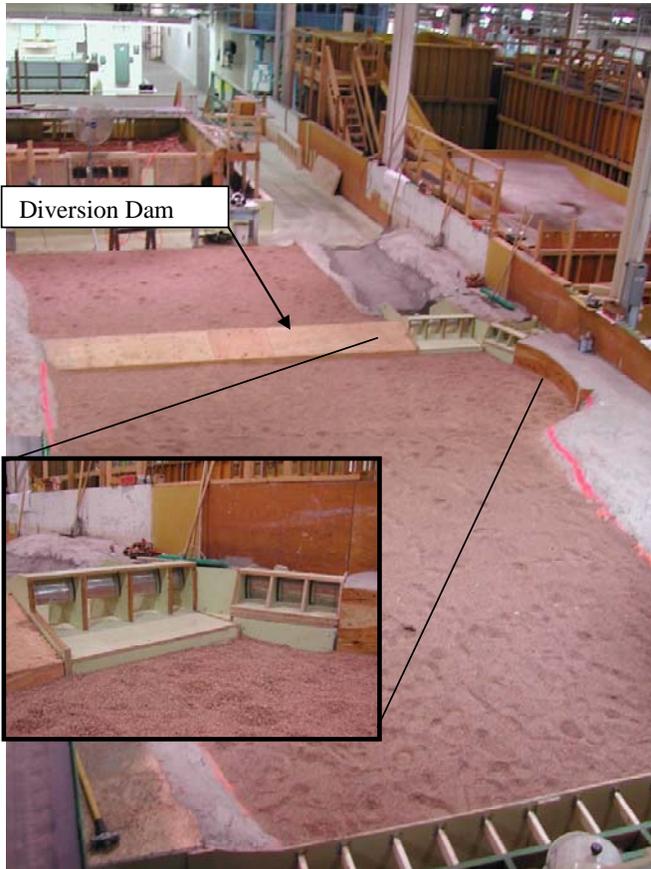
The existing diversion facility includes canal headworks, invert elevation 762.75, with three-10-ft-wide bays controlled by 8-ft-high radial gates. A gated spillway is located adjacent and to the left of the canal headworks. The spillway referred to herein as the service spillway, has one 10-ft-wide bay and three, 16-ft-wide bays controlled by 10-ft-high radial gates. The upstream apron of the service spillway is set 5 ft lower than the canal upstream apron to facilitate sluicing sediment away from the canal entrance. An incised channel extends downstream of the spillway approximately 1,000 ft before merging with the natural channel. A fishway entrance is located on the right bank near the toe of the spillway apron. The downstream spillway channel contains several rock weirs that provide improved flow conditions for upstream migrating fish. The diversion dam is an ungrouted rock structure with a wooden center cutoff wall. River flows greater than about 6,000 ft³/s exceed the spillway capacity and overtop the rock dam. Significant overtopping has historically resulted in erosion of the downstream dam slope and downstream channel. The canal headworks, spillway, downstream spillway channel and diversion dam were included in the physical model (figure 8). Fish screen facilities and fishway are located off channel and were not included in this study. The diversion dam was modeled as a fixed, non-erodible structure.

Figure 8 - View of the service spillway and canal headworks looking downstream.

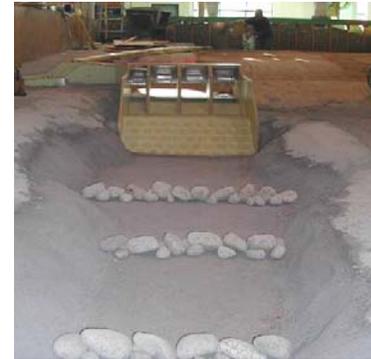
View looking upstream at service spillway discharge channel.

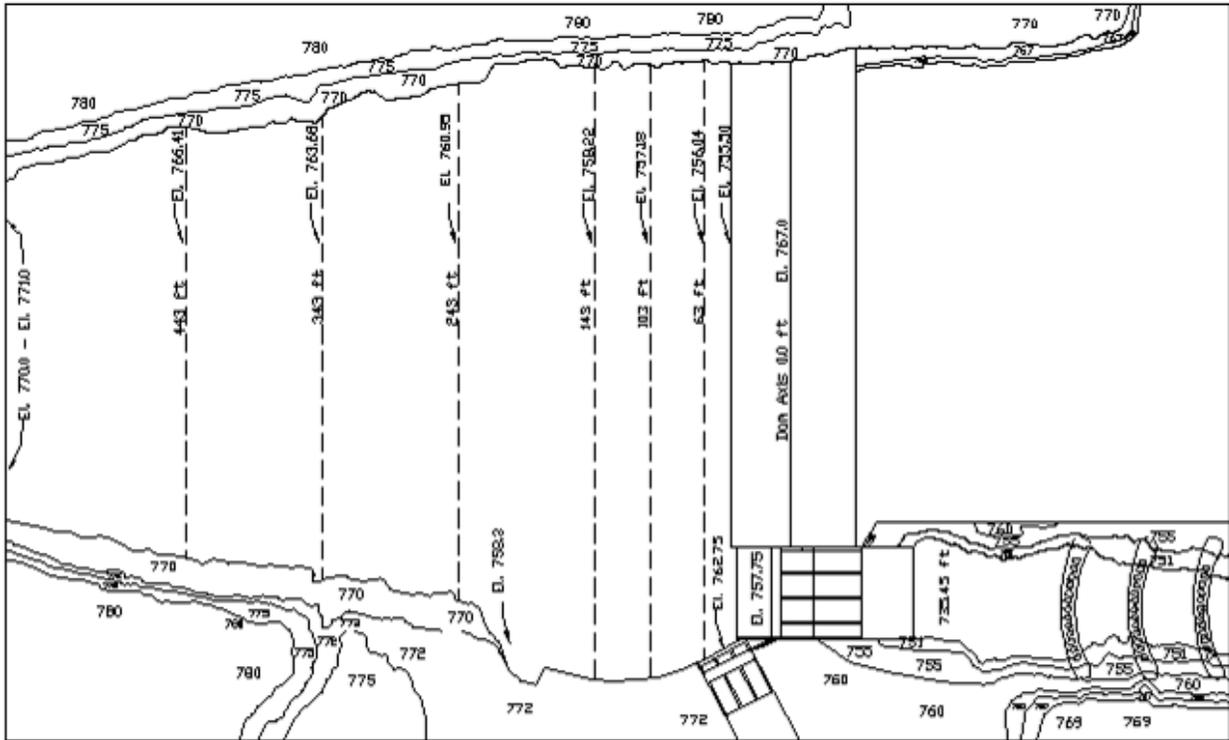
Figure 9 - Pretest channel bed topography.

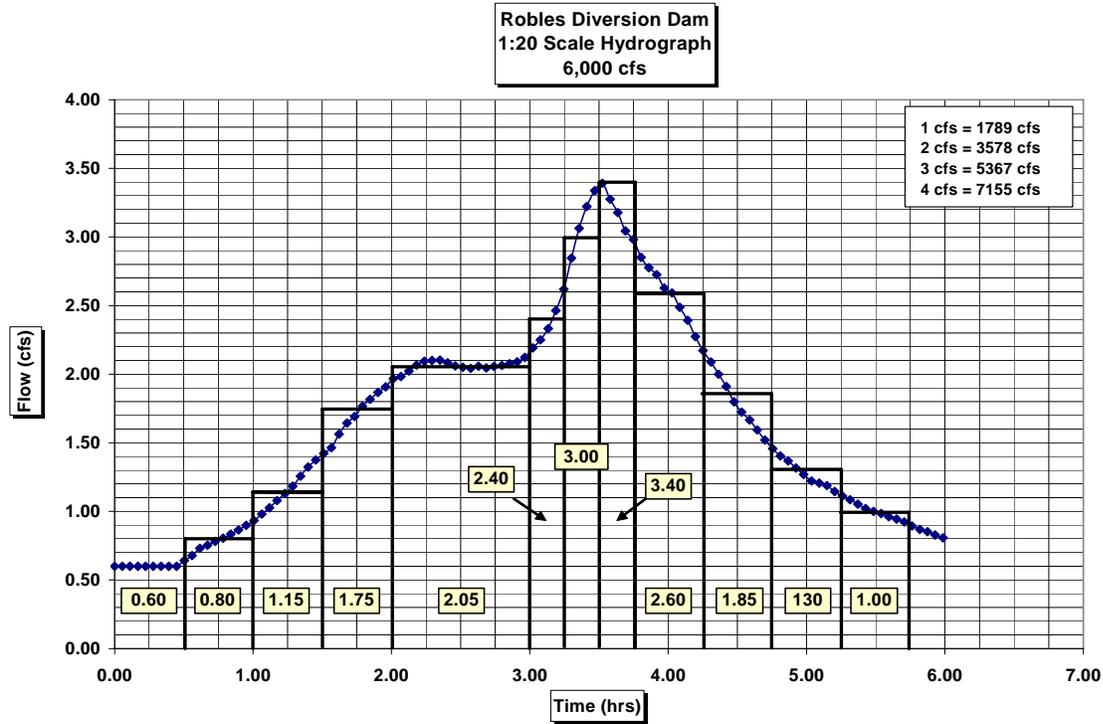
Simulated Flood Hydrographs - Tests were conducted to evaluate sediment movement and canal entrainment for simulated flood hydrographs with peak discharges of 6,000 ft³/s and 14,000 ft³/s. A 6,000 ft³/s peak flow is approximately a two-year return flood and a 14,000 ft³/s peak approximately a ten-year return flood. Hydrographs were developed for each flow by using historic events of similar peak flow from average daily flow records. Prototype hydrographs were scaled to model flow and duration, (figures 10 and 11). Discharge values corresponding to one-half-hour time increments model were then selected from model hydrographs and used during testing. In the physical model, prototype hydrographs were truncated at a flow of about 2000 ft³/s, below which numerical sediment routing analysis predicts relatively small bed load transport (4).

Figure 10 - Scaled 6,000 ft³/s peak-flow hydrograph.

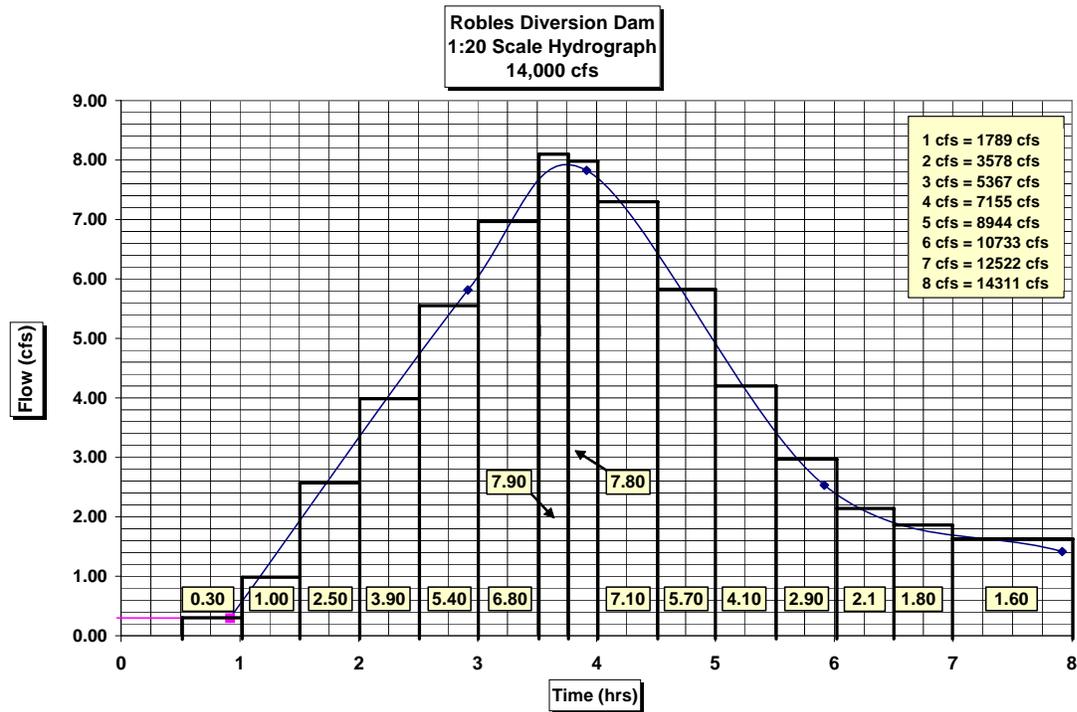
Figure 11 - Scaled 14,000 ft³/s peak-flow hydrograph.

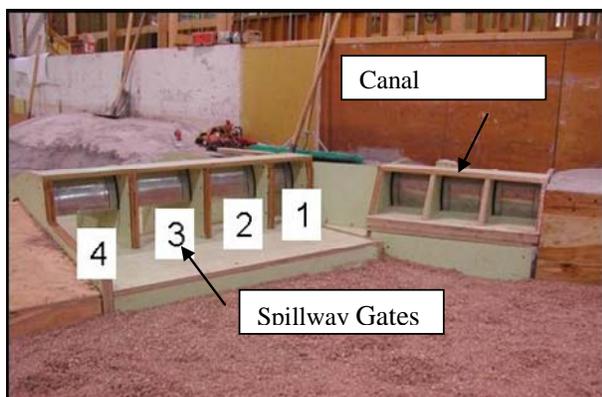
Tests were conducted for the two-year and ten-year flow hydrographs. The spillway gates were operated to maintain a pool elevation upstream of the diversion dam of 767.0 until flow exceeded the control capacity of the spillway above which the diversion dam was allowed to overtop. The canal gates were operated to limit flow diversion to the canal to a maximum of 500 ft³/s. Gate operation (gate selection and gate opening) was varied during the study to broadly investigate the relation of gate location on sediment sluicing performance. For the study, spillway gates were referred to in increasing order from right to left looking downstream, figure 12. Individual canal gates are not referenced as they were opened uniformly during the study.

Figure 12 - Photograph of the model showing canal and service spillway.

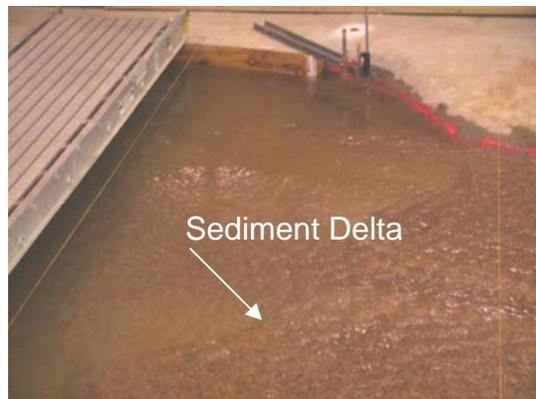
Figure 13 – Photograph of sediment delta building toward the service spillway.

Significant bed load transport started at flows between 2500 ft³/s and 3000 ft³/s. Bed load deposition within the diversion pool occurred largely in the form of a sediment delta that progressively worked downstream (figure 13). The delta progressed downstream faster near the left and right banks than mid-channel. This was likely due to higher flows entering the model near the left bank due to channel topography and the downstream right bank

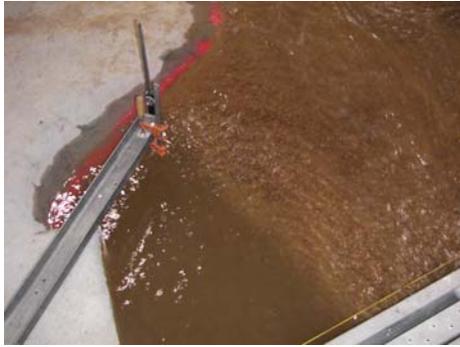
Figure 14 – Sediment delta encroaching on the fishway exit at the peak of the Ss6000 test.

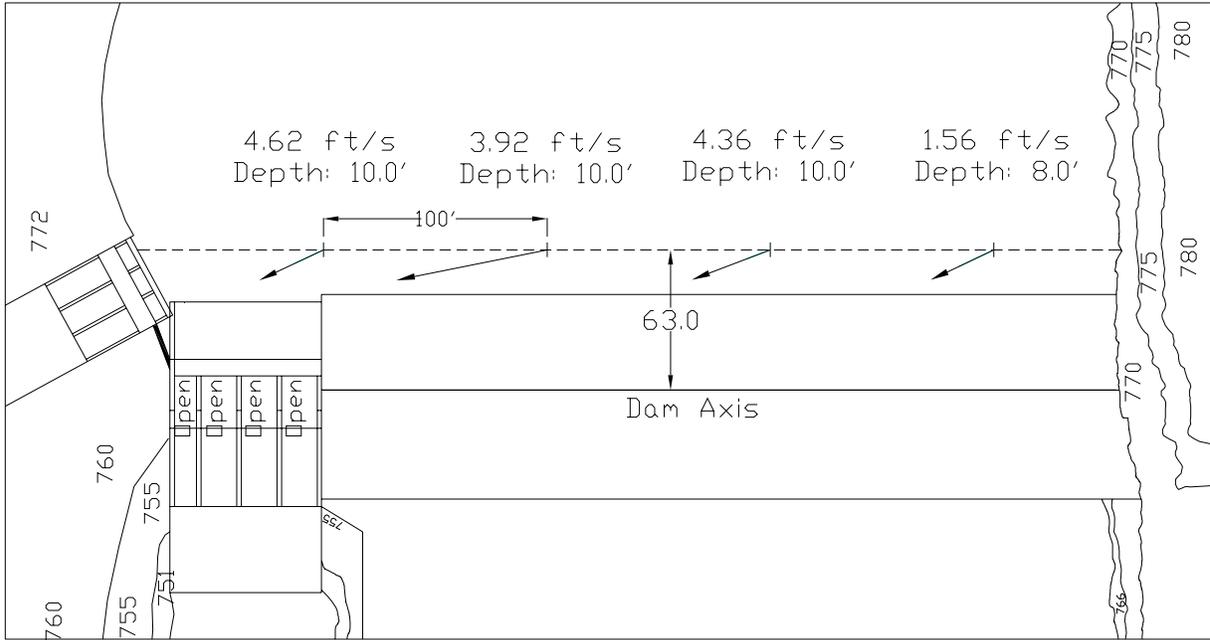
Figure 15 - Flow velocities measured during peak flow, test Ss6000.

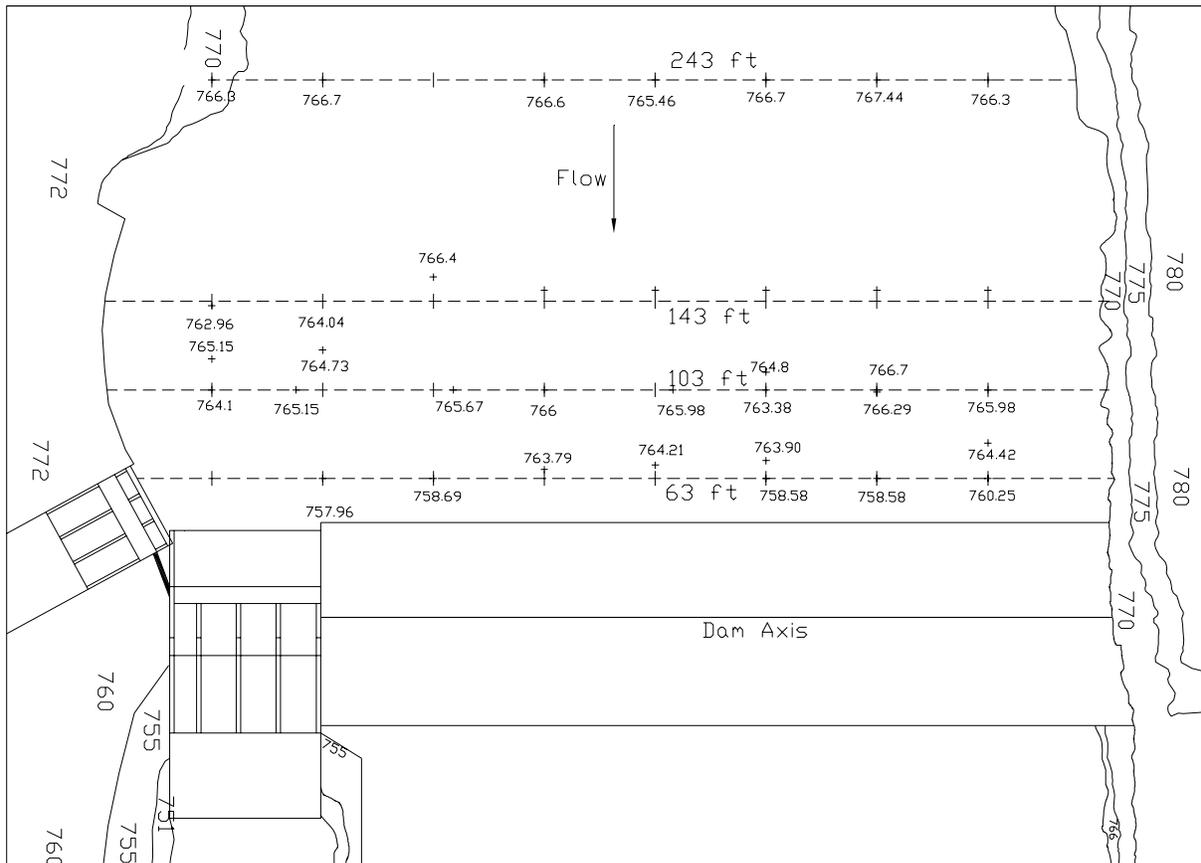
Figure 16 - Post-test Ss6000 diversion pool bed elevations upstream of diversion dam.

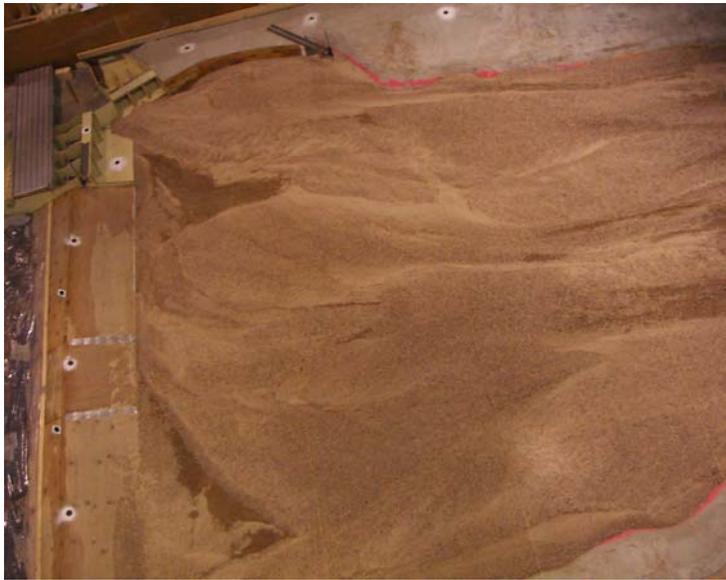
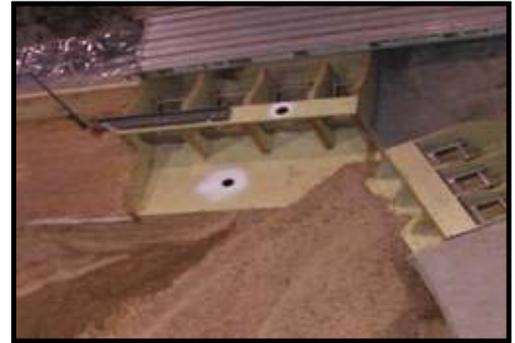
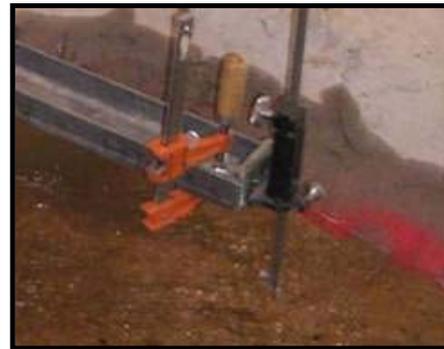
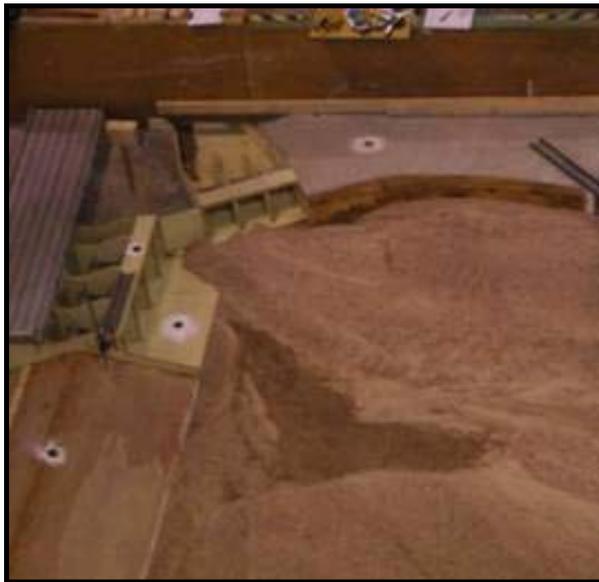
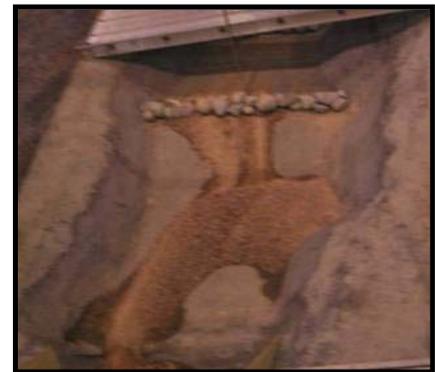
Figure 17 - Post-test sediment deposition photographs for test Ss6000.

Diversion Pool

Upstream of Diversion Canal

Upstream Fishway Exit

**Upstream of Service Spillway
Gate Structure**

**River Channel Downstream
of Service Spillway**

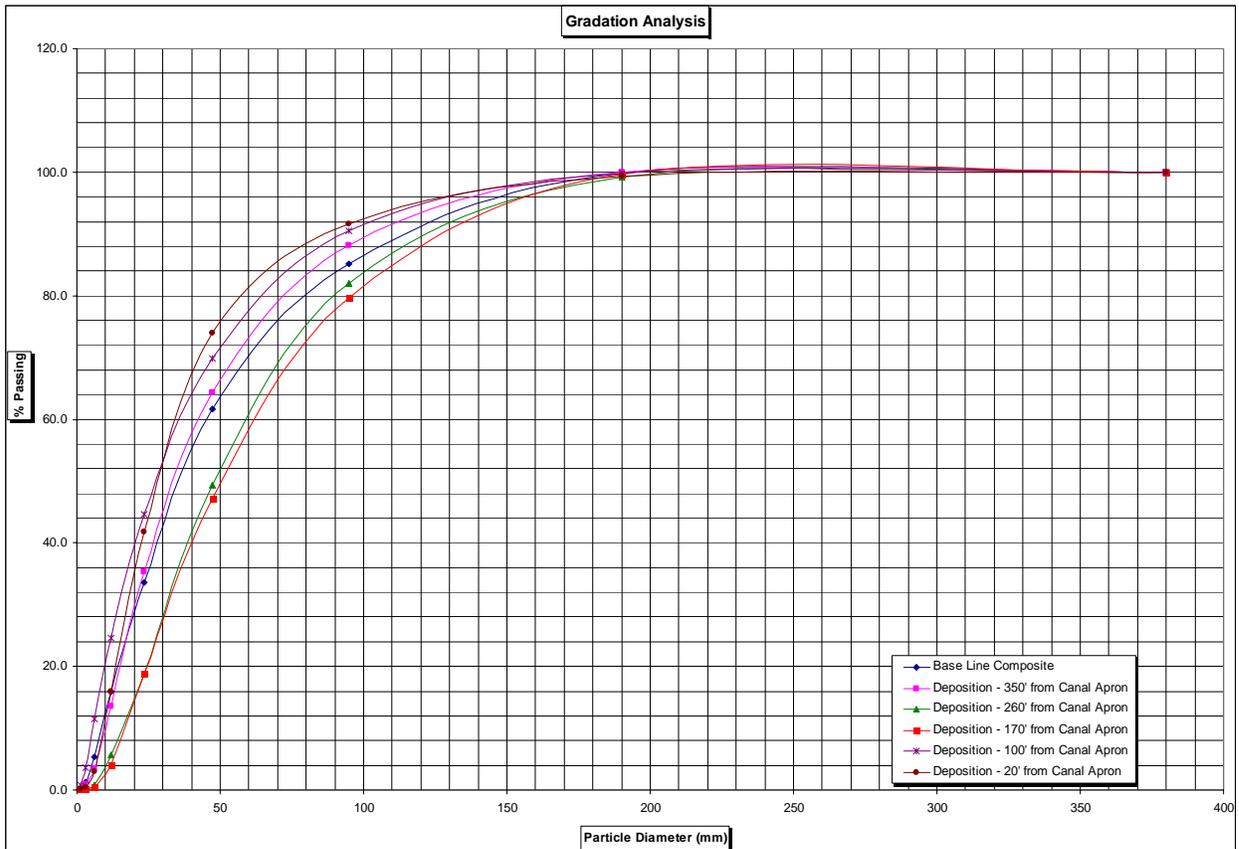
the model being held nearly constant until the test was terminated. This was necessary to evaluate and compare diversion pool deposition patterns as a function of spillway flow routing. The model was not operated to evaluate post-flood sediment sluicing effectiveness. Following the test, surface sediment samples were taken at a cross section 63 ft upstream of the dam axis. The gradation analysis of all samples is given in figure 18. The samples show coarser material located near the center of the channel and finer material near both banks.

Figure 18 – Gradation of surface sediment samples taken at a cross section 63 ft upstream of the dam axis following test Ss6000.

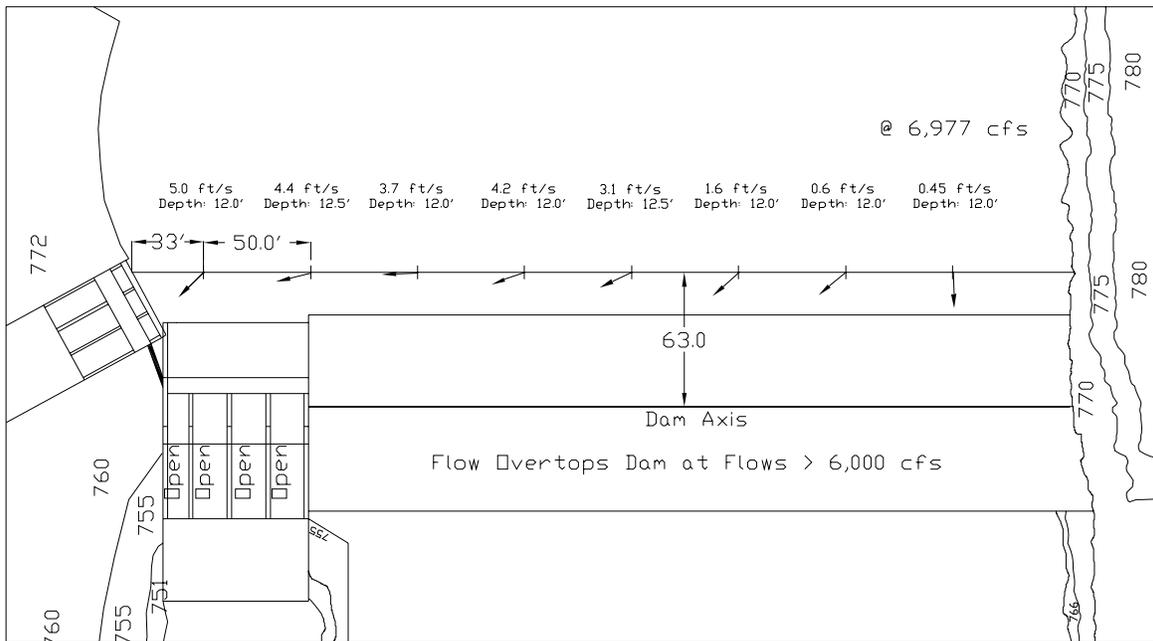
Figure 19 – Flow velocities measured during peak flow, test Ss14000.

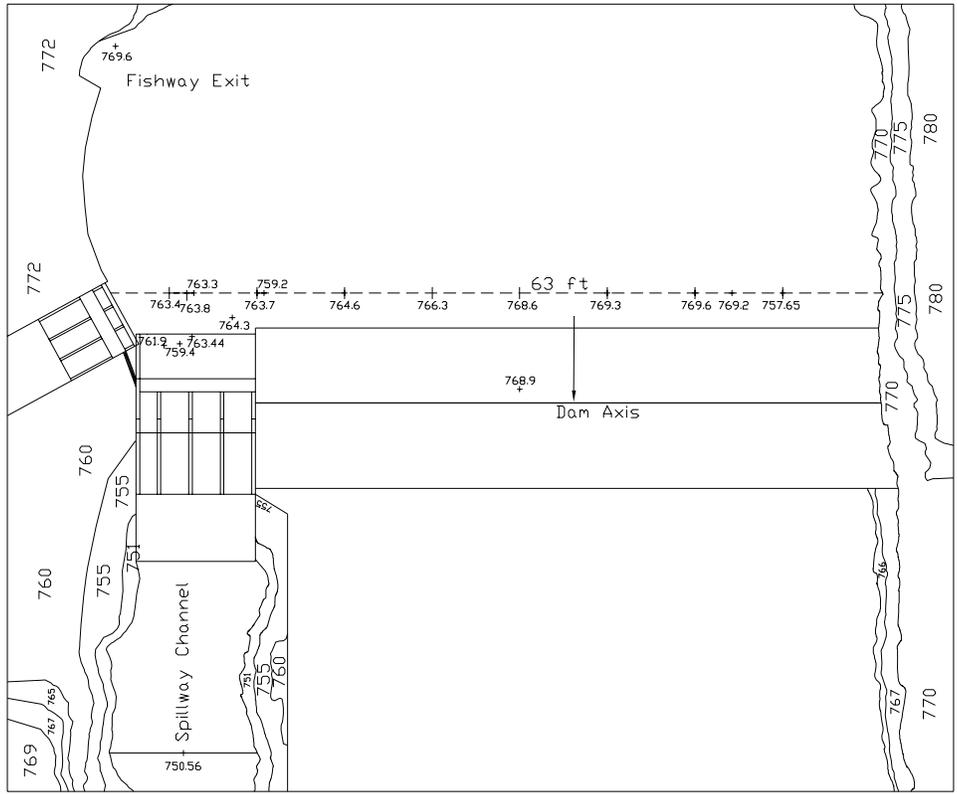
Figure 20 - Post-test Ss14000 diversion pool bed elevations upstream of diversion dam.

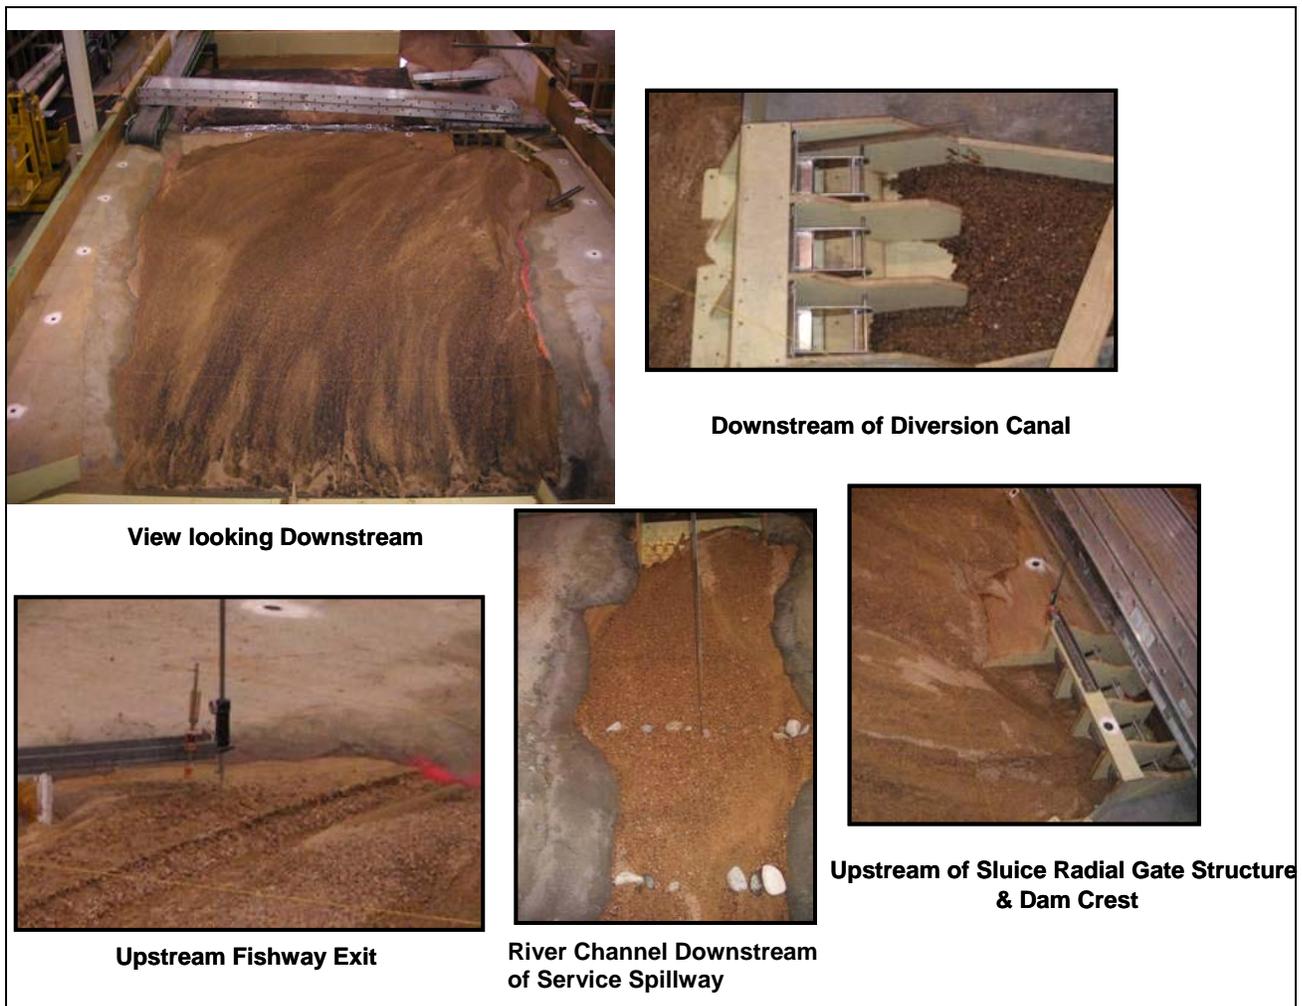
Figure 21 - Post-test sediment deposition photographs for test Ss14000.

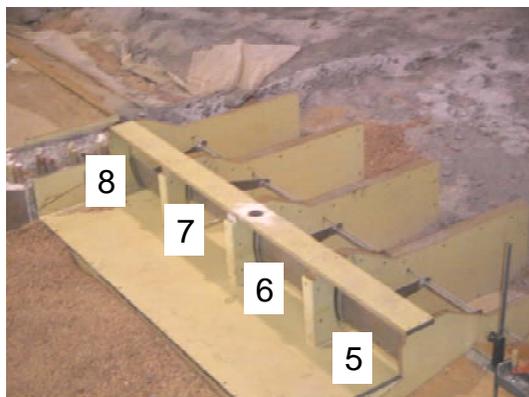
Figure 22 View of HFB spillway bay numbering scheme used in the model.

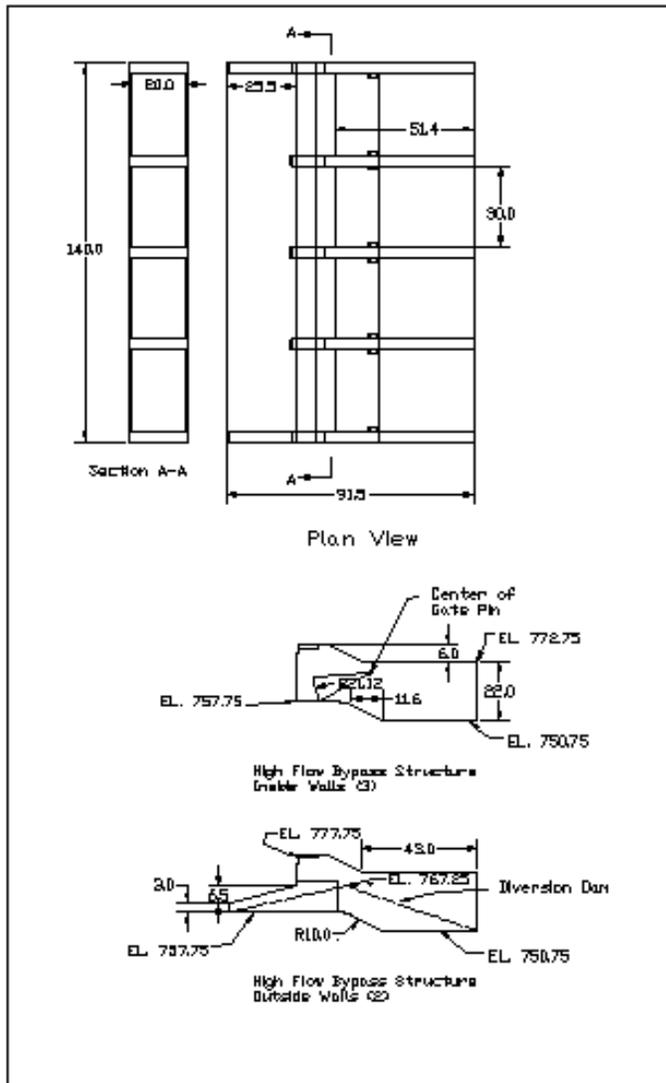
service spillway at elevation 757.75, (figure 23). Flow from the gates entered a 51.4-ft-long Reclamation Type I stilling basin. Downstream of the HFB spillway stilling basin, the channel was sloped upward at a 1V:4H slope to elevation 757.0 followed by a rock ramp sloping downward at approximately 2.5 percent. The downstream rock ramp was designed to provide flow conditions suitable for upstream passage of adult steelhead. The service spillway channel and the HFB spillway channel were separated by a rock berm for a distance of about 900 ft downstream.

Figure 23 – HFB spillway plan and sections.

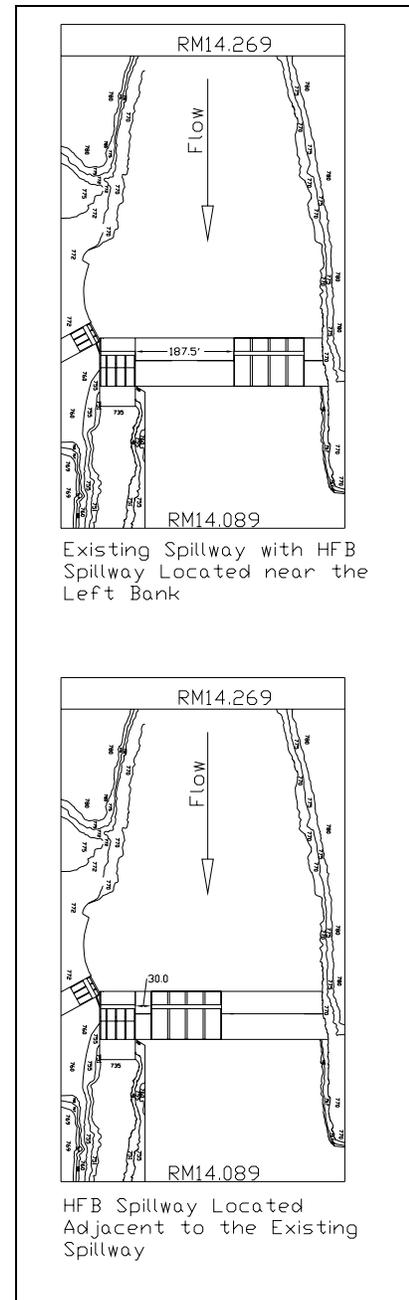
Two series of tests were conducted to evaluate sediment deposition in the diversion pool based on HFB spillway location. The first location tested was on the dam 187 ft left of the service spillway near the left bank, figure 24. This location was chosen to evaluate diversion pool sediment movement and deposition when high flows were released downstream adjacent to the bank opposite the diversion. The second HFB location tested was 30 ft to the left of the existing spillway. This location provided more of a river center release and was desirable as it provided for access to all facilitates from the right bank and allowed for easier management of spills for fish passage. Sediment movement and deposition patterns within the diversion pool were documented for both HFB positions.

Figure 24 - HFB spillway locations tested in the model

The HFB spillway was moved to a location 30 ft to the left of the service spillway and tests of 6,000 ft³/s and 14,000 ft³/s peak flow hydrographs repeated. Within this document the location is referred to as the right bank location. Thirty foot separation from the service spillway was chosen to provide reasonable separation of structures for construction of the prototype. The location resulted in the center of Bay 8 of the HFB spillway being approximately centered in the river channel,(figure 24).

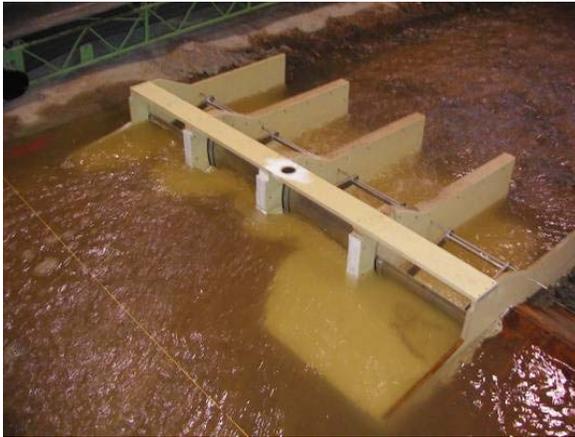
Figure 25 - Sediment passing through the HFB spillway during the flood peak.

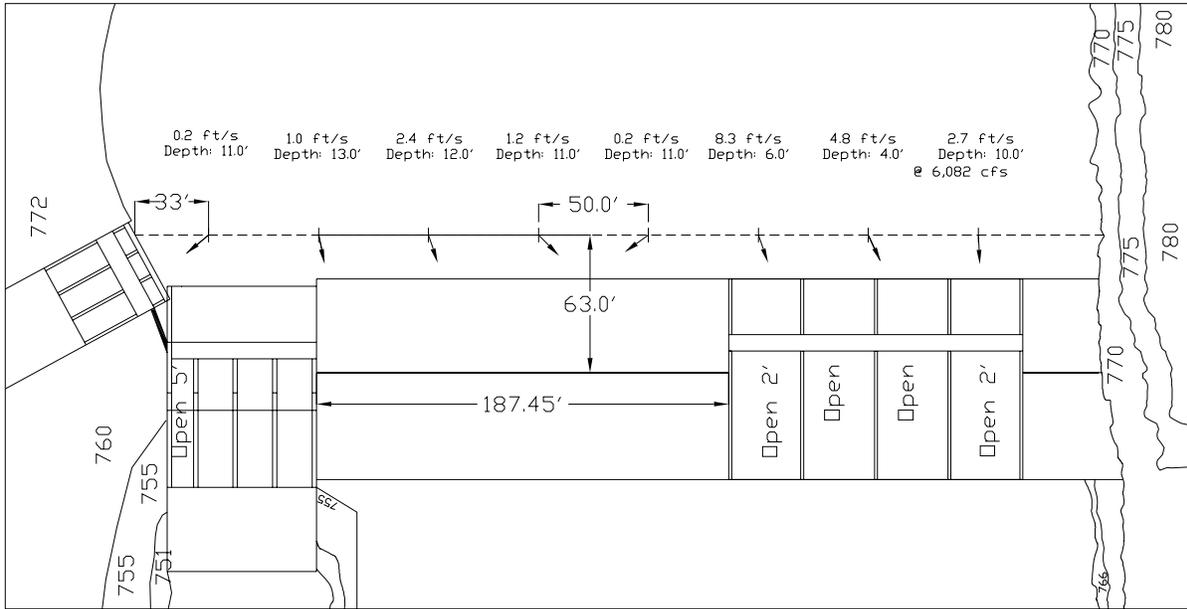
Figure 26 - Flow velocities measured during peak flow, test HFB-L6000.

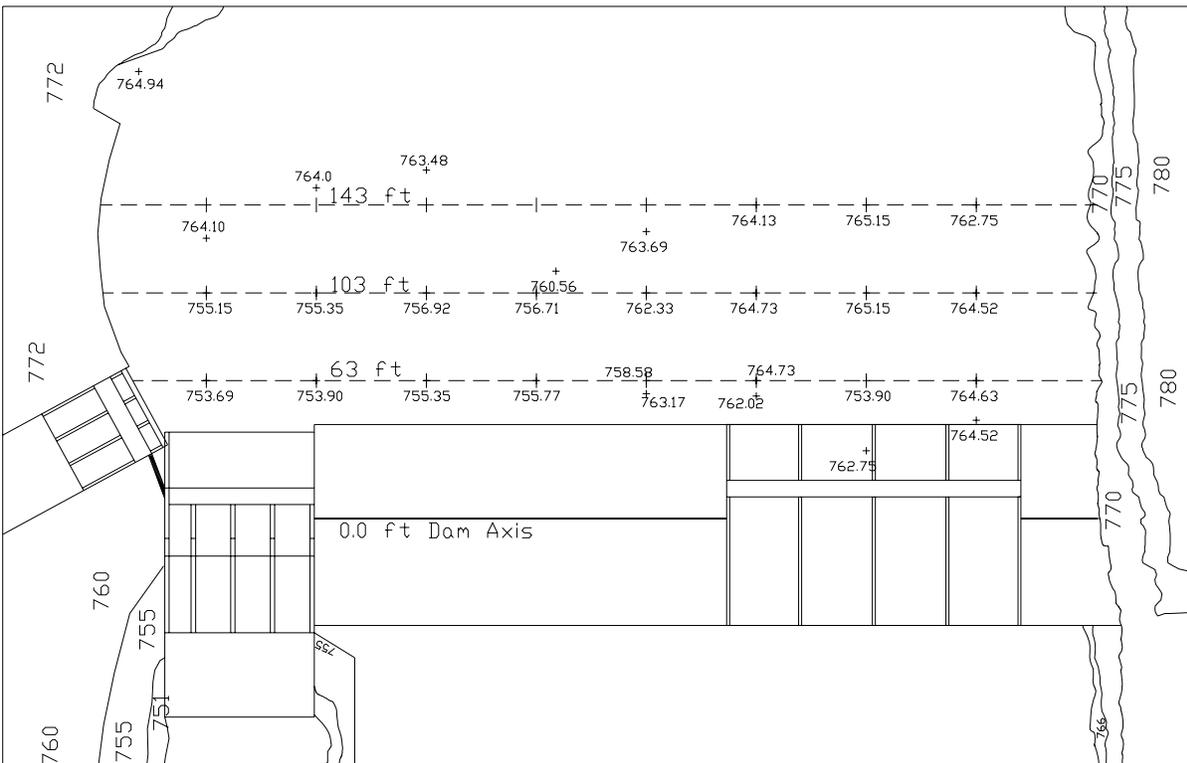
Figure 27 – Post-test HFB-L6000 diversion pool bed elevations upstream of diversion dam.

A small amount bed material passed downstream through gate 1 into the spillway channel. Survey bed elevations of the post-test sediment deposition in the diversion pool are given in figure 27. Photographic records of the post-test sediment deposition are given in figure 28. A close range photogrammetric survey of the post-test diversion pool bed is shown in figure 29. At the end of the test flood, the leading edge of the sediment delta near the right bank was located about 100 ft upstream of the canal diversion thus allowing the canal to be operated at capacity during the entire flood. Surface sediment gradation

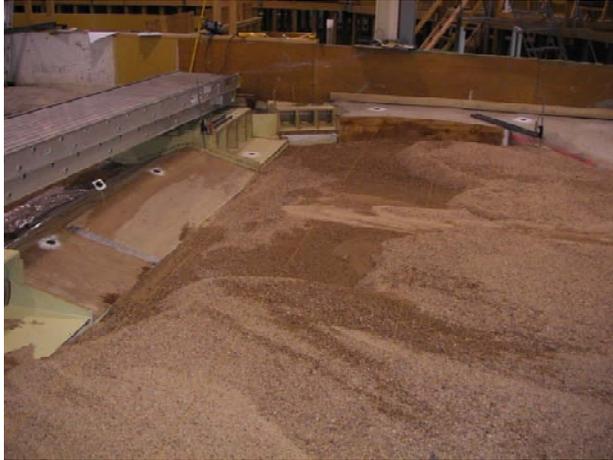
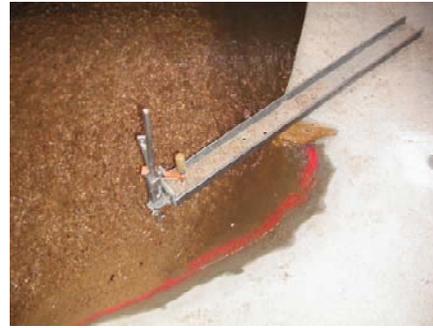
Figure 28 – Post-test sediment deposition photographs for test HFB-L6000.

View of sediment deposition at fishway exit
