Hydraulic Laboratory Report HL-2008-07

**Robles Diversion Dam
High Flow and Sediment Bypass
Structure
Ventura, California**

Physical Model Study

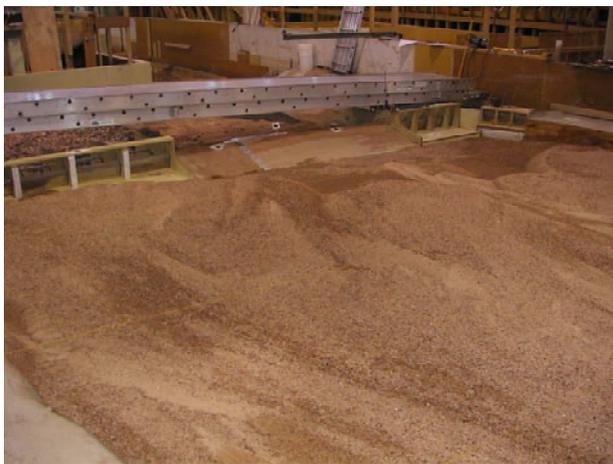
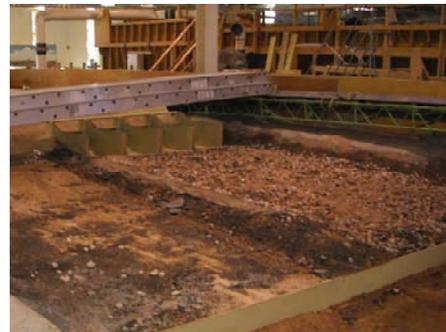
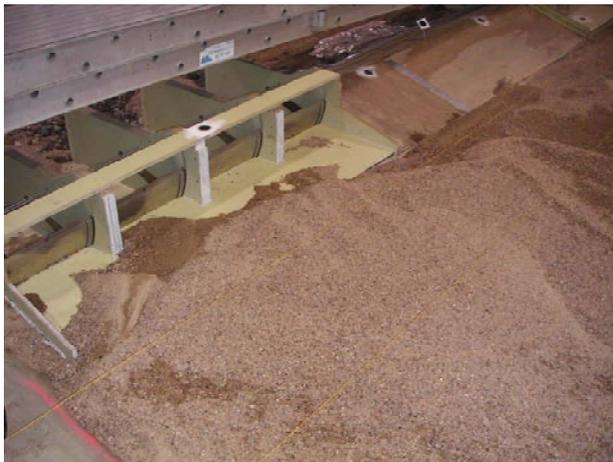
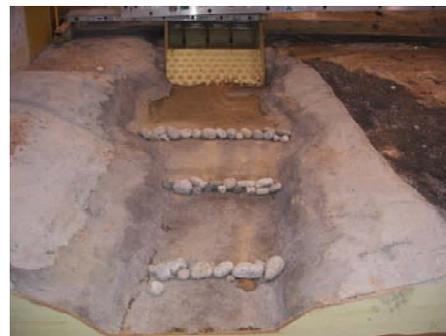
View of sediment deposition at fishway exit

View looking upstream at left bank rock ramp

Three views of Sediment in Diversion Pool with Left Bank HFB Spillway

View of Spillway Channel

Figure 28 – Post-test sediment deposition photographs for test HFB-L6000.

A small amount bed material passed downstream through gate 1 into the spillway channel. Survey bed elevations of the post-test sediment deposition in the diversion pool are given in figure 27. Photographic records of the post-test sediment deposition are given in figure 28. A close range photogrammetric survey of the post-test diversion pool bed is shown in figure 29. At the end of the test flood, the leading edge of the sediment delta near the right bank was located about 100 ft upstream of the canal diversion thus allowing the canal to be operated at capacity during the entire flood. Surface sediment gradation

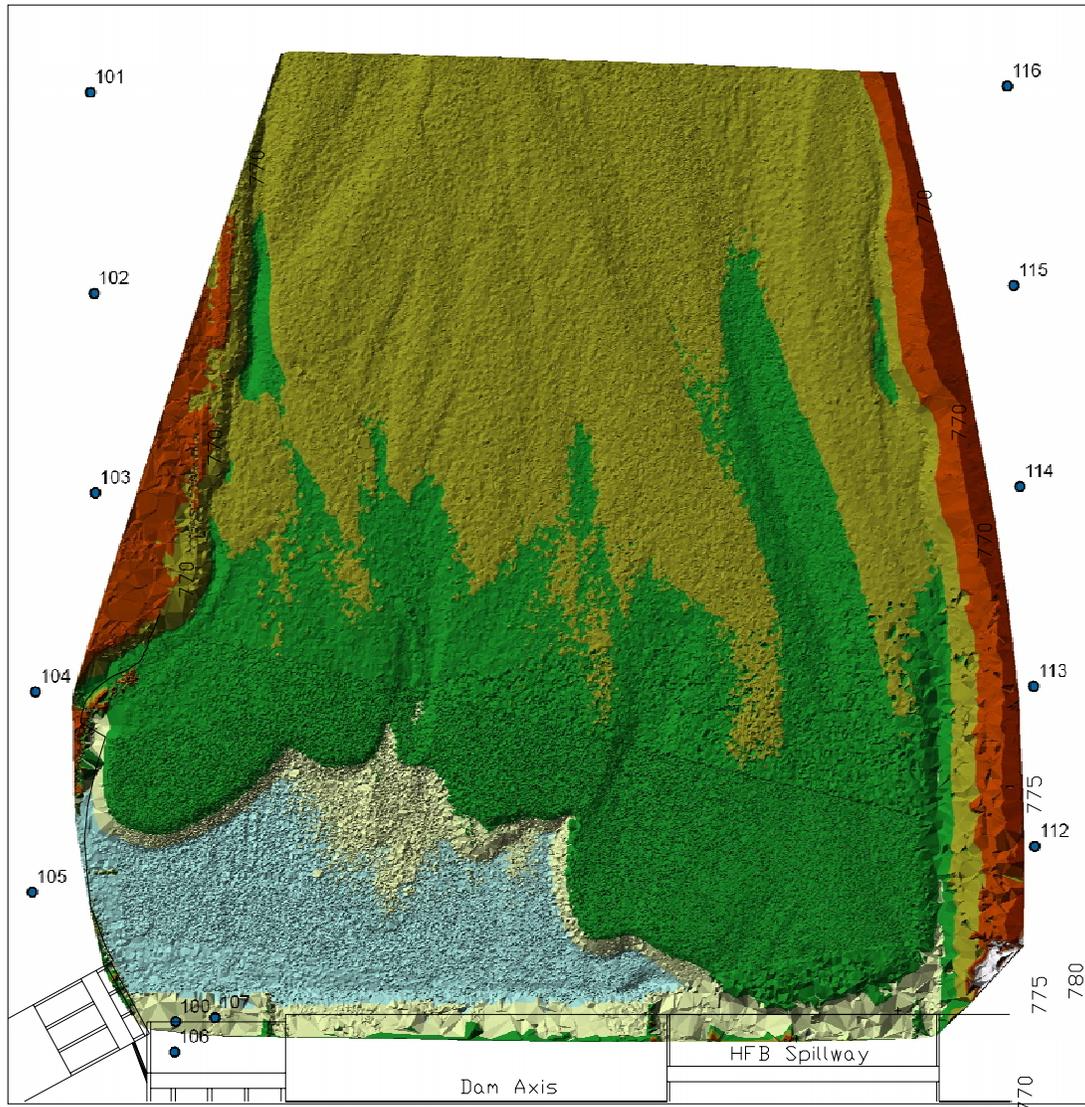
Color contoured surface generated from a digital terrain model produced photogrammetrically by the BOR Remote Sensing & GIS Team.

Figure 29 – Close range photogrammetry-generated plot of final channel elevations for test HFB-L6000. Elevations shown are model referenced to a zero datum at elevation 757.75.

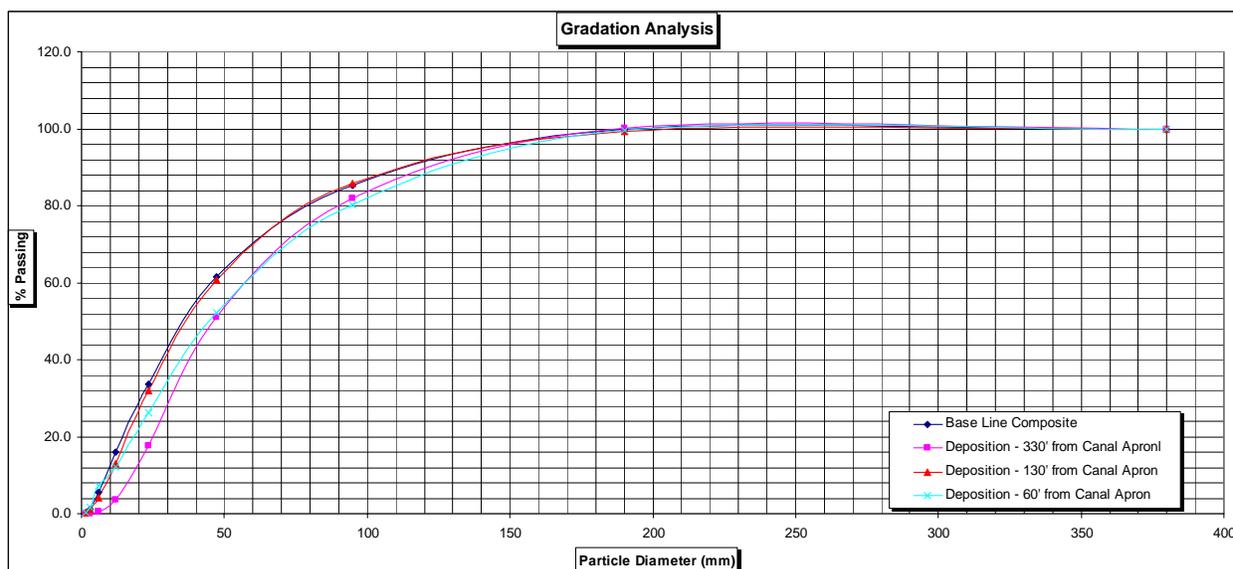
Figure 30 – HFB-L6000 surface sediment gradation sampled along a cross section located 63 ft upstream of the dam axis.

samples of the post-test bed near the dam do not indicate a significant change in bed material gradation occurred in the diversion pool, (figure 30). The data does show slightly finer material deposited adjacent to the channel boundaries.

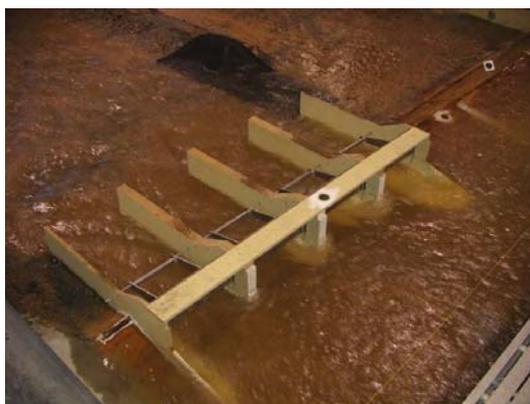
Figure 31 - View of sediment filling the HFB stilling basin.

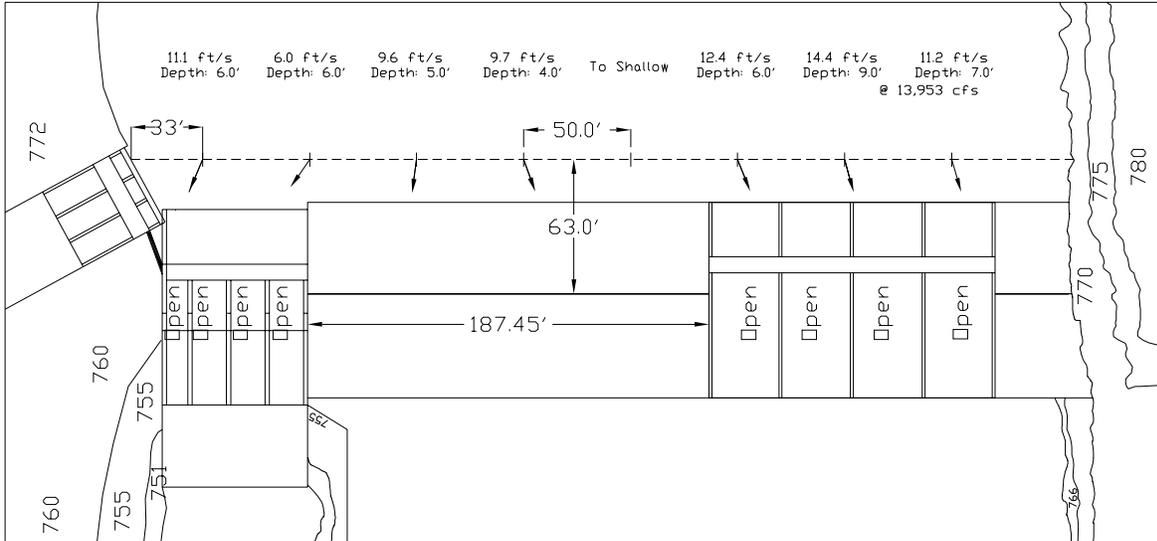
Figure 32 - Flow velocities measured during peak flow, test HFB-L14000.

during the testing due to the diversion pool response time and frequent gate adjustments required to maintain a nearly constant pool elevation until all spillway gates were full open. Near-dam velocities measured at the peak discharge are shown in figure 32. A flow stagnation point is evident located about one third the dam width from the right side. This location also was found to have the greatest sediment deposition following completion of the test, (figure 33). Small amounts of bed sediment were drawn into the canal during the test. Deposition in front of the canal apron reached approximately elevation 762. During the test 6.5 yds³ model (52,000 yds³ prototype) of sediment were fed into the model. Photographs of the post-test channel bed and a photogrammetric-generated channel surface are given in figures 34 and 35, respectively. Gradations of surface sediments deposited along a cross section 63 ft upstream of the dam axis are given in figure 36. Sediment gradations were similar with generally finer material deposited closer to the channel banks.

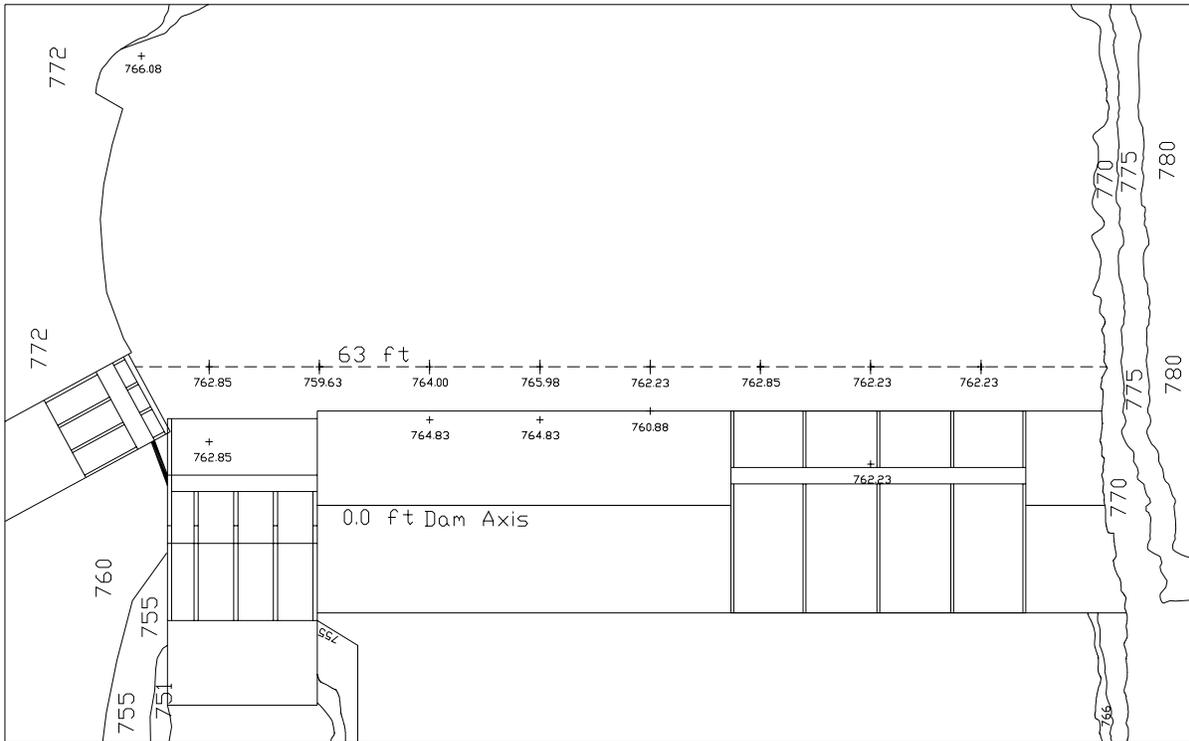
Figure 33 - Post-test HFB-L14000 diversion pool bed elevations upstream of diversion dam.

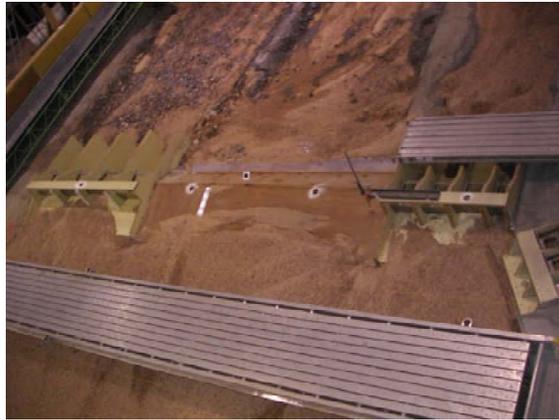
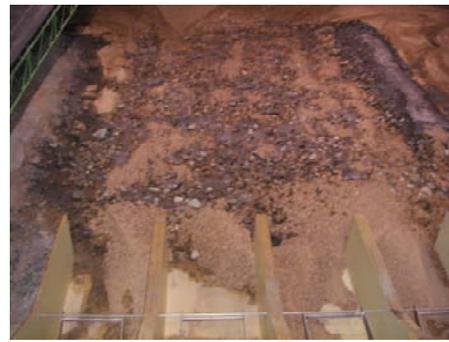
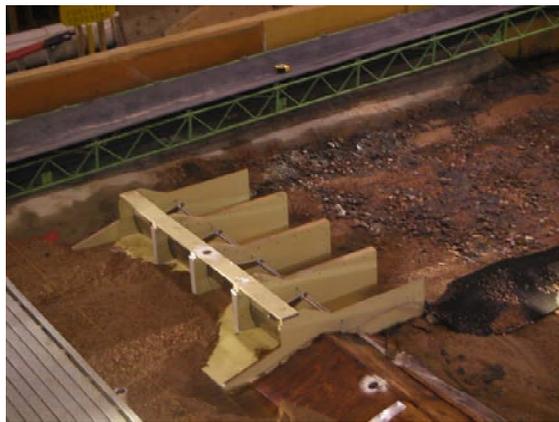
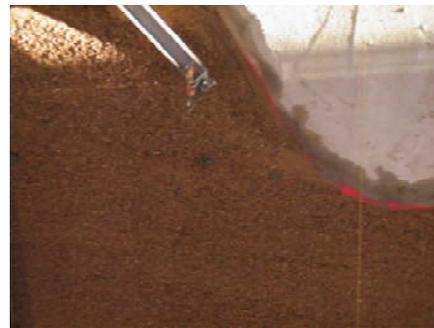
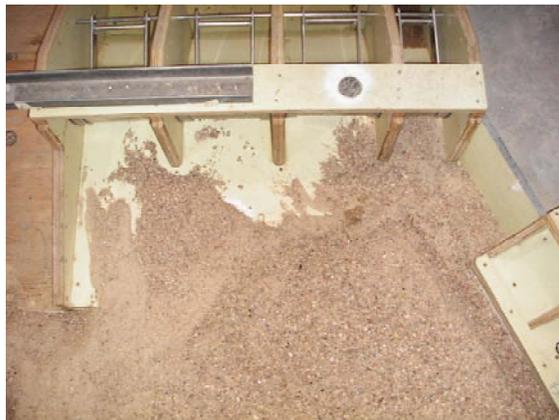
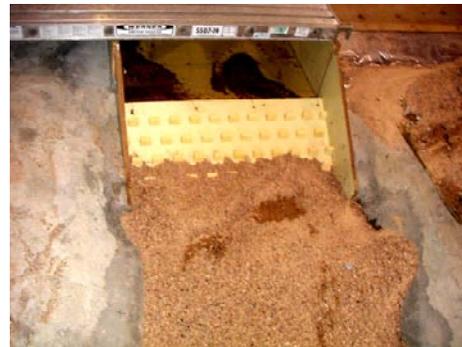
View looking downstream at rock ramp

View of sediment deposition at fishway exit

Three views of Sediment in Diversion Pool with Left Bank HFB Spillway

Figure 34 - Post-test sediment deposition photographs for test HFB-L14000.

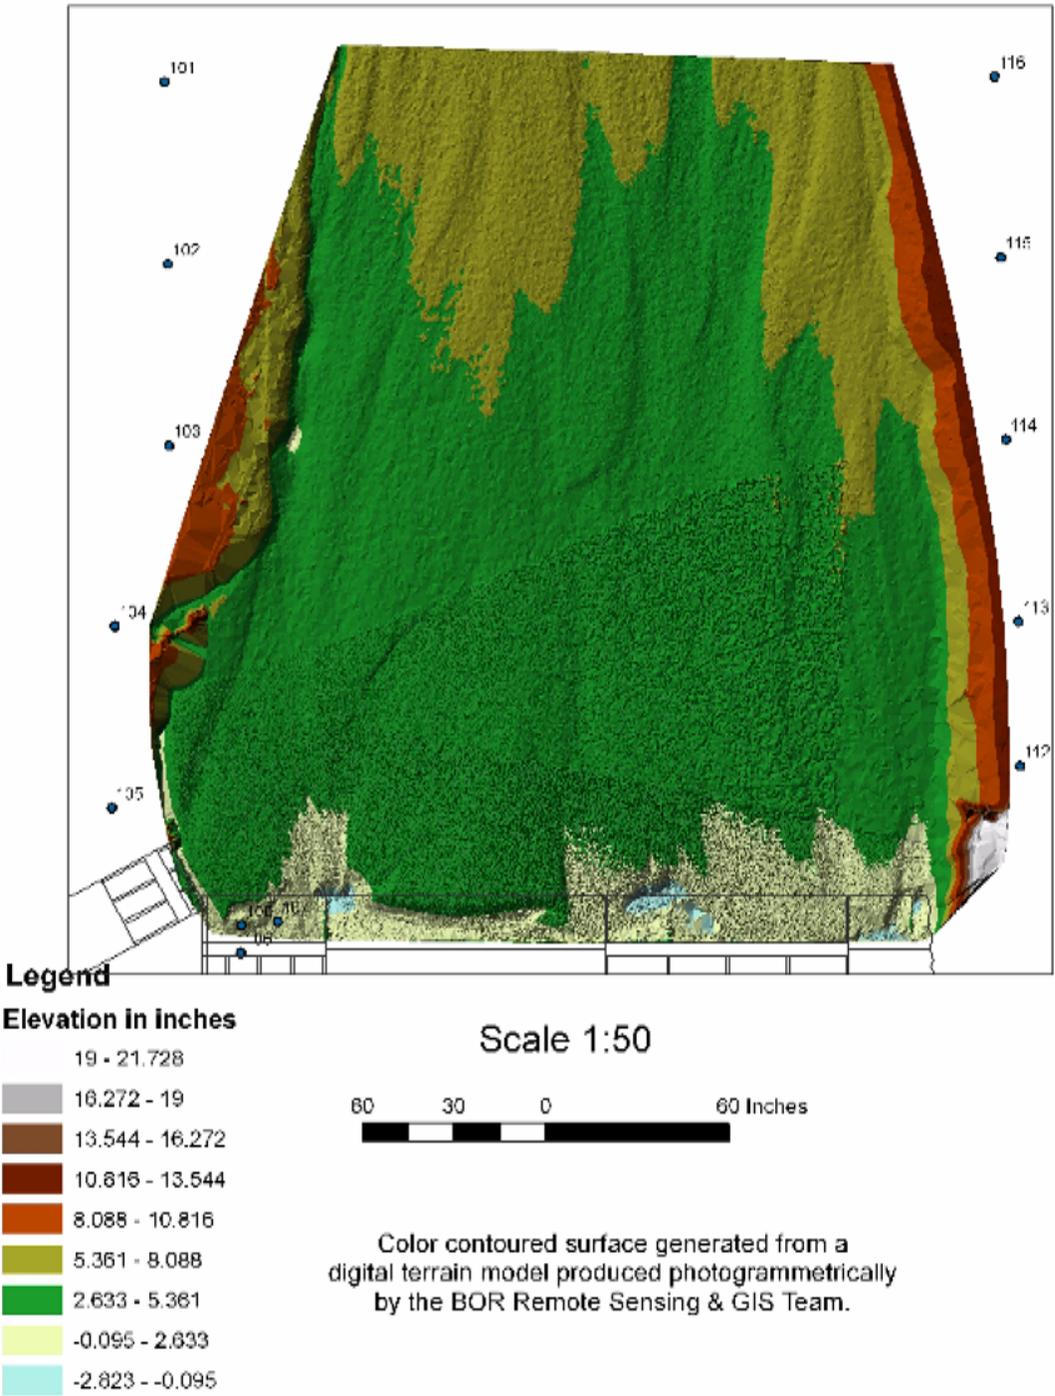
Figure 35 - Close range photogrammetry-generated plot of final channel elevations for test HFB-L14000. Elevations shown are model referenced to a zero datum at elevation 757.75.

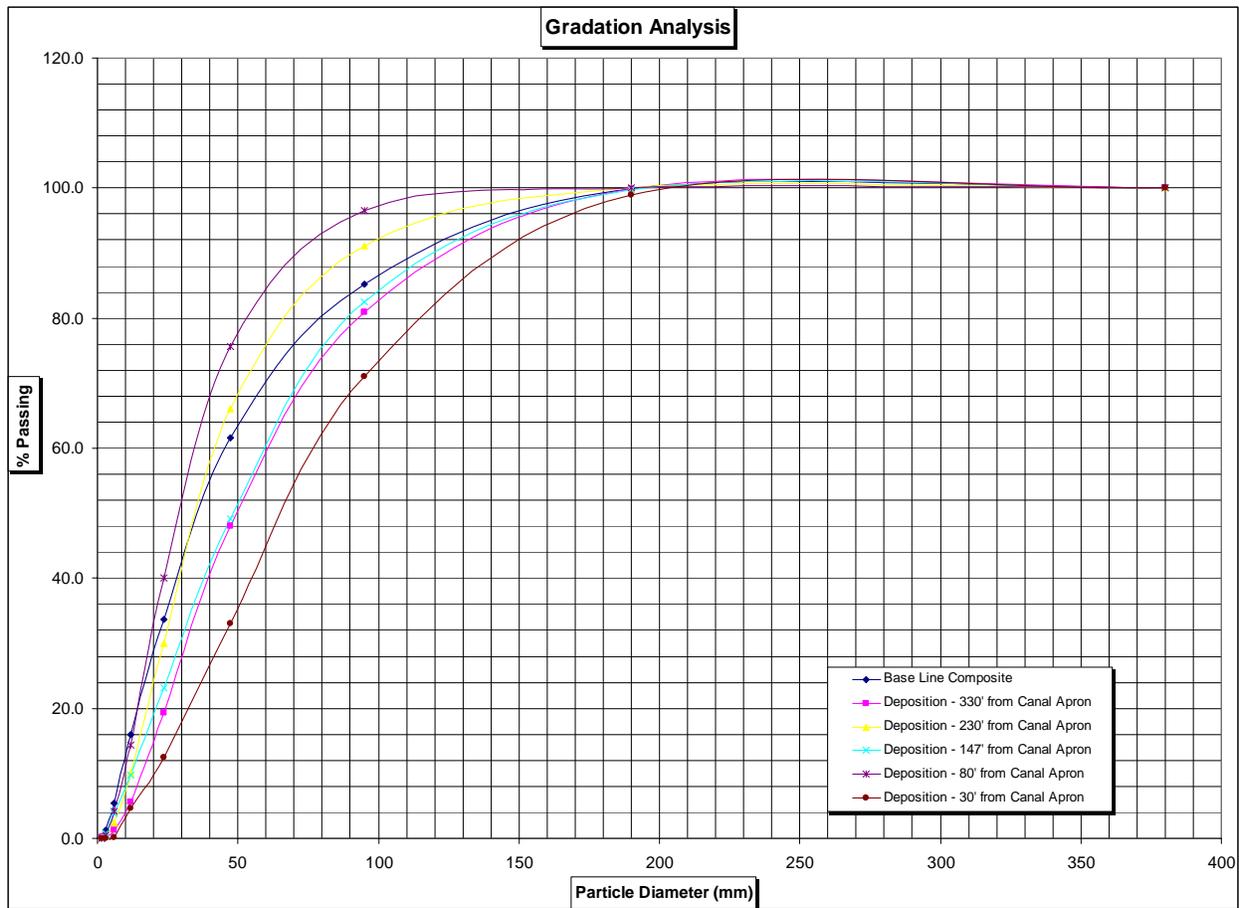
Figure 36 - HFB-L14000 surface sediment gradation sampled along a cross section located 63 ft upstream of the dam axis

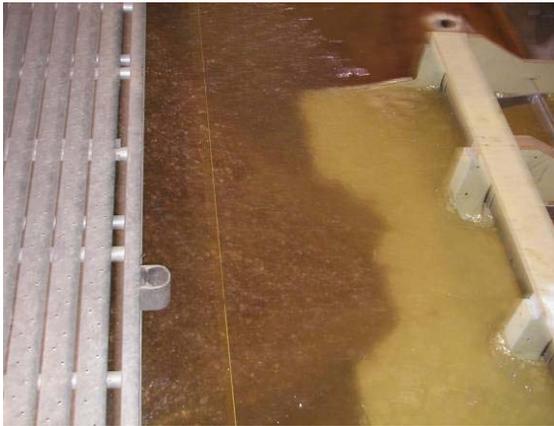
Figure 37 - View of sediment delta reaching the HFB spillway after 15.5 hrs

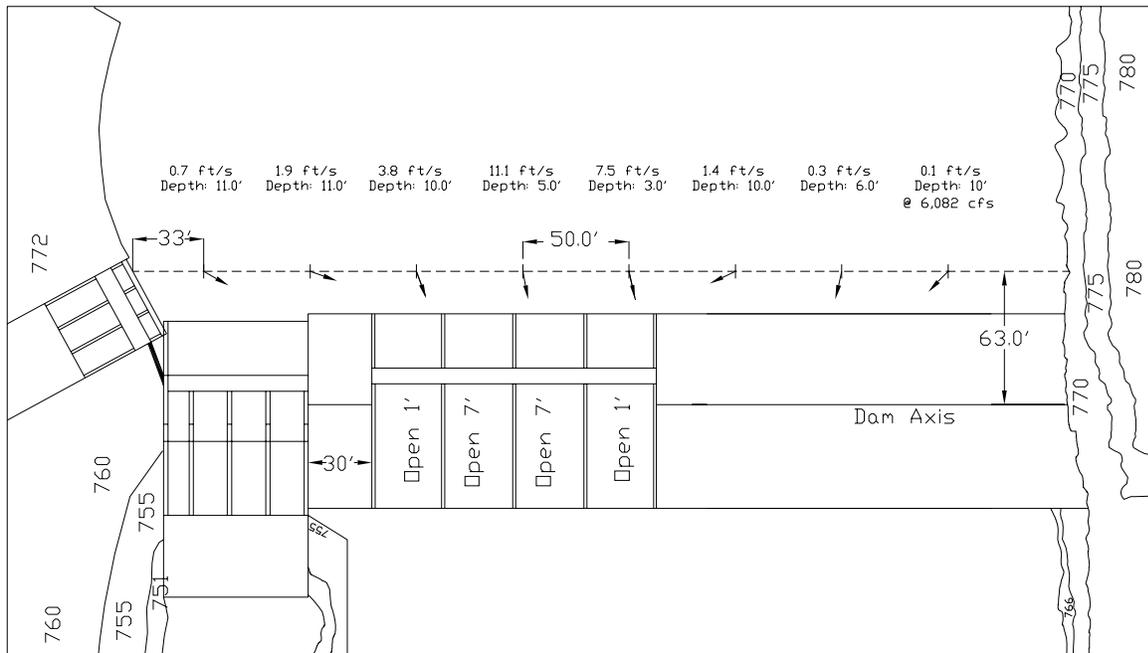
Figure 38 - Flow velocities measured during peak flow, test HFB-R6000.

shown in figure 38. During the declining limb of the hydrograph heavy sediment loads continued to pass through the HFB spillway. The progression of the sediment delta toward the service spillway and canal diversion slowed as much of the sediment was drawn toward the HFB. No bed sediments were entrained into the canal during the test. Survey bed elevations of the post-test sediment deposition in the lower diversion pool are given in figure 39. Photographic records of the post-test sediment deposition are given in figure 40 and a close range photogrammetric survey of the post-test diversion pool bed is shown in figure 41. At the end of the test flood, the leading edge of the sediment delta near the right bank was located about 40 ft upstream of the canal

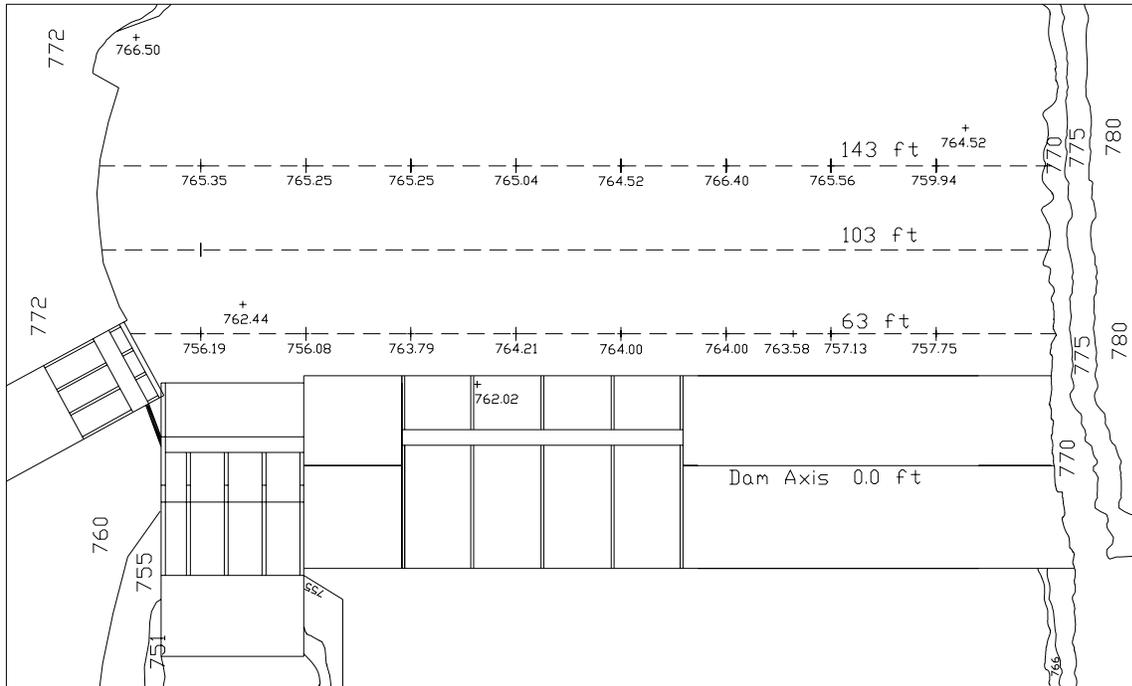
Figure 39 - Post-test HFB-R6000 diversion pool bed elevations upstream of diversion dam.

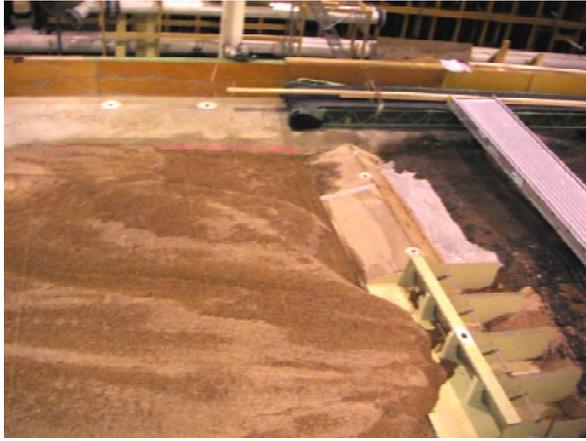
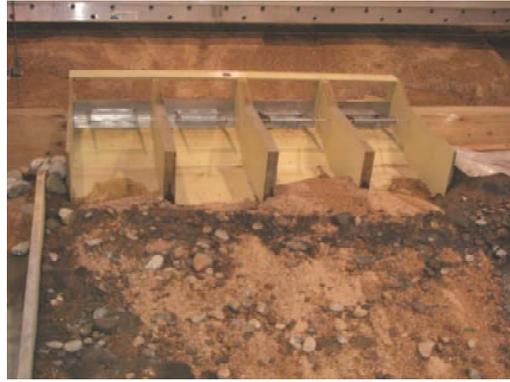
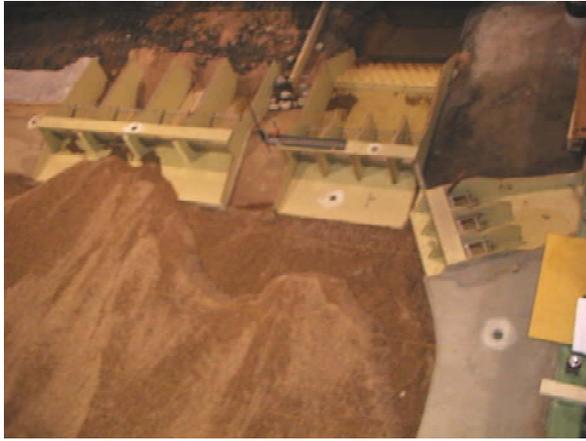
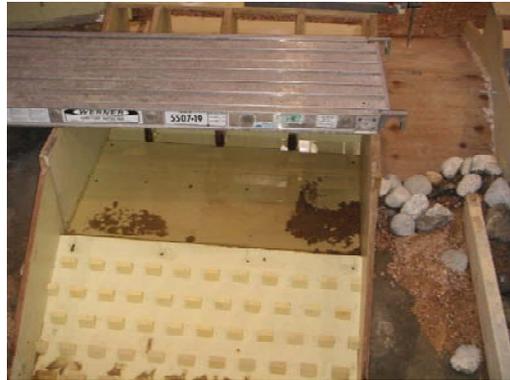
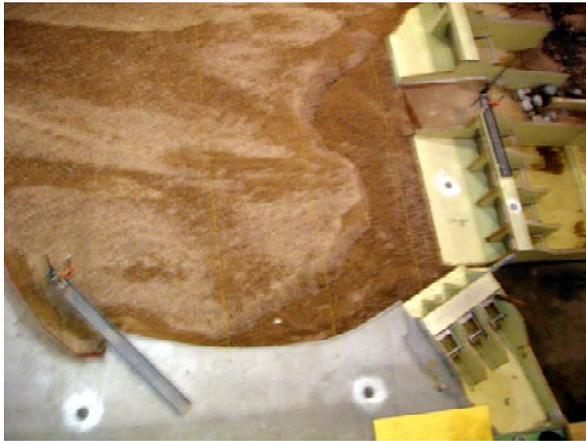
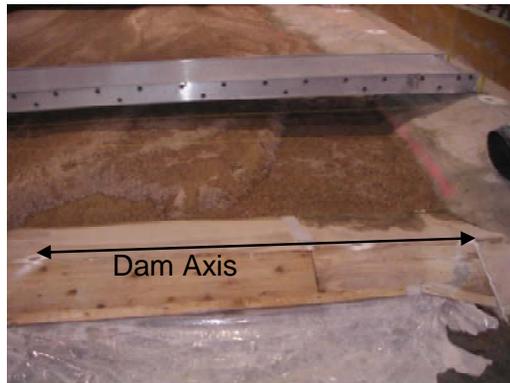
Looking Upstream at HFB Spillway

Looking Upstream at Service Spillway Stilling Basin

Views of the Sediment Delta In the Diversion Pool

Looking Upstream from the Left Bank

Figure 40 - Post-test sediment deposition photographs for test HFB-R6000.

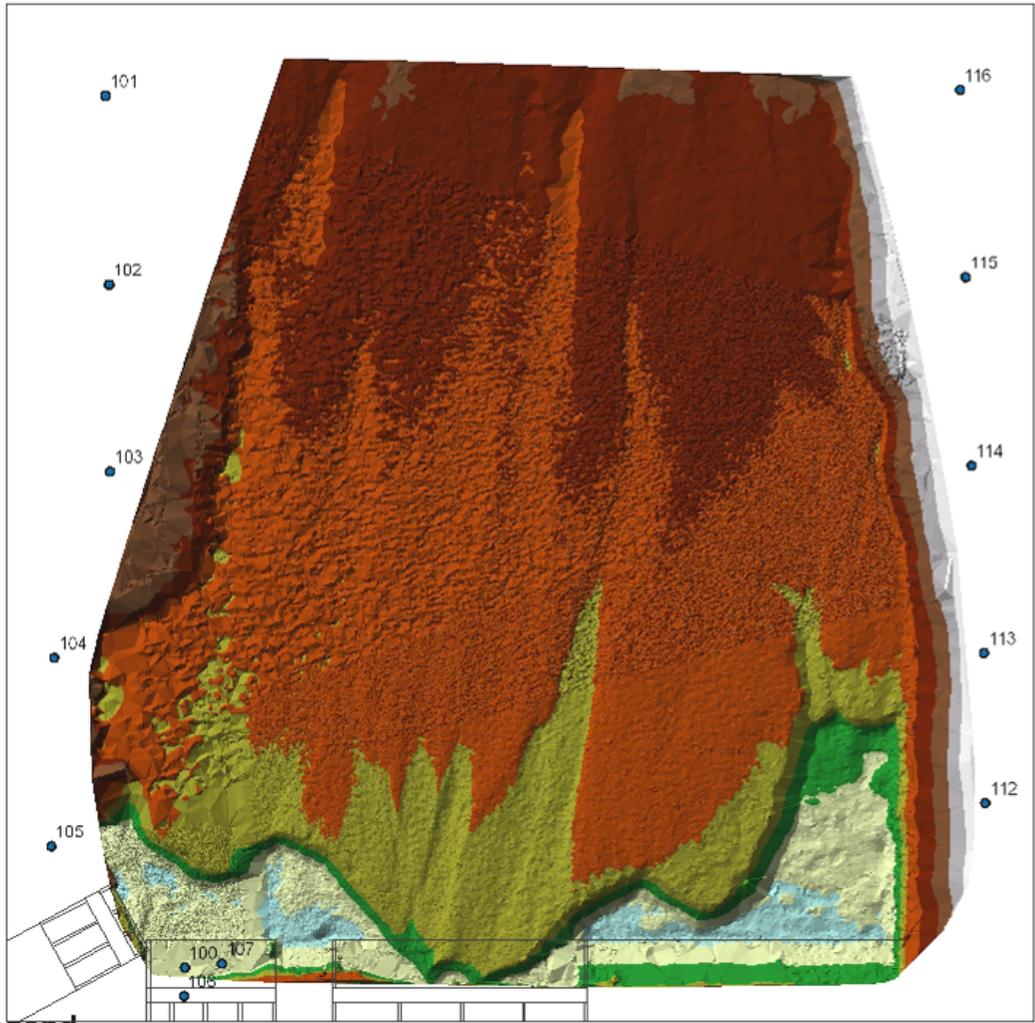
Color contoured surface generated from a digital terrain model produced photogrammetrically by the BOR Remote Sensing & GIS Team.

Figure 41 - Close range photogrammetry-generated plot of final channel elevations for test HFB-R6000. Elevations shown are model referenced to a zero datum at elevation 757.75

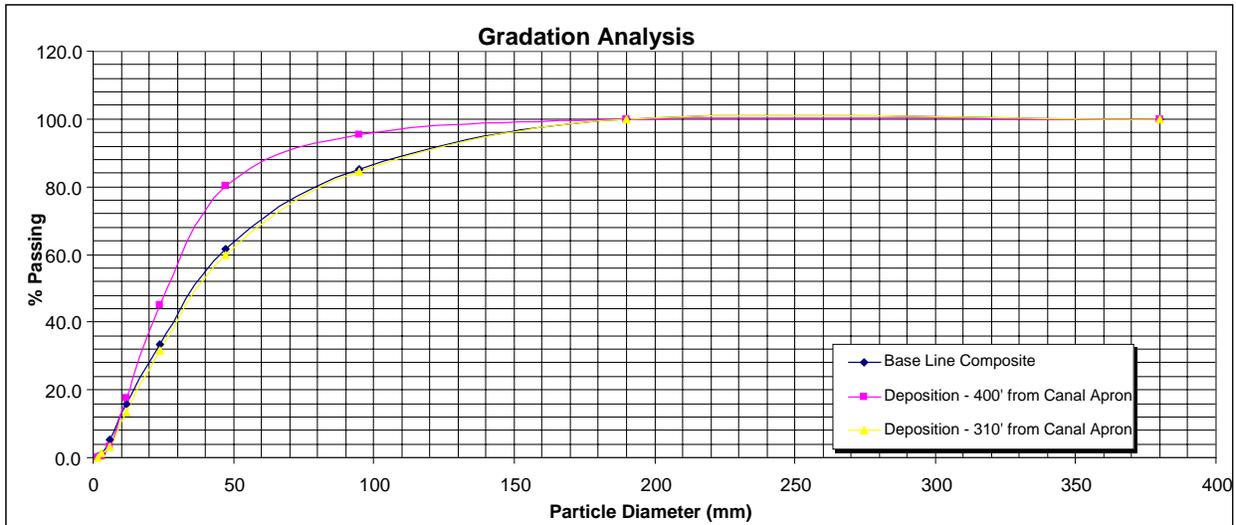
Figure 42 - HFB-R6000 surface sediment gradation sampled along a cross section located 63 ft upstream of the dam axis.

diversion, thus allowing the canal to be operated at capacity during the entire flood. Surface sediment gradation samples of the post-test bed near the dam do not indicate a significant change in bed material gradation occurred in the diversion pool, figure 42. The data does show slightly coarser material deposited near the left channel bank. Gradation data was not available for the right bank.

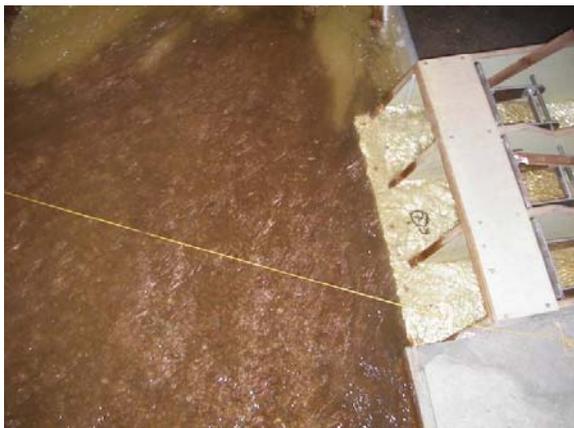
Figure 43 – Sediment delta passing in front of the canal entrance and flushing through the service spillway.

the right bank inundated the fishway exit. After 12 hrs (prototype) the sediment delta reached the service spillway and was moving along the canal apron wall and passing through the spillway (figure 43). As observed in previous tests, sediment passing through the service spillway deposited in the downstream channel forming a plain bed above the rock weirs. Similar to Test 5, the HFB stilling basins partially filled with sediment with the gates fully open. The basins self cleaned as the gates were partially closed during the recession of the flood. Near-dam velocities measured at the peak discharge are shown in figure 44. Flow velocities from 10 ft/s to 15 ft/s were measured upstream of the

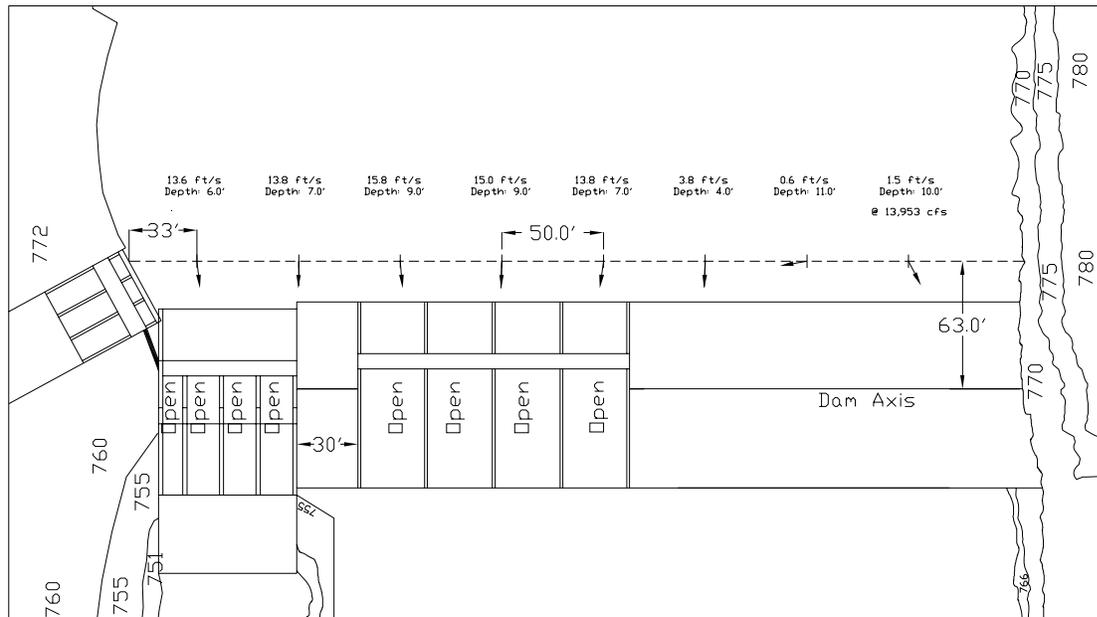
Figure 44 - Flow velocities measured during peak flow, test HFB-R14000.

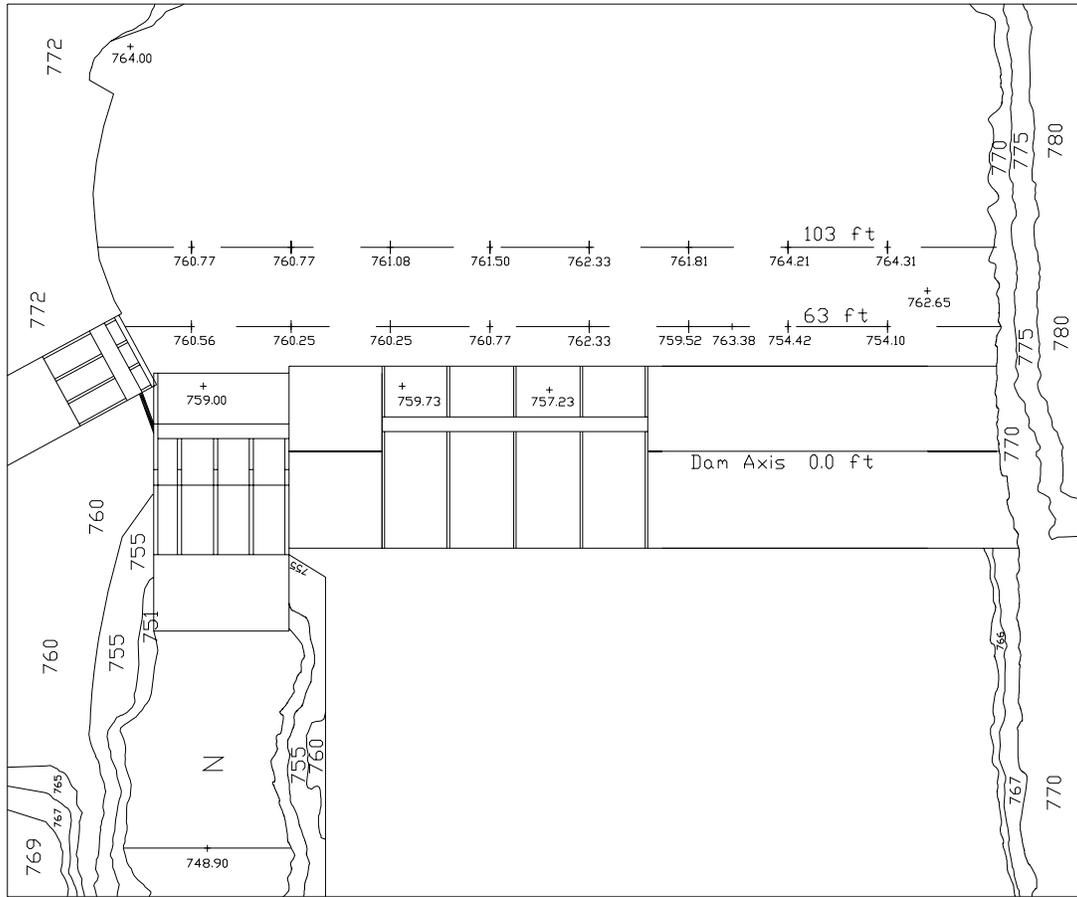
Figure 45 - Post-test HFB-R14000 diversion pool bed elevations upstream of diversion dam.

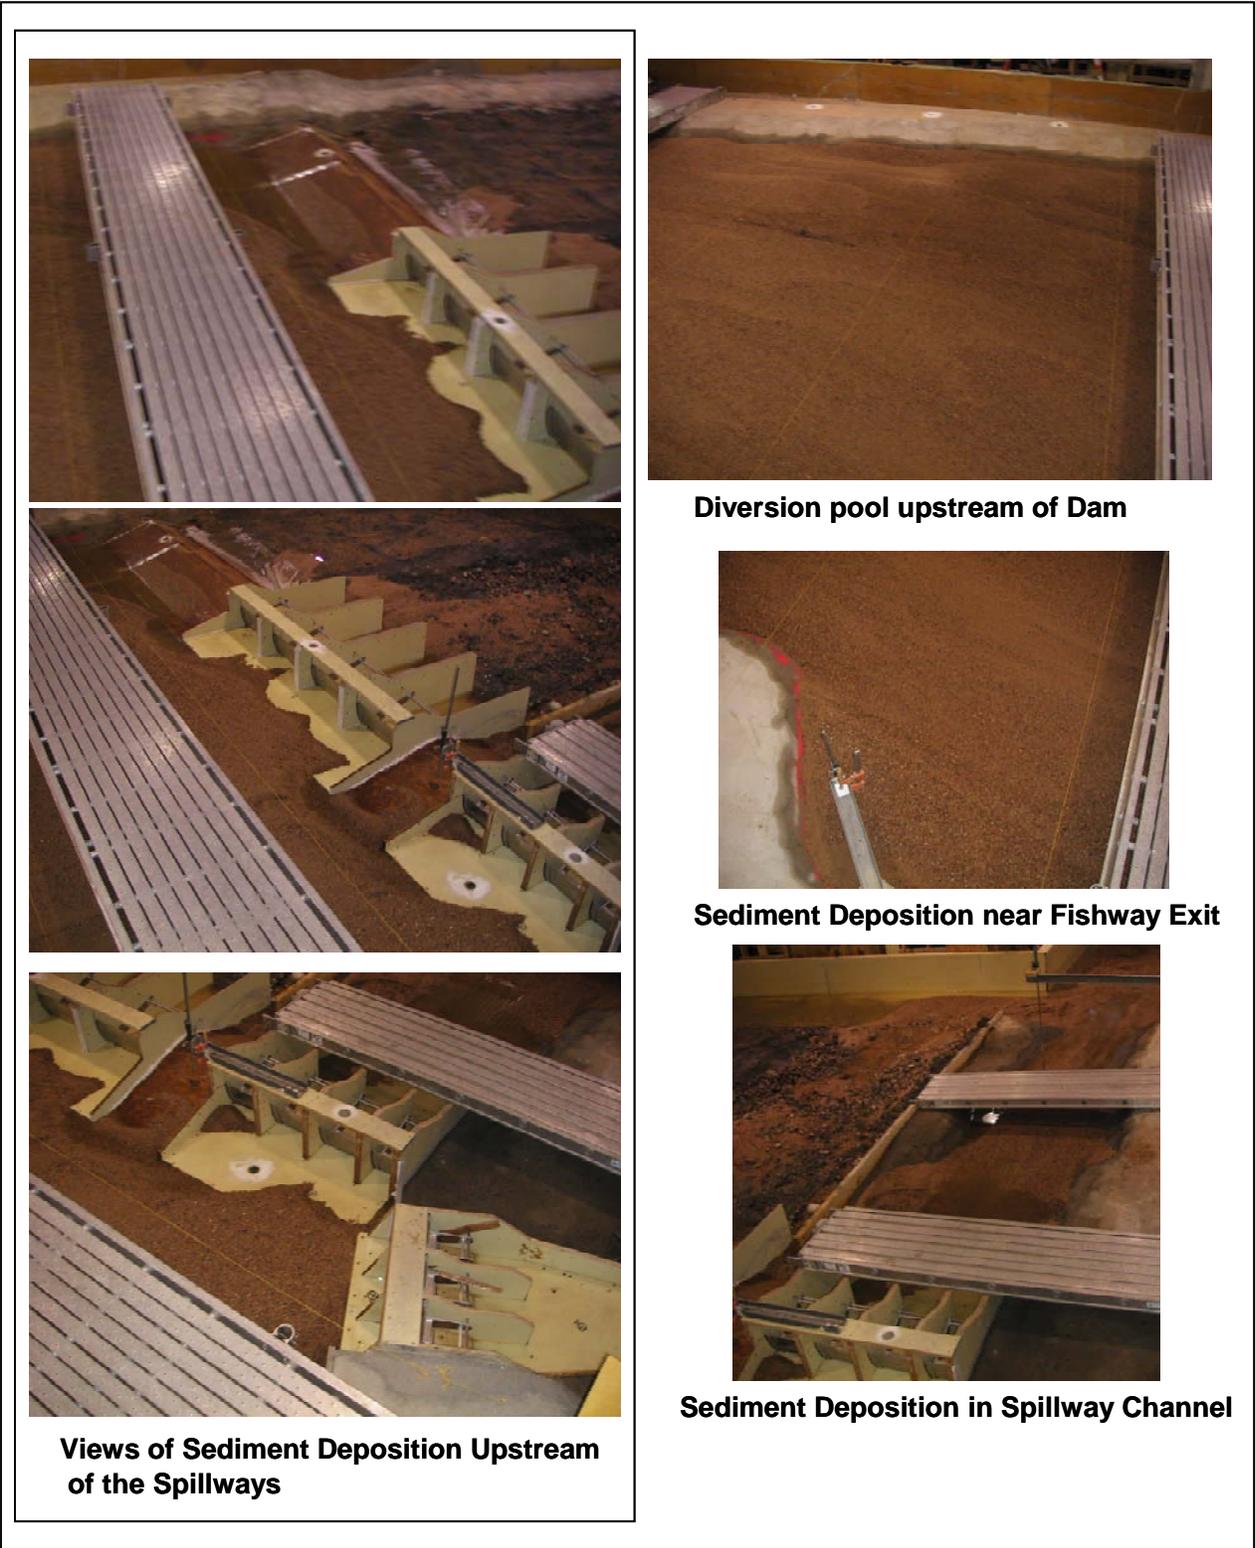
Figure 46 - Post-test sediment deposition photographs for test HFB-R14000.

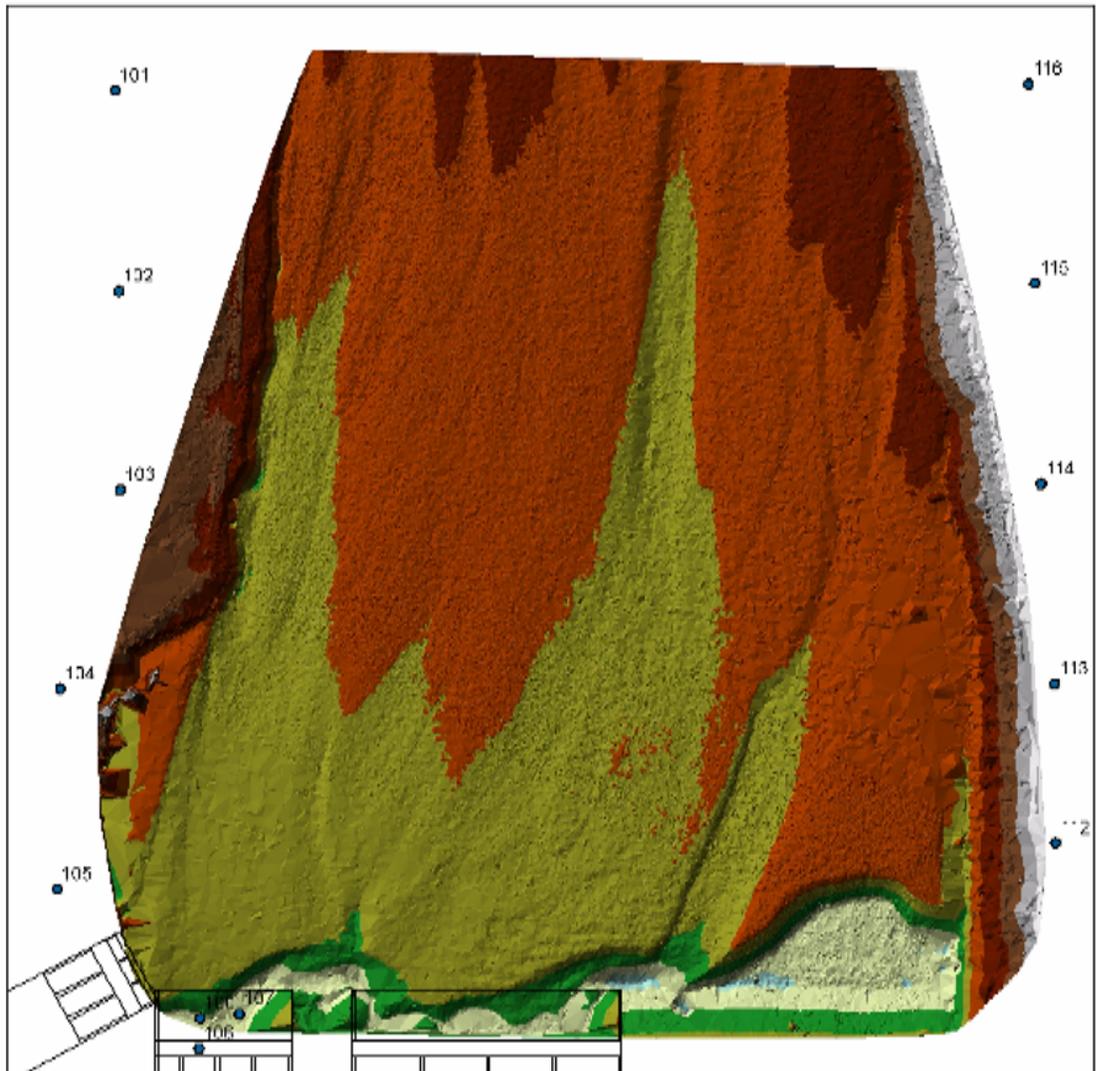
Color contoured surface generated from a digital terrain model produced photogrammetrically by the BOR Remote Sensing & GIS Team.

Figure 47 - Close range photogrammetry-generated plot of final channel elevations for test HFB-R14000. Elevations shown are model referenced to a zero datum at elevation 757.75

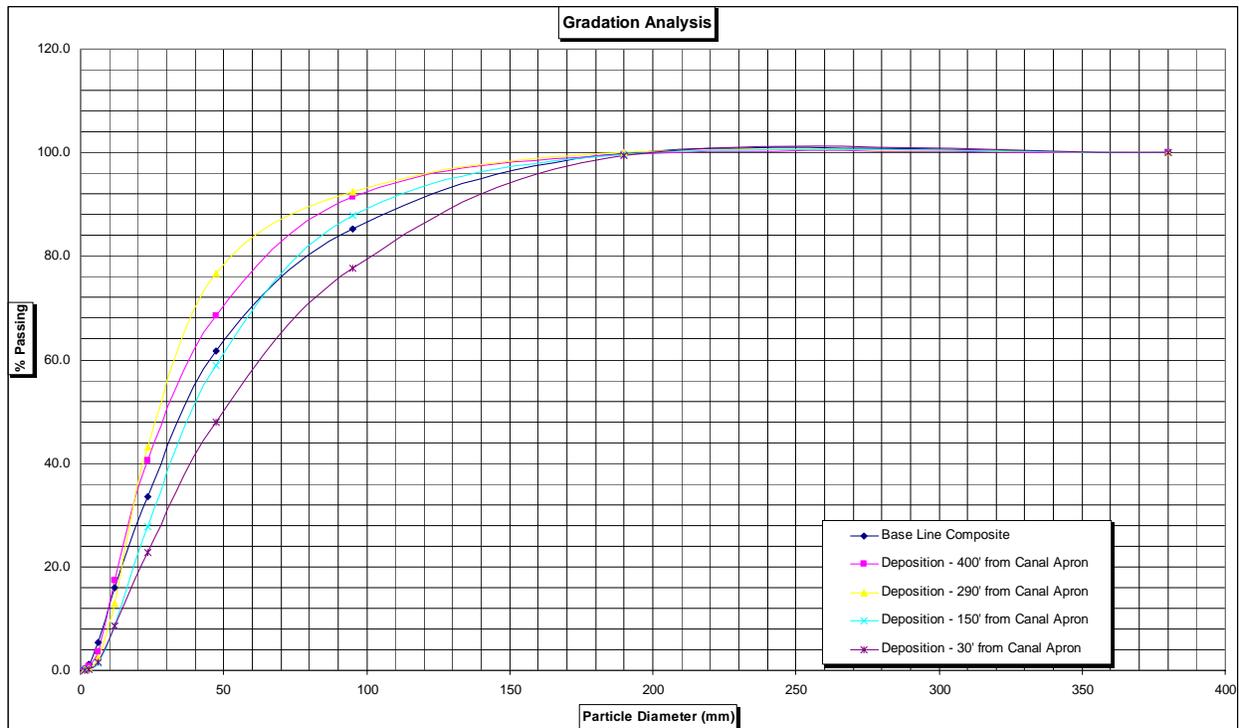
Figure 48 - HFB-R14000 surface sediment gradation sampled along a cross section located 63 ft upstream of the dam axis.

spillways and low velocity flow on the left half of the channel. The sediment delta in front of the canal apron reached about elevation 762.0 during the declining limb of the flood resulting in small amounts of bed sediment being entrained into the canal. During the test 6.0 yds³ model (48,000 yds³ prototype) of sediment were fed into the model. Post-test bed elevations, photographs of the post-test channel bed and a photogrammetric-generated map of the post-test diversion pool bed, are given in figures 45, 46, and 47, respectively. Gradations of surface sediments deposited at cross section 63 ft upstream of the dam axis are given in figure 48. Sediment gradations were similar with generally finer material deposited close to the right bank.

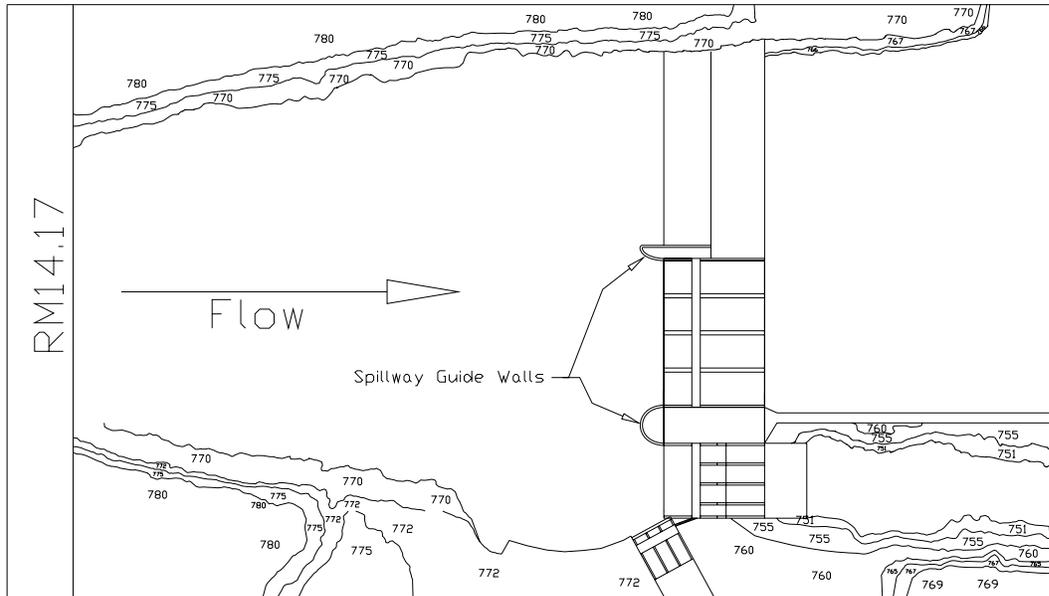
Figure 49 – Plan view of spillway guide walls tested in the model.

Guide walls were added to reduce the flow contraction that occurred on the outside walls of service spillway bay 4 and HFB spillway bays 5 and 8. A strong flow contraction occurred off the left wall of bay 4 and to a lesser extent bay 3 of the service spillway. Flow velocities measured upstream of the dam in tests Ss6000 and Ss14000 show flow approaches the service spillway entrance at an angle. Adding a curved upstream guide wall extending about 21 ft into the diversion pool was found to effectively guide flow into the spillway. Figure 49 shows the guide wall arrangement tested for the service spillway with the right bank HFB spillway option. The discharge capacity of the service spillway with the guide wall extension on bay 4 was 5,800 ft³/s at pool elevation 767.1. Strong flow contraction occurred off the outer walls of HFB bays 5 and 8 for both spillway locations tested. Entrance conditions to the spillway were improved by adding curved guide walls extended into the diversion pool similar to the service spillway guide wall. Guide walls tested for the near right bank HFB spillway location are also shown in figure 49. Although not tested in the model, similar guide walls could be applied to the left bank HFB spillway location to improve entrance conditions. For the right bank HFB location shown, guide walls between bays 4 and 5 were tested as a single pier that improved flow into both bays. The discharge capacity of the HFB spillway with upstream guide walls was 9,900 ft³/s flow at pool elevation 767.1 (test conducted without sediment transport through the spillway).
