Hydraulic Laboratory Report HL-2008-07

**Robles Diversion Dam
High Flow and Sediment Bypass
Structure
Ventura, California**

Physical Model Study

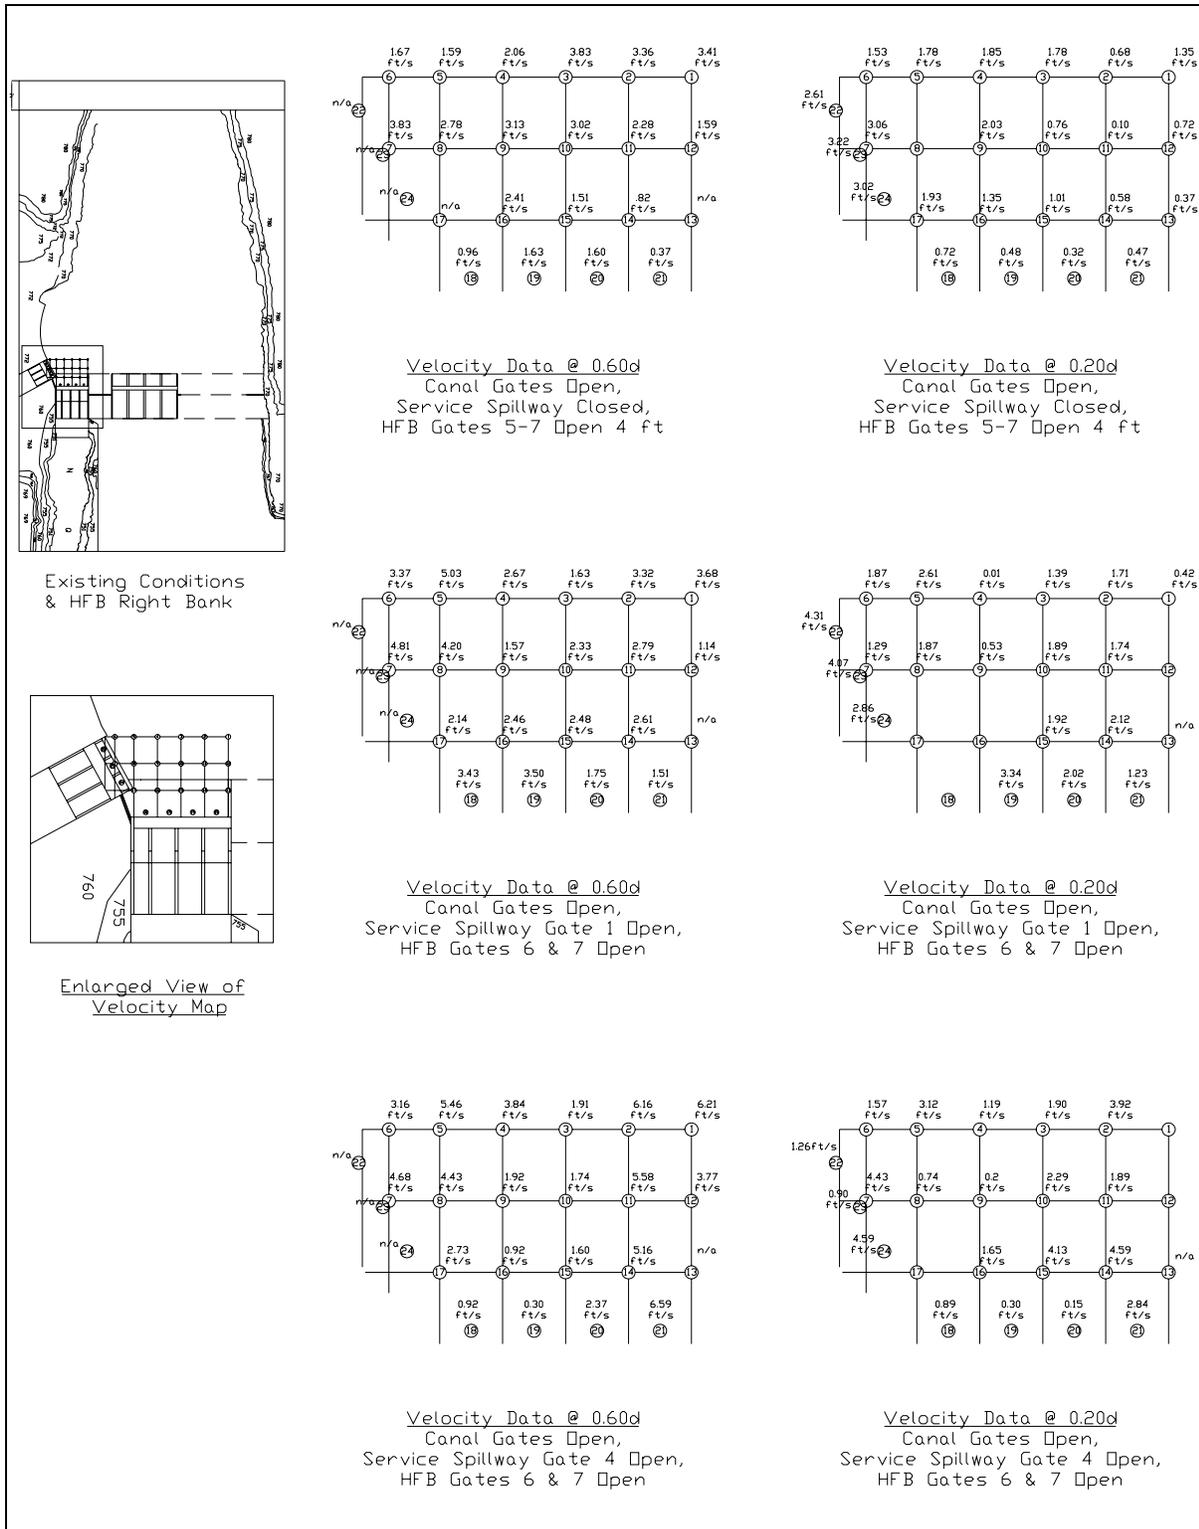
Figure 50 - Flow velocities measured in front of canal entrance.

The fish exit of the existing upstream fish passage was inundated by sediment in the diversion pool in all tests conducted. HFB spillway location and gate operation were ineffective at preventing the sediment delta from building in front of the exit. Flow through the fishway was not modeled, however, flow passing through the fishway with the sediment deposition observed would likely entrain large amounts of sediment resulting in plugging of the fishway. Based on the test results the fishway exit gates would likely be closed prior to a large flood. Fish would then have to exit through the canal headworks structure and swim past the service spillway to pass upstream. This raises the potential for fish to be re-entrained downstream through the service spillway when it is operating. To evaluate the re-entrainment potential, flow velocities were measured on a grid covering the area in front of the canal and spillway entrances for three spillway gate operations. Velocities were measured at 0.2 and 0.6 times the depth below the surface for a river flow of 5,800 ft³/s and diversion pool elevation of about 767.0. Flow velocity was generally less than 6 ft/s for all conditions tested (figure 50). Measurements were not made with all service spillway gates open as flow depth and velocity varied substantially when the sediment delta previously discussed fully developed in front of the canal intake. Flow velocities measured during test Ss14000 indicates flow velocity could reach 15 ft/s with all gates open and shallow flow over sediment deposits.

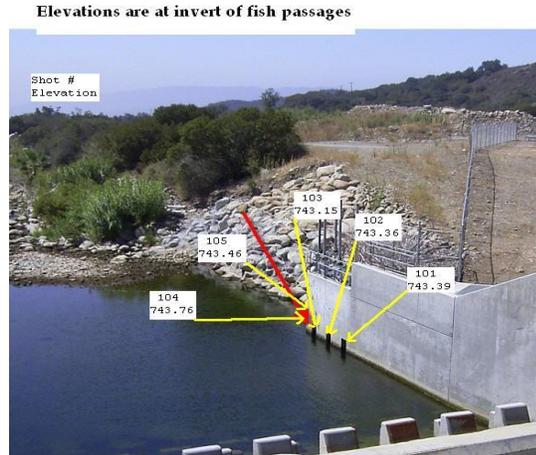
Figure 51 - Photograph of fishway entrances below Robles Diversion Dam service spillway (Casitas Irrigation District).

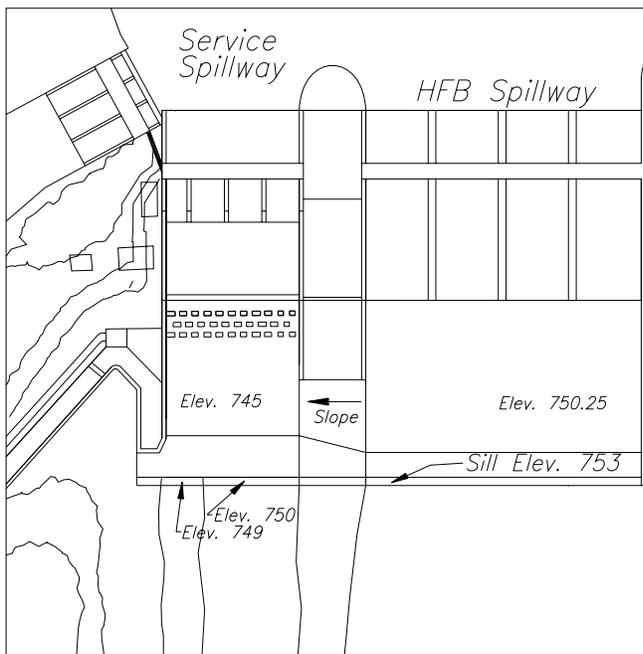
Figure 52 – Illustration of single spillway pool concept.

A single stilling pool concept was tested in the model as an alternative to the initial separate channel design. A single stilling pool would allow fish during HFB operation to move across the channel, providing better access to the fishway, figures 52 and 53. For the single pool concept, the HFB stilling pool and the downstream river channel were set higher than the river downstream of the service spillway to avoid a stagnate pool from forming downstream of the HFB during flow releases less than about 1,000 ft³/s. Tests of the single pool option identified several conditions that were undesirable. Most significantly, HFB spillway flow transported large amounts of sediment into the service spillway fishway entrance pool through the intertie between the pools. This eliminated the ability to control sediment deposition in the fishway entrance pool by adjusting spillway operation. Additionally, poor flow conditions for fish occurred during operation of the service spillway at flows above about 1,000 ft³/s with the HFB spillway closed. This type of operation resulted in flow moving into the HFB stilling basin and then flowing downstream as a wide shallow flow over the full width of the HFB end sill.

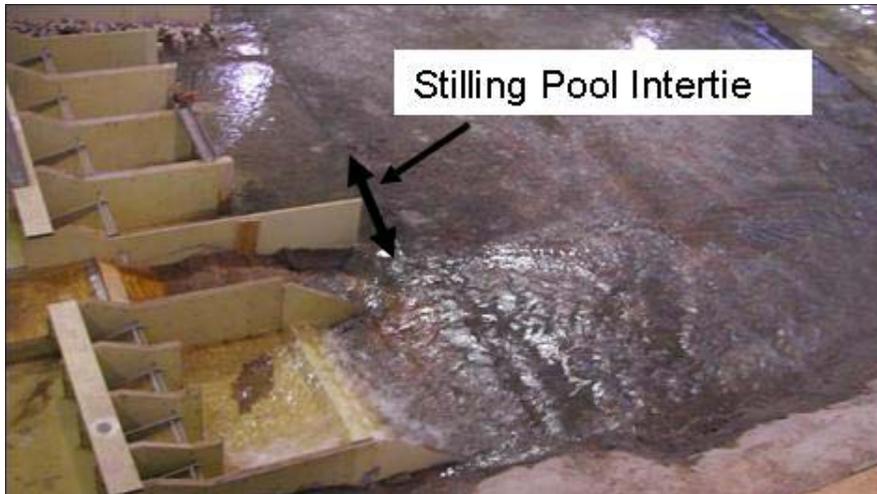
Figure 53 – Single pool concept shown with service spillway releases of 1,000 ft³/s.

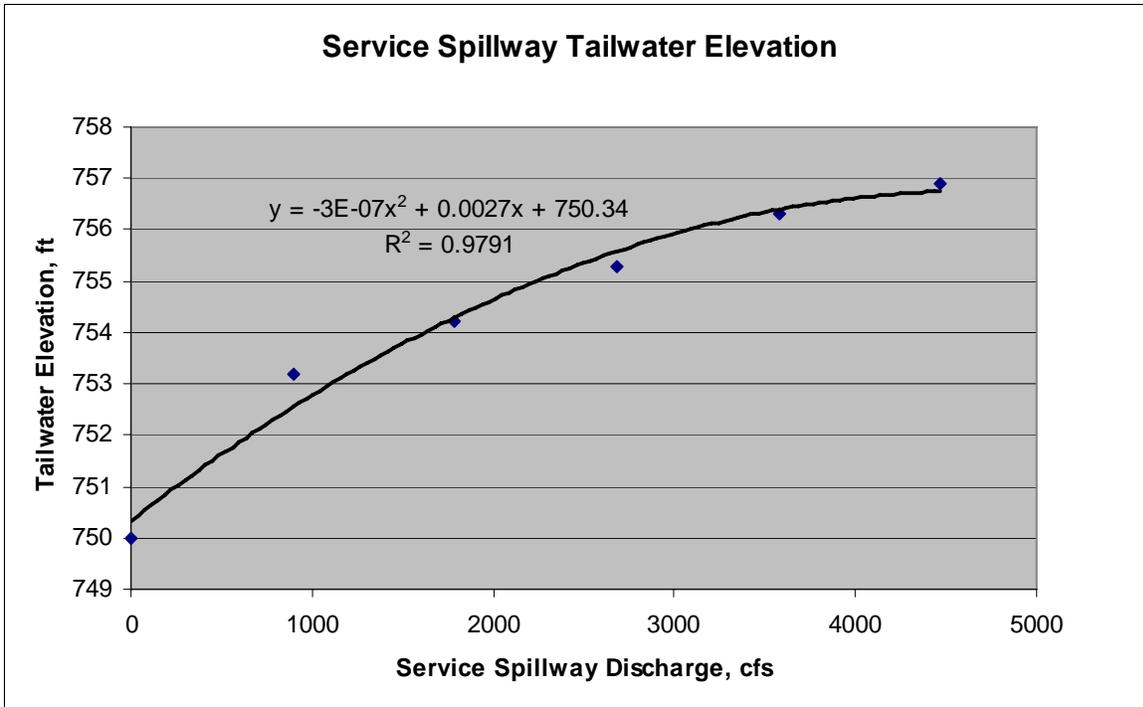
Figure 54 –Water surface elevation measured in right bank fishway entrance pool.

Tailwater elevations measured in the model for service spillway operation (HFB closed) are shown in figure 54. Both sediment and flow conditions were improved by extending the length of the HFB stilling basin 11.7 ft (basin floor length of 46.7 ft) and extending the right wall of bay 5 to the downstream end of the stilling pool, figures 55 and 56. A sluice gate was placed in the wall separating the service spillway and HFB spillway stilling pools to allow controlled movement of water between the stilling pools. Tests of the downstream wall extension resulted in no discernable movement of HFB sediment into the fishway entrance pool. The wall extension also prevented flow from the service spillway into the HFB spillway when the sluice gate was closed. The sluice gate allowed for draining the HFB basin into the lower service spillway pool following HFB operation. Operation of the service spillway during the ten-year flood resulted in about 2 to 3 ft of sediment in the fishway entrance pool following a ten-year flood simulation, figure 57. Following the flood, the service spillway was operated at 2,500 ft³/s for about eight hours prototype in an attempt to sluice material out of the fishway entrance pool. The sluicing exercise resulted in only localized scouring of material located near the base of the baffled apron, figure 58. The top three rows of baffles on the baffled apron energy dissipater were then removed in the model to determine if sluicing of the fishway entrance pool could be improved. The service spillway was again operated at full pool for eight hours prototype at 2,500 ft³/s at full pool. Removing the baffles showed improved sluicing of sediment with material being removed from the upstream one-half of the pool, figure 59.

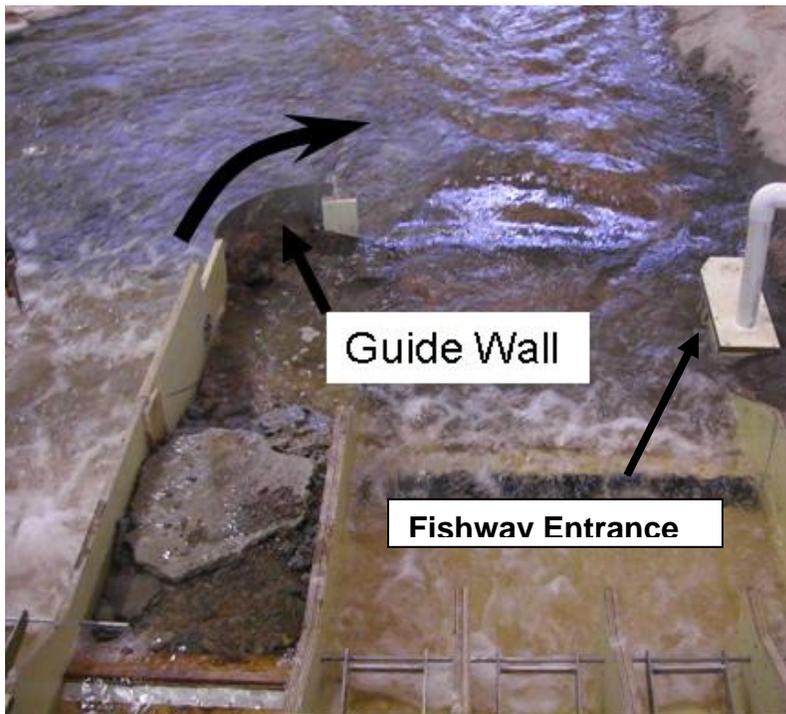
Figure 55 – View of stilling pool guide wall extension added to prevent sediment from being pulled into the right bank fishway entrance pool.

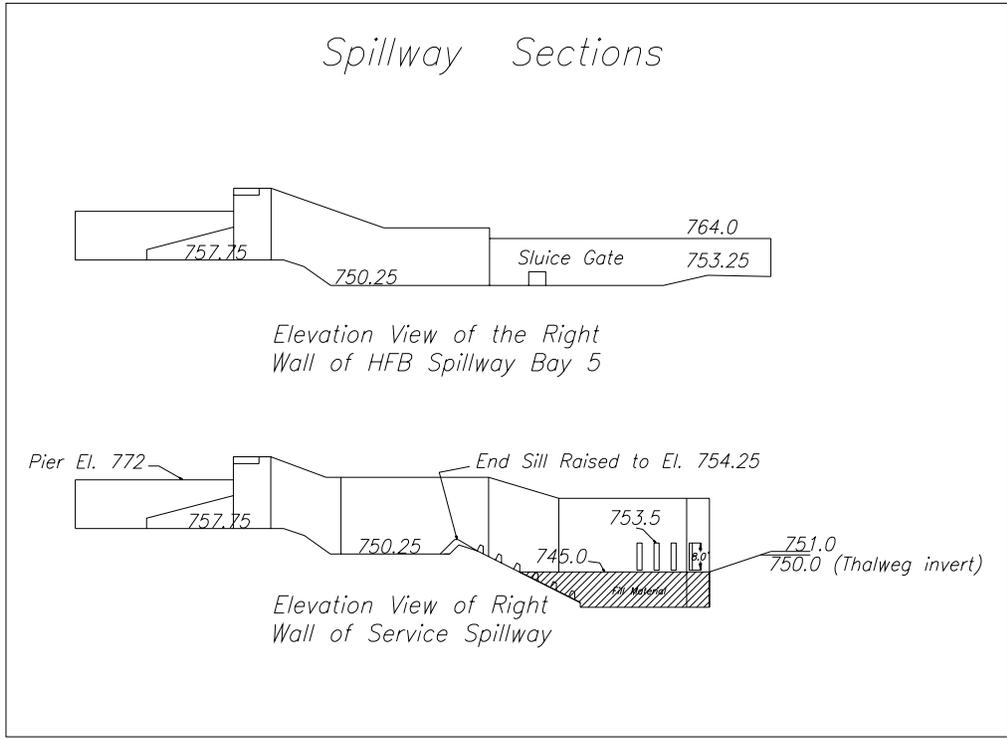
Figure 56 - Sections through the HFB spillway and service spillway.

Stilling basins of different lengths and with and without endsills were tested. Type 1 basins without endsills are recommended to promote flushing of bed load away from the structure and the HFB fishway entrance, figure 56. Downstream of the HFB stilling basins, a 2.0 percent slope rock ramp provides a transition between the HFB structure, the service spillway channel and the downstream river channel.

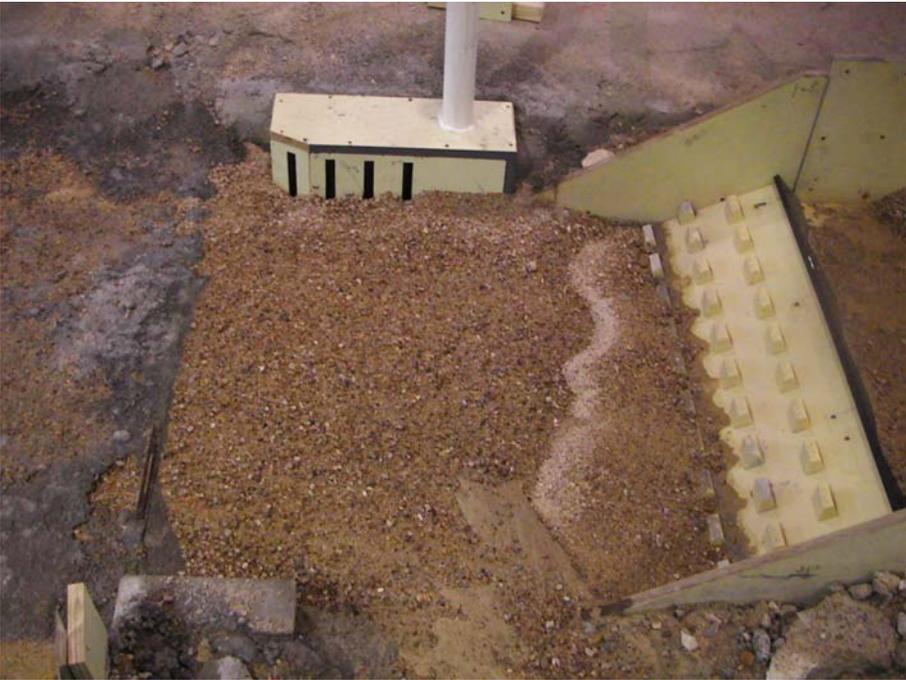
Figure 57 - Sediment deposition in the right bank fishway attraction pool following a ten year flood simulation.

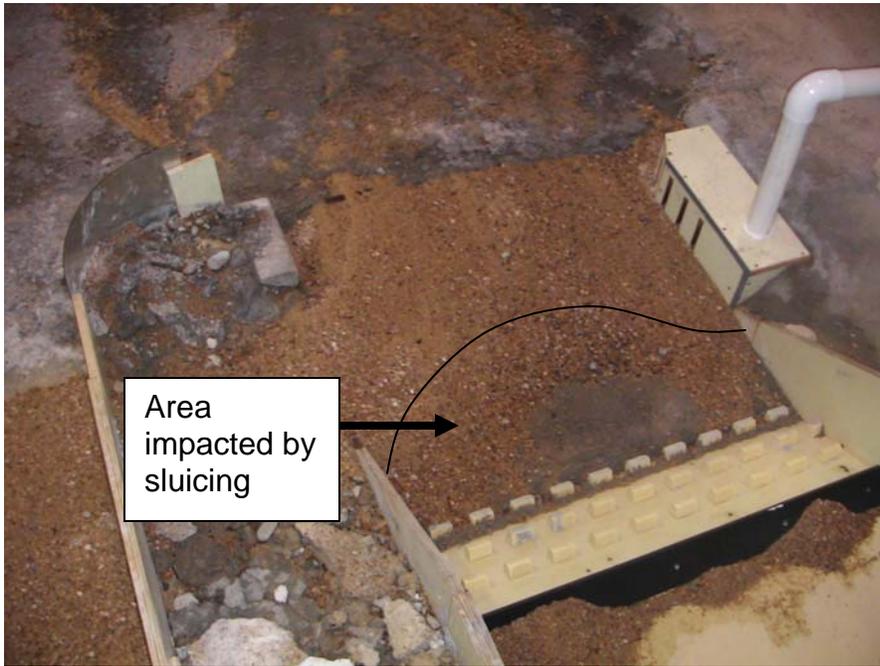
Figure 58 - Local scouring following eight hours prototype of the service spillway operating at 1500 ft³/s.

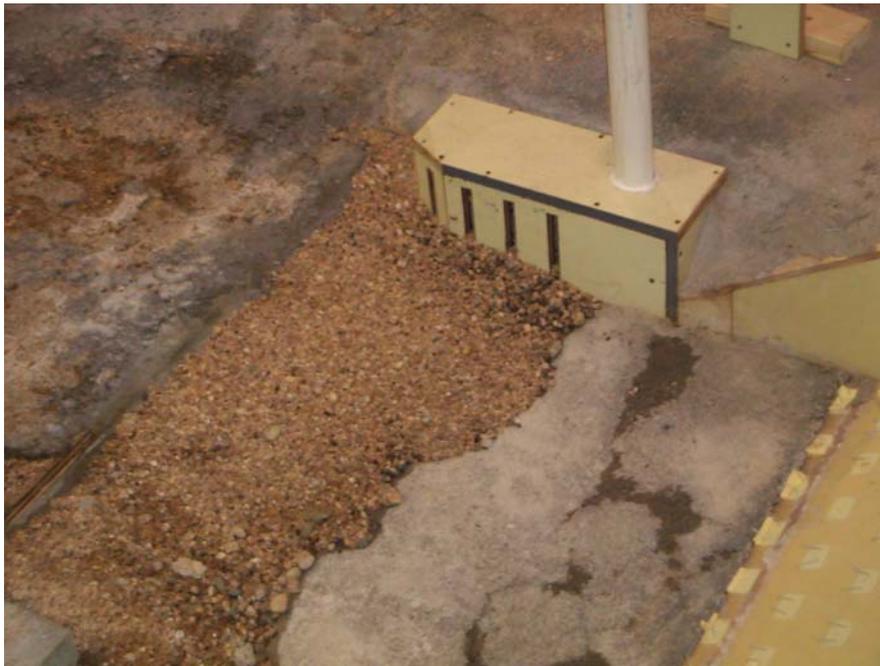
Figure 59 - Local scouring following eight hours prototype operation of the service spillway after removal of baffles on apron. Figure 56 shows pre-sluicing condition.

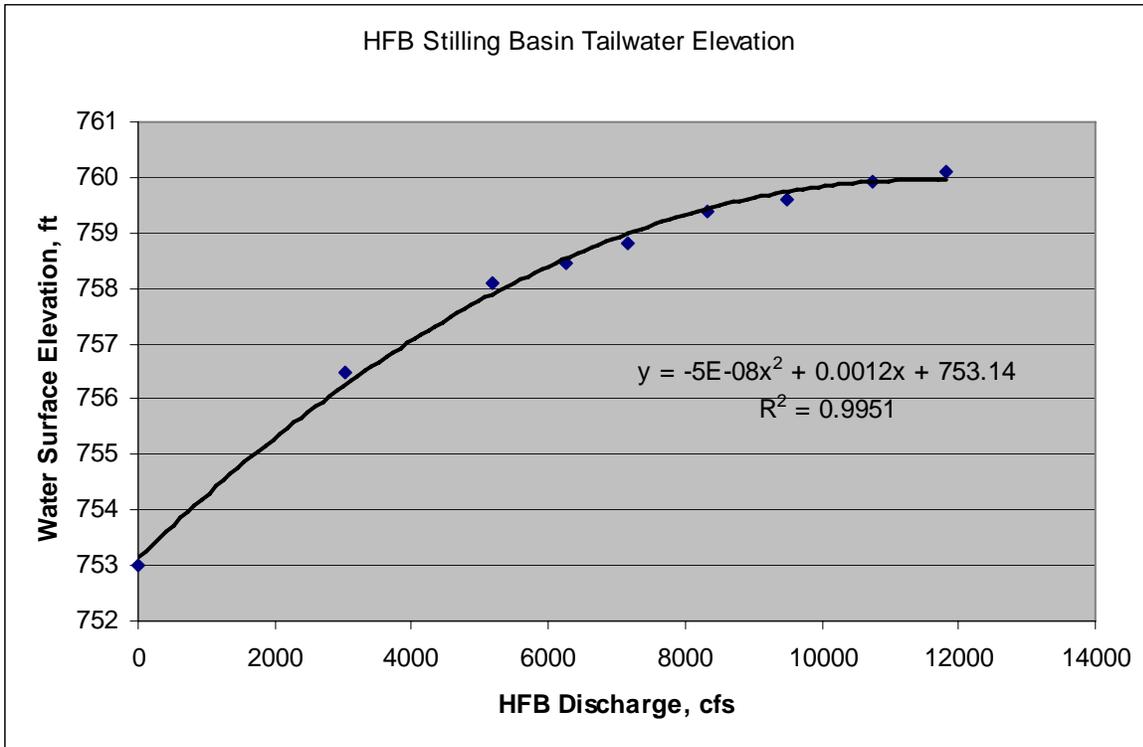
Figure 61 - Tailwater elevation measured in the HFB spillway stilling basin.

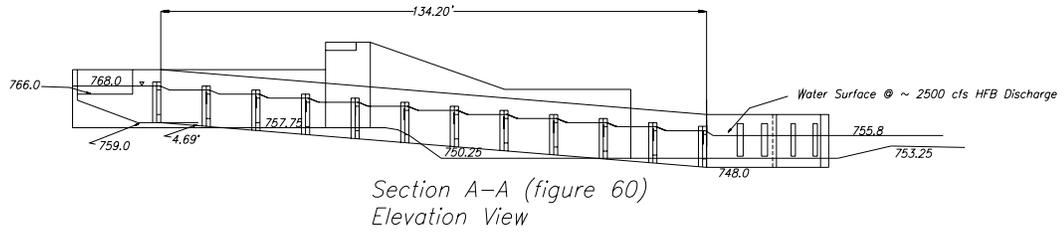
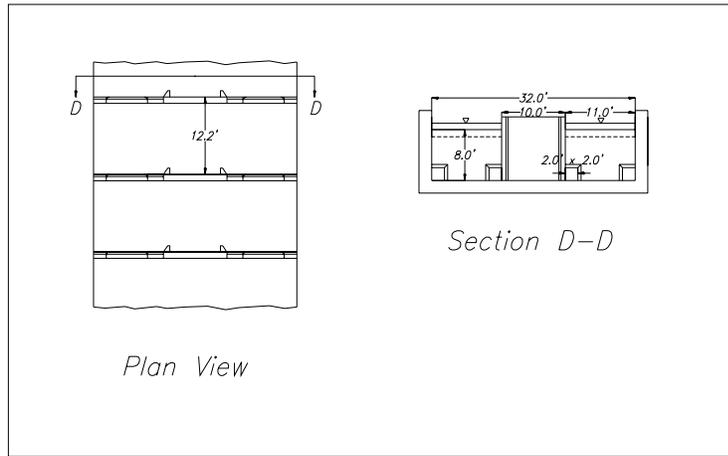
HFB Fishway Sections Weir and Orifice Style Baffles

Baffle Detail

Figure 62 - HFB spillway left side fishway shown with weir and orifice baffles. (Baffle dimensions shown are preliminary.)

The left side fishway would only operate during HFB spillway operation. The fishway exit is shown integrated with the guide wall upstream of spillway bay eight. The maximum head drop across the fishway is about 12 ft assuming a minimum flow release of 2,500 ft³/s from the HFB spillway. Tailwater elevations measured in the model HFB stilling basin are shown in figure 61. The fishway was designed to pass about 170 ft³/s at pool elevation 768.0. The fishway exit was modeled as a 20 ft long sill with a crest elevation of 766.0. An overshot gate was proposed for the sill to close off the fishway when the HFB spillway was not operating. The gate was not represented in the model. The fishway modeled was 32 ft wide with 12 baffles spaced at 12.2 ft centers at an invert slope of 8.2 percent. Fishway entrance and exit flow conditions were investigated in the model. Fishway baffles were installed in the model fishway, however flow conditions within the fishway were not investigated due to the small size of the fishway in the model. Two types of fishway baffles are offered herein for consideration. First is a modified Ice Harbor weir and orifice style baffle, figure 62. Each baffle is 8 ft high with 4-2 ft square orifices located flush with the bottom and two 11 ft long weirs adjacent to the outer walls. In the center of the baffle is a 10-ft-long non-overflow wall. The pools would have an energy dissipation factor (EDF) of 3.5 ft-lbs/s/ft³ at 170 ft³/s flow.

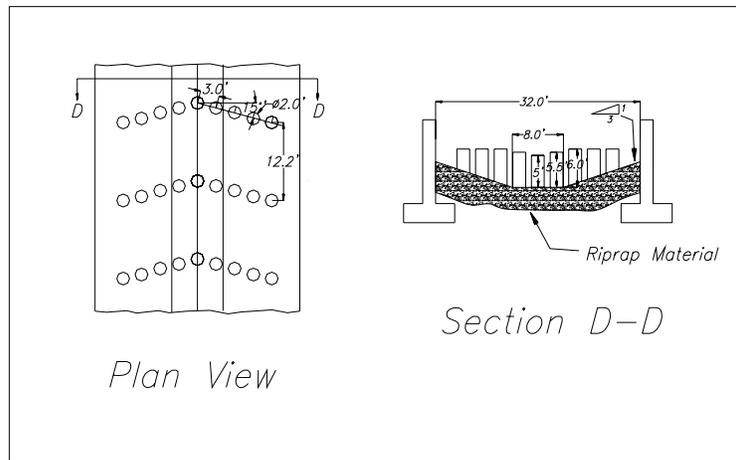
Section A-A (figure 60)
Elevation View

Plan View

Section D-D

Baffle Detail

Figure 63 - Left side fishway shown with streaming flow style baffles. (Baffle dimensions shown are preliminary.)

The second proposed baffle design is a multiple slot roughened channel design developed by the author to mimic several important attributes of flow in a natural stream, figure 63. The baffles cause a pool and drop pattern and direct the flow toward the center of the channel creating the highest velocity in the center with lower velocity near channel edges. The rock-lined trapezoid channel produces great variability of flow depth and velocity from deep higher-velocity flow in the channel center to shallower near-bank flow with low velocity. The baffles can be designed to control flow over a wide range of head change by extending all baffles to the maximum water surface design height, or baffles near the center of the channel can be shorter and allowed to overtop as the upstream water level rises during a flood. Using shorter baffles in the center of the fishway that become submerged results in rapid increases in flow passing down the center of the fishway channel. This has proven desirable where a rapid rise in through-fishway flow is needed to produce good attraction during high river flows while providing passage conditions near the channel boundaries. The HFB fishway shown herein designed on the streaming flow concept would be a 32-ft-wide rock-lined trapezoidal channel with a 10-ft-wide bottom and 3H:1V side slopes. Typical baffles for this style fishway are composed of individual rock boulders or concrete columns set in an upstream-aligned chevron shape and spaced about 1.0 to 1.5 ft apart, depending on design flow. Boulders are typically used on lower gradient fishways with pool lengths of greater than 15 ft and a flow depth under normal conditions of less than 4 ft. Concrete columns have the advantage that they can be constructed to any height and diameter. Therefore, when strong control of the fishway flow is desired and flow depths exceed about 4 ft, columns are recommended. This design has been used for numerous non-salmonid fishways at slopes up to 5 percent, and the fishway design has proven to work well where large flows are passed through the fishway.

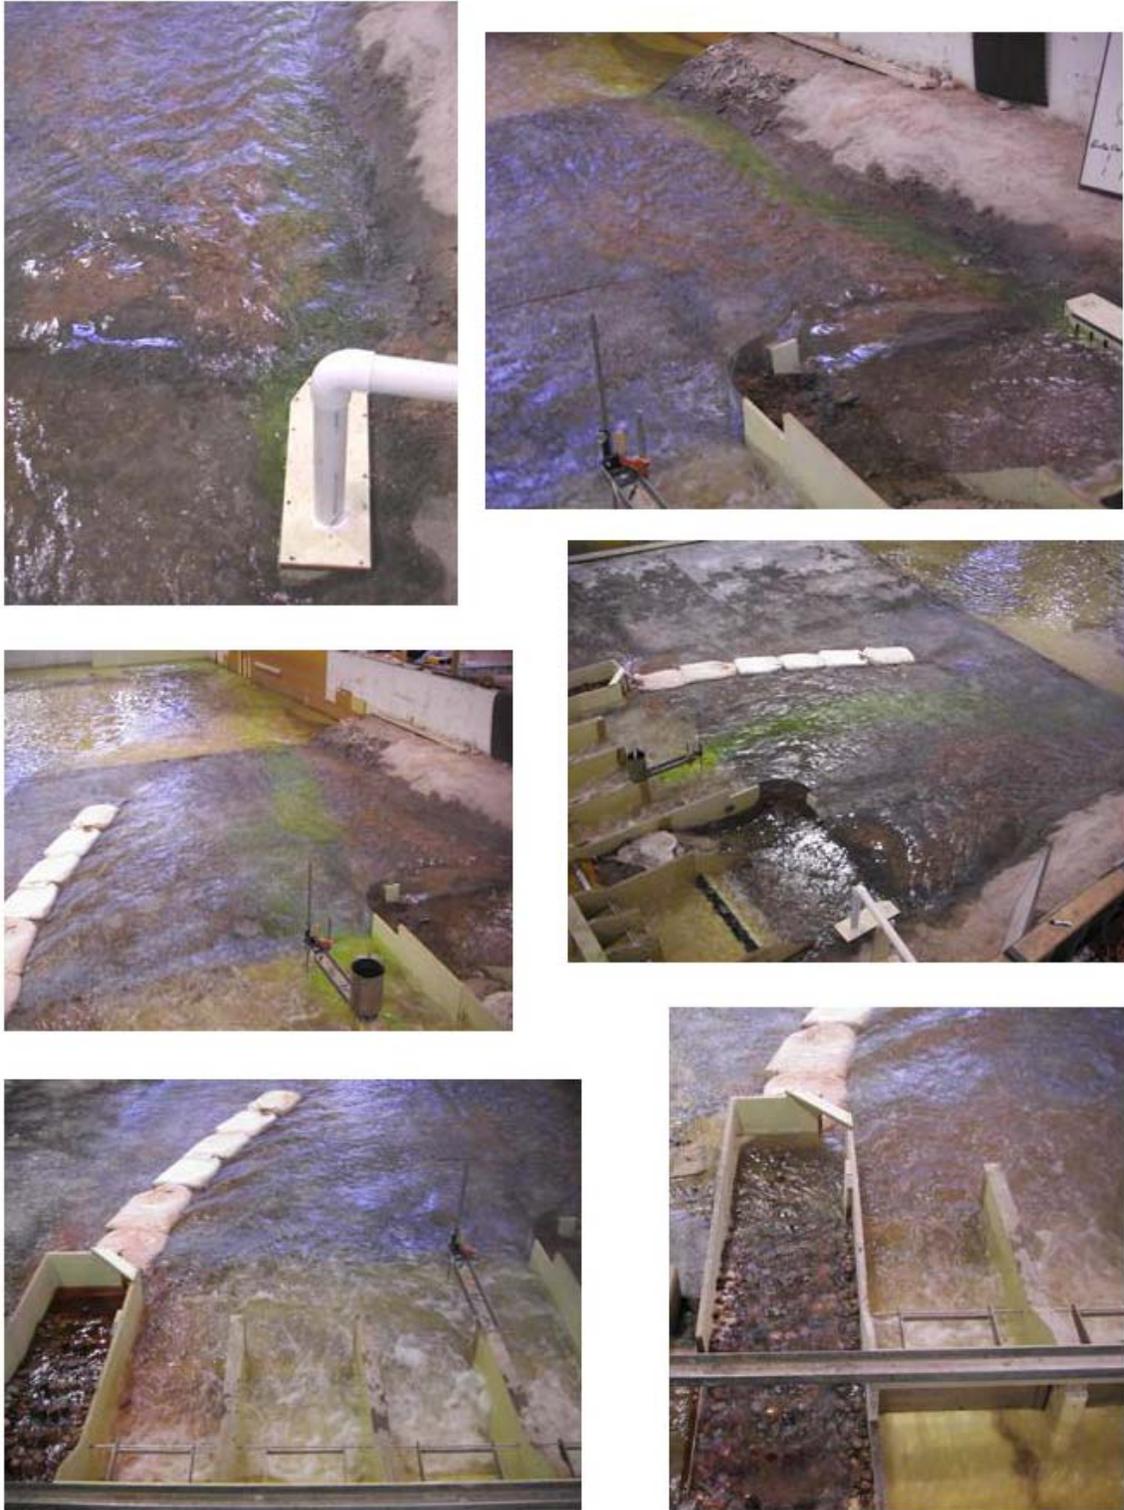
Figure 64 – Model tests showing dye injected in the right bank fishway (top), in HFB bays 5 and 6 (middle) and in bay 8 and the left bank fishway (bottom). Spillway flows are 1,300 ft³/s service spillway and 6,900 ft³/s HFB spillway.

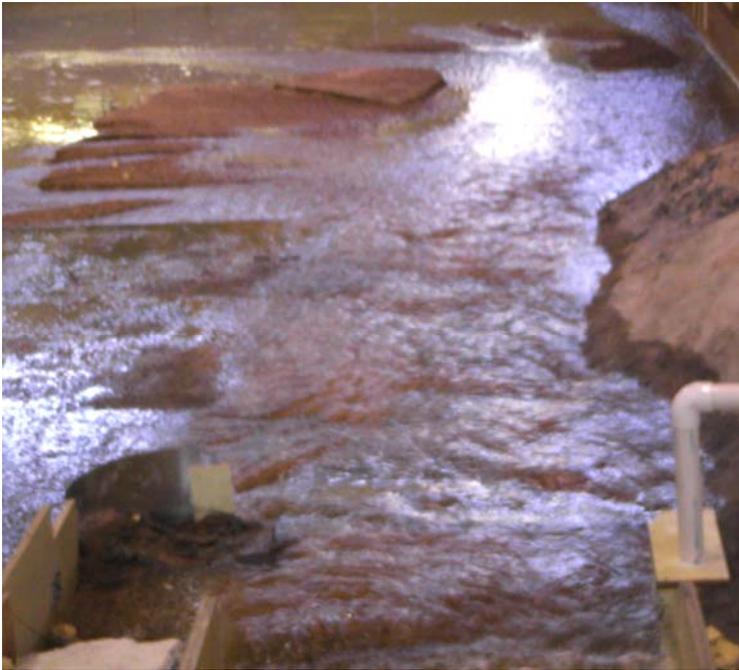
Figure 65 – Photograph of 2,500 ft³/s released from the service spillway gates flowing down the final downstream channel geometry during the declining limb of a ten year flood simulation. HFB spillway gates are closed.

Downstream Channel - Downstream of the two spillways the channels merge into a common channel with a low flow channel along the right bank. The rock berm previously separating the channels was removed and the channel shape modified to gradually merge HFB flow with the service spillway flow. The channel downstream of the service spillway was modeled with a 20-ft-wide low flow channel at elevation 750.0. To the left of the low flow channel, the channel sloped up at 1 on 5 to elevation 751 and then at approximately 1 percent to the left side of the service spillway channel. The invert elevation of the low flow channel at the downstream end of the fishway pool was held similar to existing to maintain the required tailwater on the fishway. The low flow channel was sloped at 1.5 percent until intersecting the existing channel elevation, a distance of about 400 ft. The invert elevation of the channel downstream of the HFB stilling pool was set at 753.25. The channel was sloped downstream at 2.0 percent and 0.25 percent normal to the downstream direction until intersecting the low flow channel. The left bank of the HFB channel was converged toward the low flow channel as shown in figure 60. Combined spillway operation and right and left bank fishway operation are shown in figure 64. Several photographs show dye streaks to highlight the direction of flow movement. The channel flowing at 2,500 ft³/s released from the service spillway following a ten year flood simulation is shown in figure 65.
