**COUNTY OF VENTURA
PUBLIC WORKS AGENCY
TRANSPORTATION DEPARTMENT
HUENEME ROAD CORRIDOR TRAFFIC SIGNAL AND SAFETY IMPROVEMENTS PROJECT
WOOD ROAD TO LAS POSAS ROAD**

**COUNTY OF VENTURA
PUBLIC WORKS AGENCY
TRANSPORTATION DEPARTMENT**
HUENEME ROAD CORRIDOR TRAFFIC SIGNAL
AND SAFETY IMPROVEMENTS
HUENEME ROAD AT LAS POSAS ROAD

**PROPOSED
PLAN
VIEW**

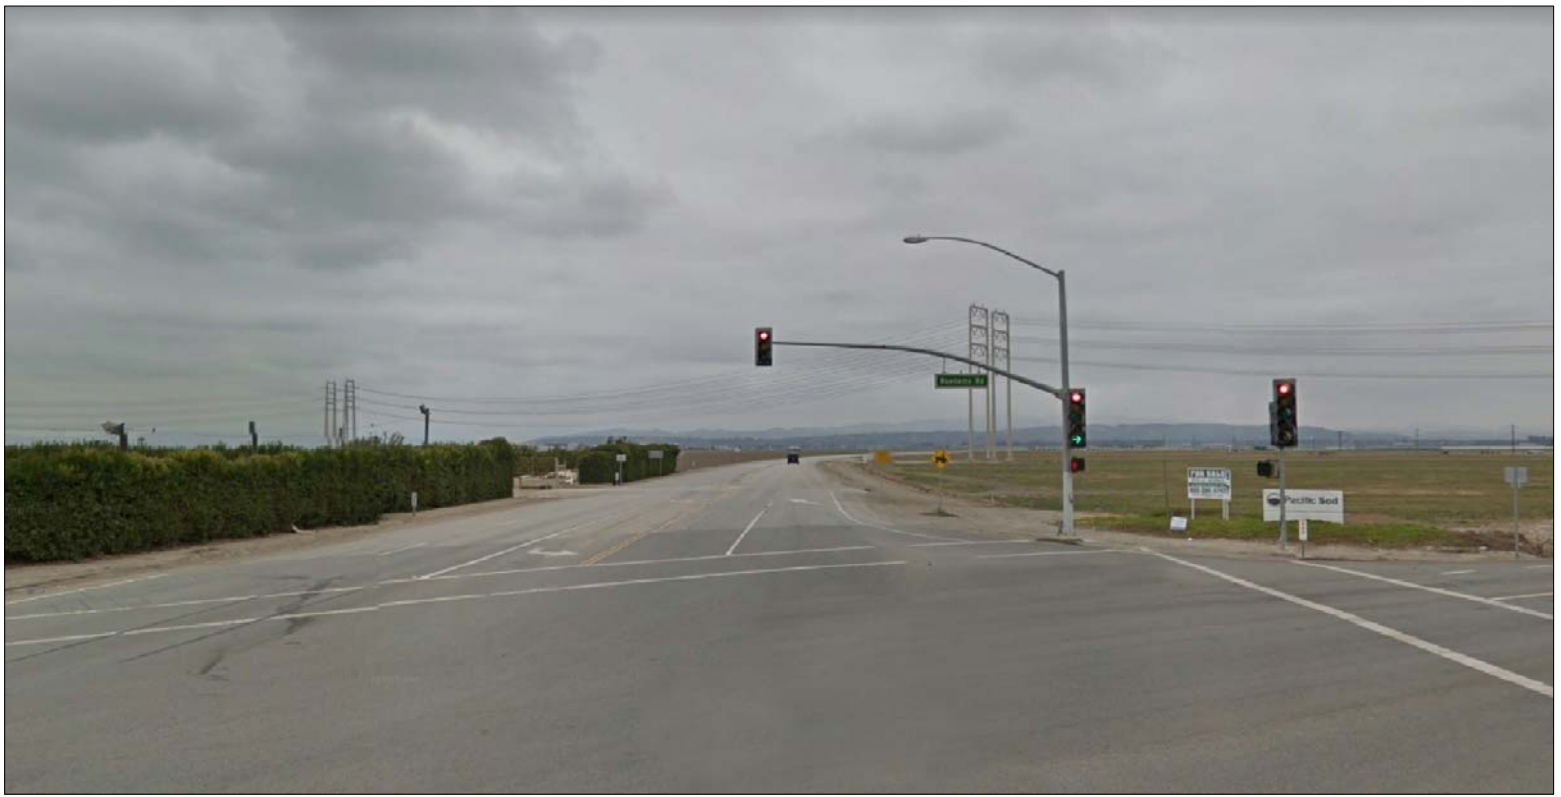
EXISTING CONDITION NORTHBOUND
 EXISTING - NO PROTECTED LEFT-TURN

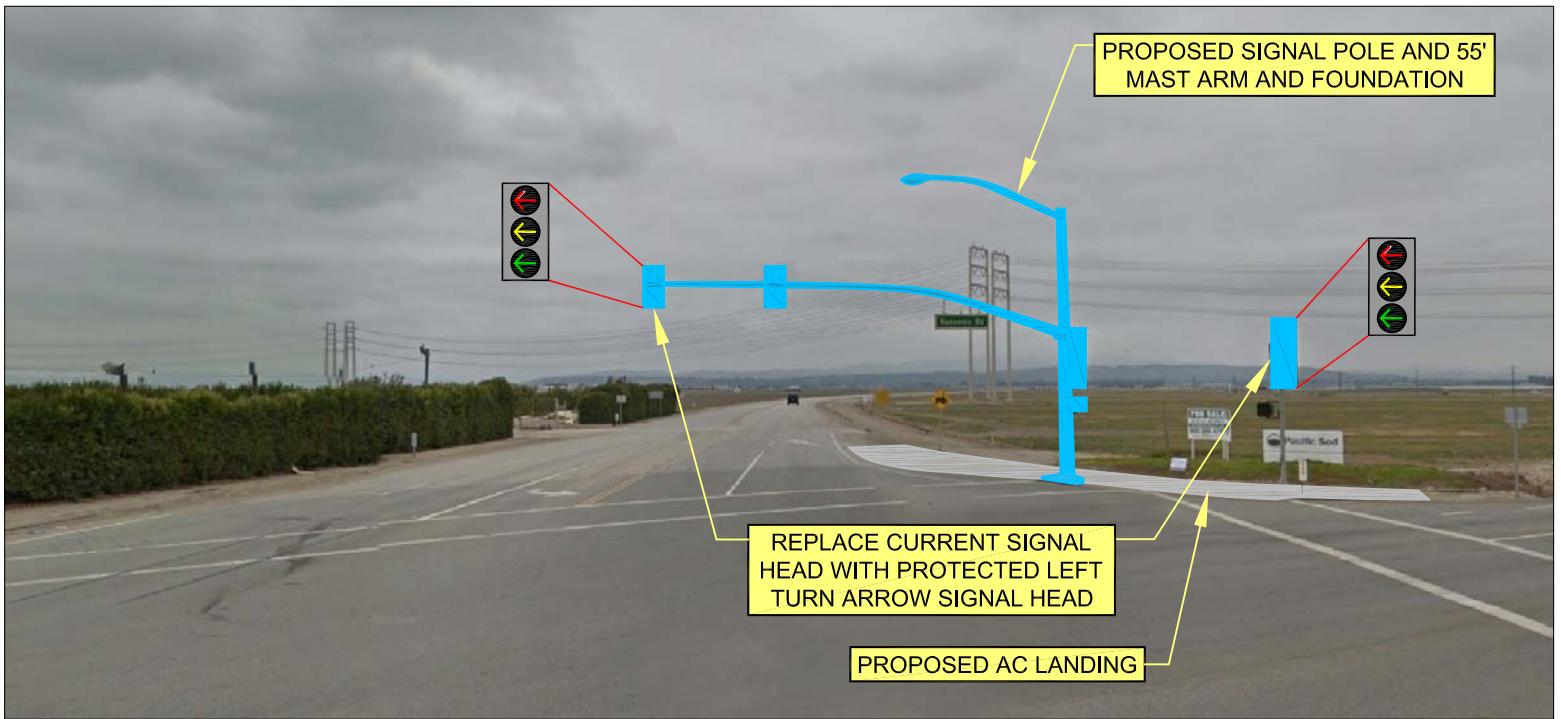
PROPOSED CONDITION NORTHBOUND
 PROPOSED - PROTECTED LEFT-TURN

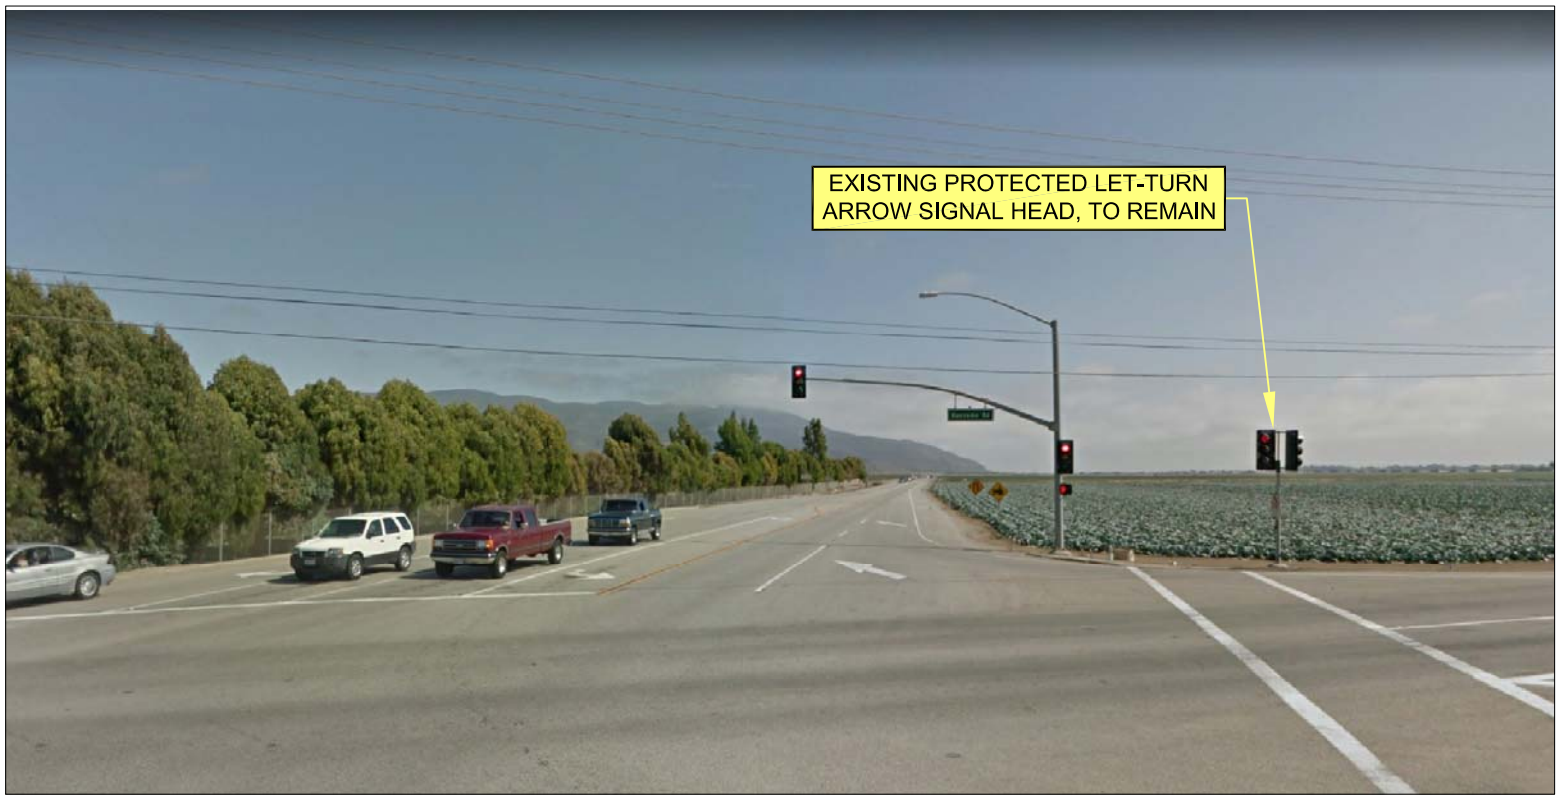
EXISTING CONDITION SOUTHBOUND
 EXISTING - NO PROTECTED LEFT-TURN

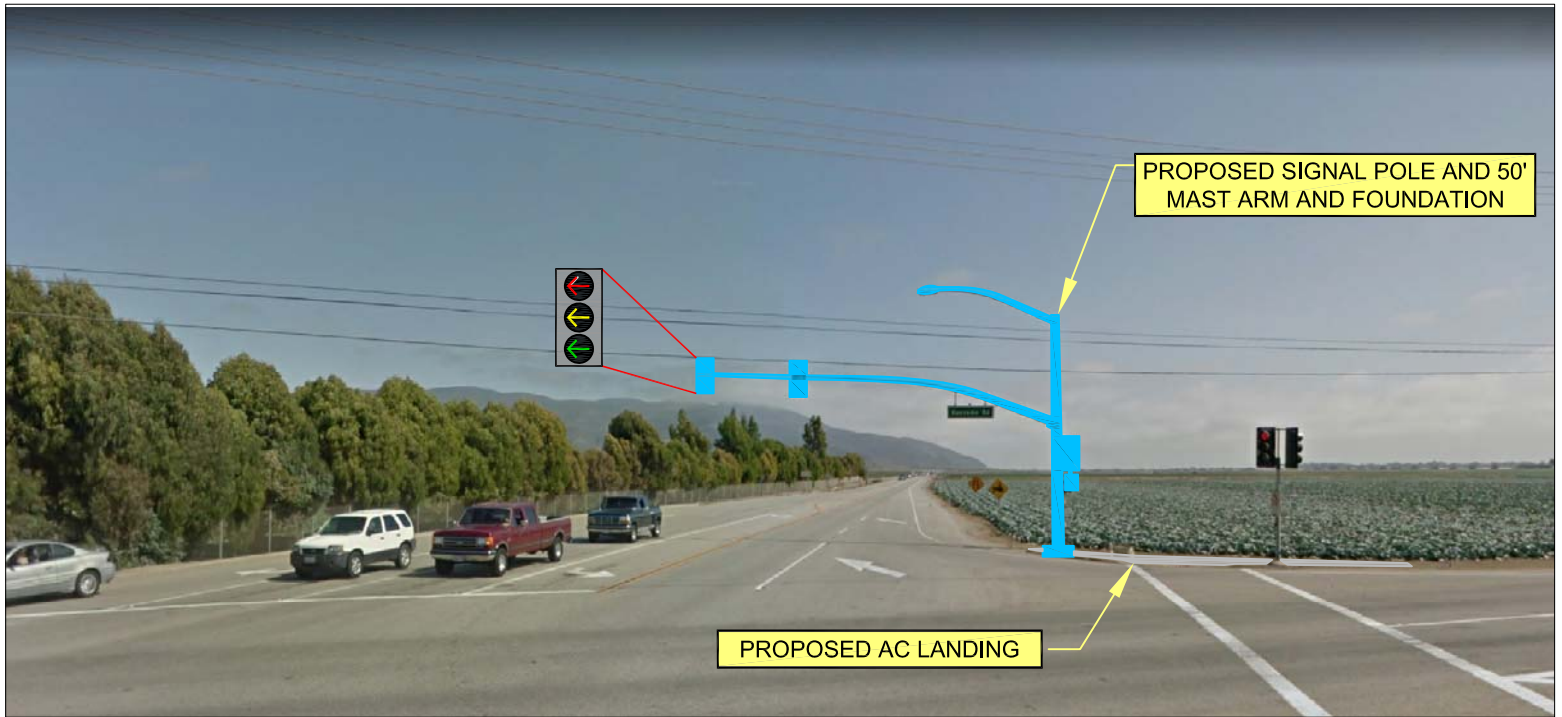
PROPOSED CONDITION SOUTHBOUND
 PROPOSED - PROTECTED LEFT-TURN

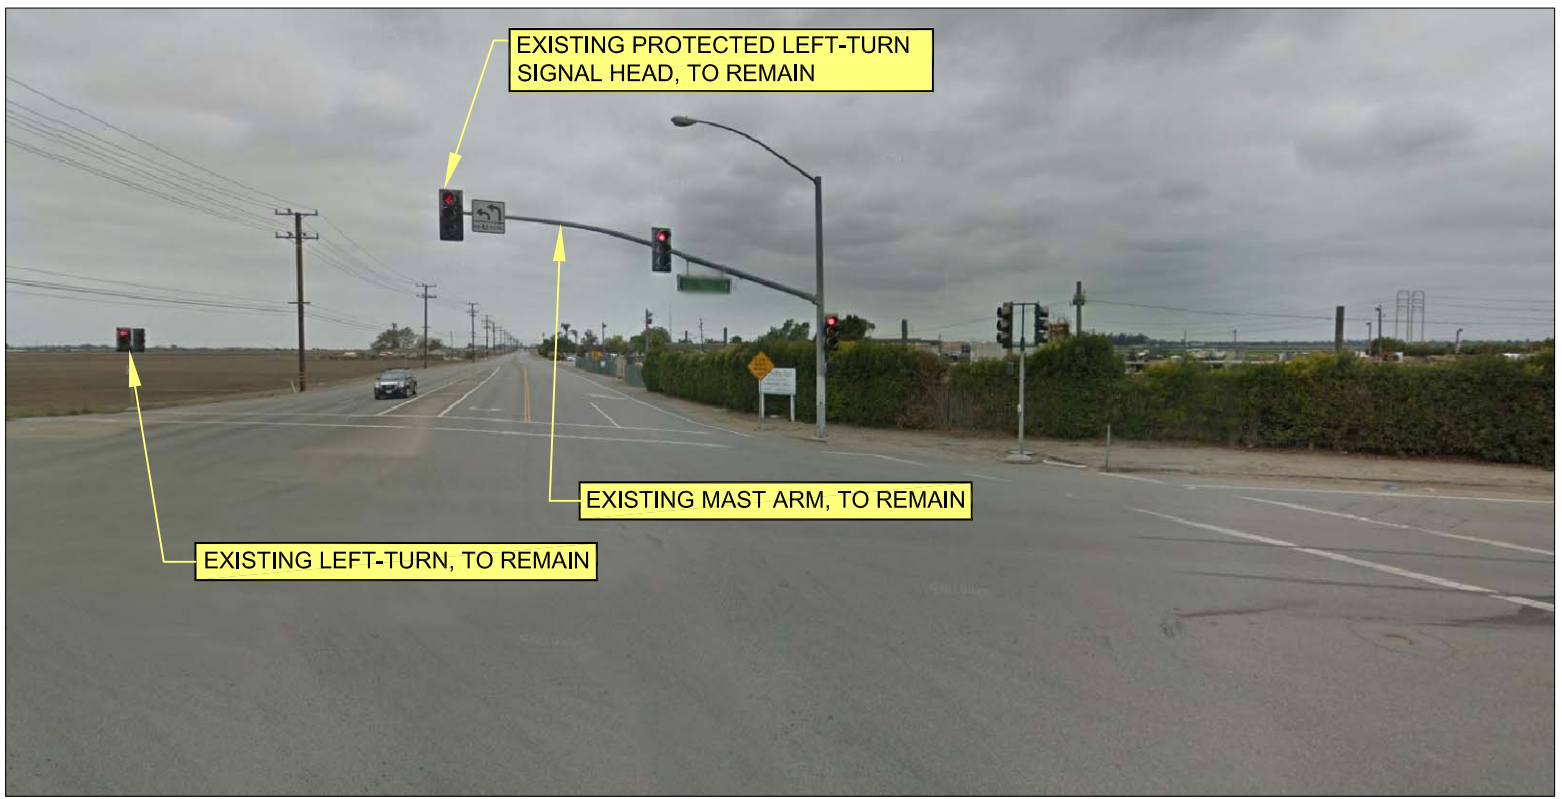
EXISTING CONDITION WESTBOUND
EXISTING - PROTECTED LEFT-TURN

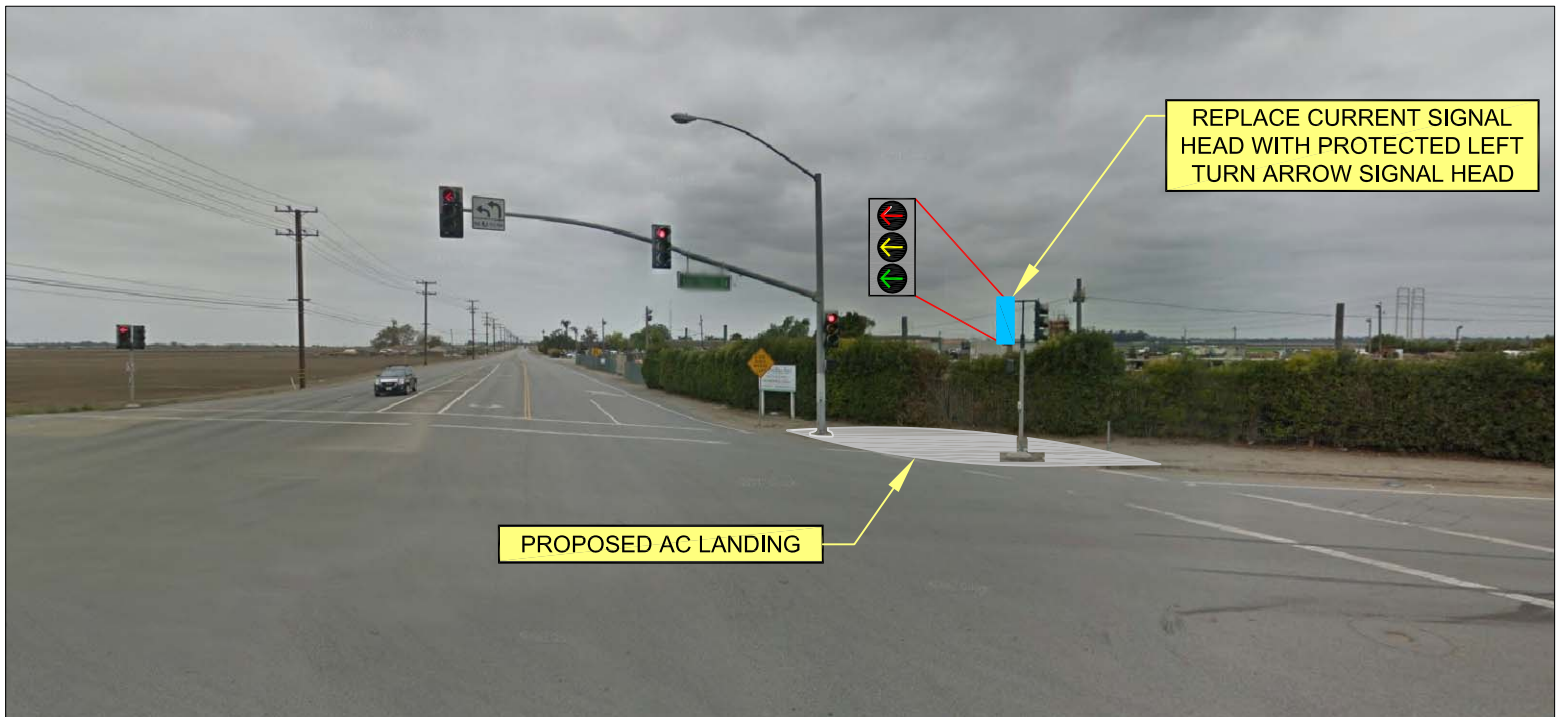
PROPOSED CONDITION WESTBOUND
PROPOSED - PROTECTED LEFT-TURN

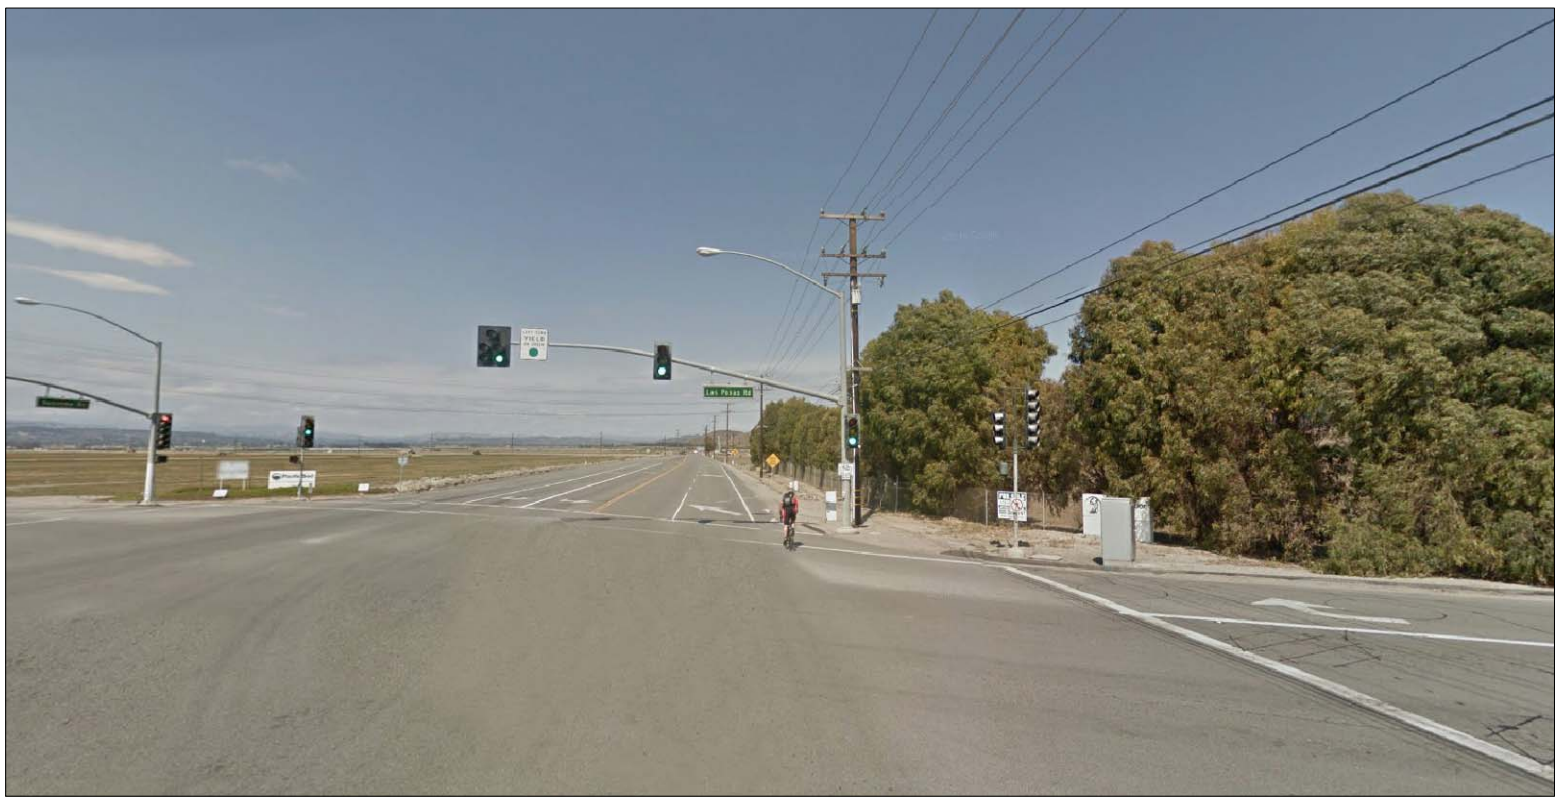
EXISTING CONDITION EASTBOUND
 EXISTING - PERMISSIVE LEFT-TURN

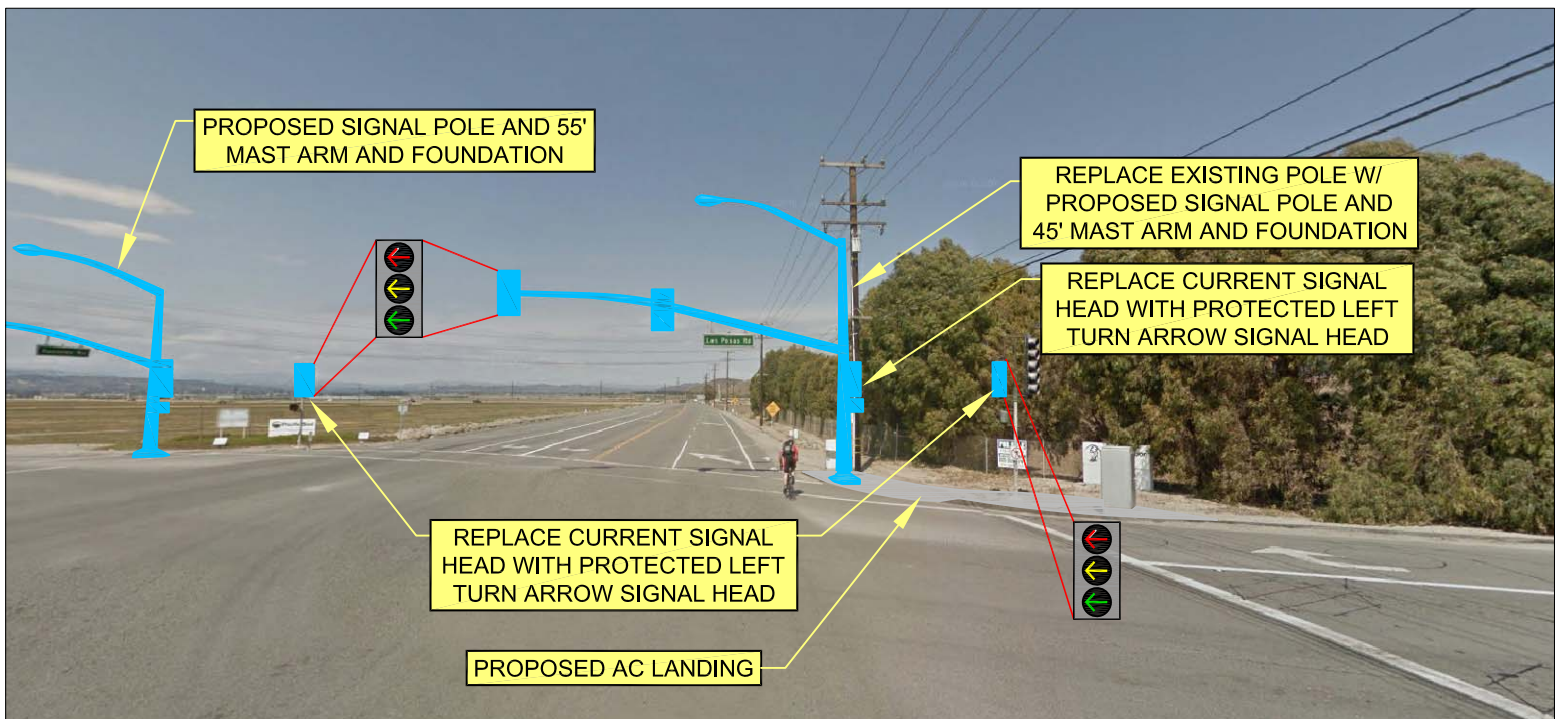
PROPOSED CONDITION EASTBOUND
 PROPOSED - PROTECTED LEFT-TURN

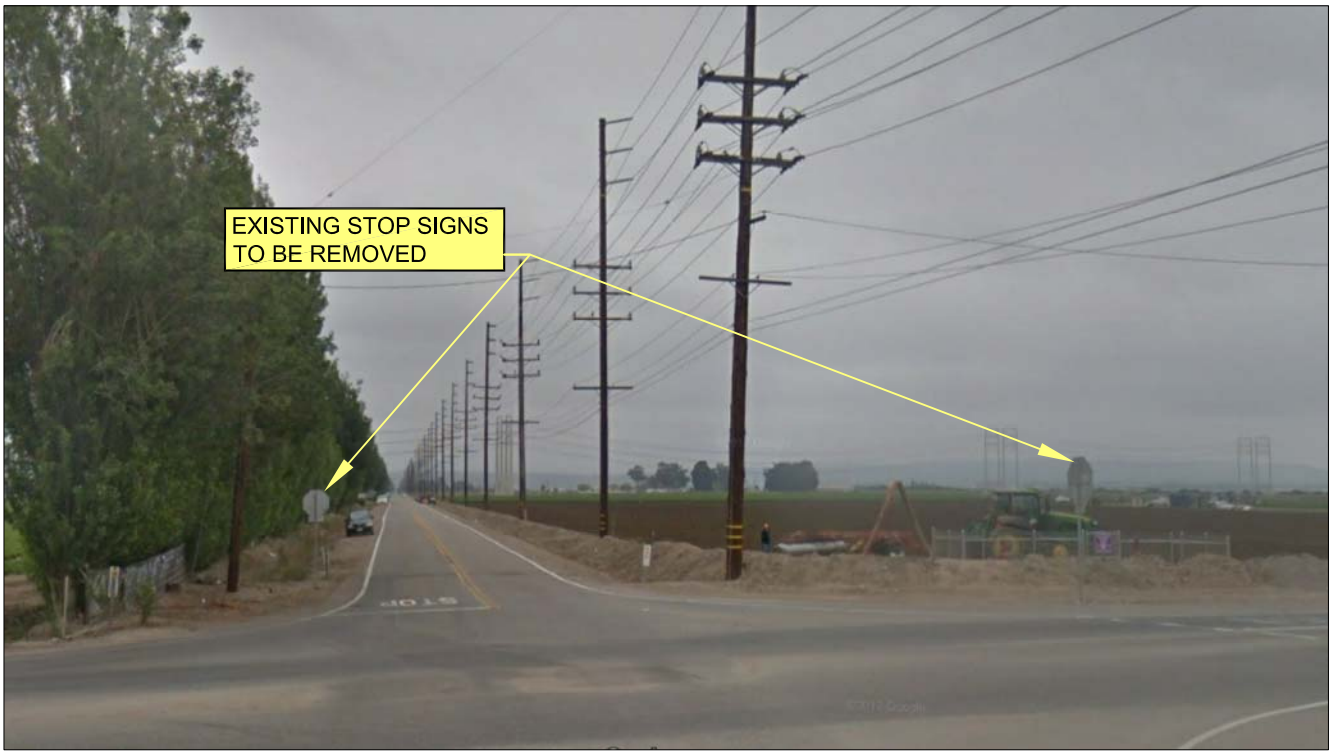
EXISTING STOP SIGNS
TO BE REMOVED

EXISTING CONDITION NORTHBOUND
EXISTING - 4-WAY STOP

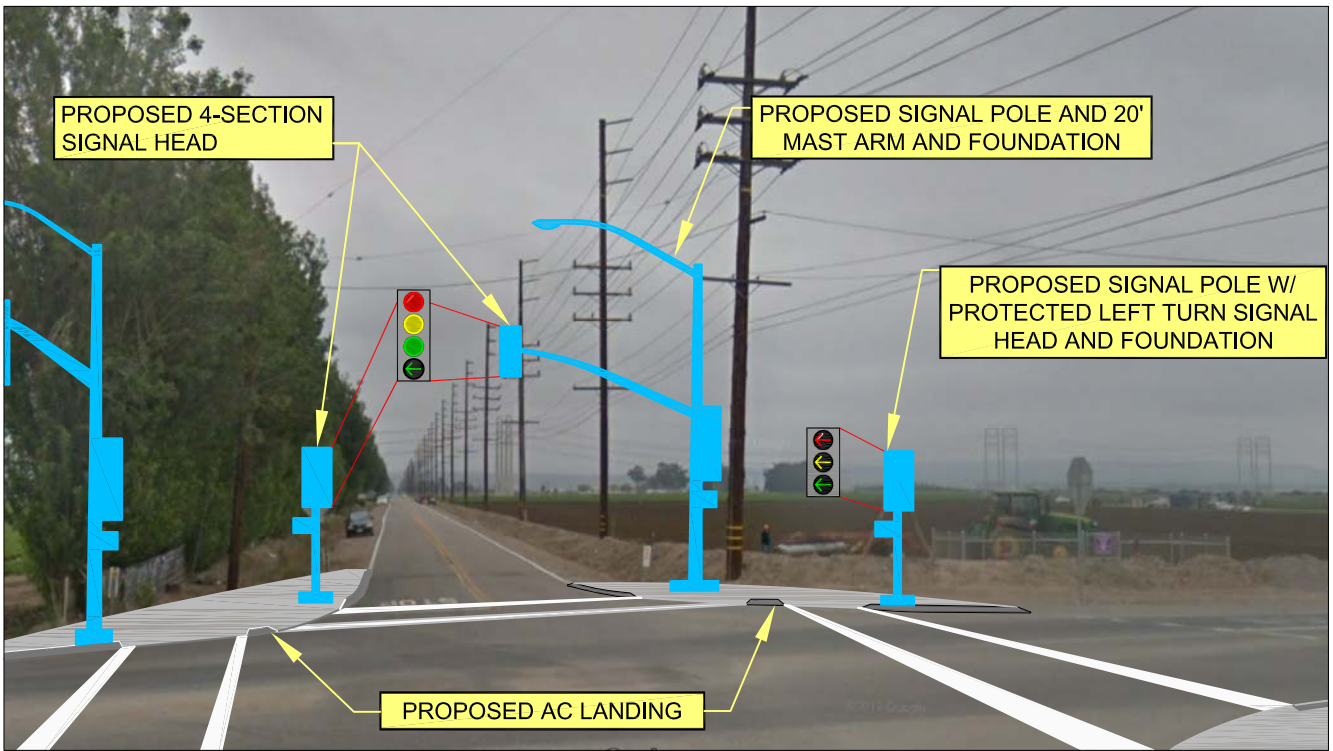
PROPOSED 4-SECTION
SIGNAL HEAD

PROPOSED SIGNAL POLE AND 20'
MAST ARM AND FOUNDATION

PROPOSED SIGNAL POLE W/
PROTECTED LEFT TURN SIGNAL
HEAD AND FOUNDATION

PROPOSED AC LANDING

PROPOSED CONDITION NORTHBOUND
PROPOSED - SIGNALIZED INTERSECTION

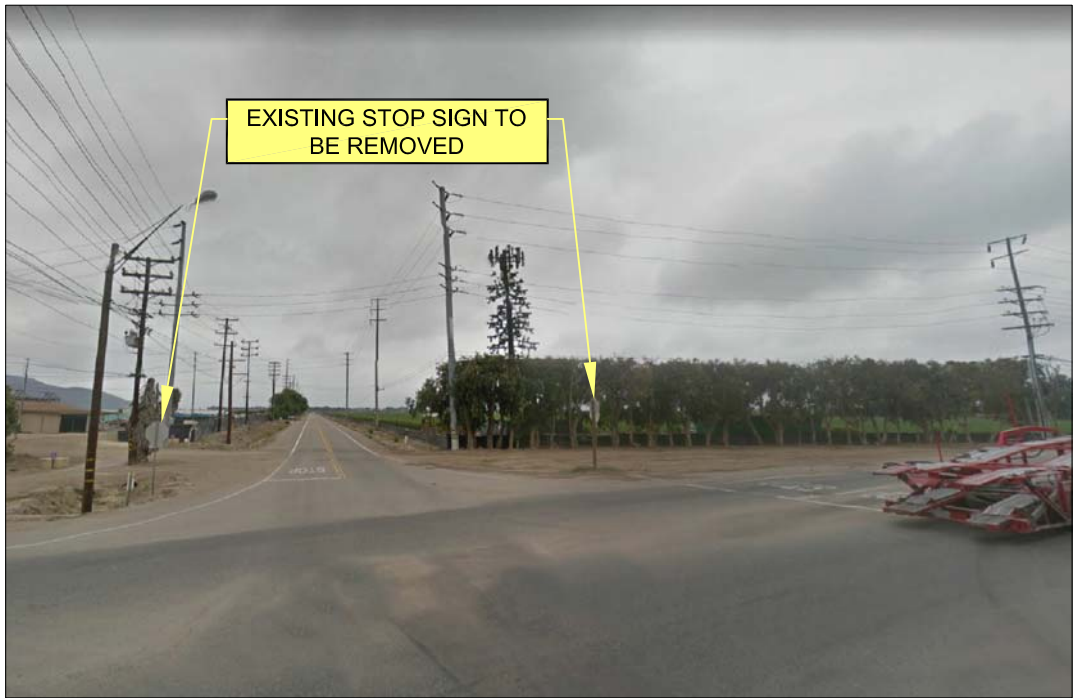
EXISTING CONDITION SOUTHBOUND
EXISTING - 4-WAY STOP

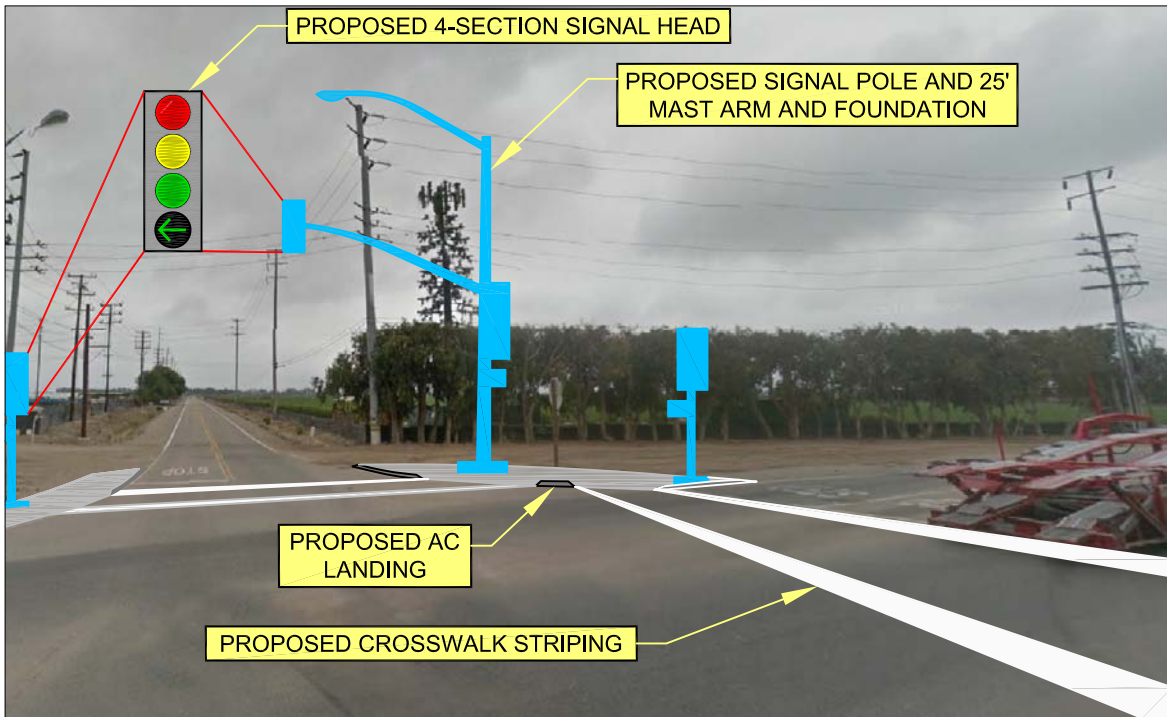
PROPOSED CONDITION SOUTHBOUND
PROPOSED - SIGNALIZED INTERSECTION

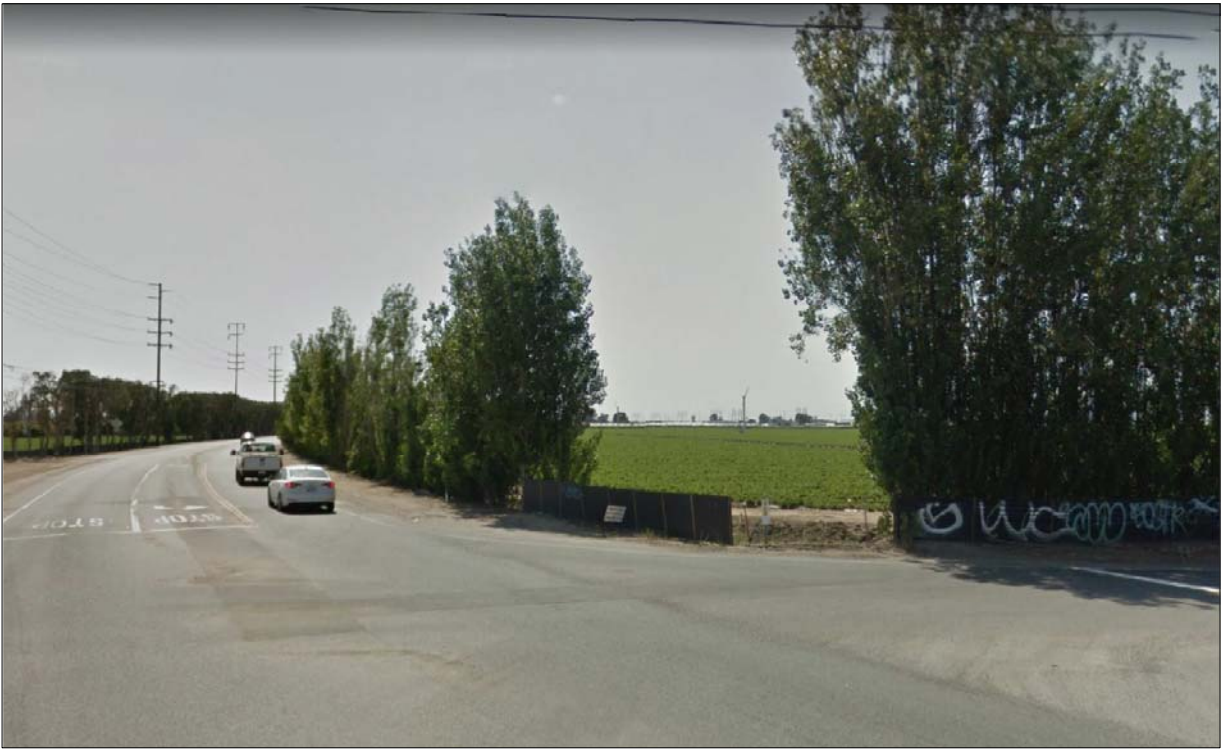
EXISTING CONDITION WESTBOUND
EXISTING - 4-WAY STOP

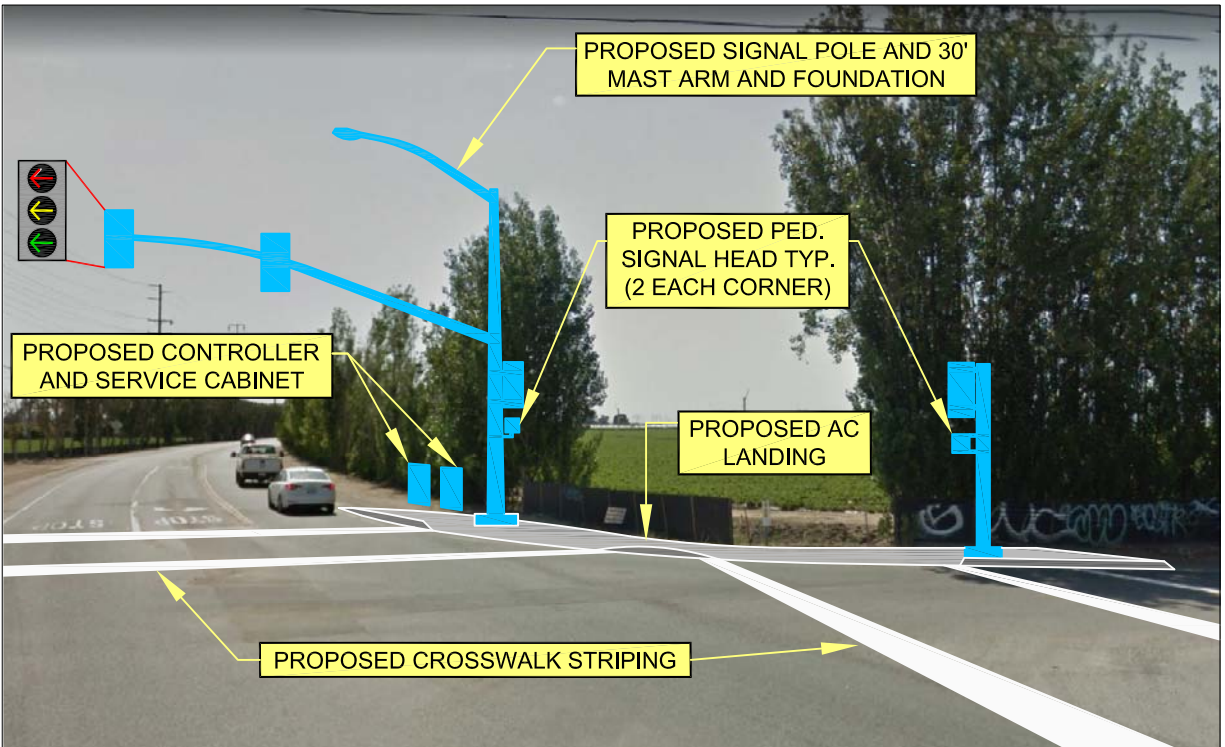
PROPOSED CONDITION WESTBOUND
PROPOSED - SIGNALIZED INTERSECTION

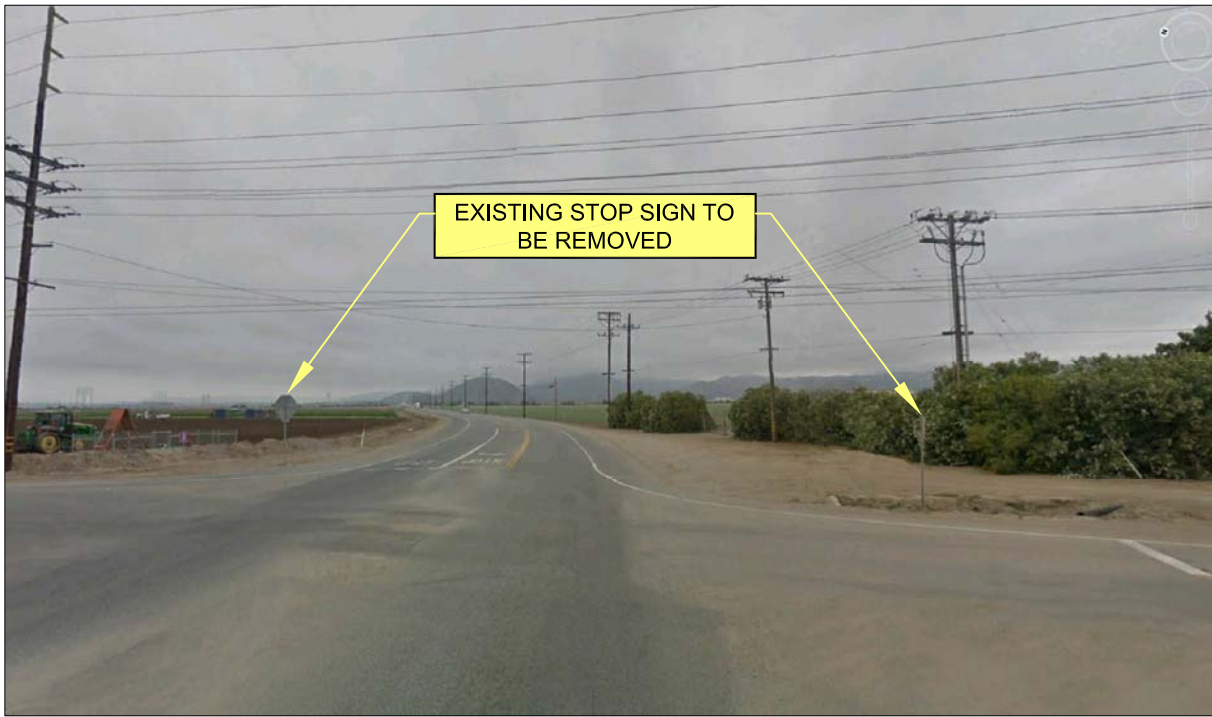
EXISTING CONDITION EAST BOUND
EXISTING - 4-WAY STOP

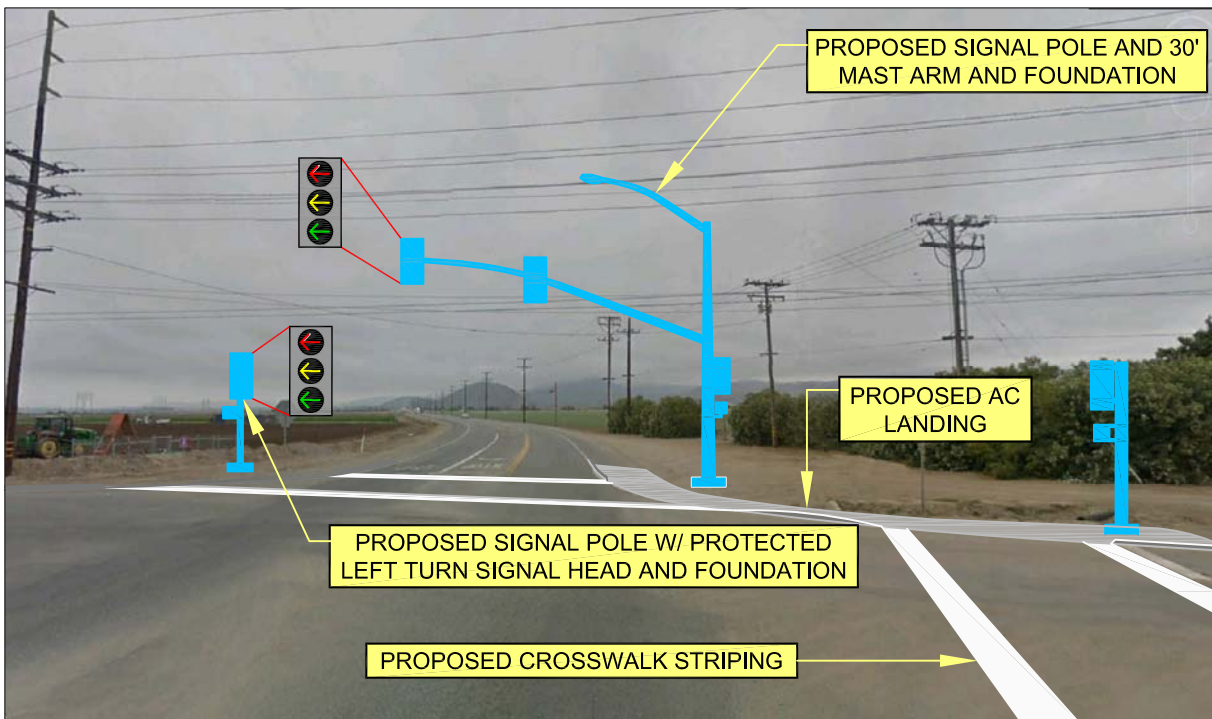
PROPOSED CONDITION EASTBOUND
PROPOSED - SIGNALIZED INTERSECTION
