J Street Drain / Ormond Beach Lagoon Coastal Engineering Report

County of Ventura
800 S. Victoria Ave.
Ventura, CA 93009-1600

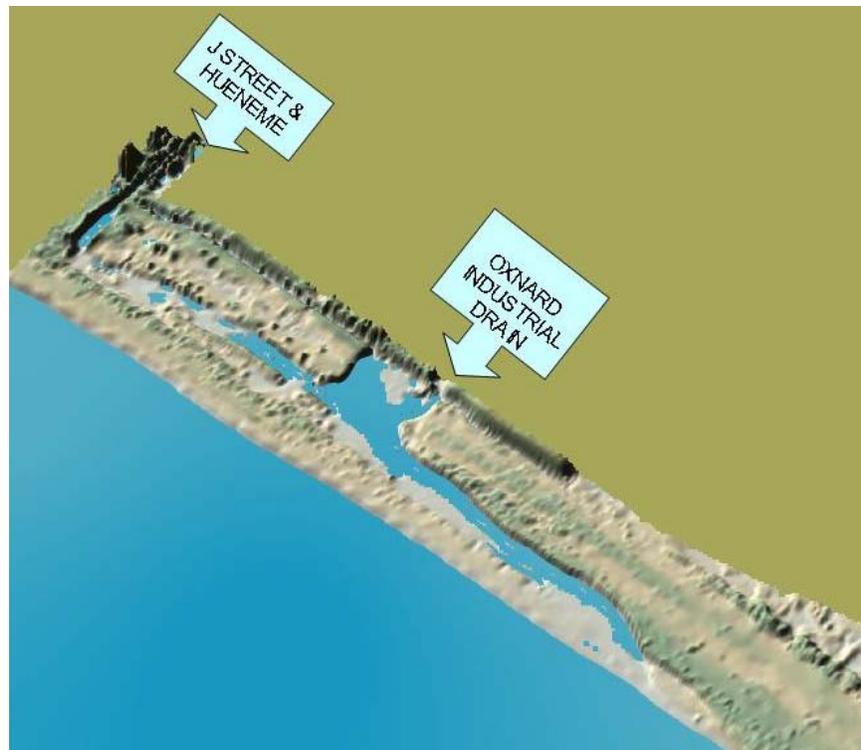
Figure 3.1. Three dimensional plot of the lagoon, Marsh 2008.

J Street drain was originally constructed in 1960 and discharged directly to the Pacific Ocean. As a result of storm water ponding behind the dunes and beach, two shallow lagoons formed at both J Street and OID, eventually becoming hydraulically connected and forming the existing lagoon. The lowest (deepest) areas of the lagoon are now located at the ends of J Street Drain and OID. These low areas are connected by a higher and relatively flat channel that varies in width from 50 to 100 ft. The surface area of the lagoon varies with freshwater inflow, the configuration of ephemeral side channels, and condition of the breach (open or closed). The majority of the wetted lagoon is located near to and south of the OID. The lagoon and adjacent wetlands intermittently connect to the Pacific Ocean following rain events when the lagoon water levels exceed the elevations of Ormond Beach. Bottom elevations in the lagoon are high compared to tide levels, thus limiting tidal range and prism. Figure 3.1 shows a three dimensional plot of the lagoon based on March 2008 aerial survey data. The water level shown is representative of mean higher high water (MHHW).

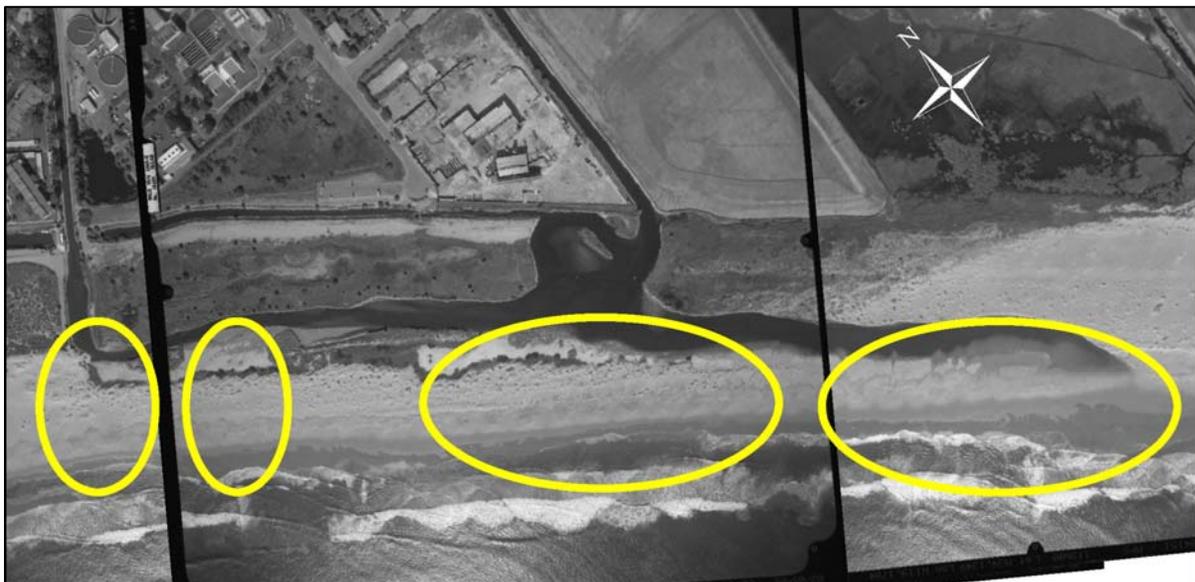
Figure 4.1. Locations of previous breaches.

For reference, Figure 4.1 shows the location of previous historic breaches along Ormond Beach, based on historic surveys and aerial photographs. Breaches tend to occur along the lagoon south of J Street and, more recently, near the outlet of the OID. The figure shows that the breach has occurred at many different locations. Recent breaches have been located closer to OID than to J-Street.

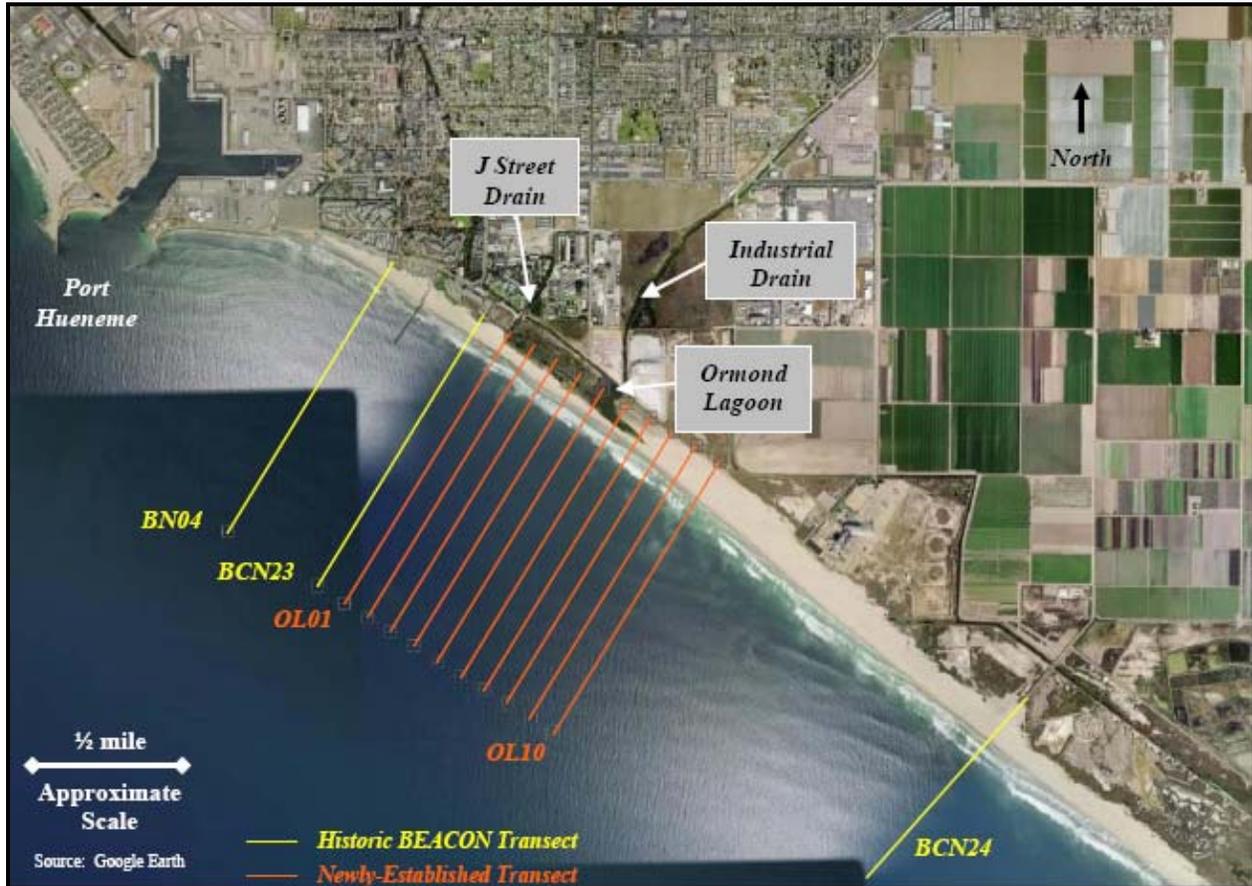
Figure 5.1. Location of beach profile survey transects (Coastal Frontiers 2008).

Street, approximately 575 ft east of transect BCN23, while transects OL02 through OL10 were taken at 500-ft intervals. The transect establishment activities, data collection procedure, and reduction processes are described by Coastal Frontiers (2008). The accuracy of the soundings vertically and horizontally is approximately ± 0.5 ft and ± 2.0 ft, respectively.

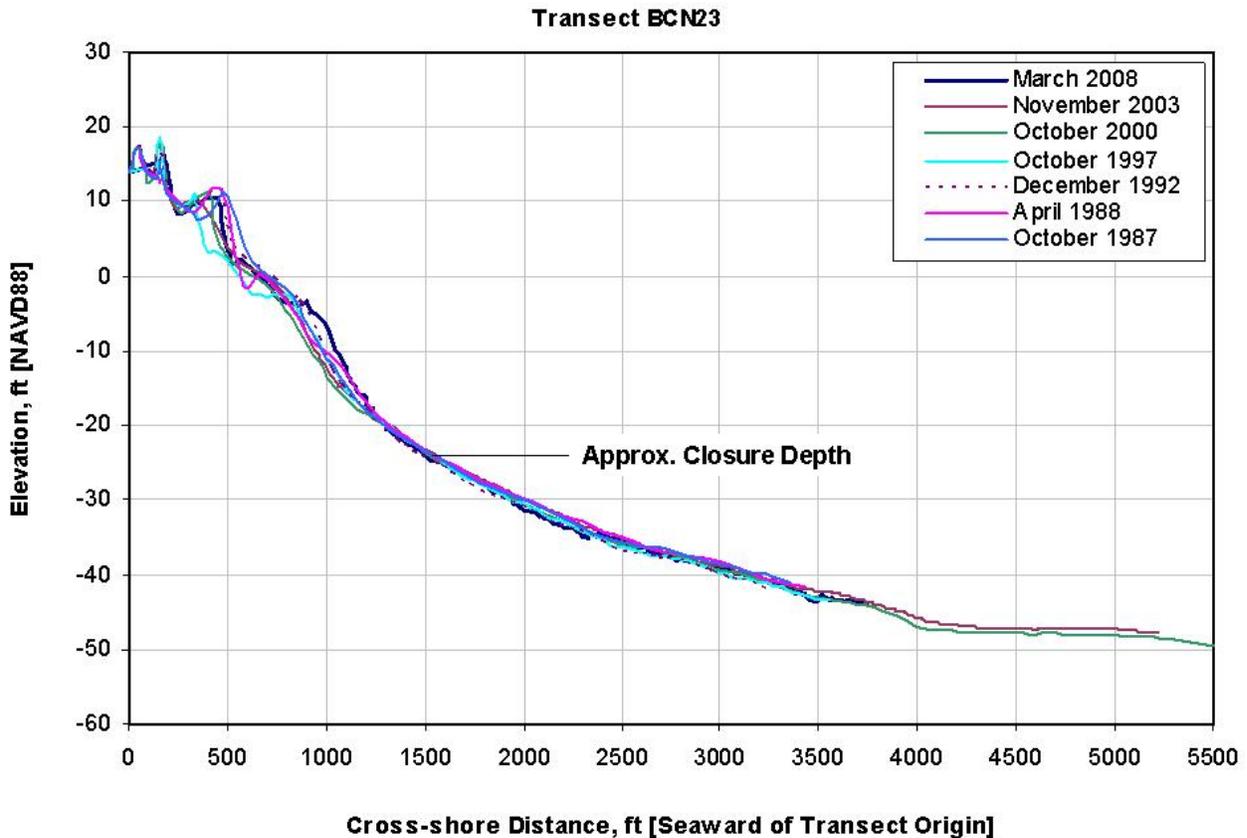
Figure 5.2. Historical cross-shore profiles for Transect BCN23.

Figure 5.2 provides a beach profile plot for transect BCN23 and includes selected profiles obtained between October 1987 and November 2003 as provided by BEACON. Also shown is the observed depth of closure based on the beach profiles shown in Figure 5.2 (refer to Appendix B for additional details on depth of closure). All beach profile plots are provided in Coastal Frontiers (2008).

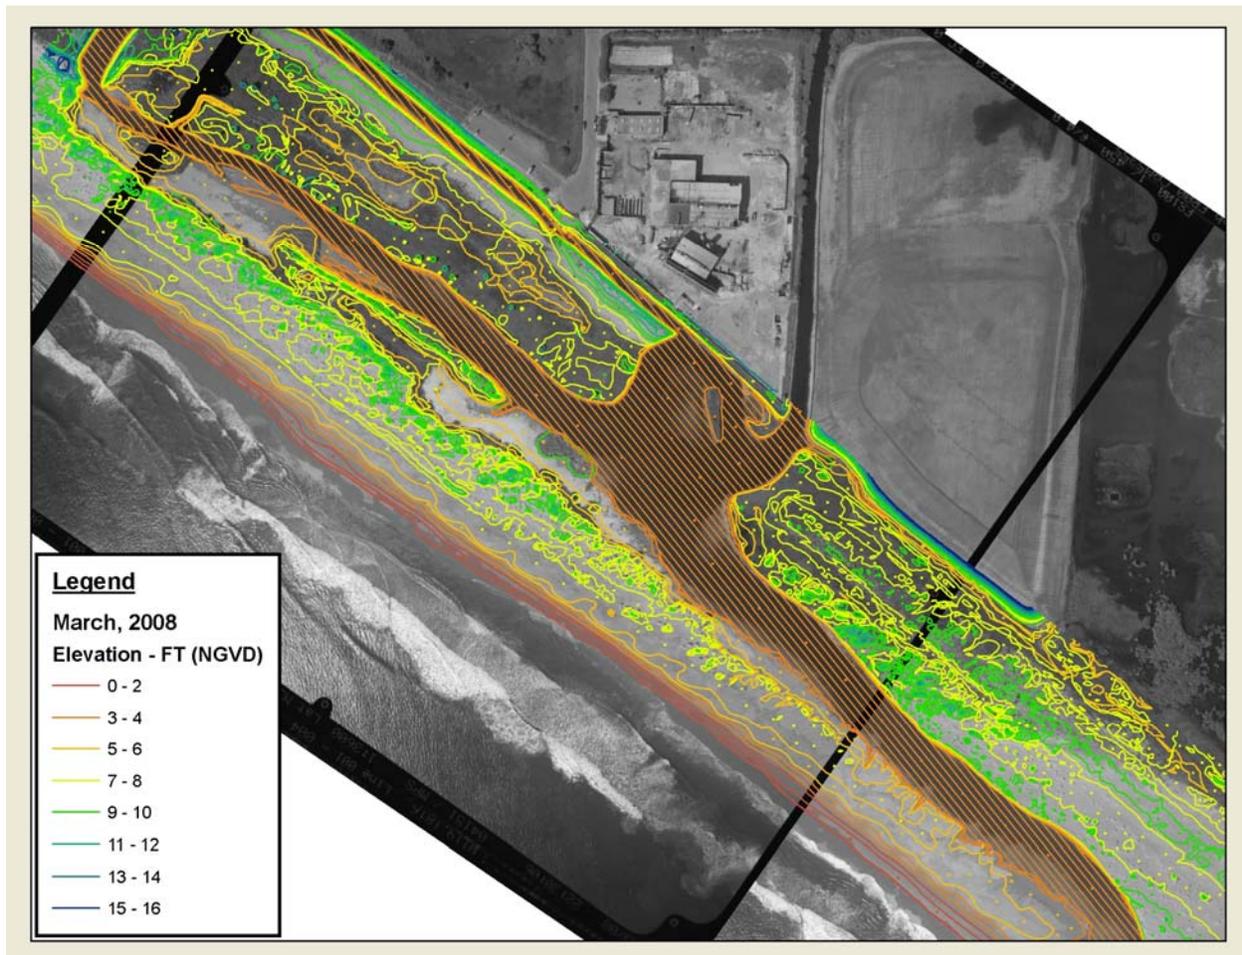
Figure 5.3. Aerial survey flown 3/5/2008 by Mercator Photogrammetric Systems.

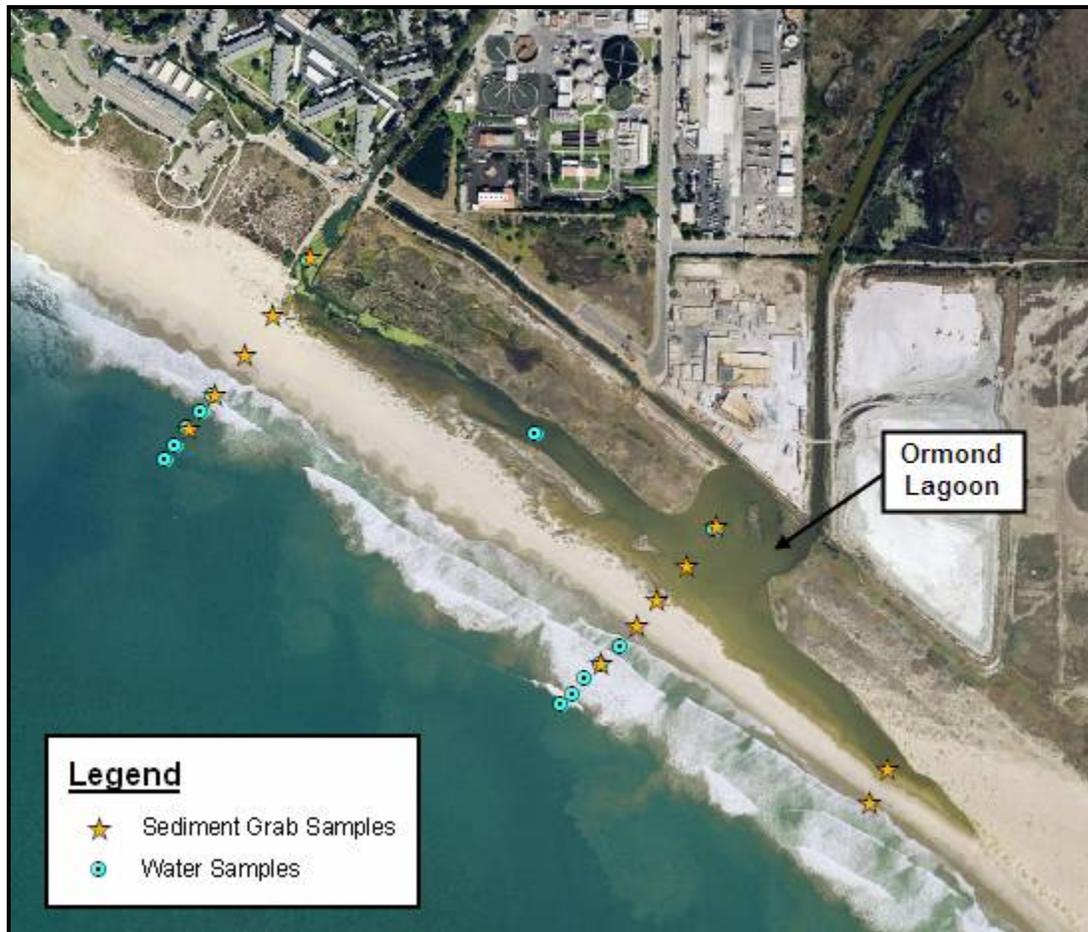
Figure 5.4. Location of water and sediment grab samples.

A total of 14 sediment samples were collected at different locations along Transects OL01 and OL09 and inside Ormond Lagoon (Figure 5.4). Five samples were collected along each transect, two samples were collected in the lagoon, and the remaining two samples were collected at the site of the recent breach. Each sample consisted of 30 cm³ of sand collected in two glass containers. A sieve analysis was performed on each of the sediment samples to determine the median grain size and particle size distribution. Results show that grain sizes along the Ormond Beach range from fine to medium sand with a median grain size between 0.23 and 0.57 mm, depending on location. Detailed sieve analysis results for each sample are provided separately in Coastal Frontiers (2008).

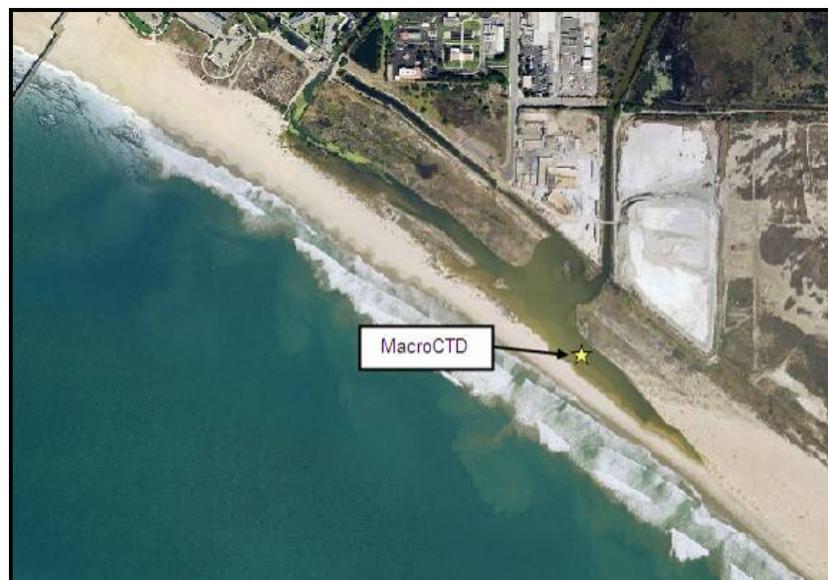
Figure 5.5. MacroCTD location in Ormond Lagoon.

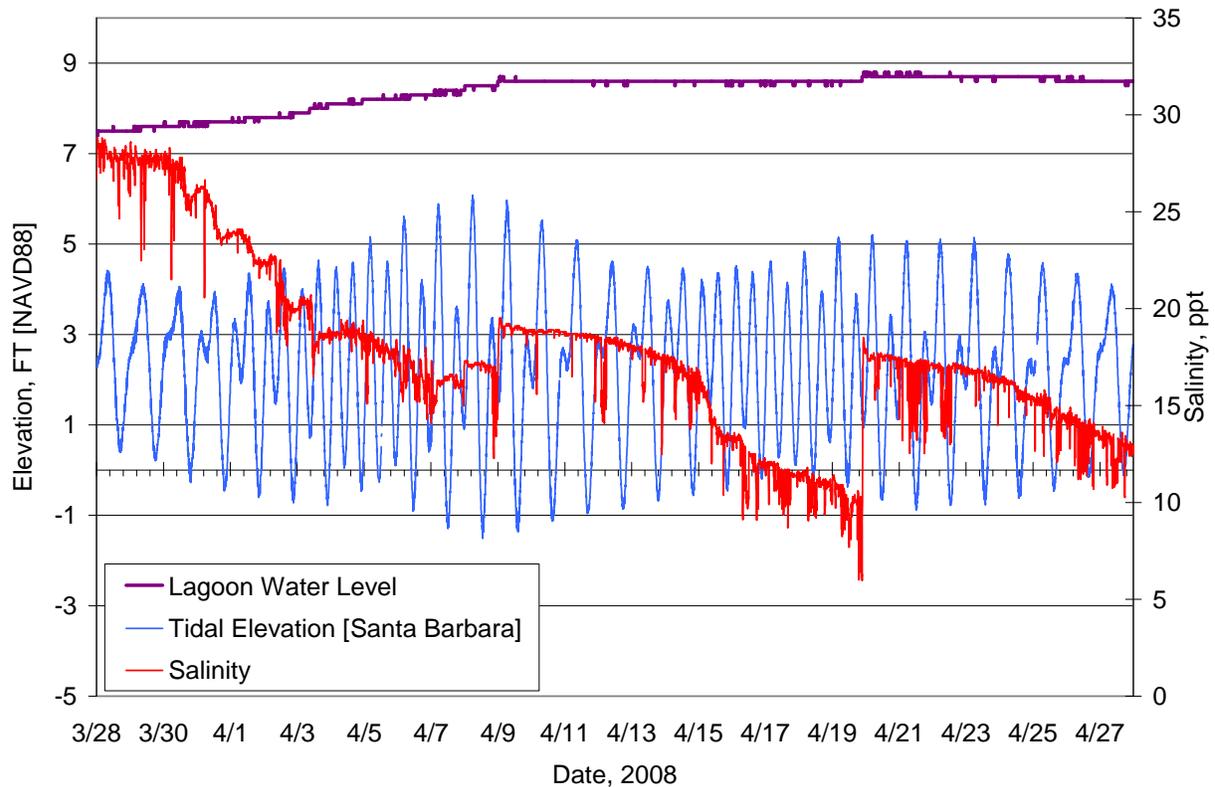
Figure 5.6. Measured lagoon water level, salinity and tide.

During the data collection period, the lagoon remained closed and water levels were not tidally influenced; however, some exchange of salinity between the ocean and lagoon did occur. The measured salinity in the lagoon, water level in the lagoon, and tidal elevation are shown in Figure 5.6. Salinity in the lagoon responded to fluctuating water levels in the ocean, with high tides resulting in an increase of salinity at the gage location. Even though the lagoon was not open to tidal exchange, waves in combination with high tides appear to have overtopped the recently closed breach, resulting in slightly higher water levels and salinity spikes measured at the gage. The overall trend of decreasing salinity combined with rising water level is attributed to industrial and agricultural runoff, and not precipitation. Significant rainfall was not recorded during the monitoring period.

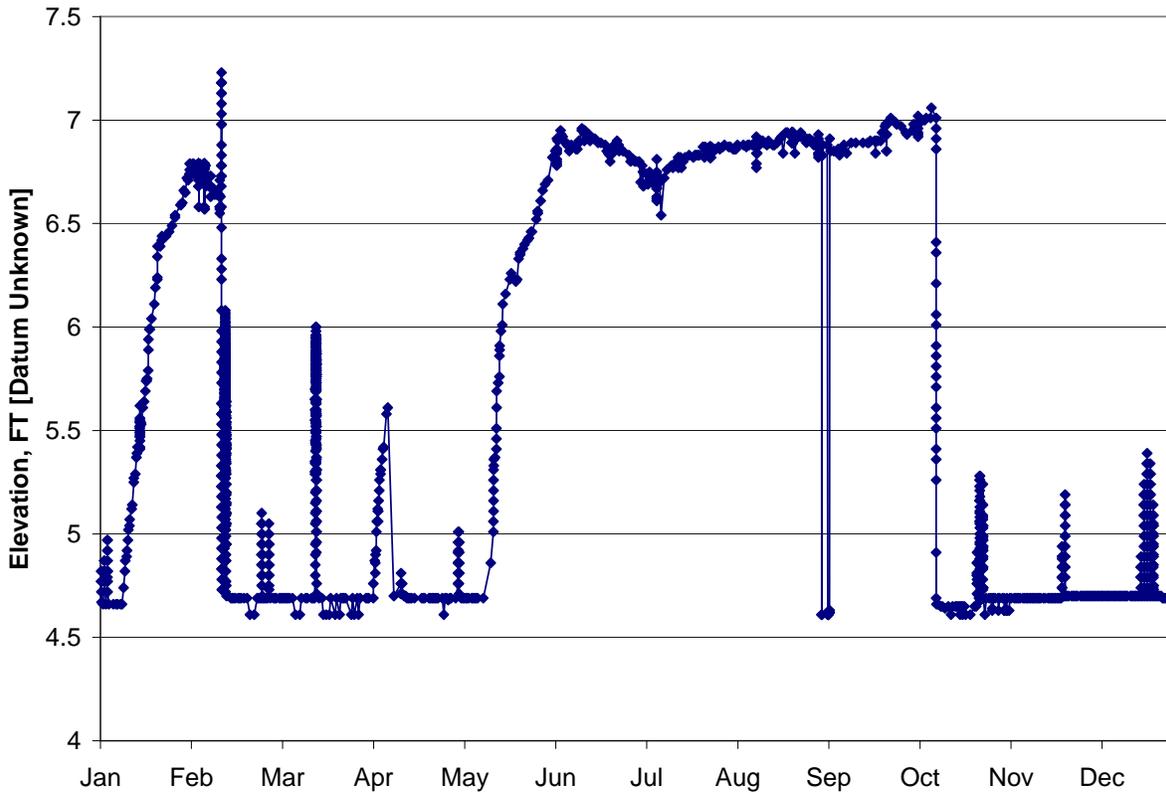
Figure 5.7. J Street 793 Alert Gage stage data for 2003.

A water level gage was installed by VCWPD near the Hueneme pump station in J Street Drain and operated from 2002 to 2005. Figure 5.7 presents the gage data from 2003. Calibration information was not available and the gage datum could not be determined by comparison with overlapping data sets. However, the data qualitatively indicate that the lagoon water levels generally rise and remain elevated above tidal levels during the summer months from May to September, and then rapidly decrease by 2 to 3 ft following breaches in early fall through the spring. The gage data also demonstrate that breaches form and close multiple times each year, from the early fall through the spring. Duration of lagoon closure may range from one week to five months or more. The data also indicate that the lagoon empties within 30 minutes to two hours following a breach, depending on the tide at the time of the breach.

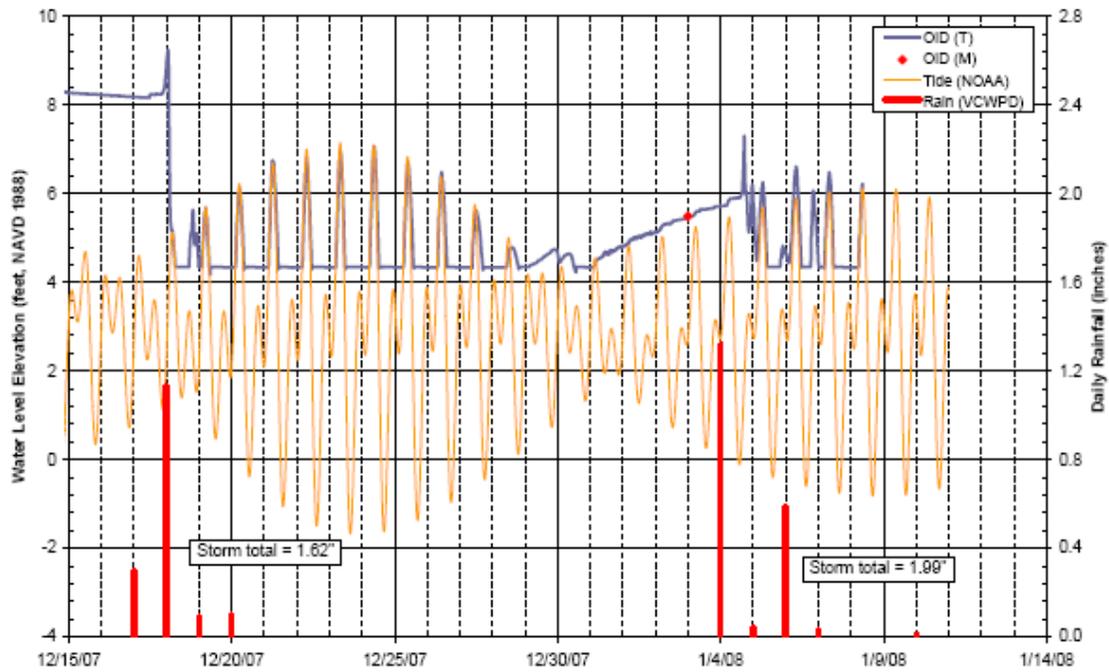
Figure 5.8. Water level in the lagoon 12/5/2007 – 1/10/2008 (CH2M Hill 2008).

CH2M Hill (2008) collected water level data in OID near the lagoon from mid-October 2007 through the first week of January 2008 and provided these to the VCWPD. Plotted in Figures 5.8 and 5.9 are measured water level at OID, NOAA tide data averaged between the Santa Monica and Santa Barbara stations, and precipitation. Two breaches occurred during the monitoring period, first on December 17, 2007 and again on January 4, 2008. The December breach appears to have occurred with an initial lagoon water level near 8.3 ft NAVD. Freshwater inflow caused the water level to rise to around 9.2 ft NAVD before the lagoon breached and water level dropped. From the plots, it appears that the lagoon emptied and equilibrated with the tide in less than 6 hours, consistent with observations at the J Street gauge discussed above.

Following the breach, water levels at OID remained tidally dominated, with no appreciable phase lag. However, the low tide level is clipped. This may have resulted from either drying of the water level gage or more likely impoundment of water within the lagoon above the tidal level due to the bathymetry of the lagoon or tidal channel. The breach closed during a neap tidal cycle around January 1, 2008, and water levels in the lagoon began to rise until the lagoon breached again on January 4.

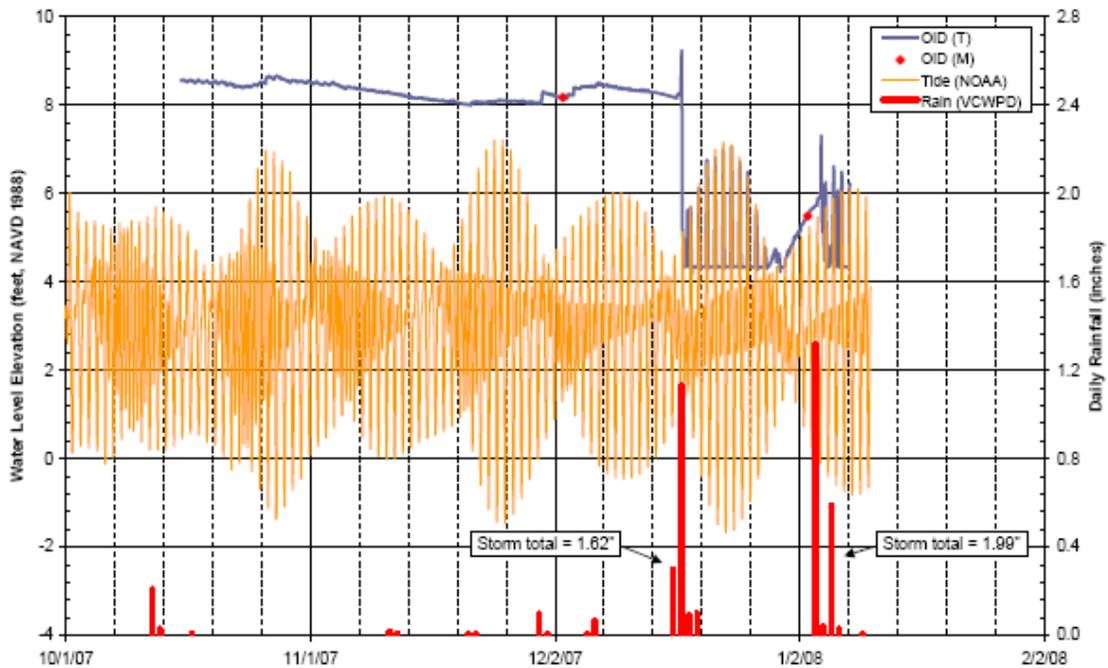
Figure 5.9. Water level in the lagoon 10/2007 – 1/2008 (CH2M Hill 2008).

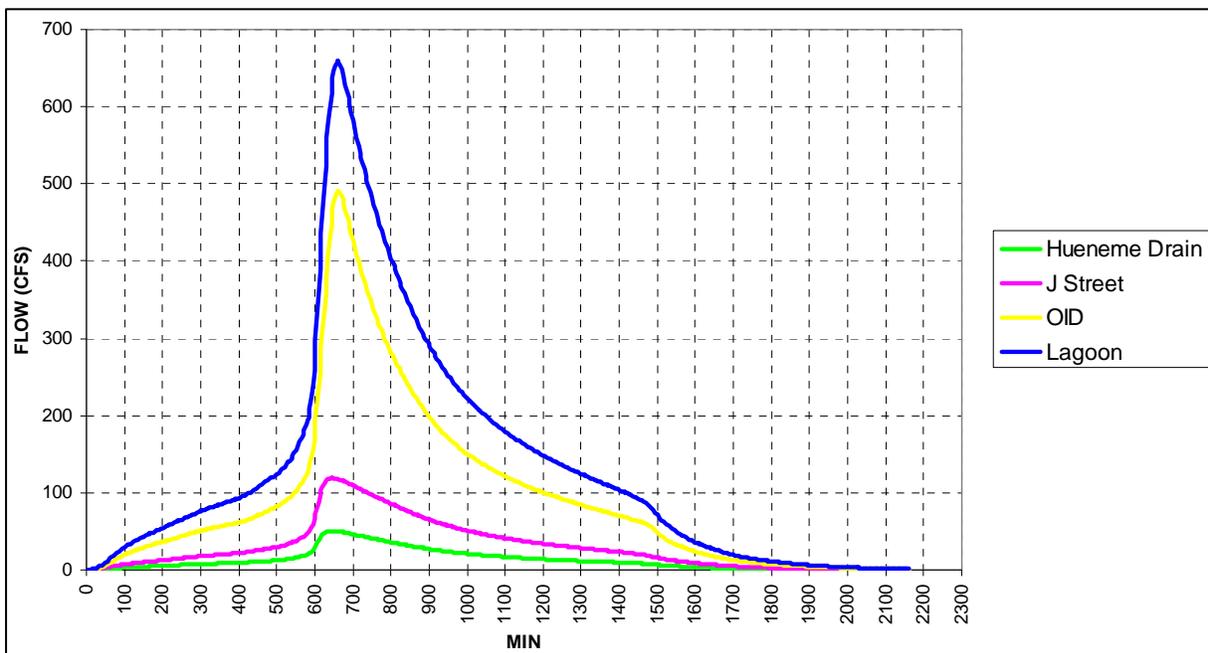
Figure 5.10. Hydrograph for 2-year event.

Hydrographs were provided by VCWPD for the 2, 5, 10, 50 and 100-year events. Figures 5.10 and 5.11 plot the provided 2-year and 100-year event hydrographs, respectively. The storm hydrographs were applied as inputs to the lagoon hydrodynamic model to simulate storm events and evaluate outlet alternatives discussed in the next section.

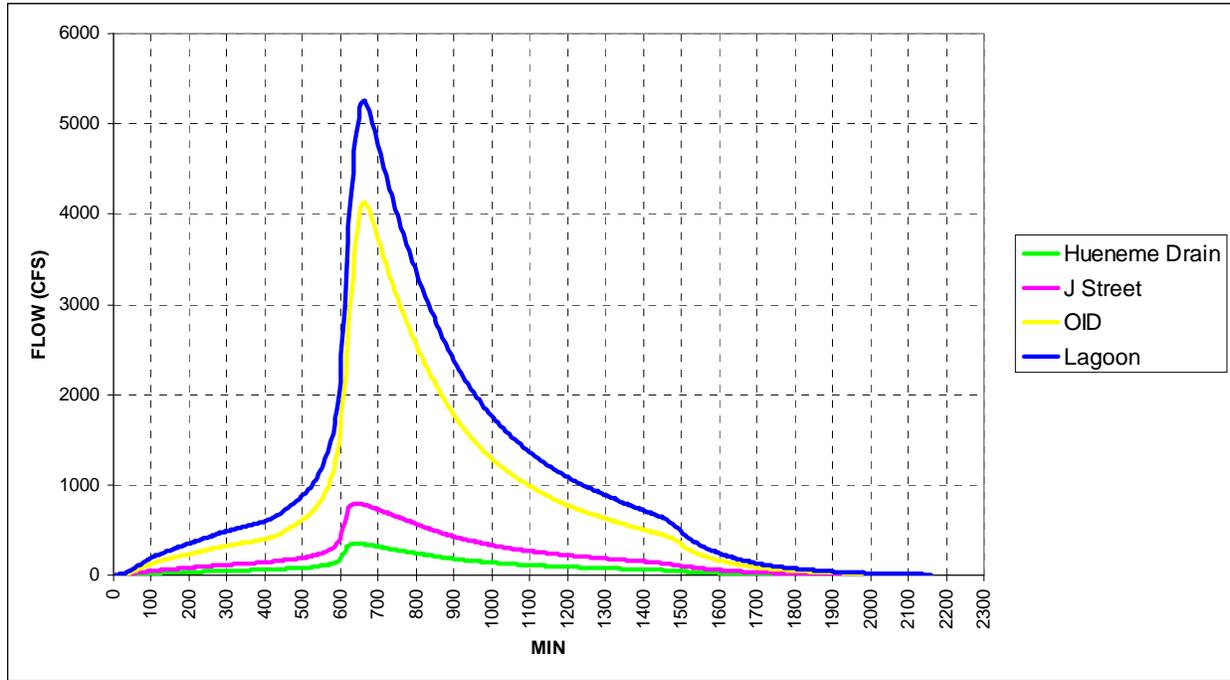
Figure 5.11. Hydrograph for 100-year event.

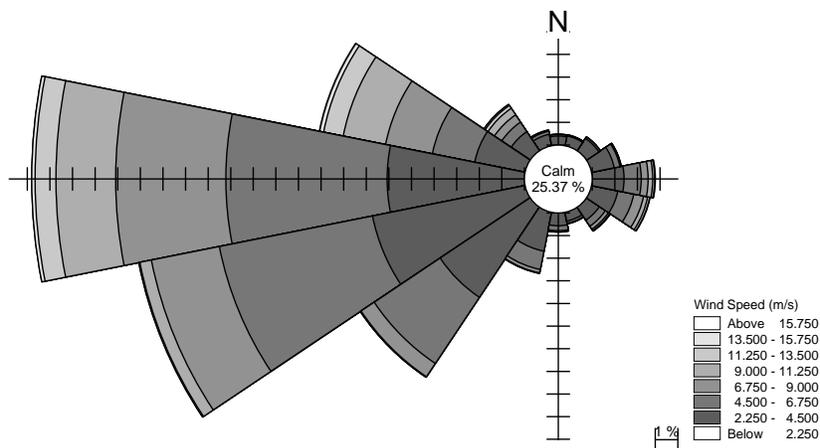
Figure A.1. Wind rose for Santa Barbara, Station 46053.

Wind data were obtained from the National Data Buoy Center (NDBC). Average hourly winds were analyzed for NDBC Station 46053 offshore Santa Barbara (Figure A.1) for the period of 1996 through 2007 and NDBC Station 46025 offshore Santa Monica (Figure A.2) for the period of 1997 through 2007. Daily average winds at Naval Base, Port Hueneme (Figure A.3) were analyzed for the period from 1996 through 2008 with significant gaps in coverage. Wind directions are displayed following standard meteorological convention.

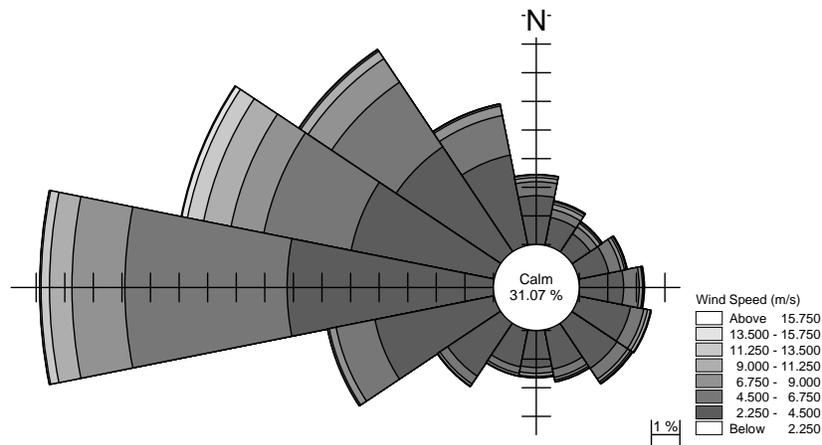
Figure A.2. Wind rose for Santa Monica, Station 46025.

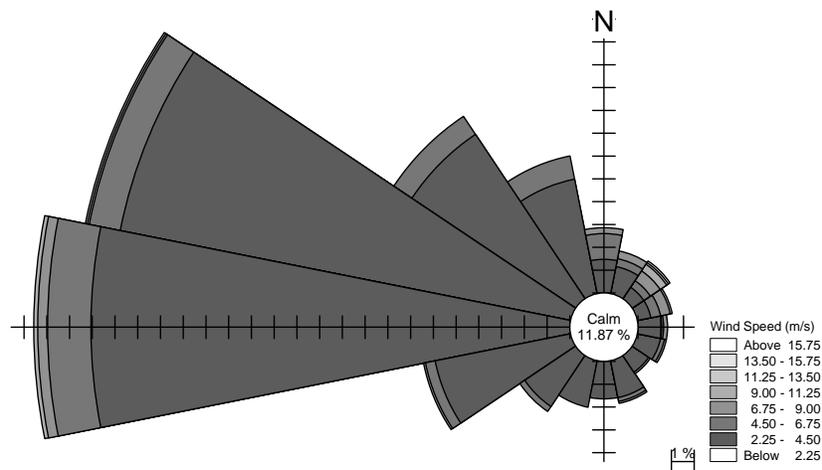
Figure A.3. Wind rose for Port Hueneme.

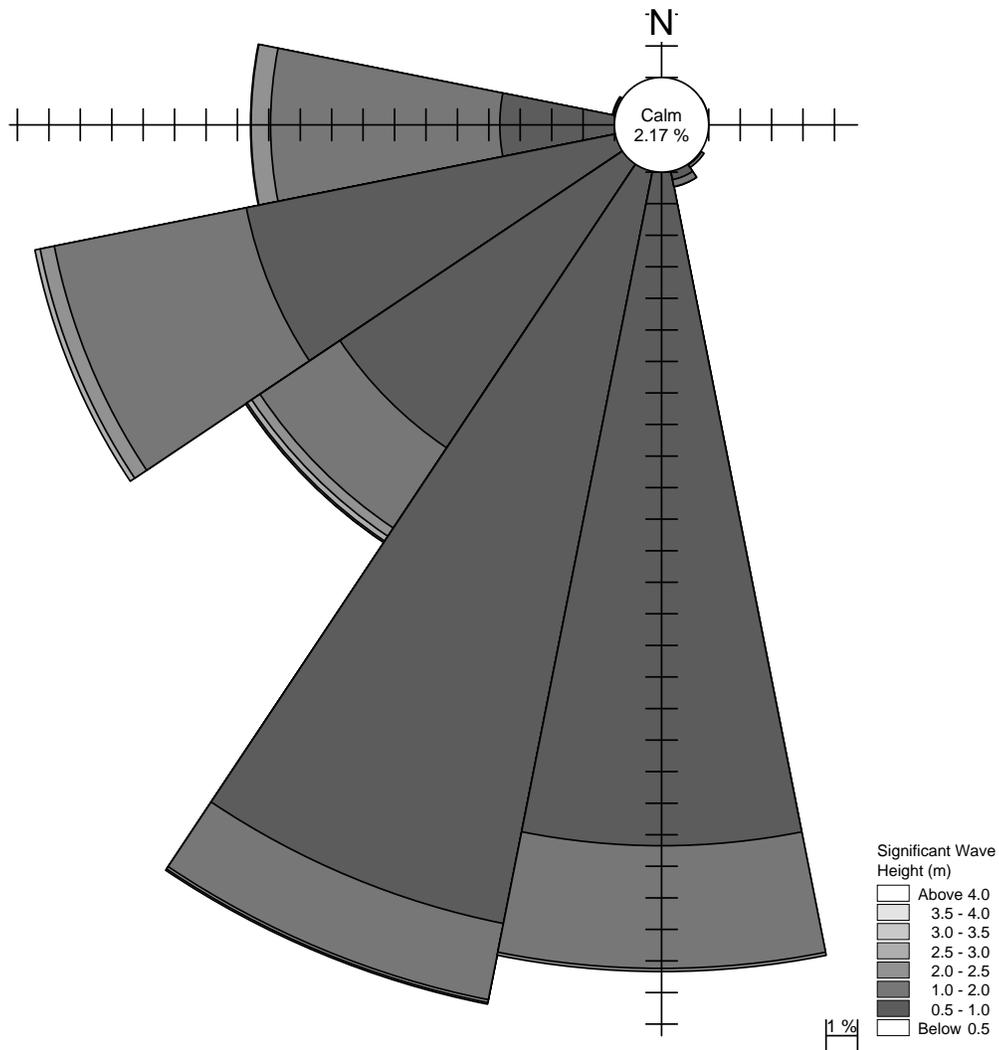
Figure A.4. Wave rose for CDIP Station 141.

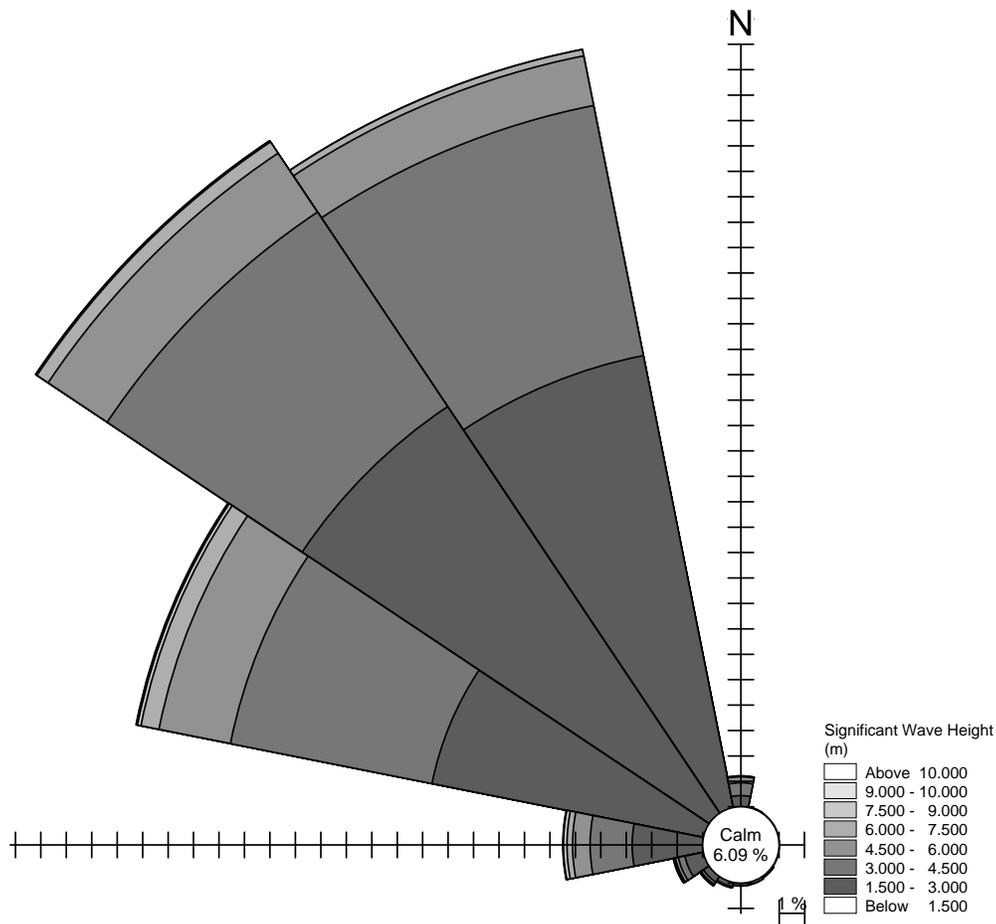
Figure A.5. Wave rose for WIS Station 91.

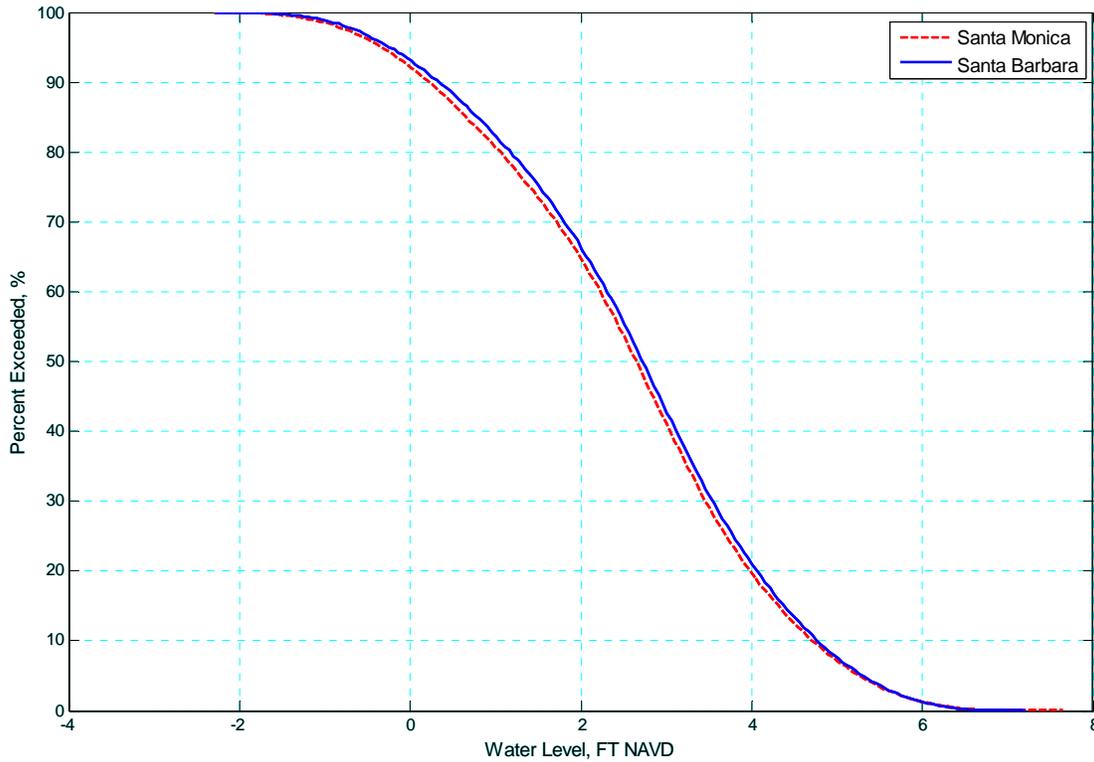
Figure A.6. Water level frequency of exceedance.

Water level data was collected inside the lagoon in an effort to compare with water level at the tide gauges and to calibrate the numerical model. The water level data inside the lagoon would have provided a time history of flow into the lagoon depending on the weather during deployment. Water level in the ocean is generally much lower than the elevation of the beach crest.

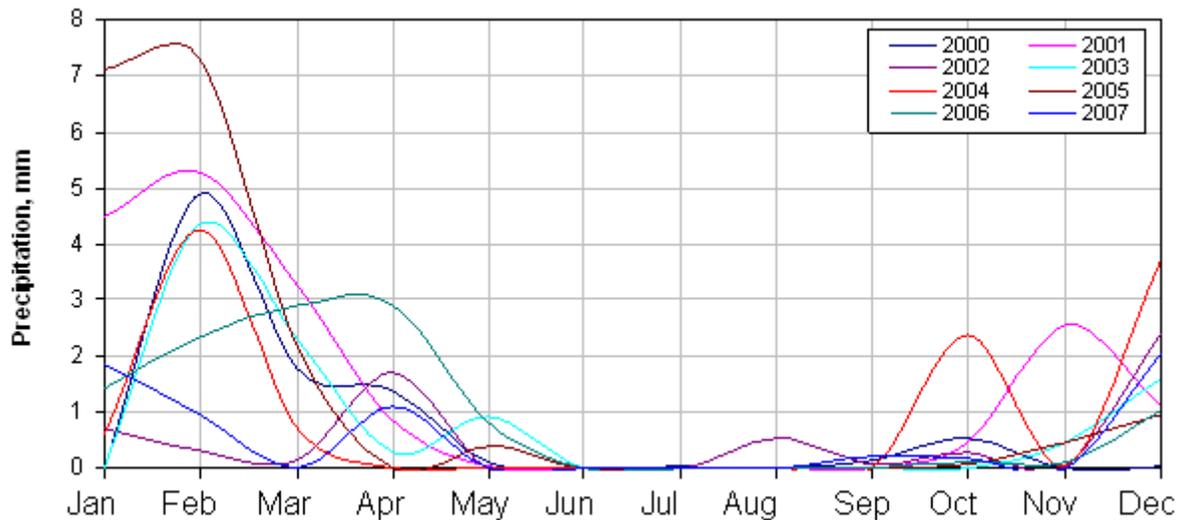
Figure A.7. Monthly precipitation fluctuations in Oxnard, CA.

Precipitation data was gathered from the University of California Climate Station #156 in Oxnard. Based on eight years of data the average daily precipitation rate near the proposed project site is approximately 0.95 mm/day. Monthly fluctuations are shown in Figure A.7.

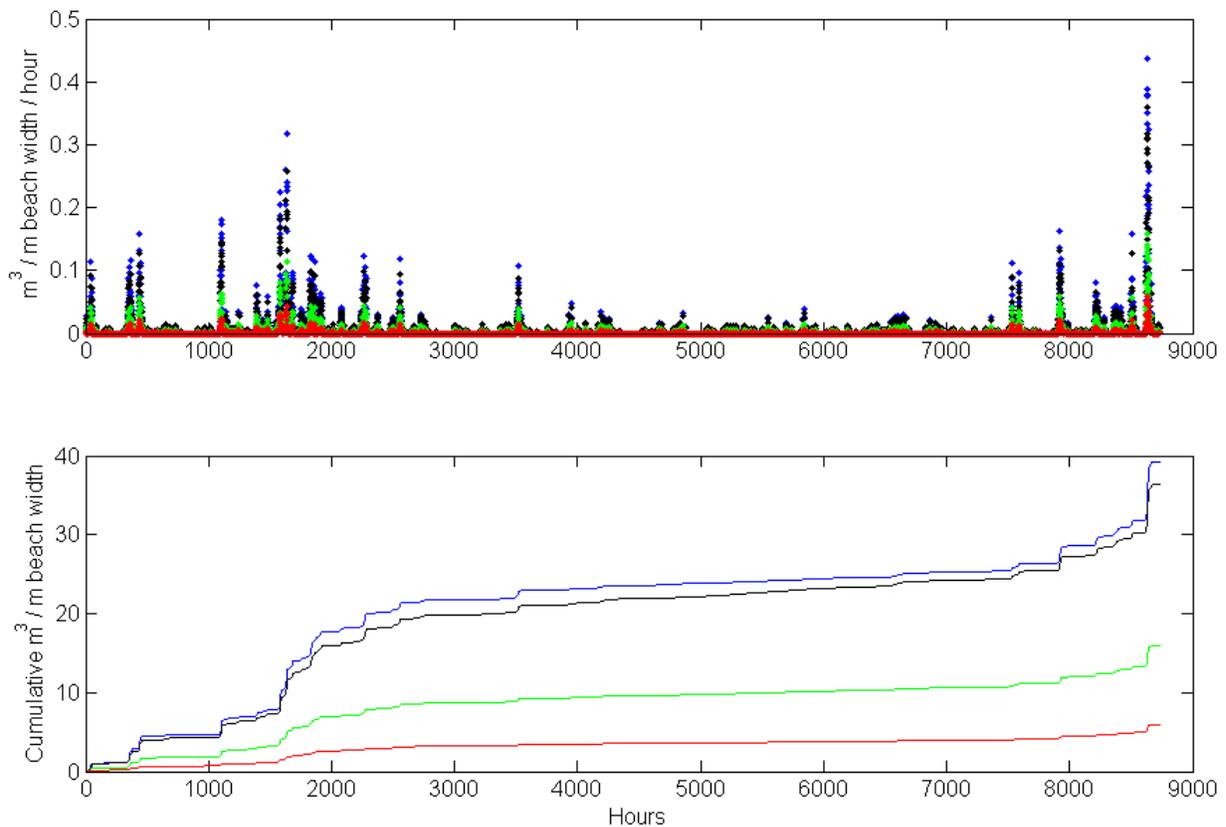
Figure A.8. Four methods for estimating wind-blown sand transport for the year 2006.

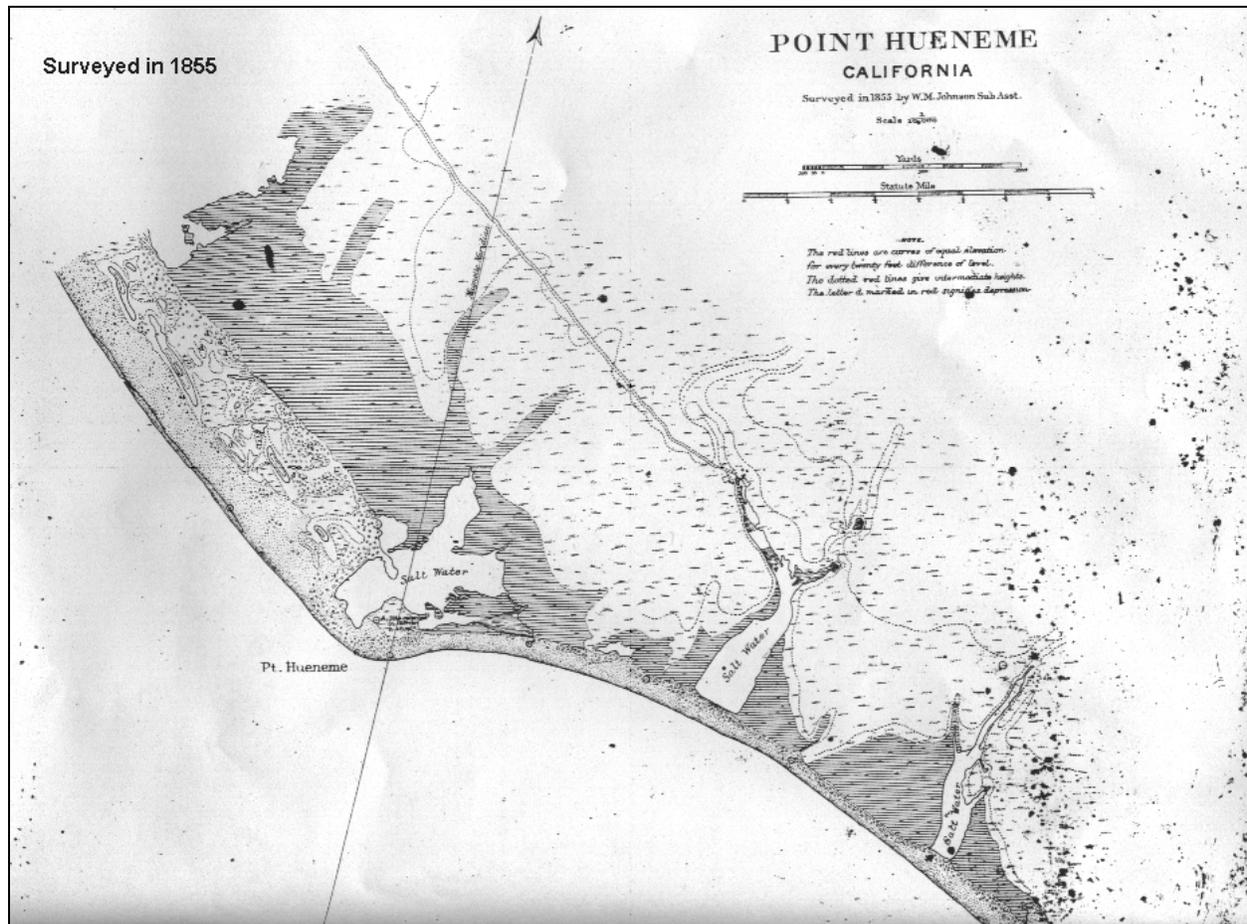
Figure A.9. 1855 shoreline survey (Johnson 1855).

Figure A.9 shows the 1855 survey, indicating that three nearby lagoons existed in 1855. Historically, a natural drainage, wetland, and lagoon existed at the current location of the OID. Portions of this lagoon and wetland features are still evident at the south end existing lagoon. The central lagoon has been filled and no longer exists. Historical drainage is now captured by the Hueneme and J Street Drains. The central and south lagoons likely breached to the Pacific Ocean following large rainfall events but did not remain permanently connected. However, the lagoons may have been open to tidal influence longer than under existing conditions because of the larger tidal prism of the lagoons and adjacent wetlands. The large lagoons shown in Figure A.9 are similar to one of the alternatives being considered by the California State Coastal Conservancy to restore wetland habitat in the area.

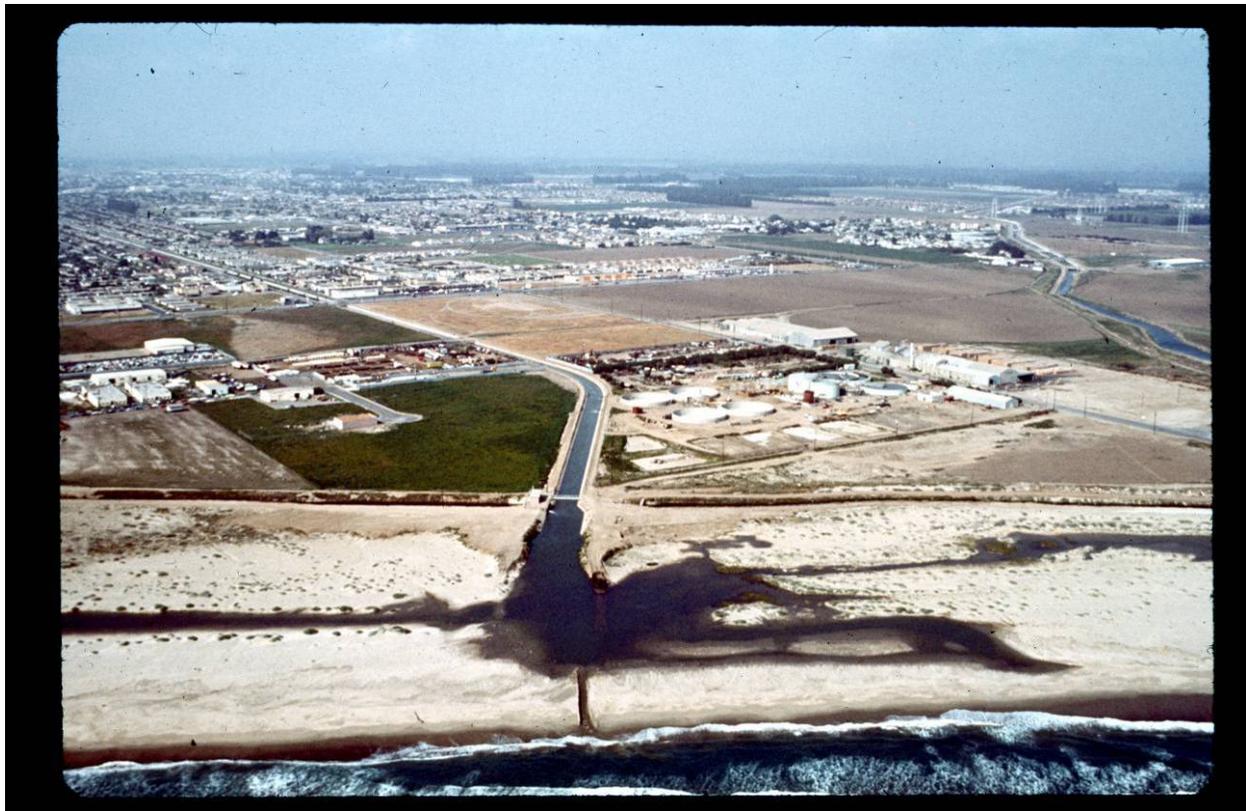
Figure A.11. Aerial photograph facing J Street Drain, 1972, Copyright © 2002-2007 Kenneth & Gabrielle Adelman, California Coastal Records Project, www.Californiacoastline.org.

Figure A.11 shows the early formation of the lagoon at the outfall of J Street Drain in 1972, ten years after construction in 1962. Available information suggests that during this time the breach was periodically maintained to promote flow from J Street directly to the ocean and mechanically excavated breach is evident in the photograph. The figure also shows that water frequently drained behind the dunes and within dune swales, forming what were likely ephemeral wetlands and channels. Sediment from the dunes was likely transported from the lagoon to the ocean following storm events. Comparison between the 1972 photos and the 1945 photo indicate that discharge from the J Street Drain created the northern portions of the lagoon because direct flow from the drain to the ocean wasn't maintained at all times. Lateral spreading of the impounded water, both north and south, occurred until the J Street drainage flows scoured a path south to the Oxnard Drain, connecting the two systems.
