J Street Drain / Ormond Beach Lagoon Coastal Engineering Report

County of Ventura
800 S. Victoria Ave.
Ventura, CA 93009-1600

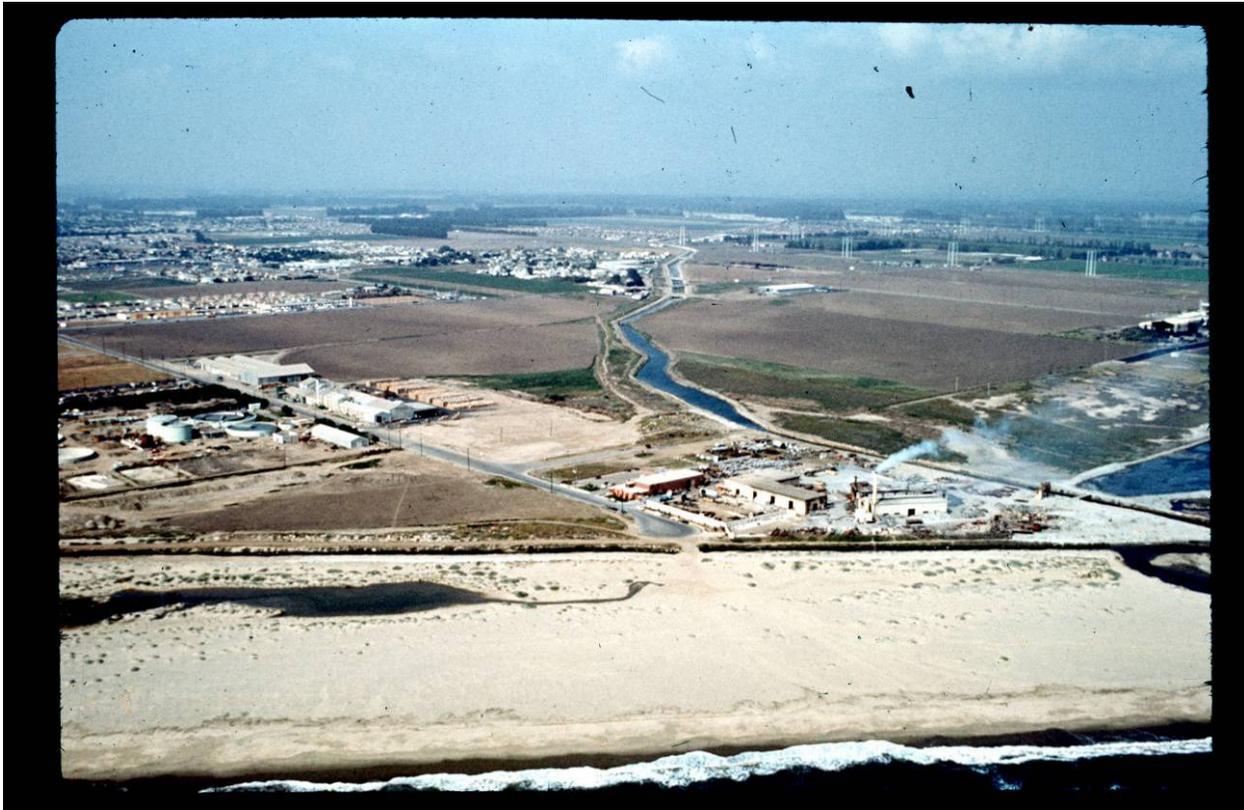
Figure A.12. Aerial photograph between J Street and Industrial Drains, 1972, Copyright © 2002-2007 Kenneth & Gabrielle Adelman, California Coastal Records Project, www.Californiacoastline.org.

Figure A.12 shows the between J Street and Industrial Drains in 1972. Stormwater was no longer routed south, instead it flowed over Ormond Beach. The backwater at J Street Drain had not yet connected to the lagoon at Oxnard Industrial Drain (OID). Channelization of what is now OID likely increased the capacity of the lagoon to convey floodwater directly to the Pacific Ocean and prevented flooding of inland areas. These changes also likely increased the frequency and intensity of breaching by conveying more flow directly to the lagoon and beach rather than allowing for local storage in uplands and adjacent wetlands. The result was the formation of a well defined lagoon channel.

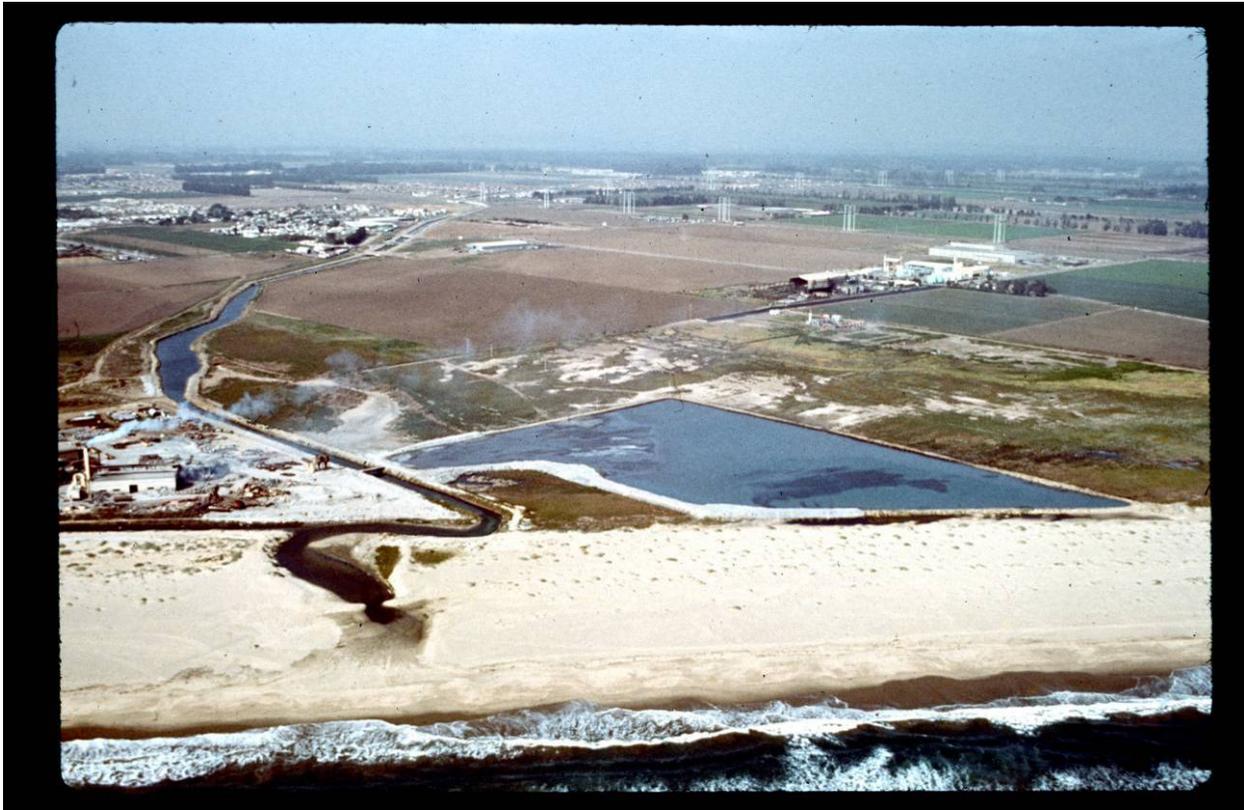
Figure A.13. Aerial photograph facing Industrial Drain, 1972, Copyright © 2002-2007 Kenneth & Gabrielle Adelman, California Coastal Records Project, www.Californiacoastline.org.

Figure A.13 shows Industrial Drain and a small developing lagoon, including portions of Hueneme Drain. Breaching has recently occurred at the lagoon formed by Industrial Drain.

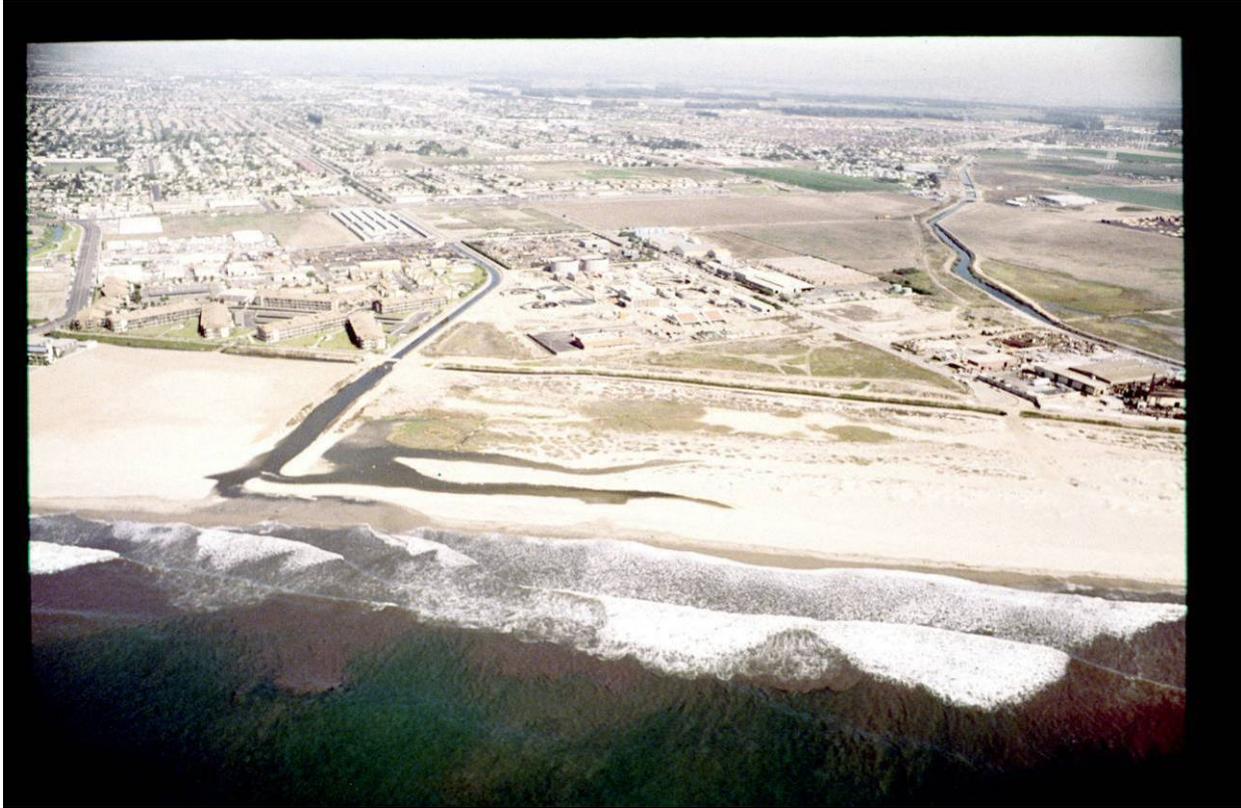
Figure A.14. Aerial photograph showing J Street Drain, 1979, Copyright © 2002-2007 Kenneth & Gabrielle Adelman, California Coastal Records Project, www.Californiacoastline.org.

Figure A.14 reflects the dynamic nature and recent evolution of the lagoon system. The lagoon appeared to have been growing in 1972, but by 1979 only a weak hydrologic connection between J Street and OID had developed. Few permanent wetlands appear in the photographs from 1979.

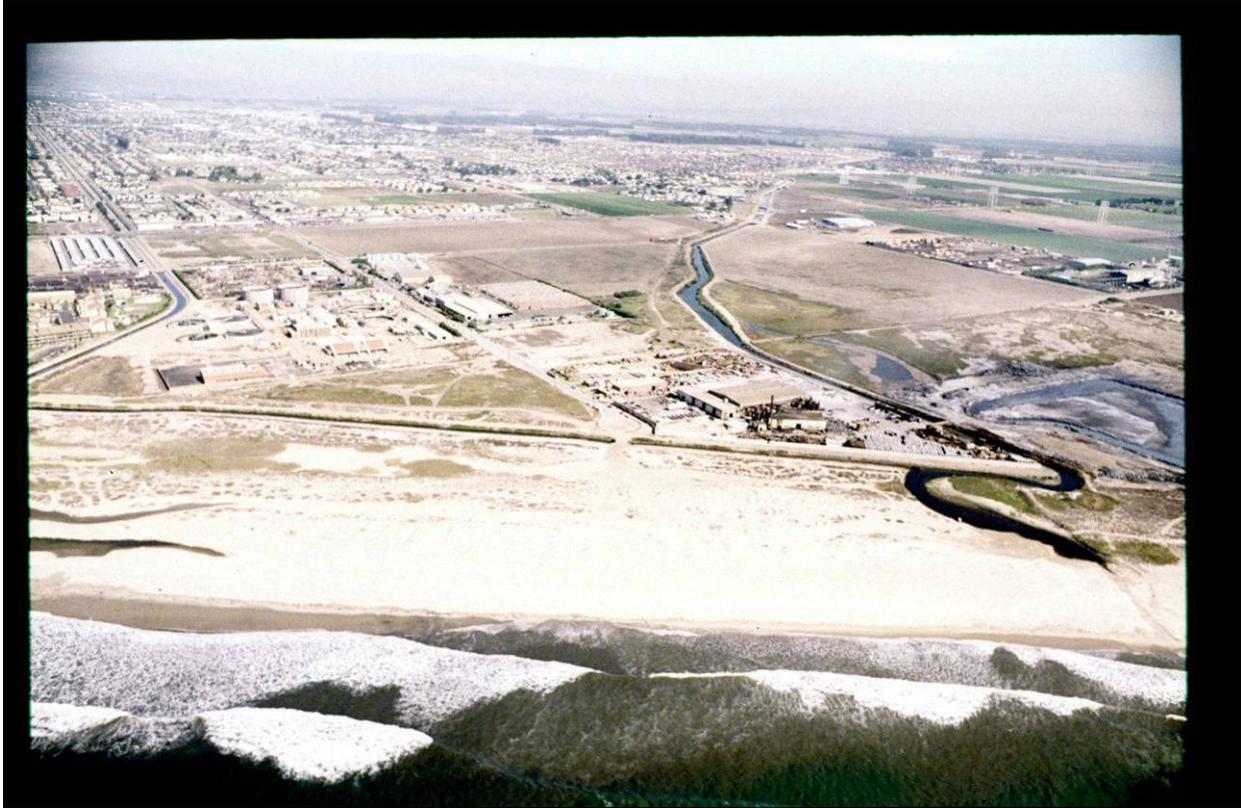
Figure A.15. Aerial photograph showing the area between J Street and Industrial Drain, 1979, Copyright © 2002-2007 Kenneth & Gabrielle Adelman, California Coastal Records Project, www.Californiacoastline.org.

Figure A.15 shows that, in 1979, Industrial Drain had not recently flowed directly to the Pacific Ocean. The overwash features on the beach evident in 1972 are less evident, although still visible. At the time of this photograph, it had likely been at least a few months since Industrial Drain last breached without mechanical assistance. From the photograph, it appears that mechanical breaching was occurring at OID as well as at J Street.

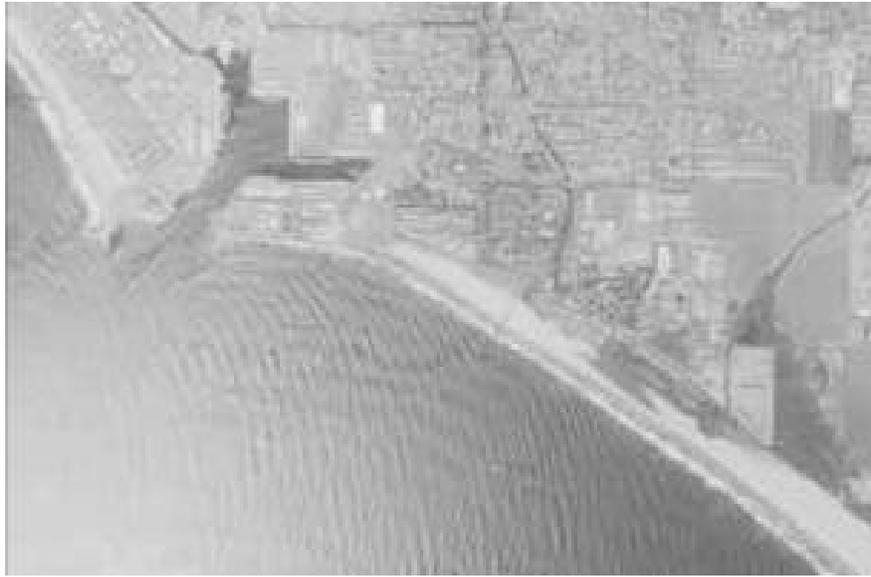
Figure A.16. Aerial photograph, 1994 (USGS 1994).

This low resolution 1994 aerial photograph in Figure A.16 shows a significantly larger connection/lagoon between J Street and OID. This can be attributed to the lack of mechanical breaching at both J Street and OID. The lagoon appears most similar to the current configuration. Flow from J Street and OID converge at the lagoon in this photograph. The lagoon exists on the beach bounded on its landward side by development and infrastructure.

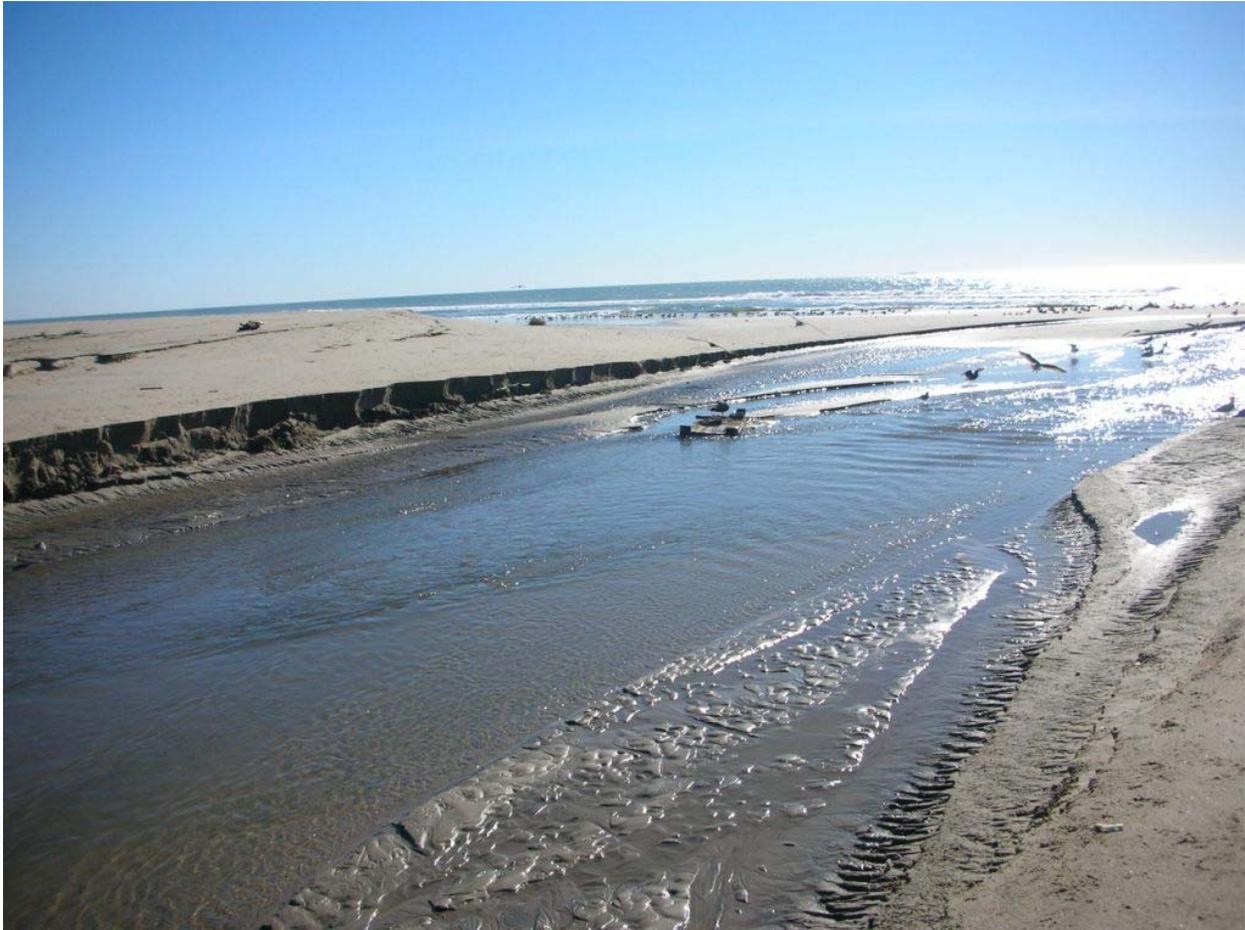
Figure A.18. Breach on December 22, 2007.

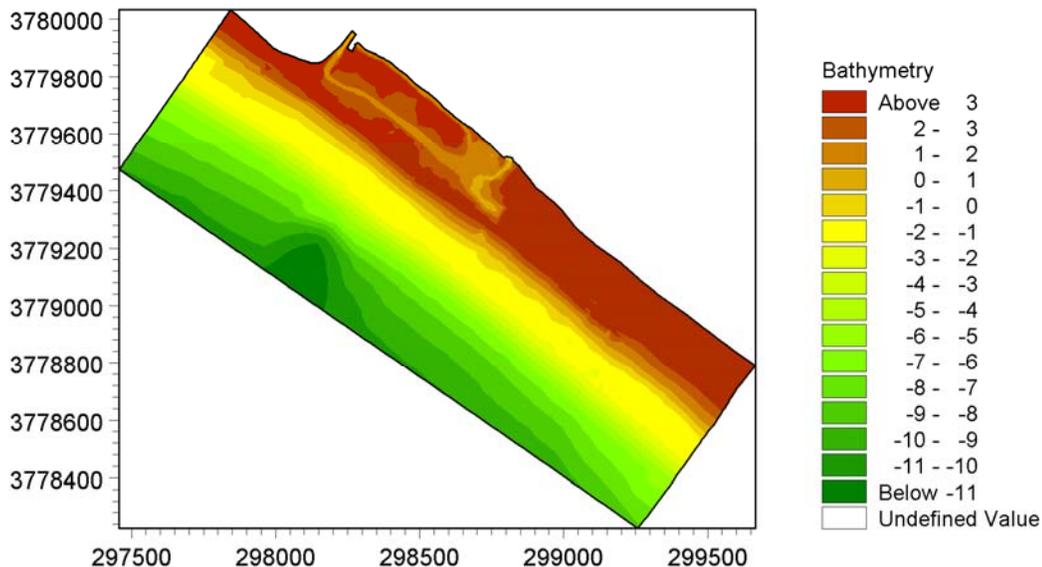
Figure B.1 - Breaching Model Domain, no action idealized beach.

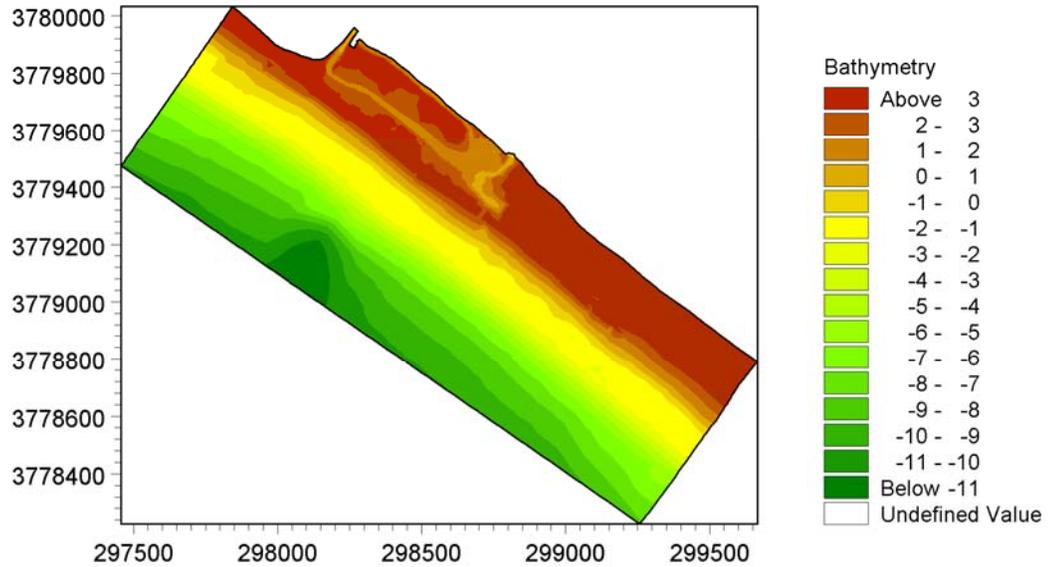
Figure B.2 - Breaching Model Domain, maintained beach.

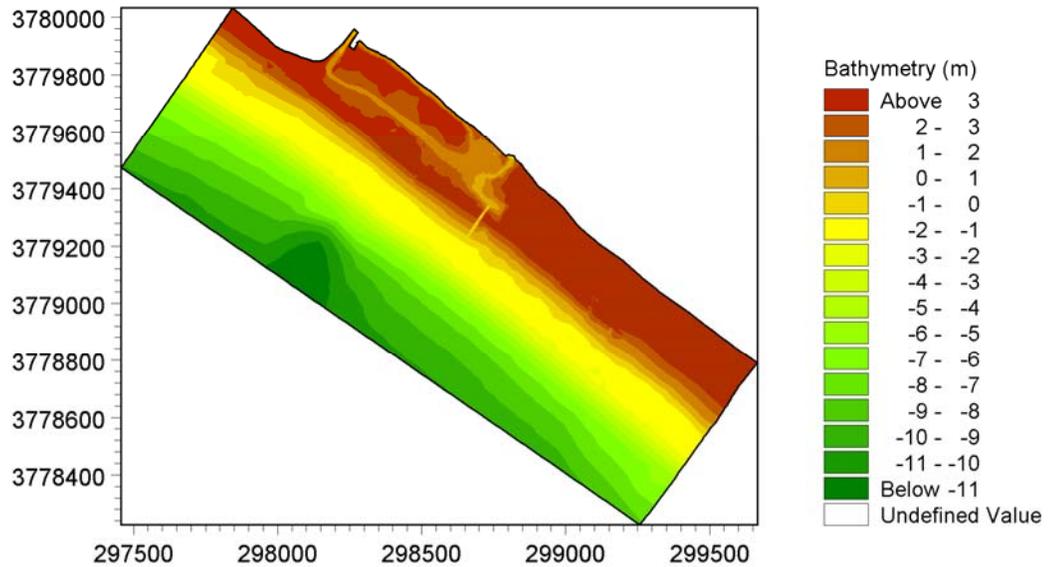
Figure B.3 - Breaching Model Domain, emergency mechanical breach near OID.

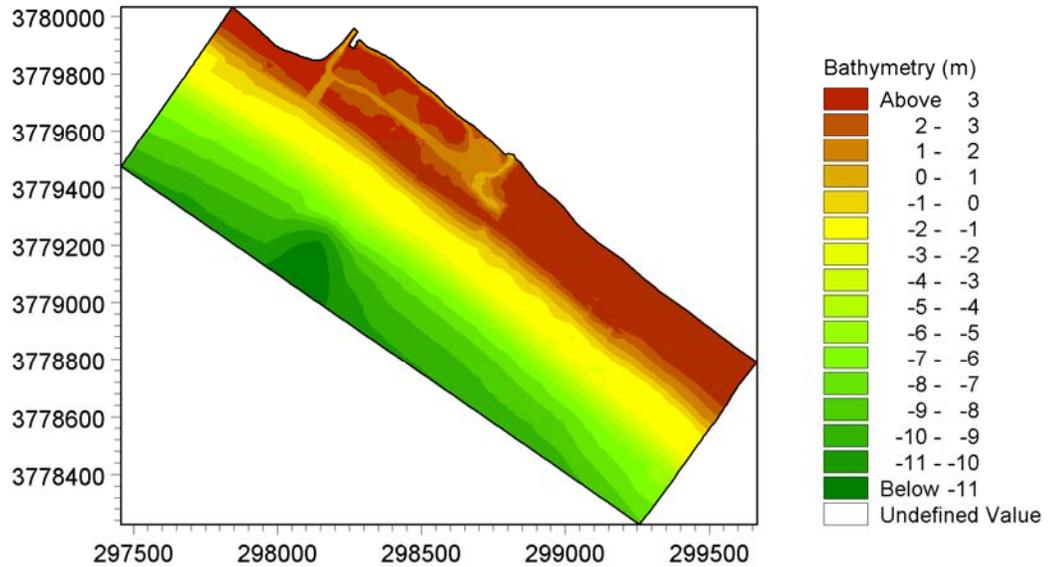
Figure B.4 – Breaching model domain, emergency mechanical breach near J Street.

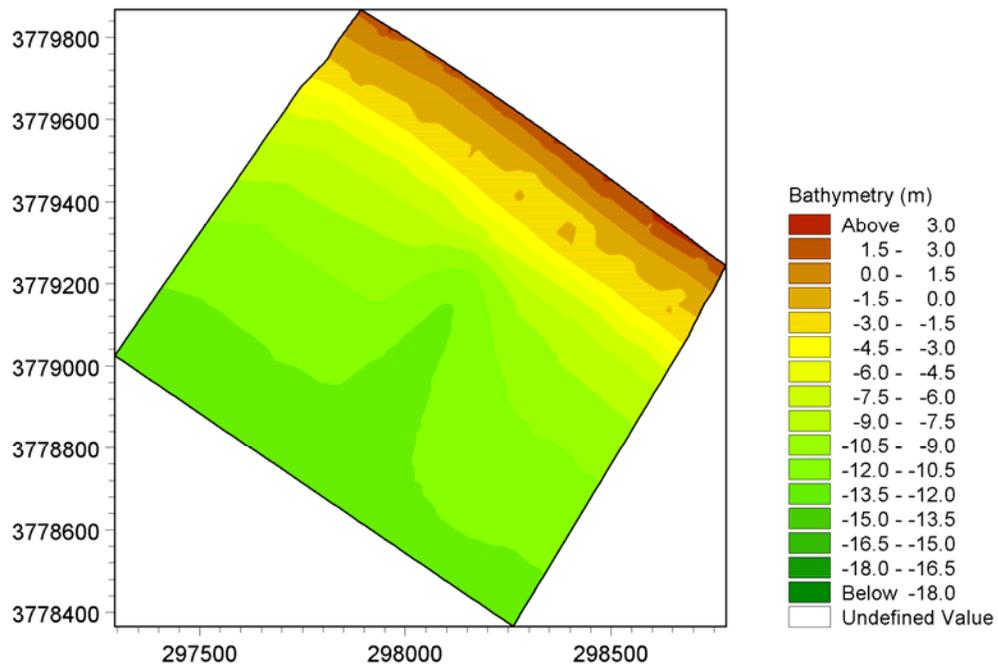
Figure B.5 – Calibration Model Domain.

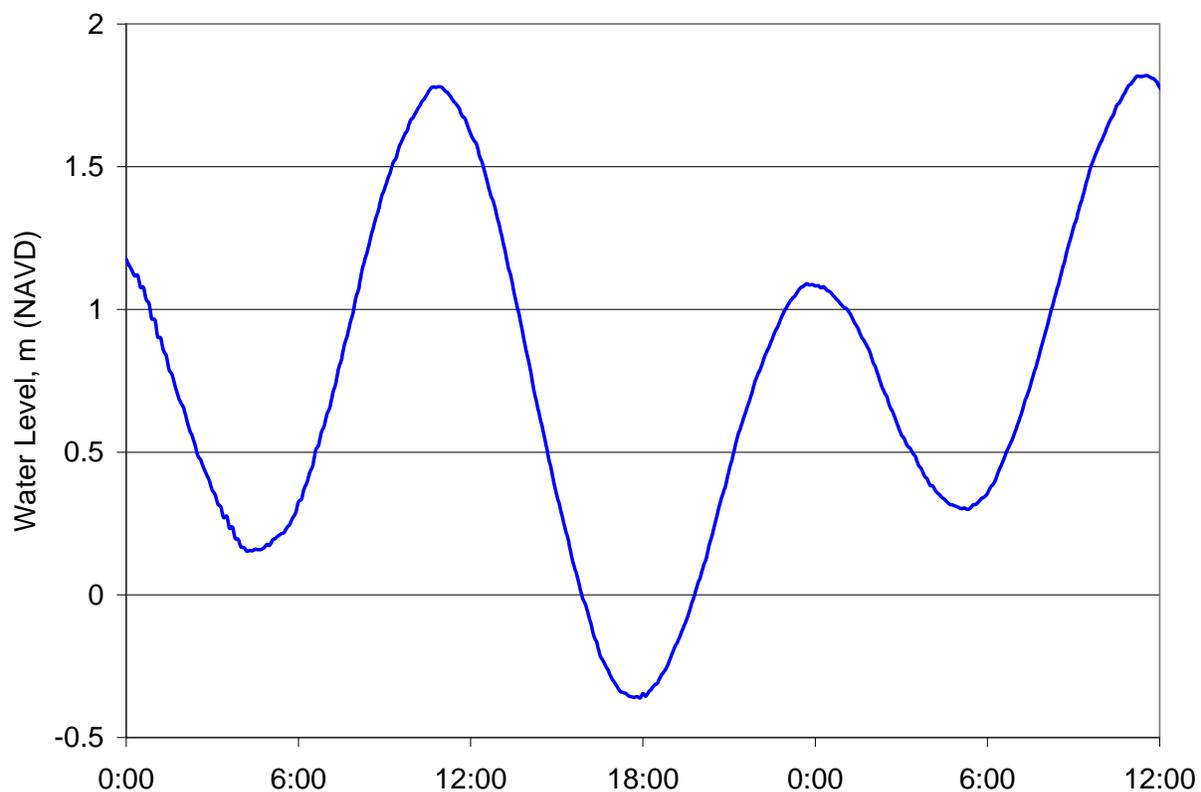
Figure B.6. Water level boundary applied during breaching.

The open boundary on the ocean side of the domain was forced with a typical spring tide based on tidal observations at Santa Barbara shown in Figure B.6. The tidal boundary condition represents the range of tidal elevations exceeded over 90% of the time. The tidal elevation plays a role in determining the absolute depth to which the breach cuts but has little effect on the breaching process since the lagoon is generally perched above the tide.

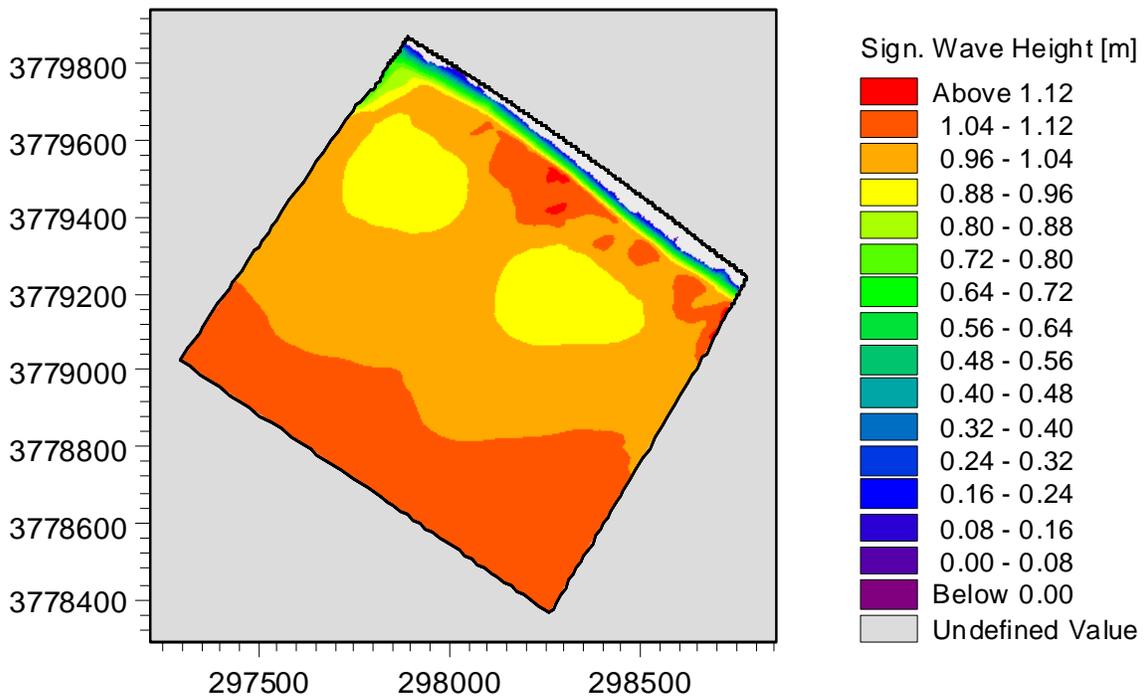
Figure B.7 – Waves during model verification.

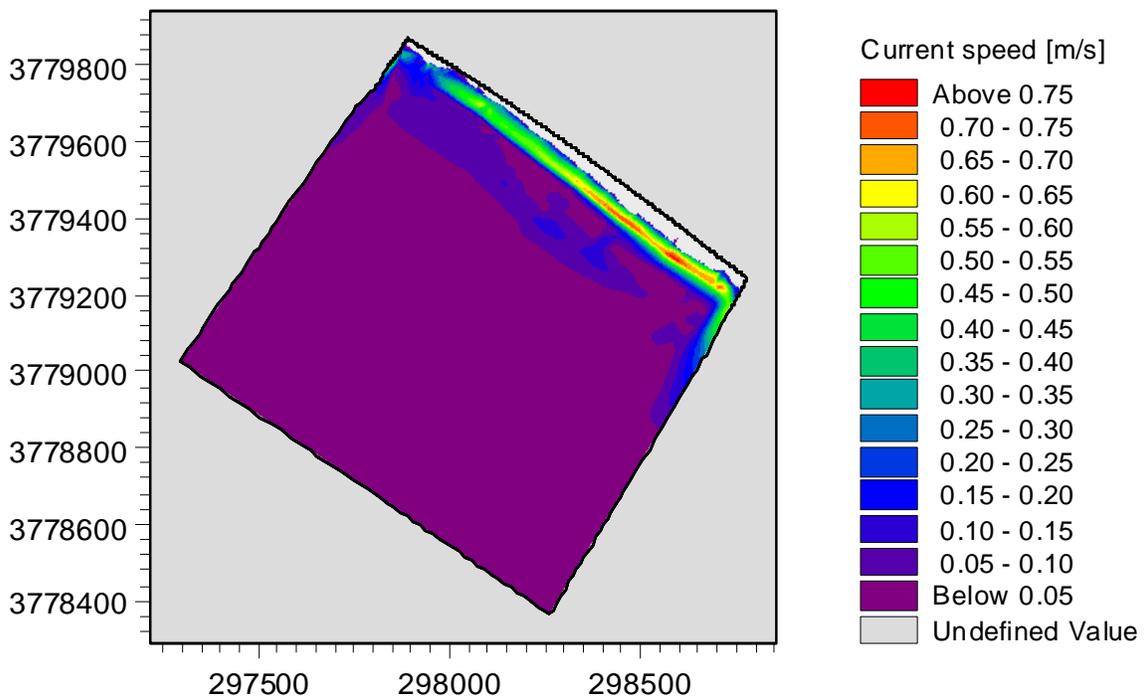
Figure B.8 – Wave and tide induced currents during model verification.

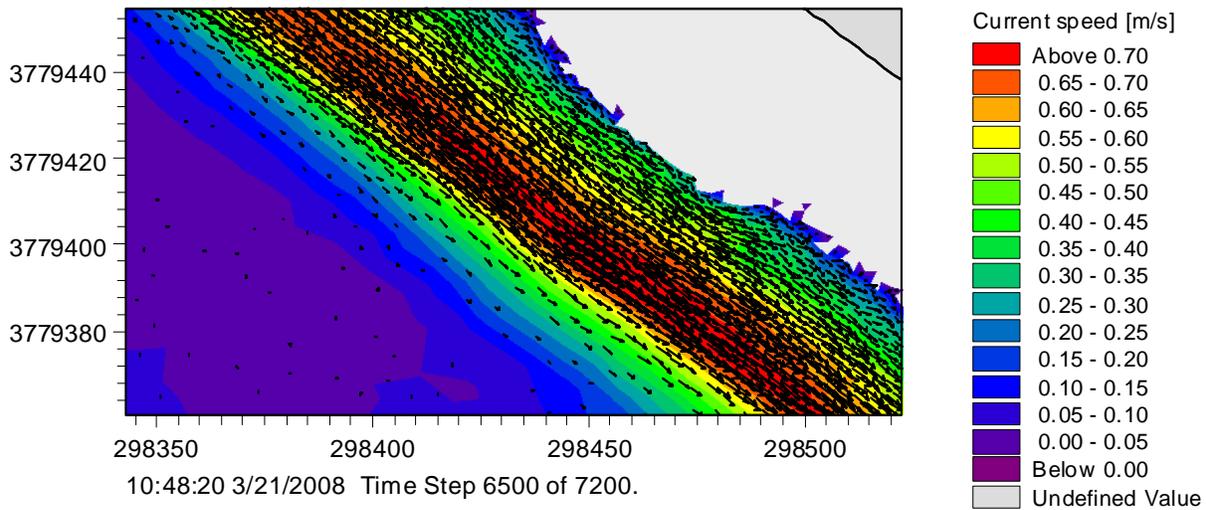
Figure B.9 – Enlarged wave and tide induced currents during model verification.

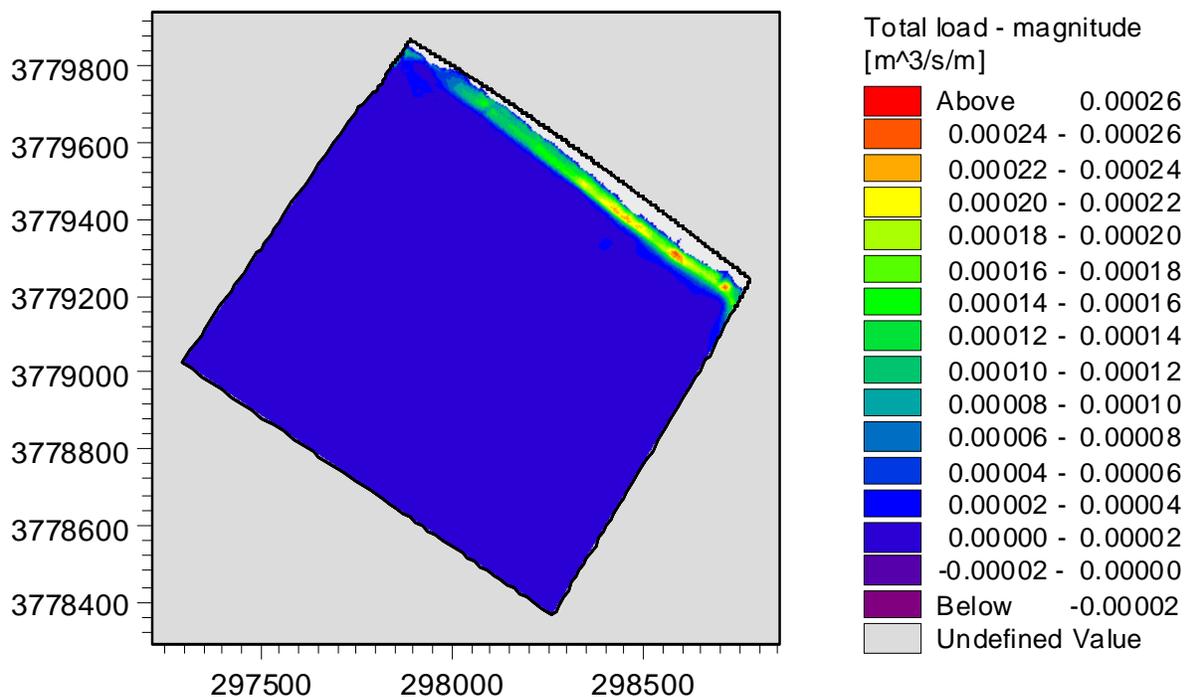
Figure B.10 – Wave and current induced sediment transport during model verification.

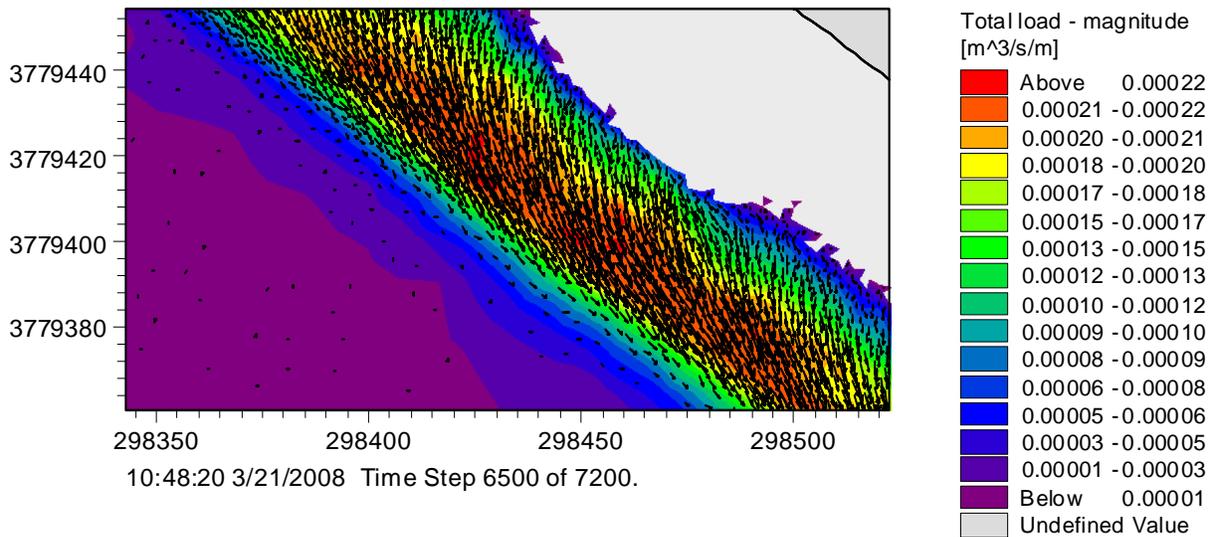
Figure B.11 – Enlarged sediment transport during model verification.

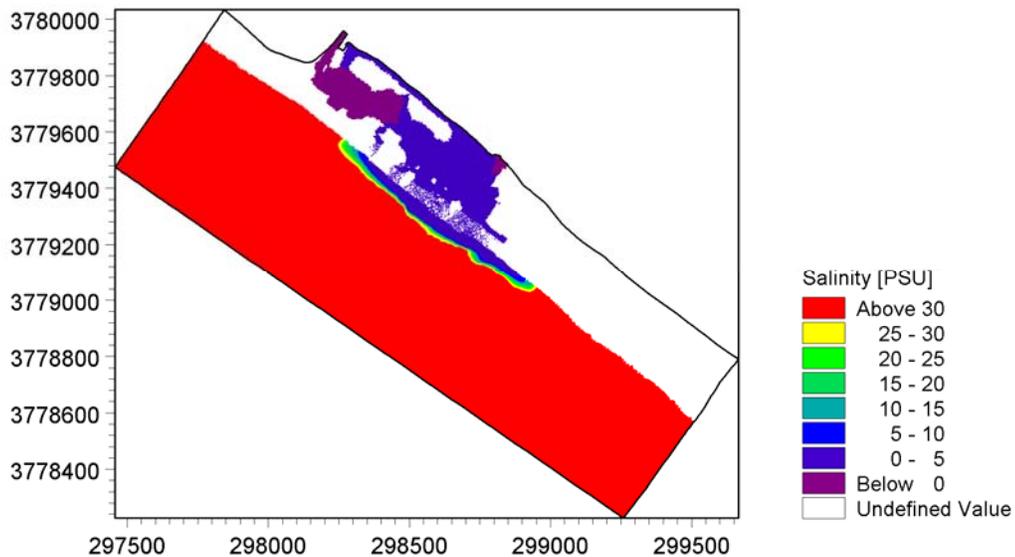
Figure B.12. Salinity at 2-year peak flow over idealized representative beach.

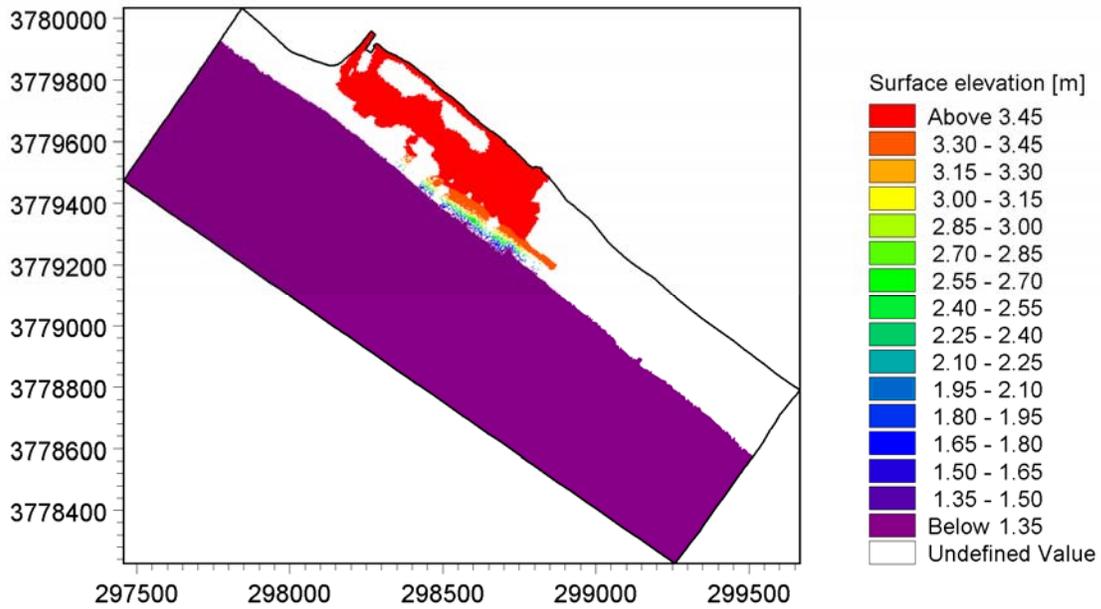
Figure B.13. Peak water level during 2-year event with representative beach.

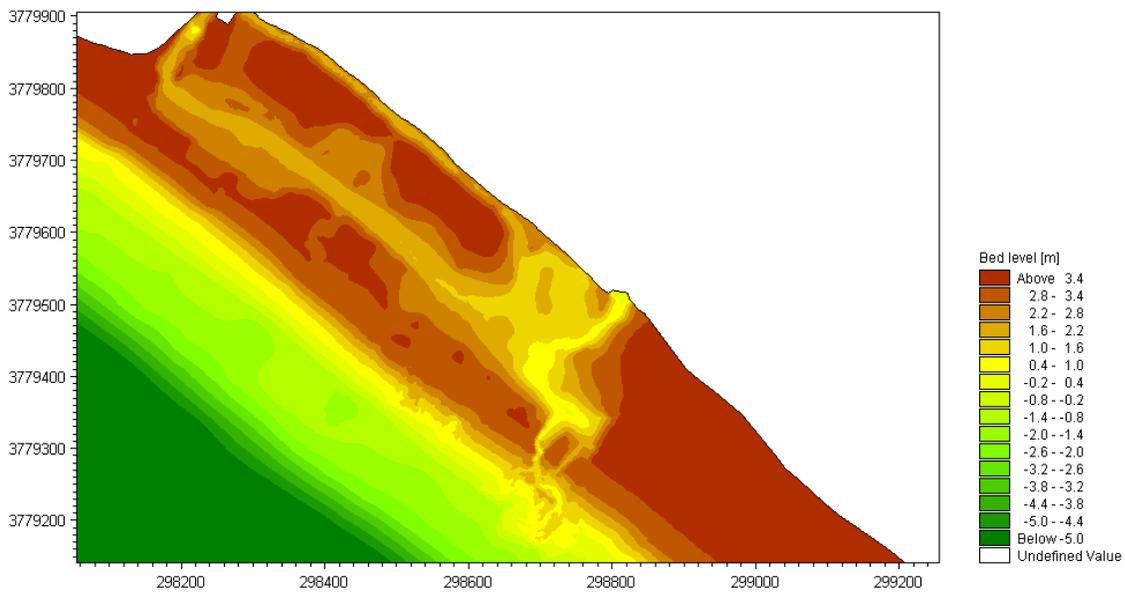
Figure B.14. Bed level at the end of the 2 year storm over the idealized beach.

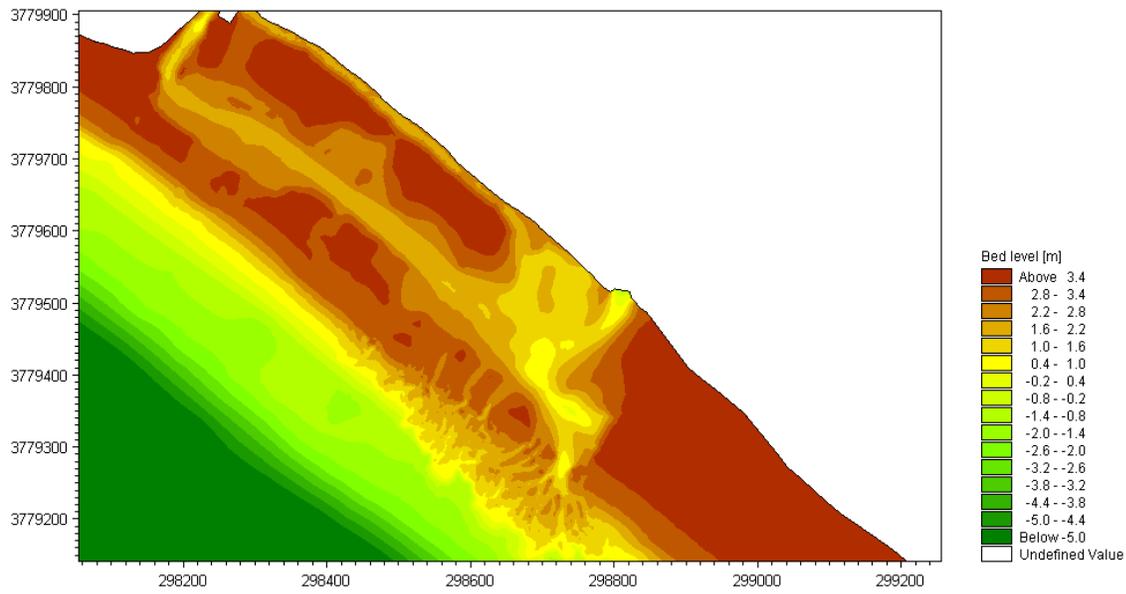
Figure B.15. Bed level at the end of the 100 year storm over the idealized beach.

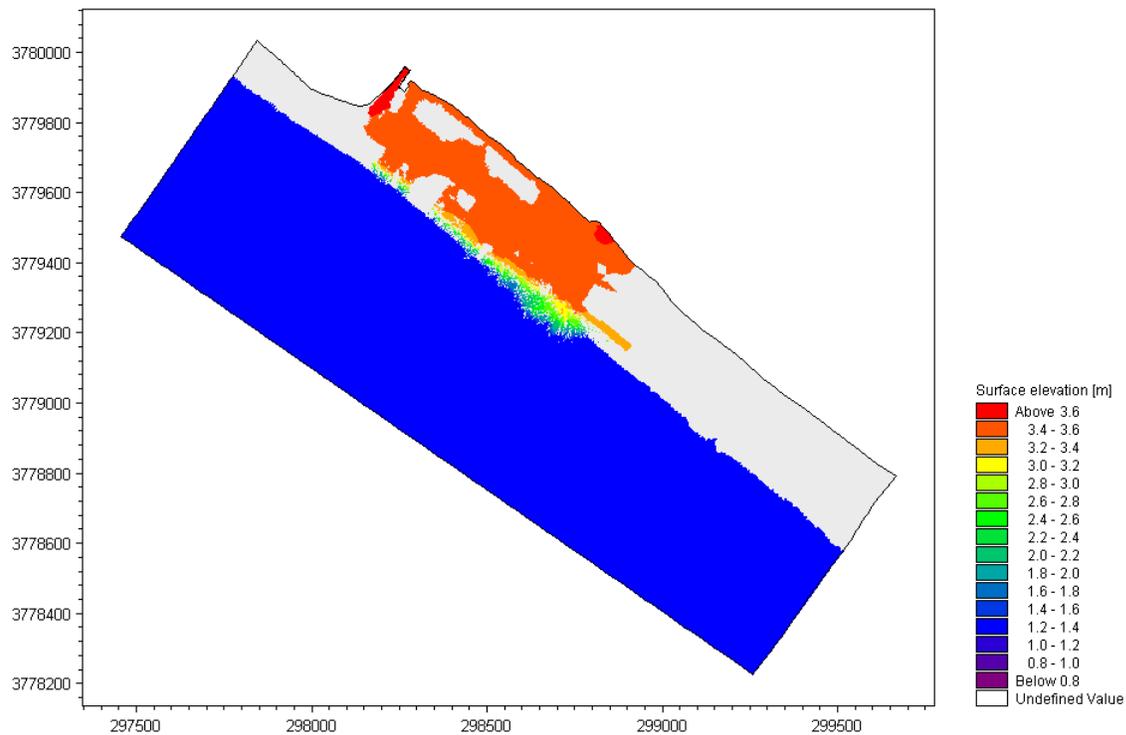
Figure B.16. Peak water level during the 100 year storm over the idealized beach.

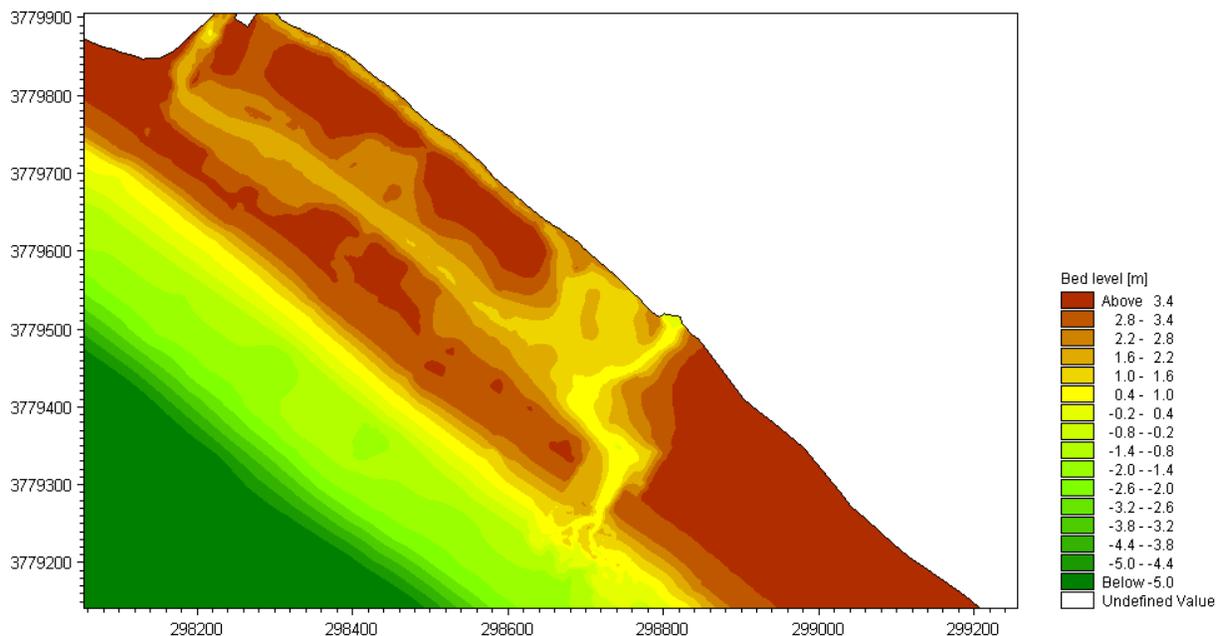
Figure B.17. Bed level at the end of the 2 year storm over the maintained beach.

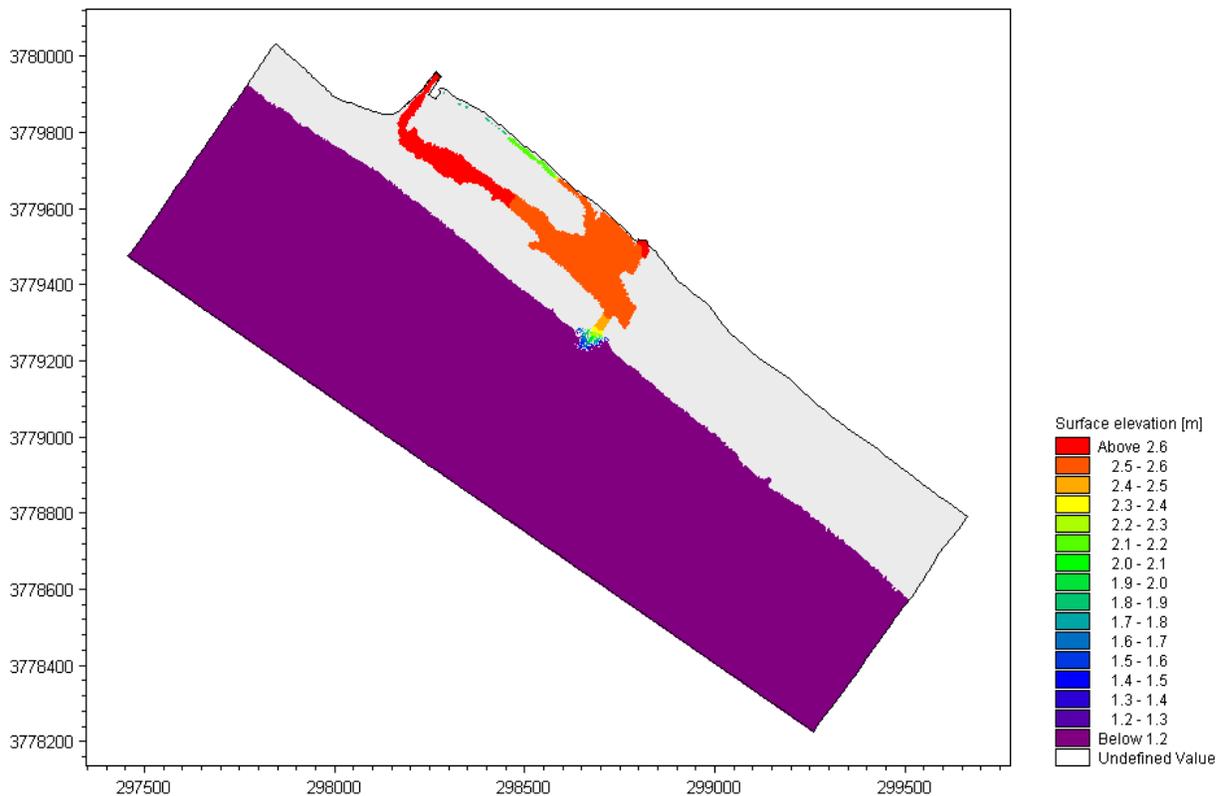
Figure B.18. Peak water level during the 2 year storm over the maintained beach crest.

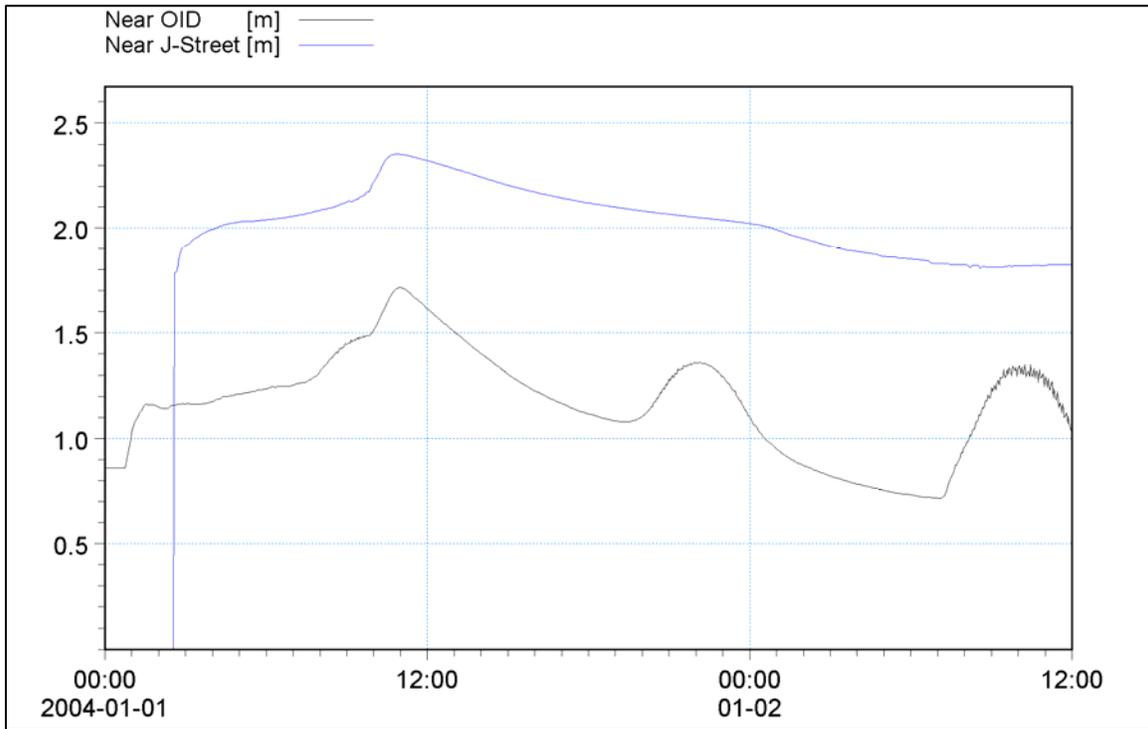
Figure B.19. Water level during the 2-year storm with an emergency breach near OID.

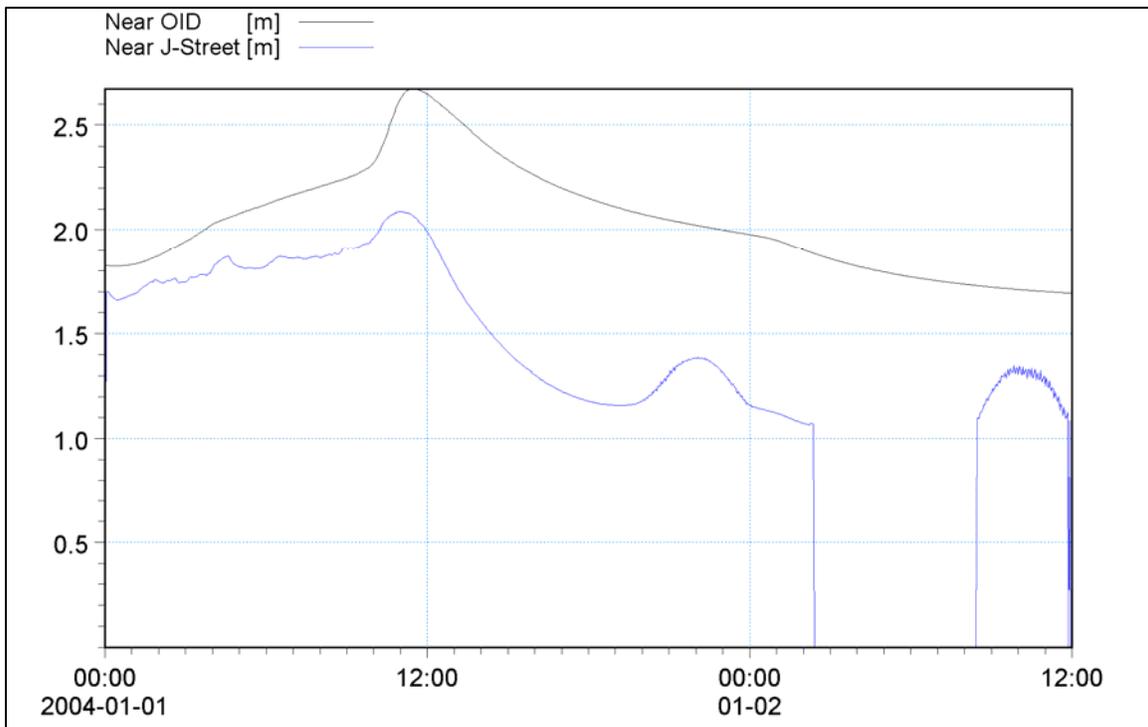
Figure B.20. Water level during the 2 year storm with an inlet near J Street.

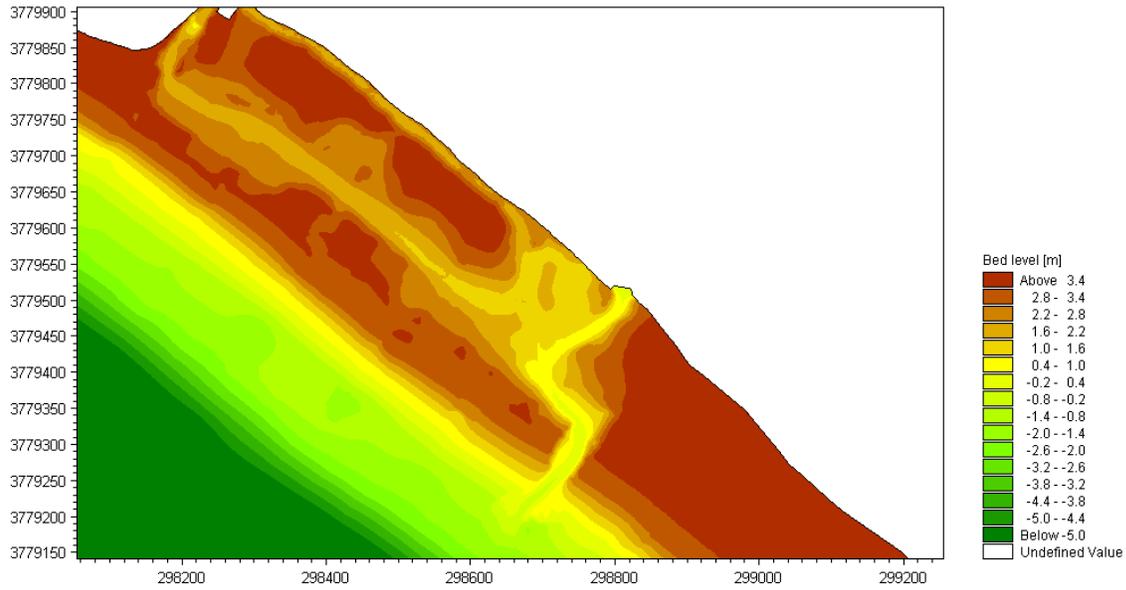
Figure B.21. Bed level after the 2 year storm with an inlet near OID.

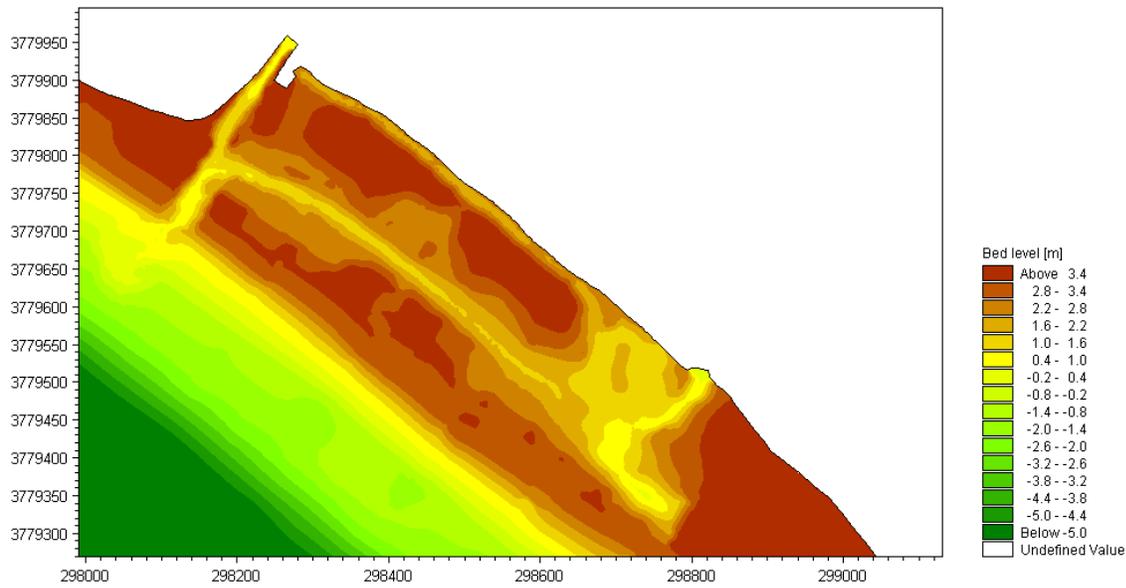
Figure B.22. Bed level after the 2 year storm with an inlet near J Street.
