J Street Drain / Ormond Beach Lagoon Coastal Engineering Report

County of Ventura
800 S. Victoria Ave.
Ventura, CA 93009-1600

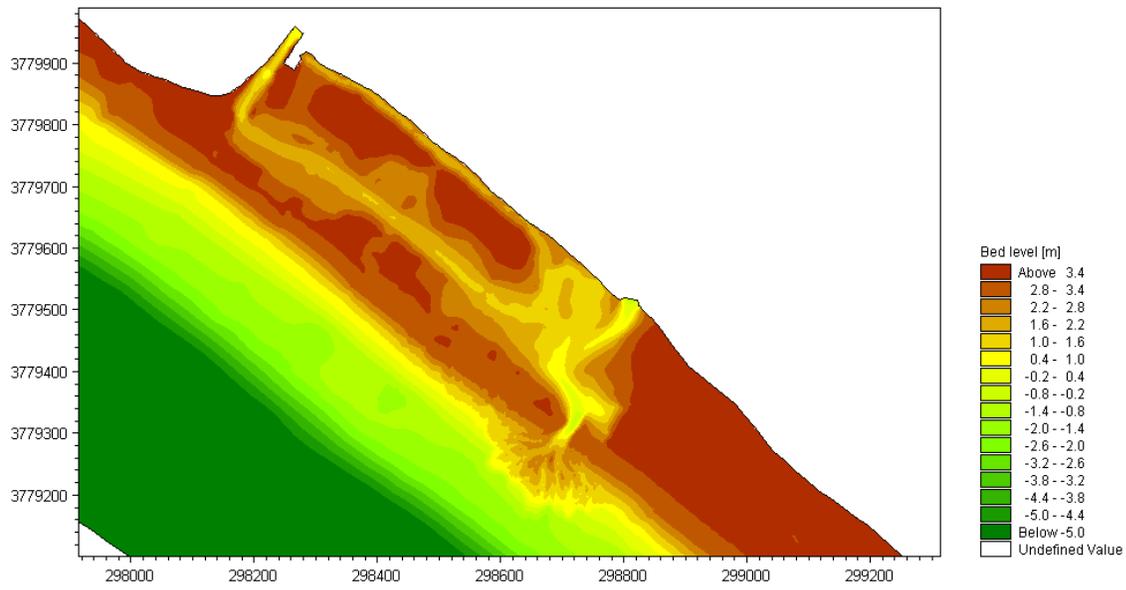
Figure B.23. Bed level after the 100 year storm with an inlet near OID.

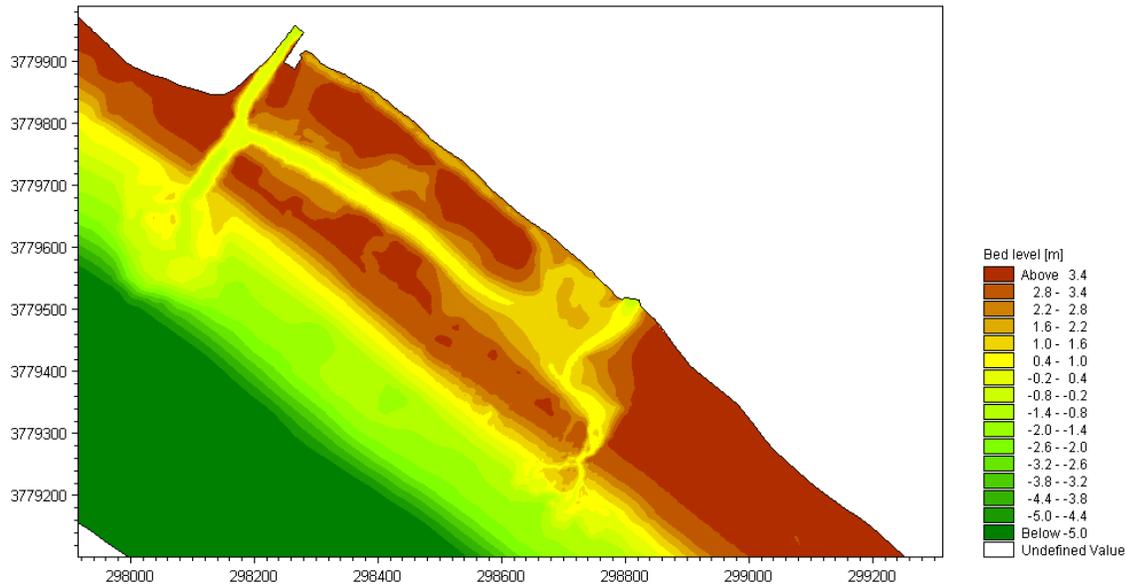
Figure B.24. Bed level after the 100 year storm with an inlet near J-Street.

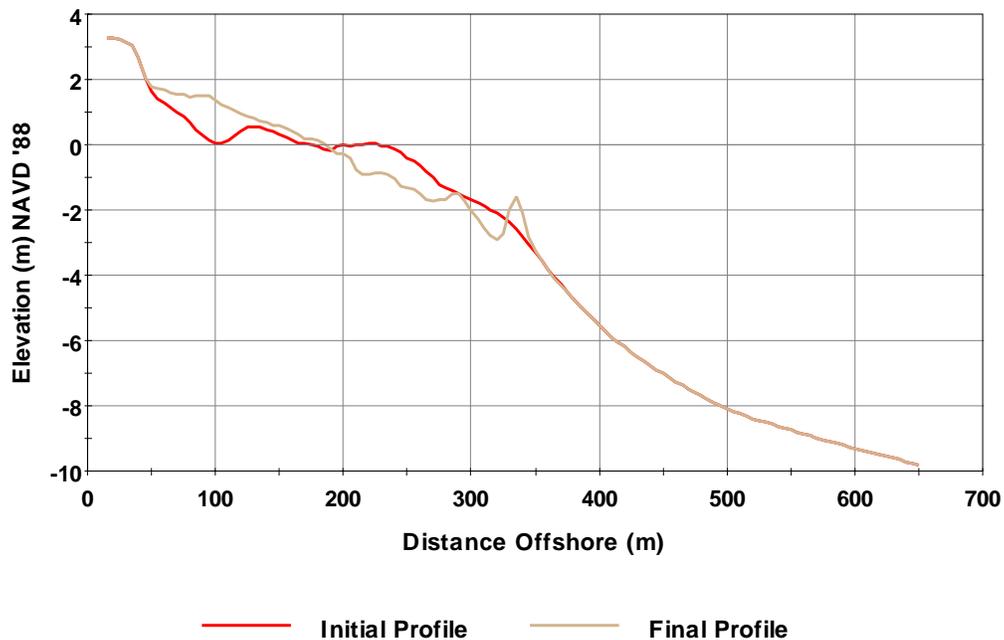
Figure B.25. Modeled cross-shore profile change, March 5 – March 20, 2008

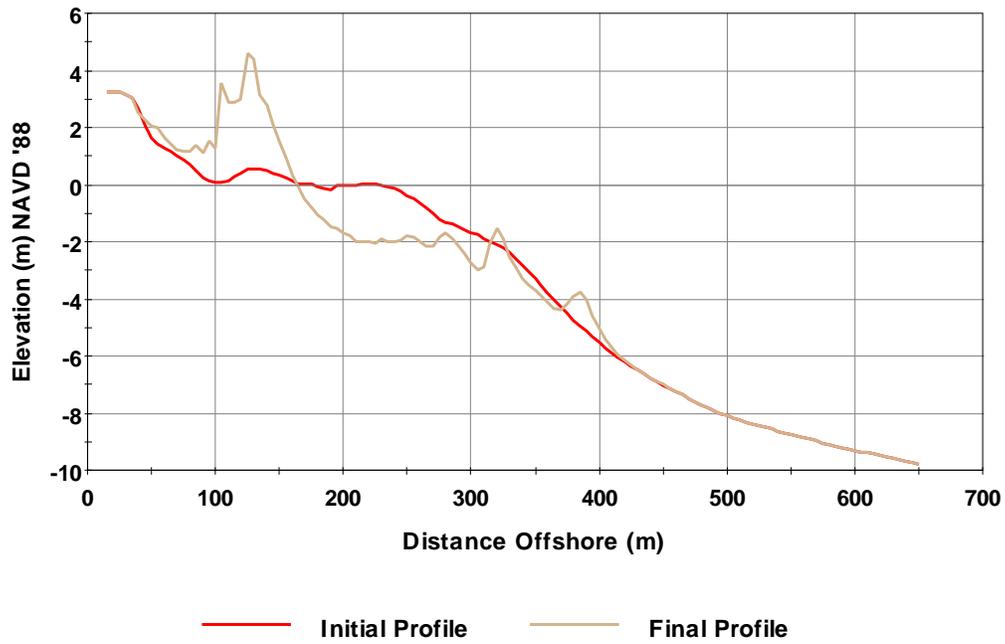
Figure B.26. Modeled cross-shore profile change, February 20 – March 20, 2008
