2005 ANNUAL PROGRESS REPORT
FOR THE
ROBLES DIVERSION FISH PASSAGE FACILITY
AND
VENTURA RIVER IMPEDIMENT MONITORING

CASITAS MUNICIPAL WATER DISTRICT
1055 N. VENTURA AVENUE
OAK VIEW, CALIFORNIA 93022
DRAFT

October 27, 2005

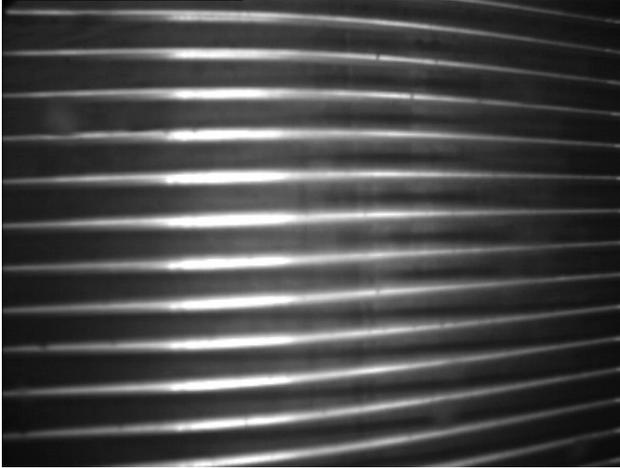
4/21/05 non-fish – image from Riverwatcher camera (note: nothing in photo)

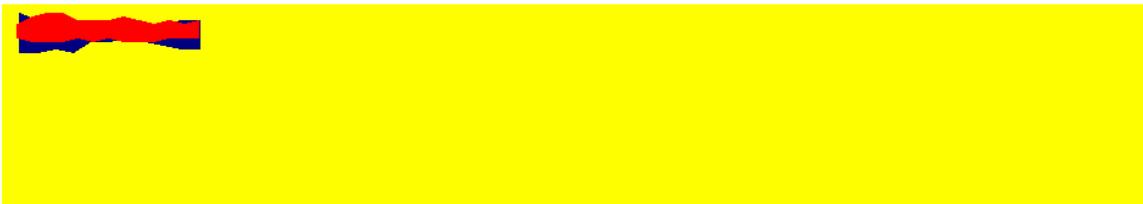
5/3/05 0925 #110 – Image of object passing upstream (no object is seen passing through in photo) through Riverwater – correlating silhouette below – In addition, an example of debris, which clogs the Riverwatcher and shroud.

5/3/05 0925 #110 – Silhouette #1 and #2 of object passing upstream through Riverwatcher – correlating image above.

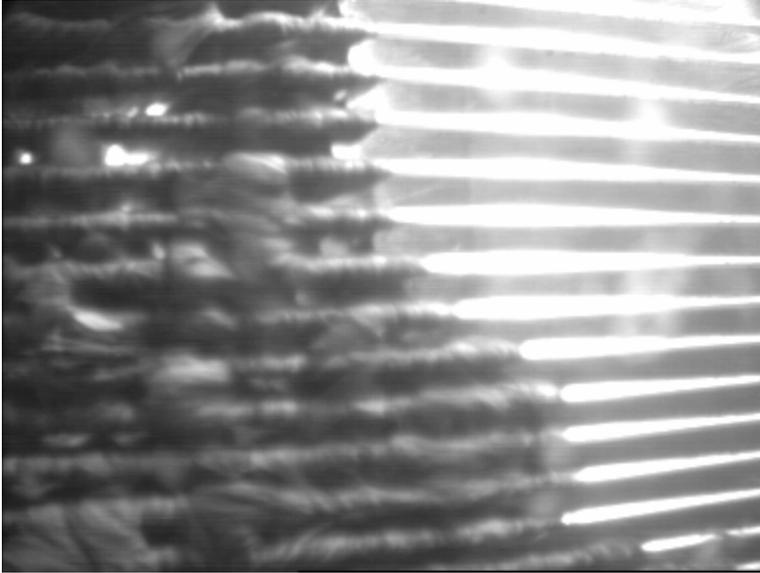
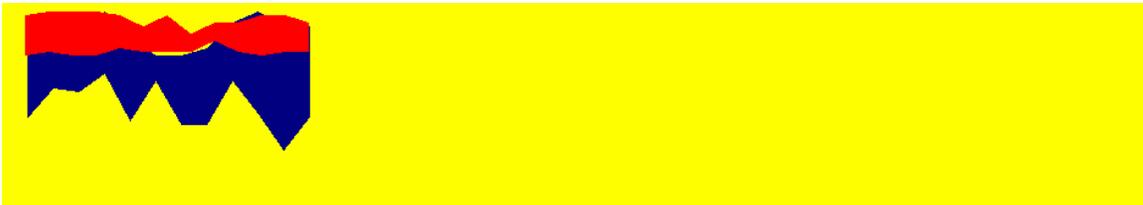
4/29/05 1007 #74 - Image of object passing upstream (object is not seen, i.e. false count) through Riverwater – correlating silhouette below – In addition, an example of debris, which clogs the Riverwatcher and shroud.

4/29/05 1007 #74 - Silhouette #1 and #2 of object passing upstream through Riverwatcher – correlating image above.

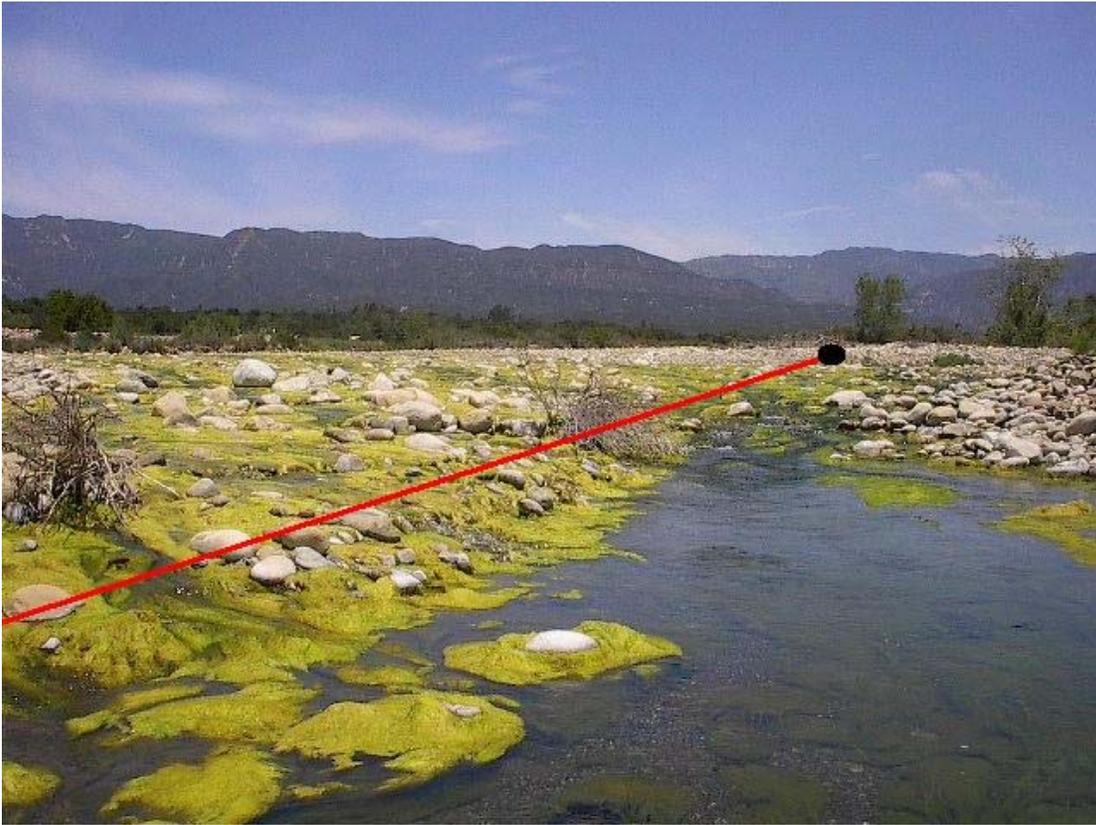
Figure 11.3: Photo of Mark 12 looking upstream, approximate transect location is marked in red.

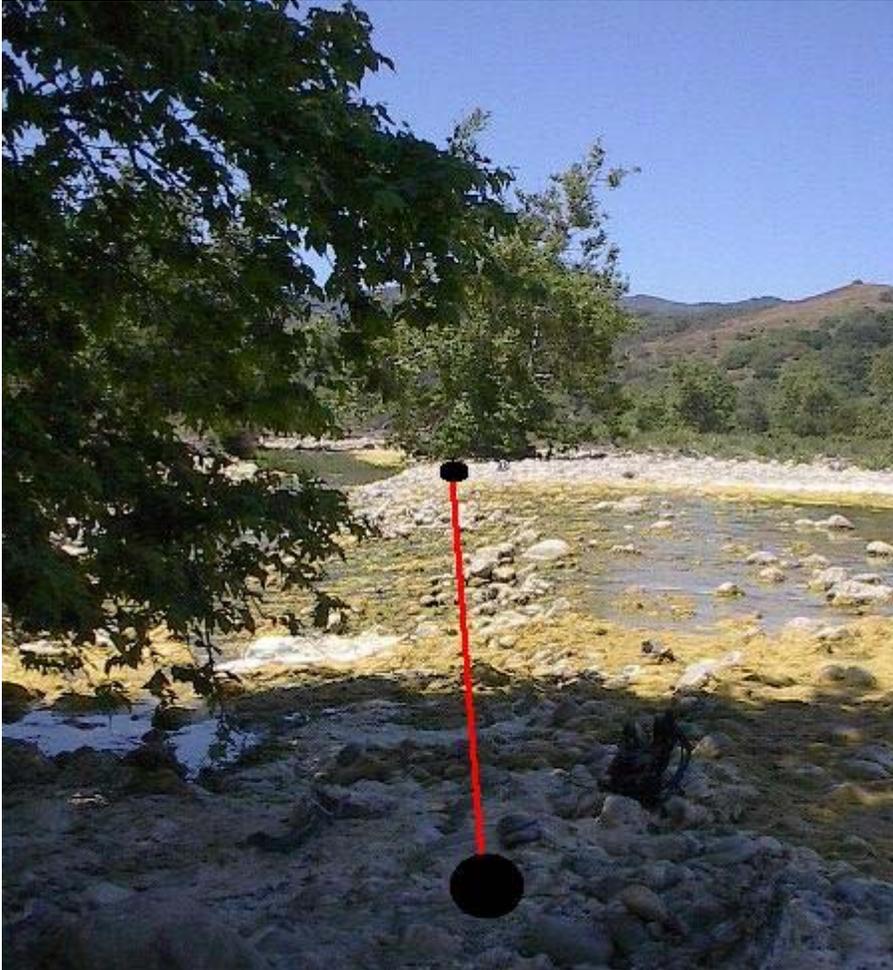
Figure 12.3: Photo of Mark 13 looking downstream, approximate transect location is marked in red.

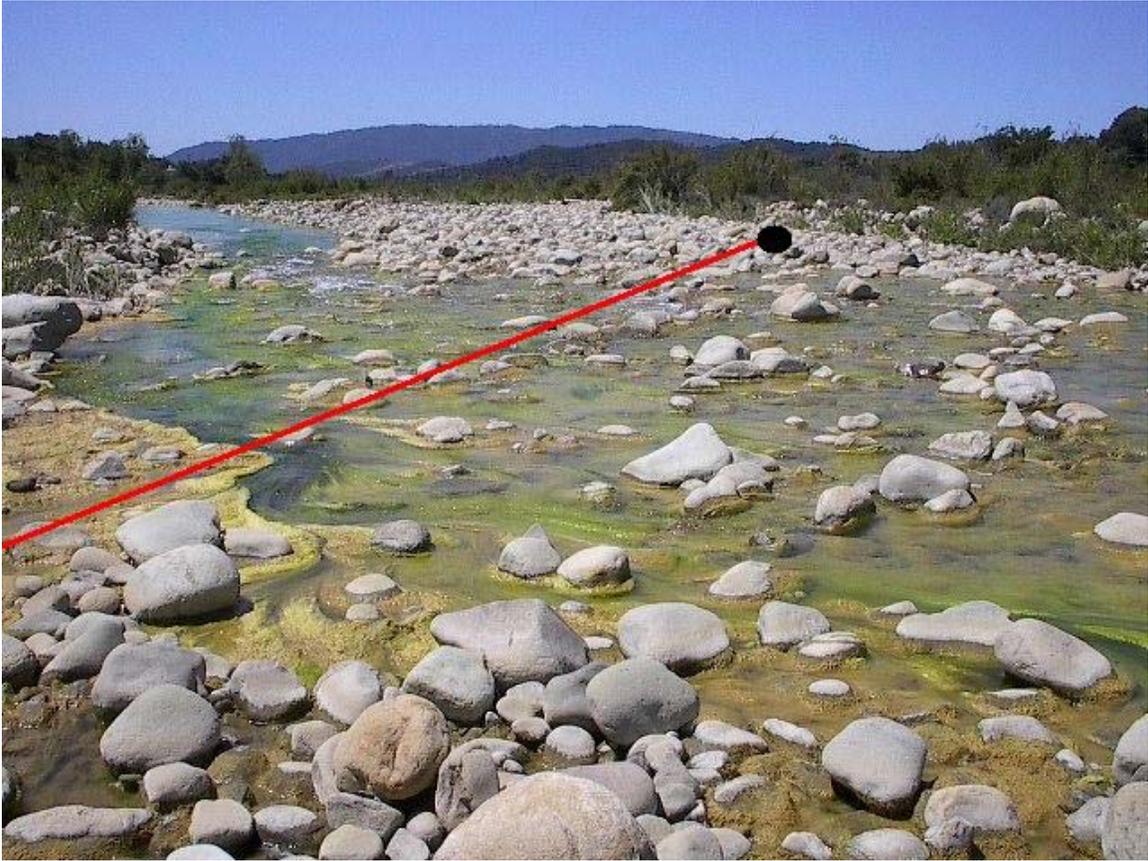
Figure 13.3: Photo of Mark 17 looking downstream, approximate transect location is marked in red.

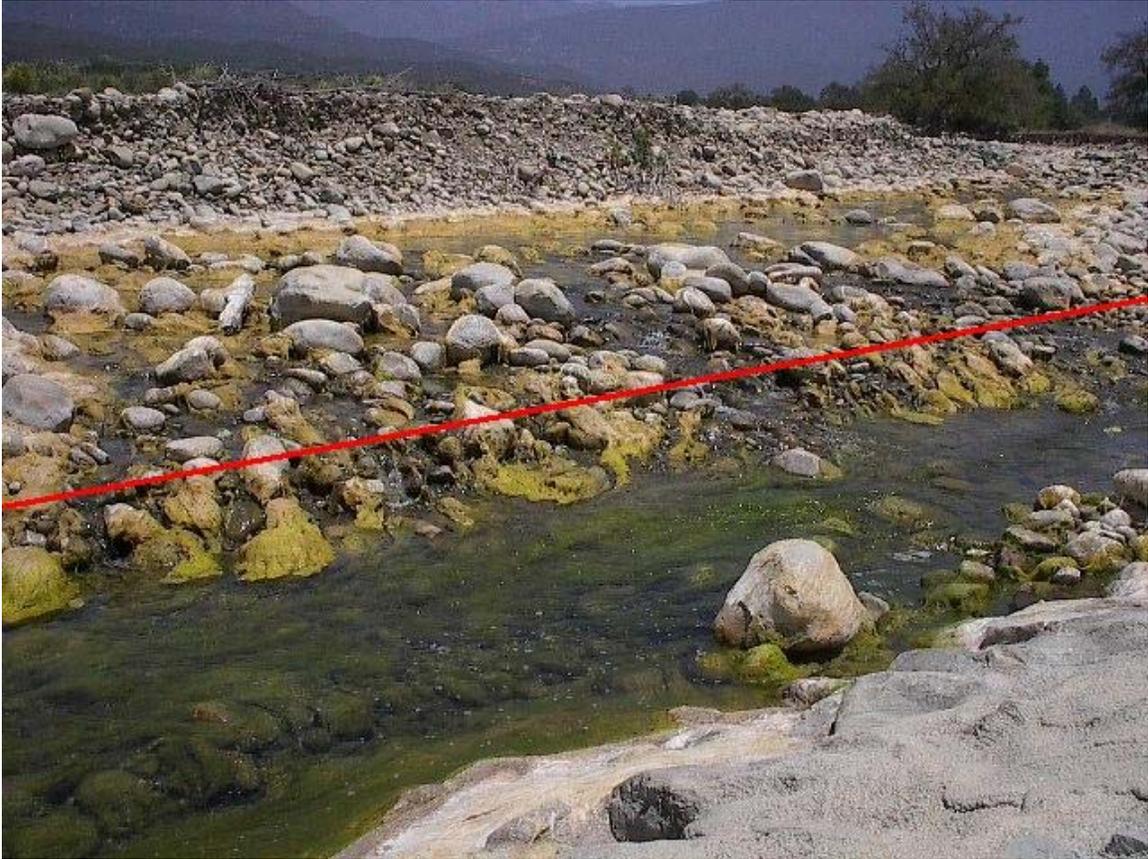
Figure 3: Photo of Mark 12 looking upstream, approximate transect location is marked in red.

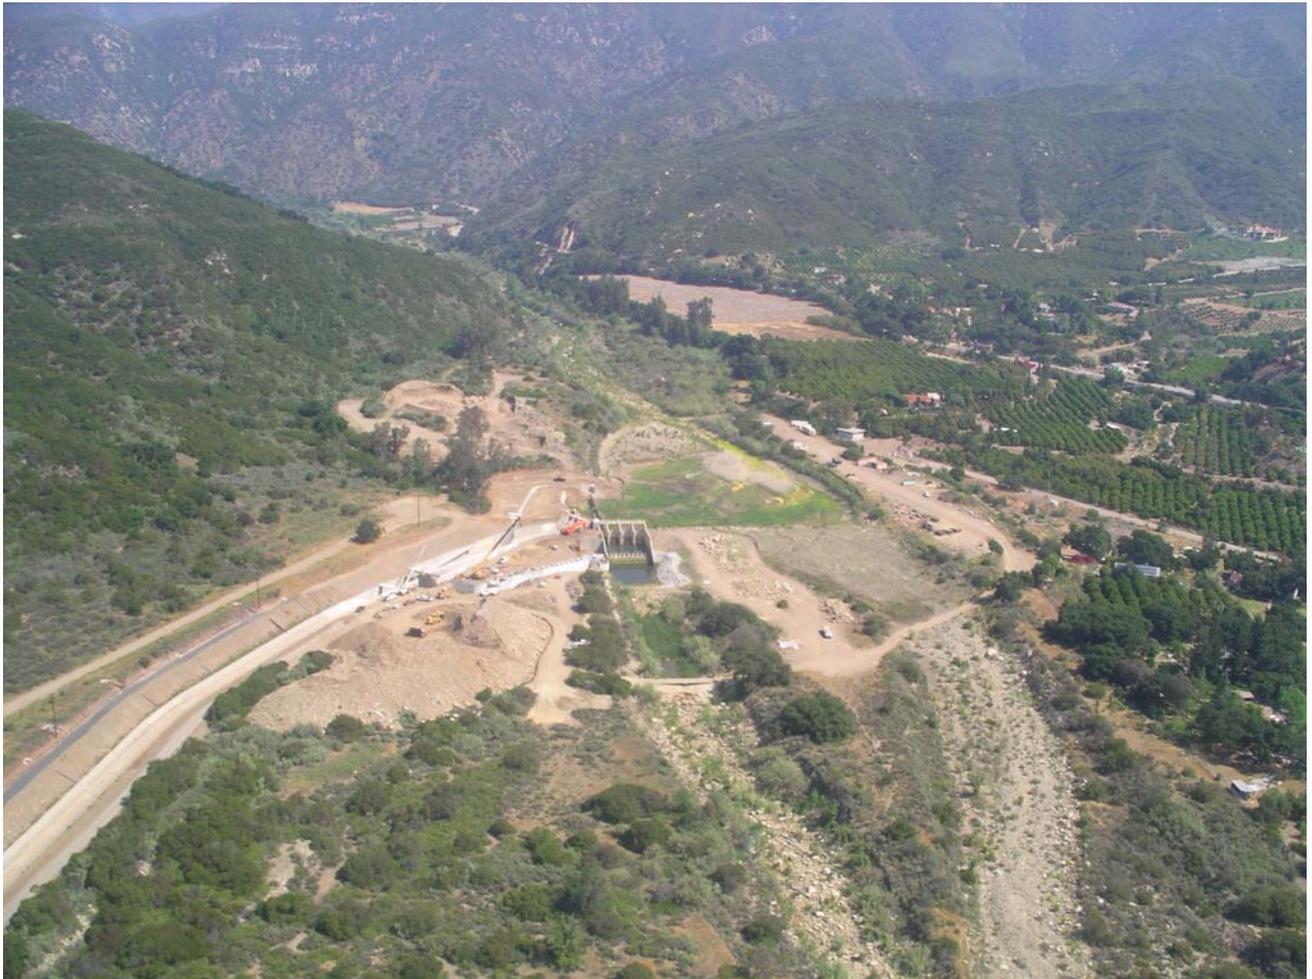
10/1/04 – Project construction continuing with the installation of fish screens and brush system. Note that the electrical and programming systems for the brush system were not installed until the last week of December 2004.

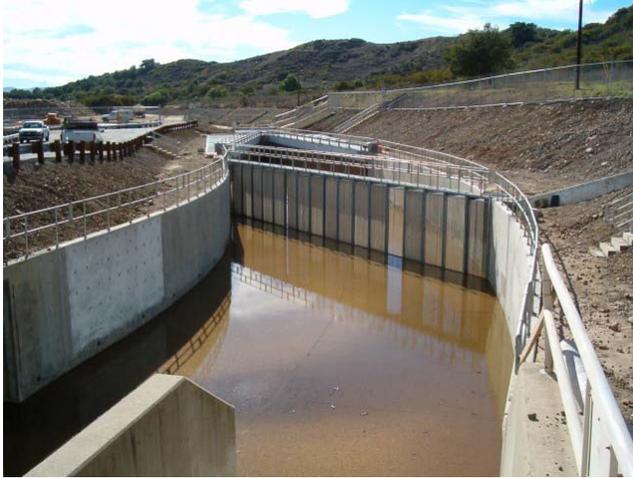
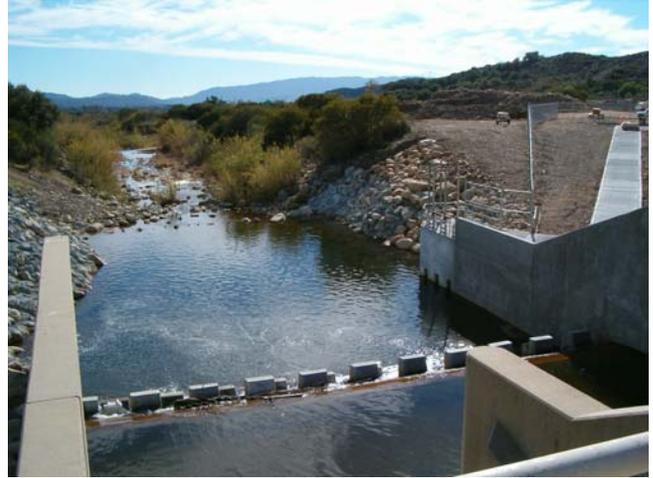
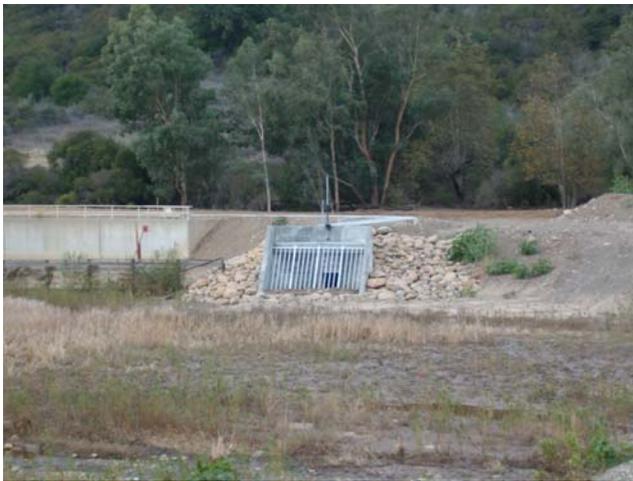
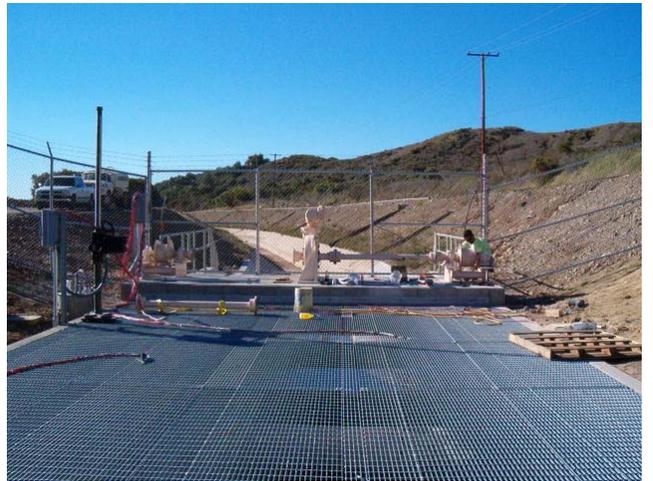
11/3/04 – Small amount of runoff allowed to pass through the spillway gates while work is proceeding in the fish passage and on the overshot gate (top and middle).

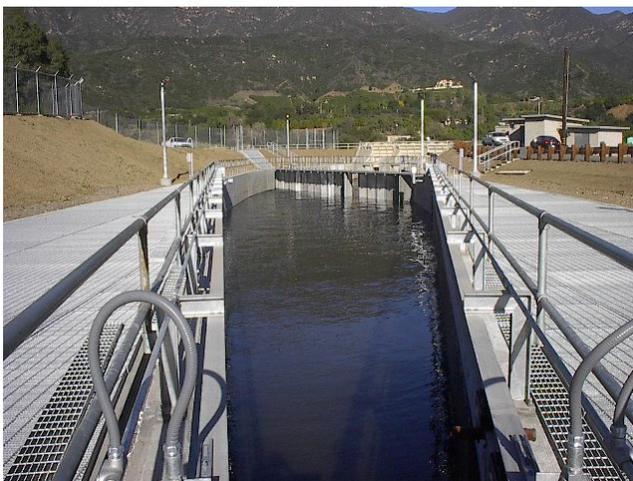
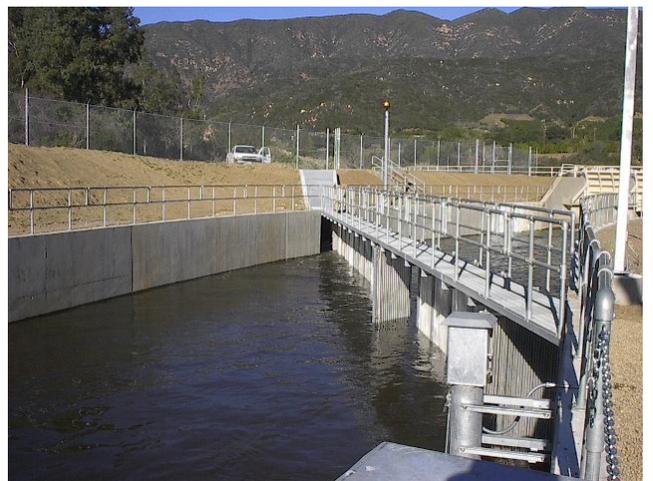
12/21/04 – District performed a release of water from Matilija Dam and diversion to Lake Casitas (bottom). Brush system was still inoperable.

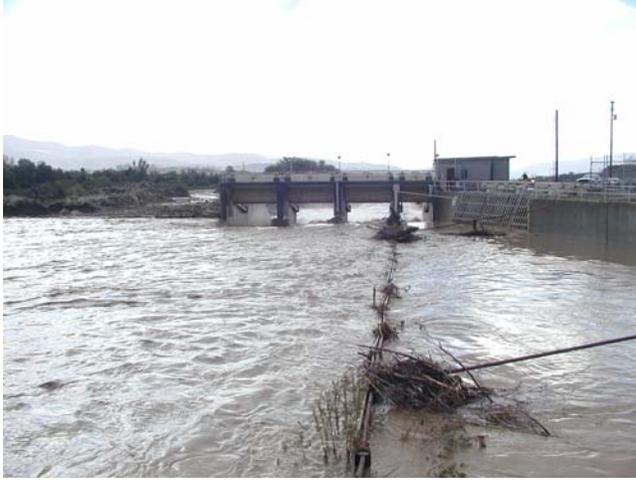
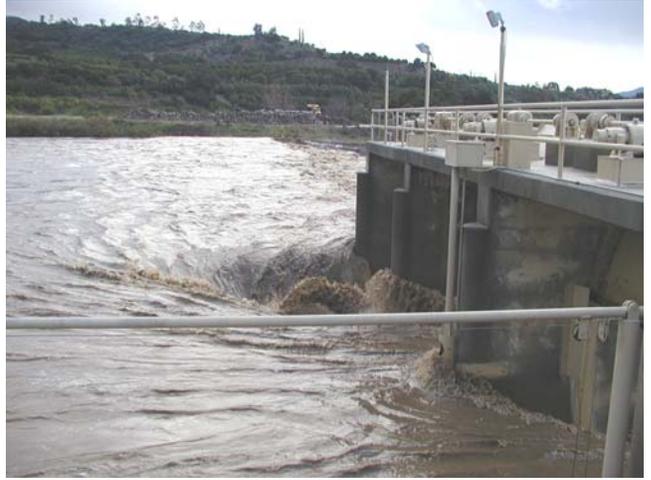
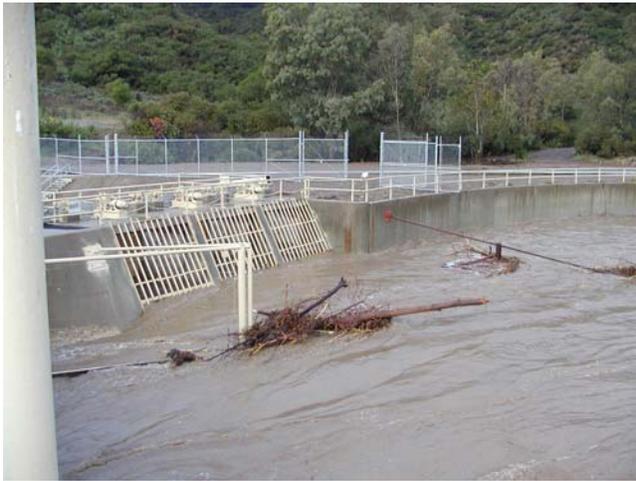
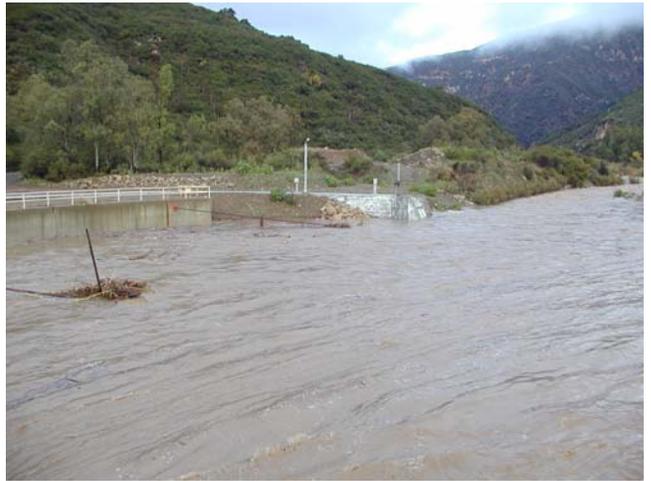
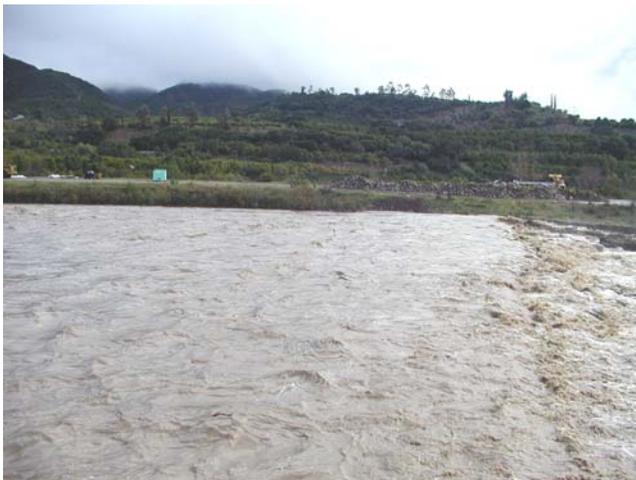
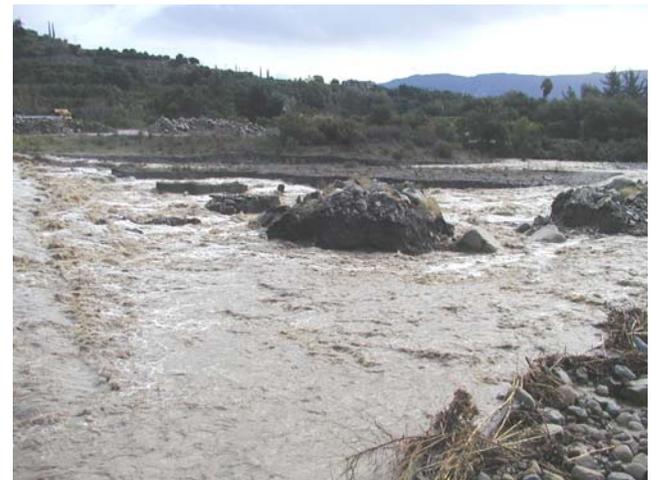
12/31/04 – Robles Basin conditions during the first major storm of the season. Trash wall and spillway gates (top left and right), Canal Entrance (middle left) and fish exit structure (middle right), and Robles basin and cutoff wall breaching (bottom left and right) during peak of storm.

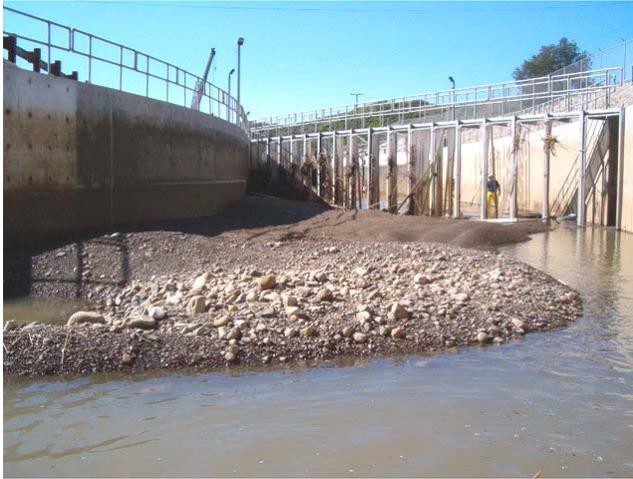
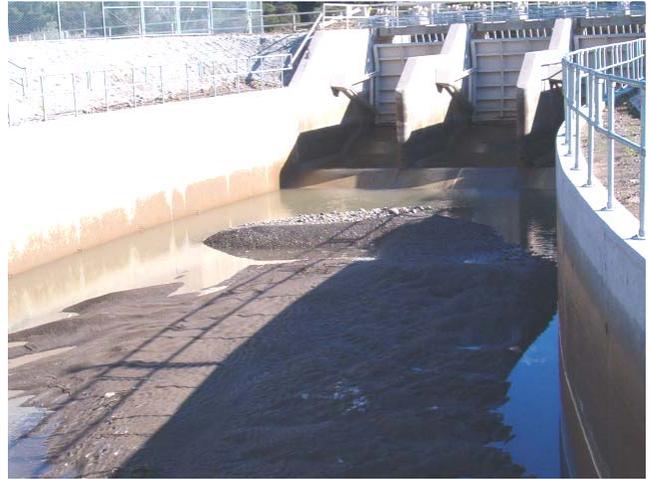
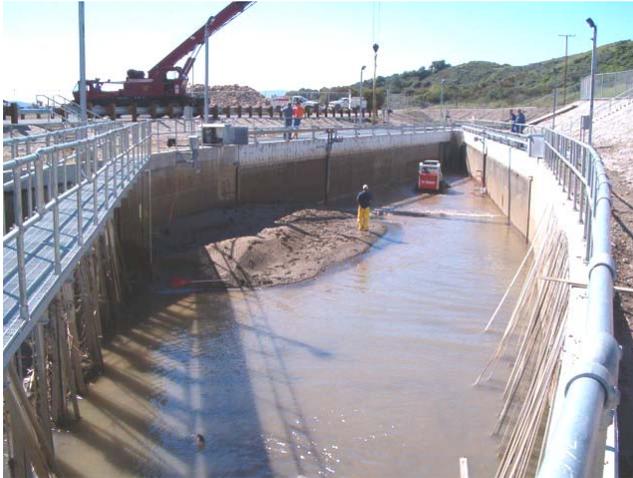
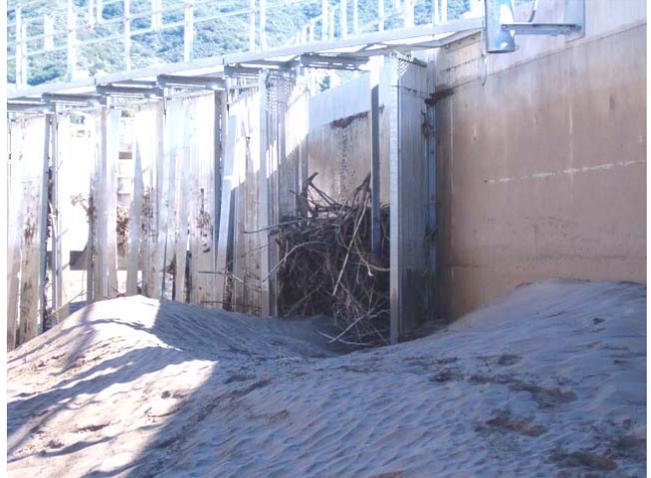
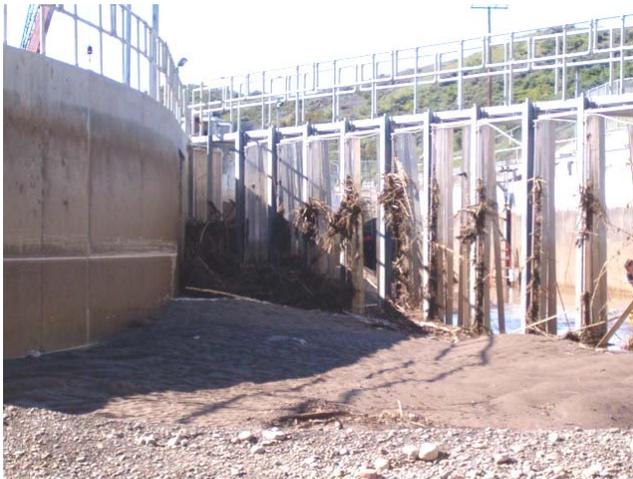
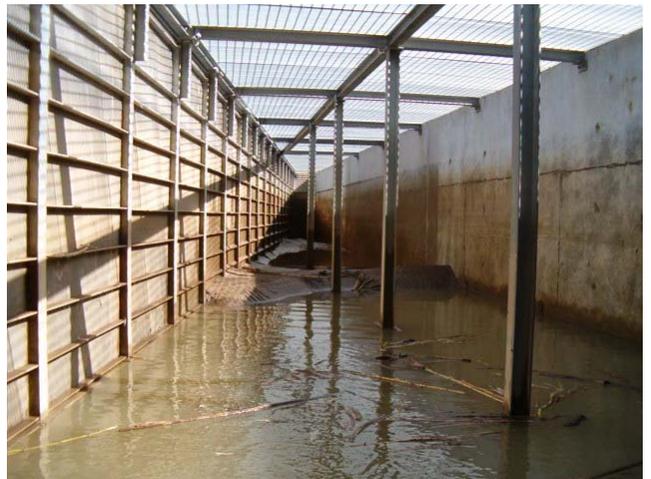
3/03/03 – District performed maintenance on the fish passage facility. Sediment deposition in the forebay.

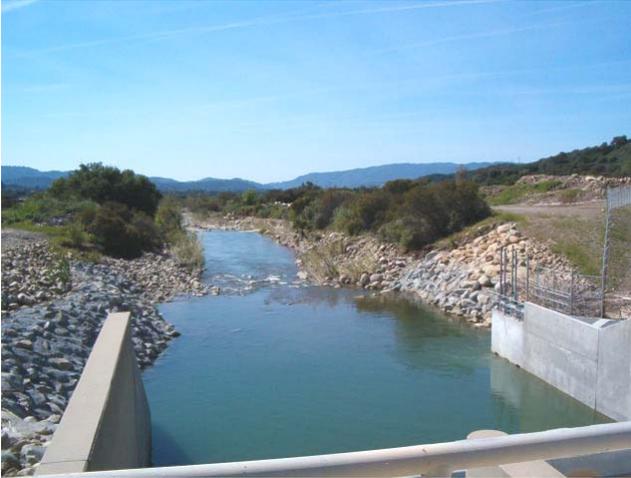
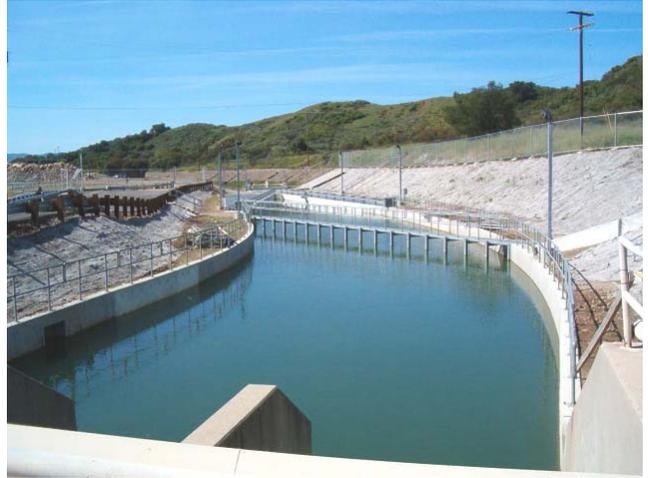
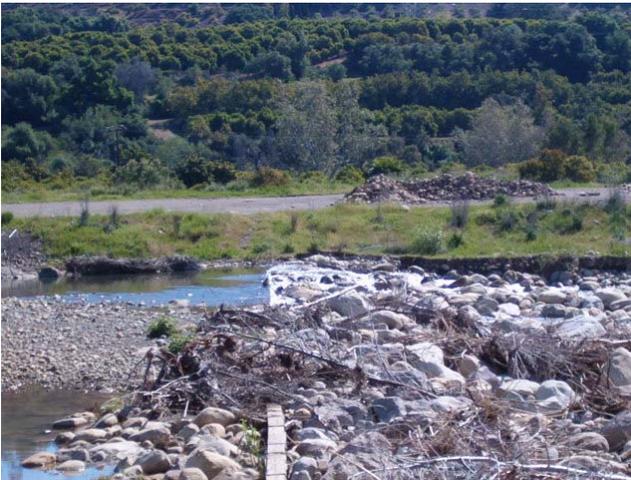
3/25/05 – Facility in operation without the use of the fish guidance device, water flowing over the cutoff wall.

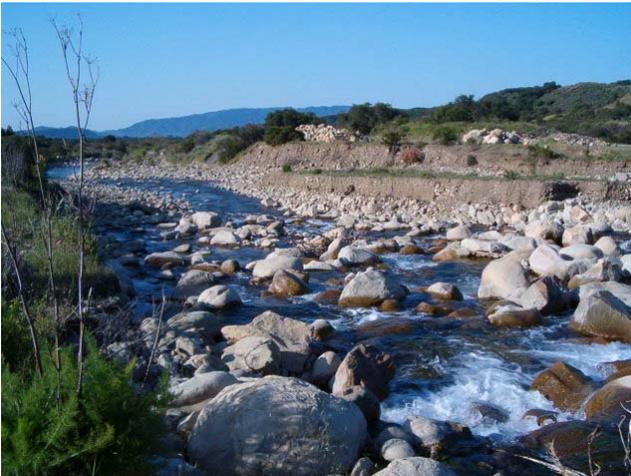
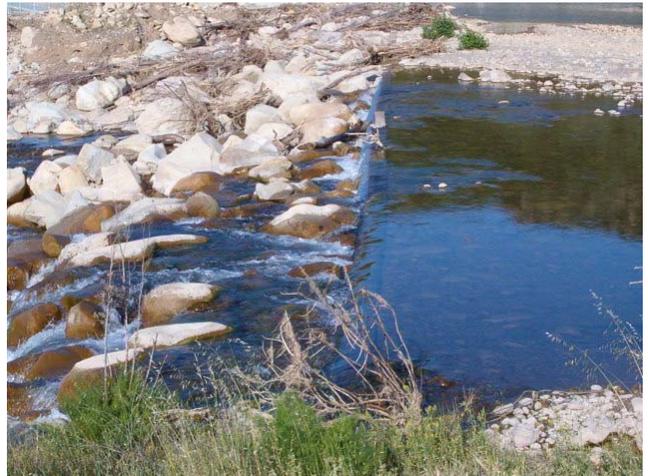
4/29/05 – Cutoff wall overflow still occurring.

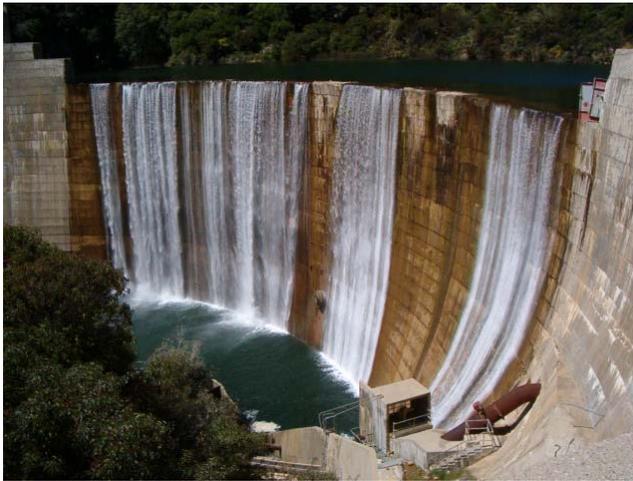
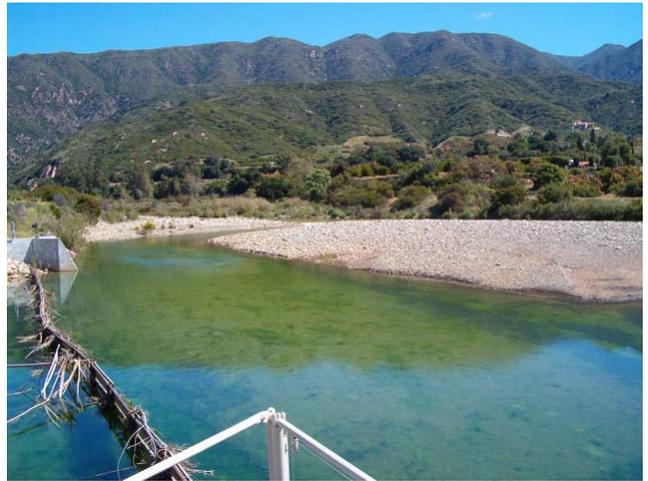
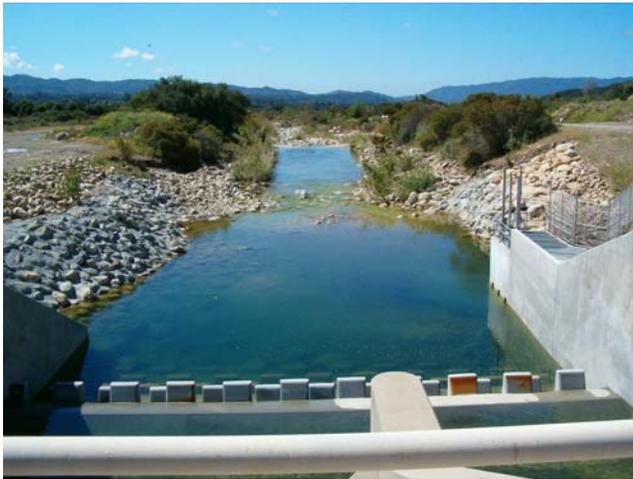
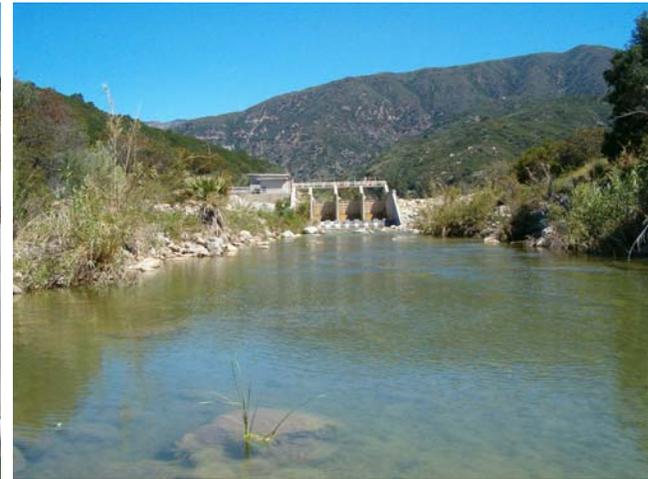
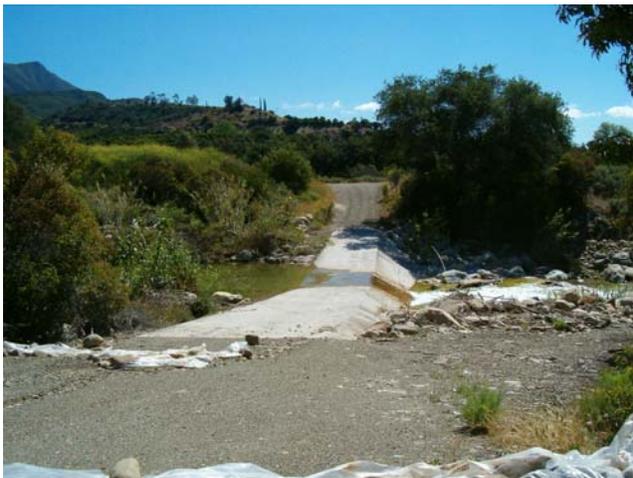
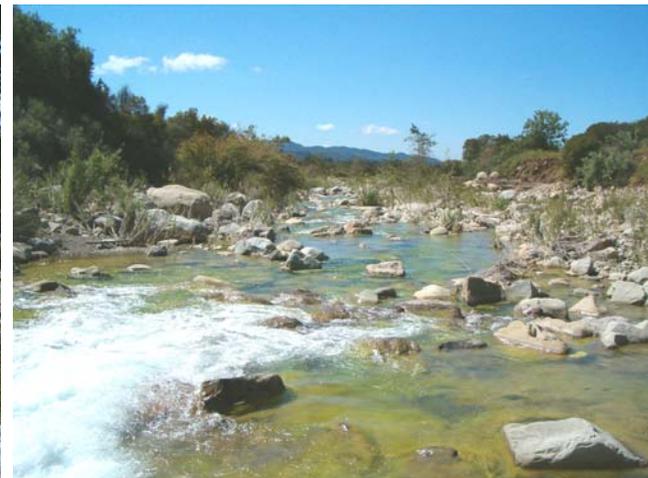
4/29/05 – Matilija Dam in spill condition, algae growth beginning to occur in river, flow condition at the entrance structure and downstream channel.
